KY 86 SCOPING STUDY
BRECKINRIDGE AND HARDIN COUNTIES
KYTC ITEM NO. 4-8901.00

APPENDIX F – GEOTECHNICAL OVERVIEW

Report of Geotechnical Overview

KY 86
Breckenridge and Hardin
Counties, Kentucky
Item No.4-8901.00
P-001-2017

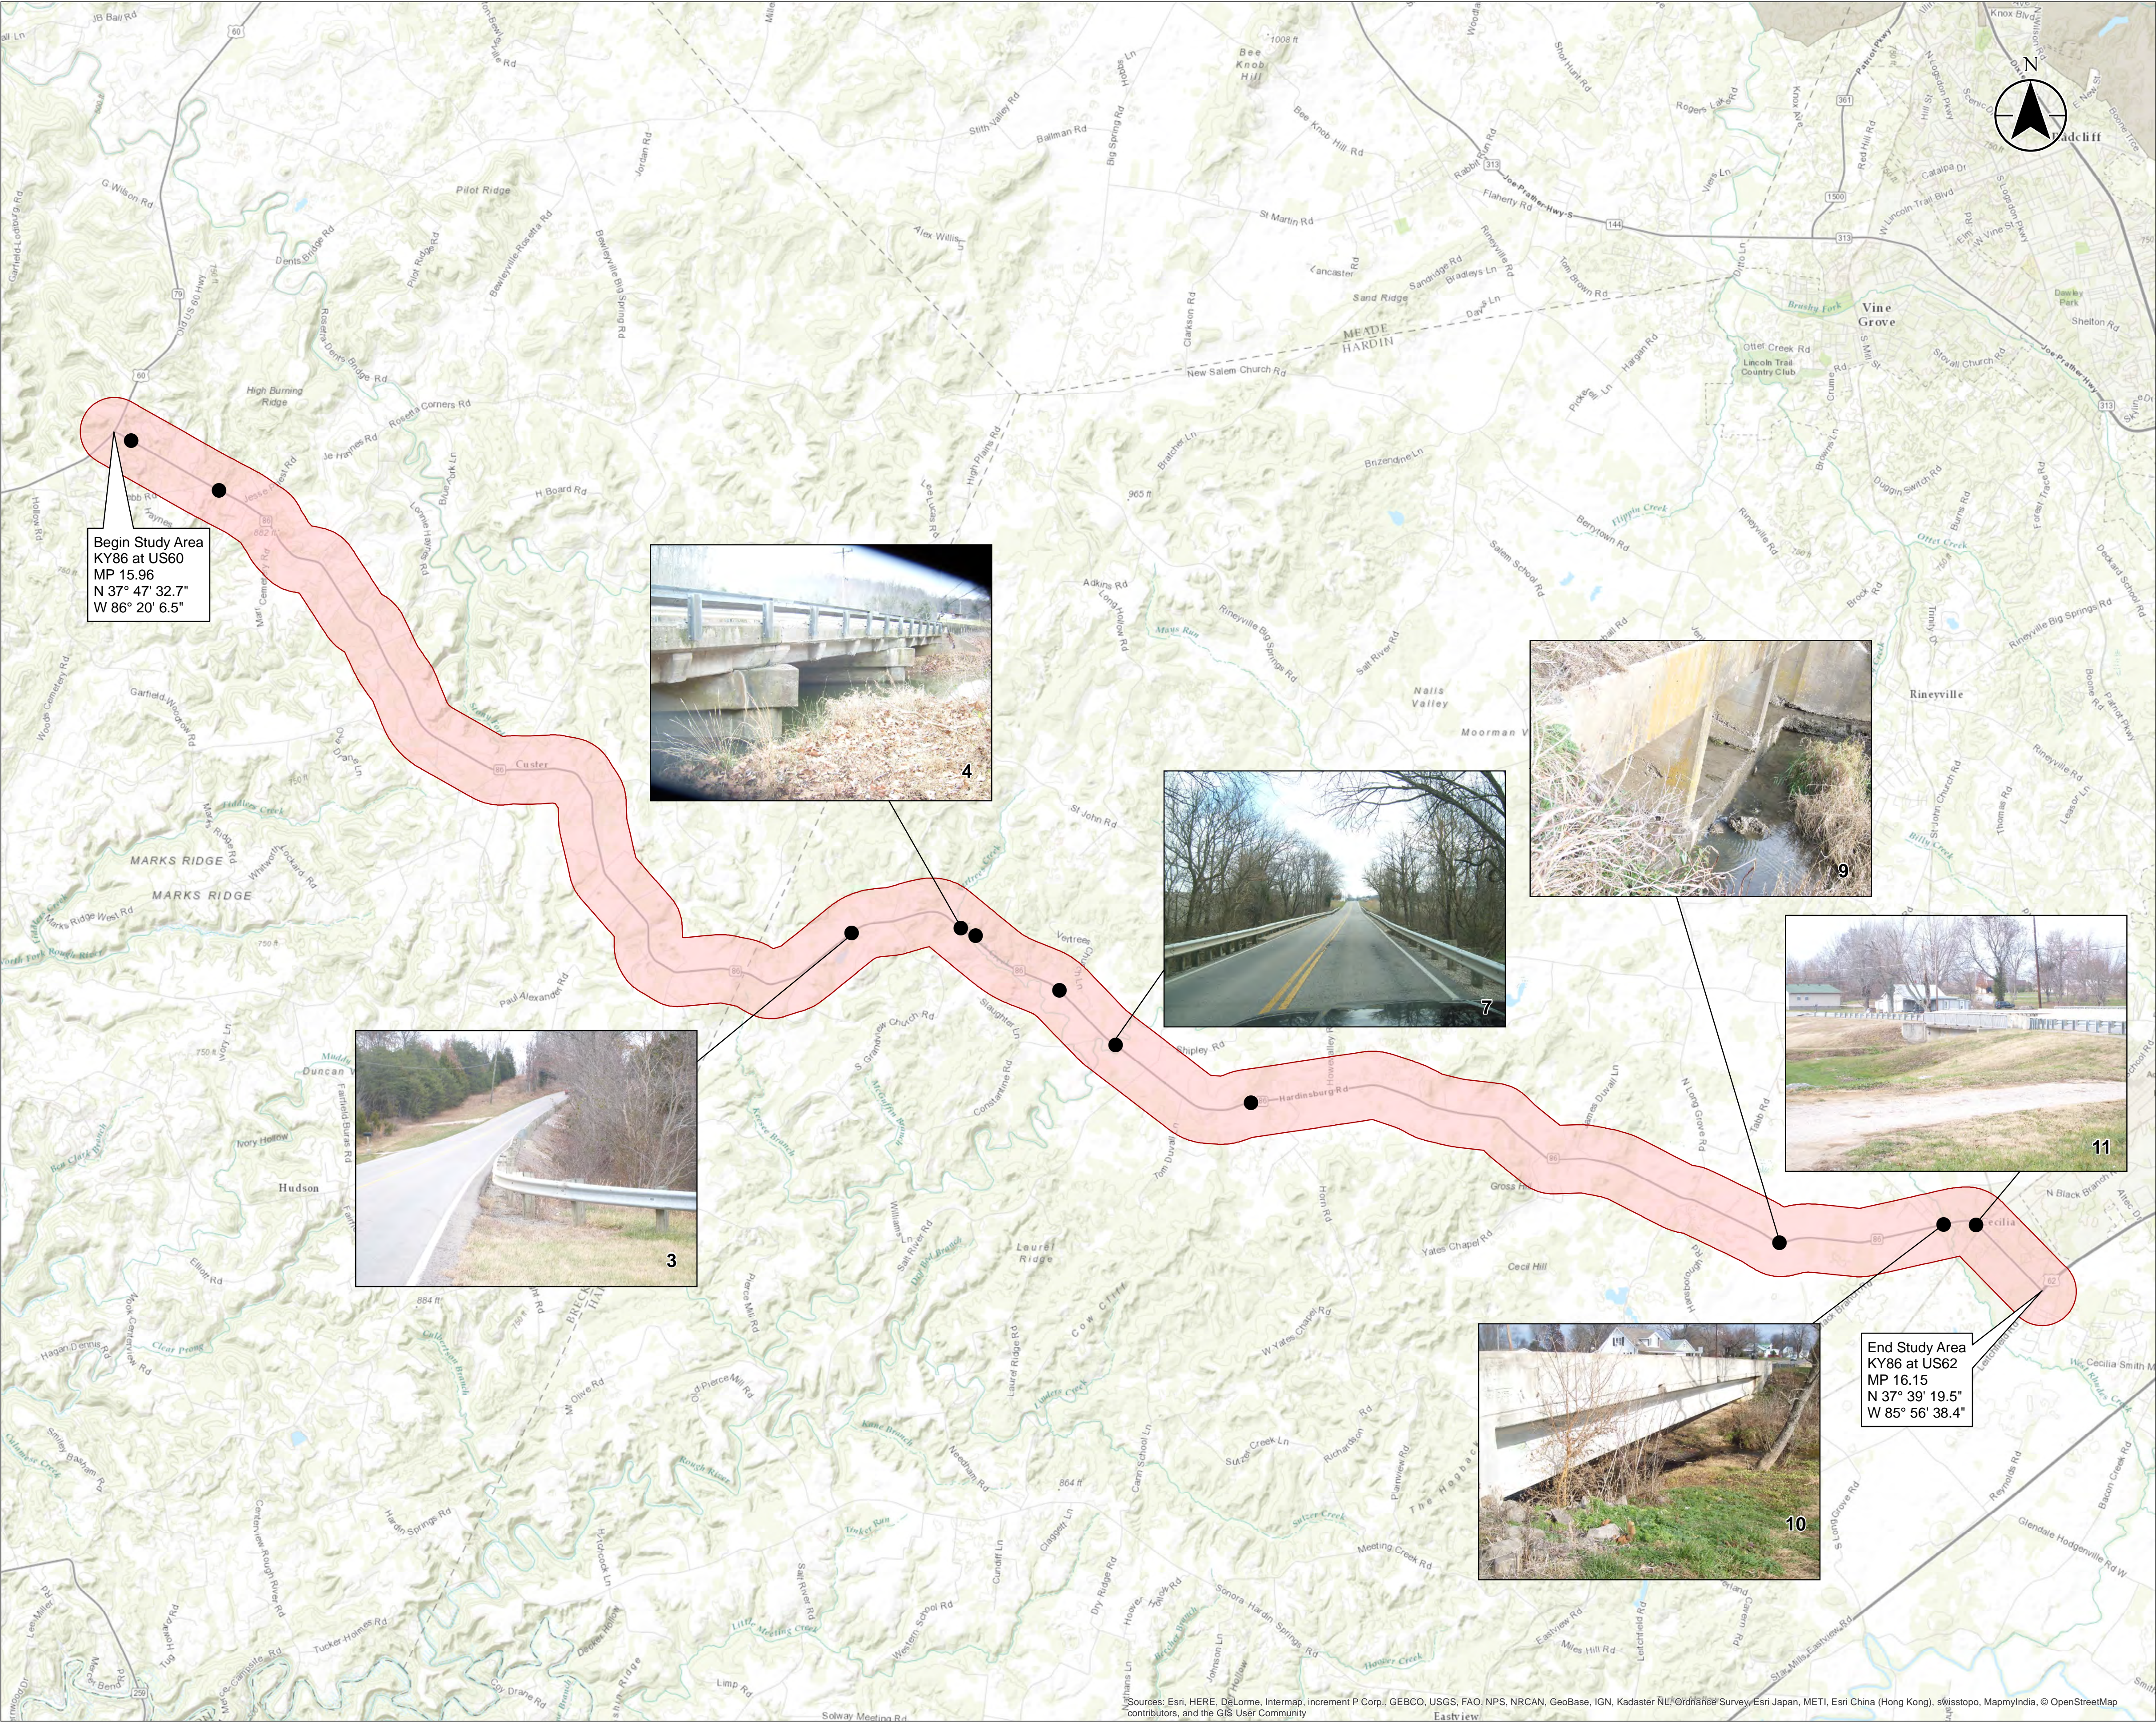
Photograph Number 3 shown on the topographic mapping in Appendix A, shows a dip in the guardrail which may be a sign of slope instability.

It is anticipated that mainline bridges will need to be widened and or replaced to meet horizontal clearances with the new highway. At this time, it is unknown as to whether the proposed roadway would require new and/or widened substructure elements. Based on Stantec's knowledge of the area, it can be anticipated that the majority of the bridges within the project corridor are likely supported by rock bearing foundation systems, which could be a spread footing or steel H-piles driven to bedrock. Culverts along the proposed alignment may be replaced or widened. It can be anticipated the culverts within the project corridor are likely supported by either a non-yielding or yielding foundation system depending upon the location along the proposed alignment. A detailed geotechnical investigation will be required to determine the foundation support system. Typical structures that are along the existing alignment are shown in Appendix A, Photograph Numbers 4, 7, 9, 10 and 11.

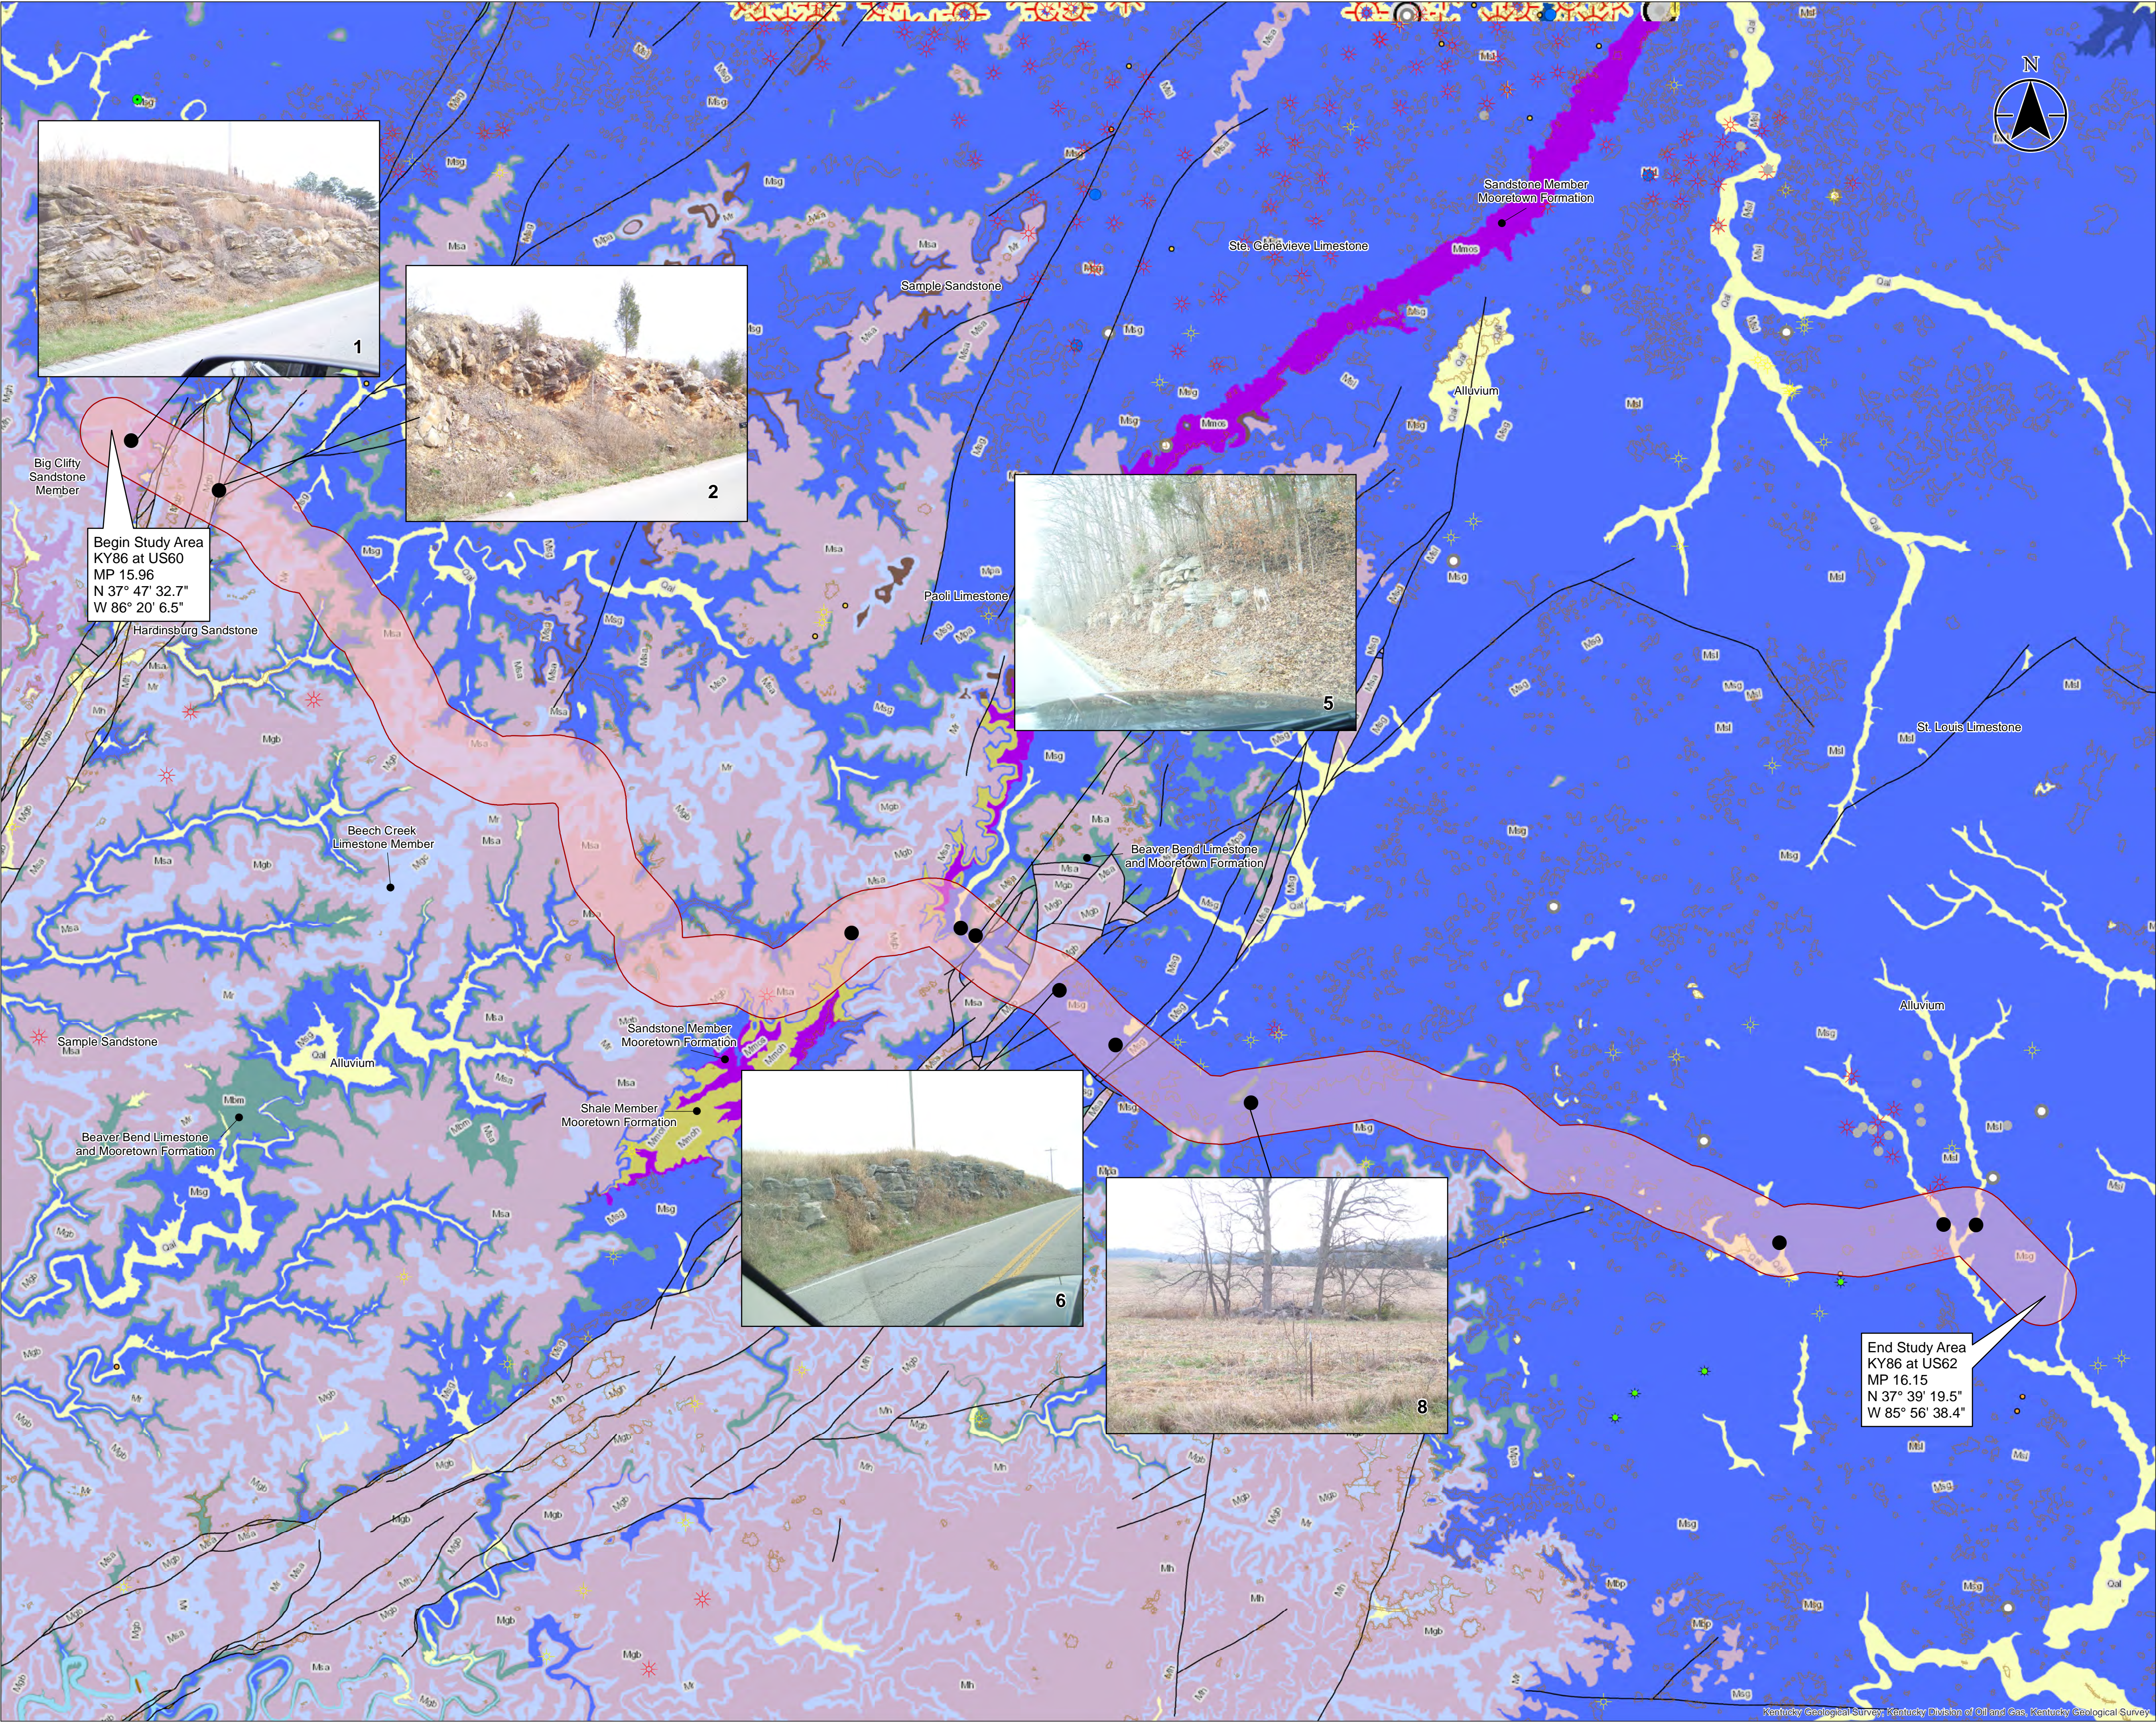
Available geologic mapping indicates that beginning half of the project corridor (near the Pole Bridge Fault), is underlain by the Big Clifty Sandstone and Beech Creek Limestone of the Golconda Formation, Reelsville Limestone, Sample Sandstone, Beaver Bend Limestone and Mooretown Formation. The Paoli Limestone and Ste. Genevieve Limestone primarily underlie the remaining portion of the alignment which is more prone to karst activity. Photograph 8 in Appendix B depicts a sinkhole area near the existing roadway alignment.

Faults are depicted along/near the project. The Locust Hill Fault and the Cave Spring Fault intersects the project alignment near the beginning of the project ranging approximately one-half to 1.5 miles south east of the community of Hensley. The Mount Olive and Pole Bridge Faults are mapped approximately 2 miles southeast of the Breckenridge-Hardin County Line. Additional geotechnical information may be needed in these areas, however they are not expected to have a detrimental effect on the project. These areas are depicted on the geologic mapping in Appendix B.

Typical cuts along the existing KY 86 alignment are shown in Photograph Numbers 1 and 2 on the geologic map presented in Appendix B. Photograph Number 2 shows a cut slope in an area of faulting. Based on visual observations, the bedding dips at an angle between 45 and 30 degrees.
