| TO: | Dave Heil, PE |
|---|---|
| SUBJECT: | Floyd and Johnson Counties |
| | KY 3 Corridor Study |

Geotechnical Overview Report

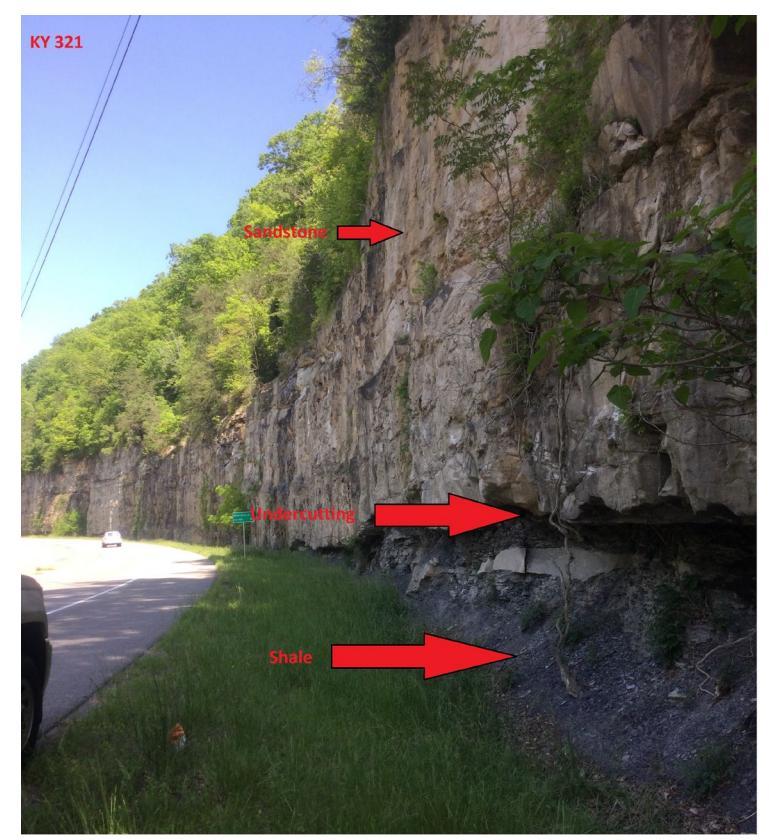
The project corridor is in an area that is prone to rock falls. Special care should be taken in the rock cut slope design phase to minimize conditions that enhance the probability of rock fall conditions. Shales are highly weatherable, when underneath a more resistant sandstone bed undercutting can occur increasing rock fall potential. During a site visit to the scoping area there was evidence of relatively recent rock falls Along KY 321. This may be attributed to over steepening of the rock cut on a single lift. Under cutting was also evident between the shale and sandstone contact. Please see picture below.

Picture 1: KY 321 more resistant sandstone overlaying a less resistant shale.
