Grant County

Corrin Gulick, PE, PTOE 12/14/2011

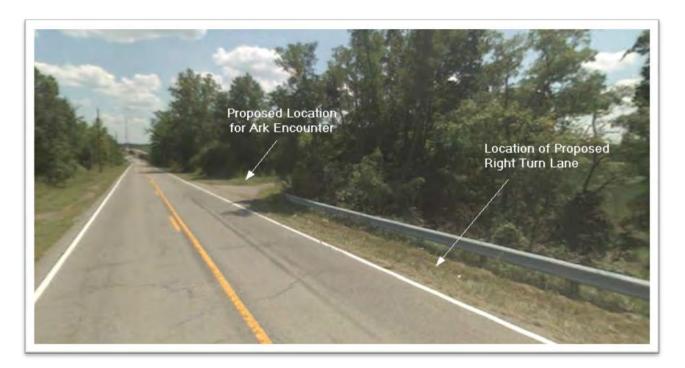
Figure 12 - Existing conditions at the proposed Ark Encounter

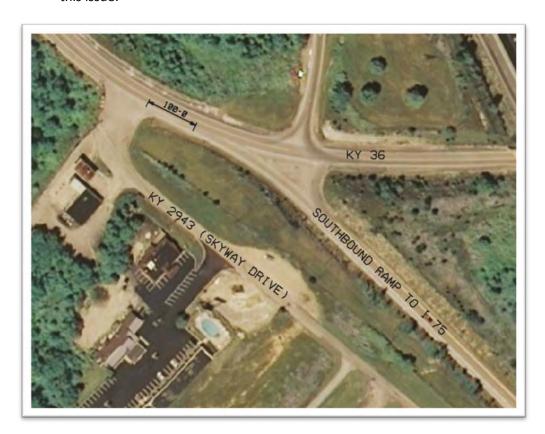
Figure 13 - Diagram depicting the spacing deficiencies between Skyway Drive and the southbound ramp onto I-75

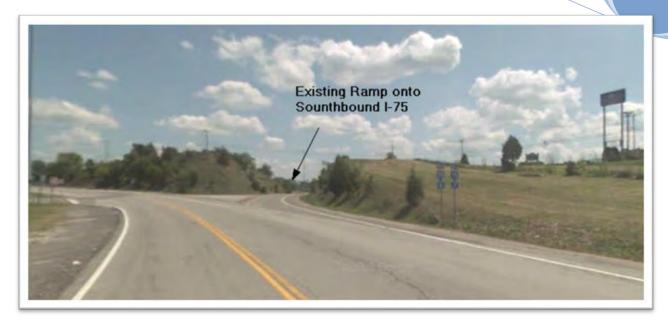
Figure 14 – On KY 36 looking east to the ramp onto southbound I-75

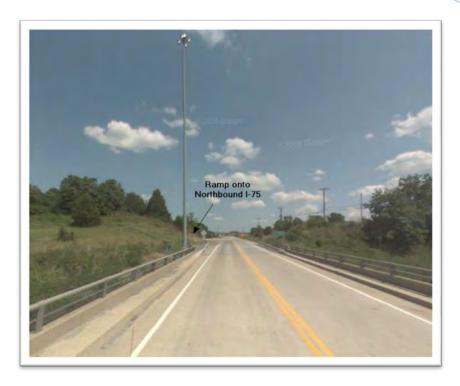
Figure 18 – On the KY 36 Bridge over I-75, looking east to the ramp onto northbound I-75
