DNA Study

06-1076 – CS 1193 Bridge Over Taylor Creek

Kentucky Transportation
Cabinet Department of
Highways District 6

6/14/2011

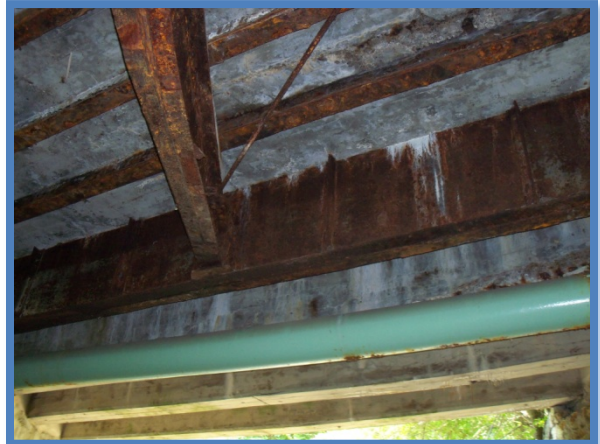
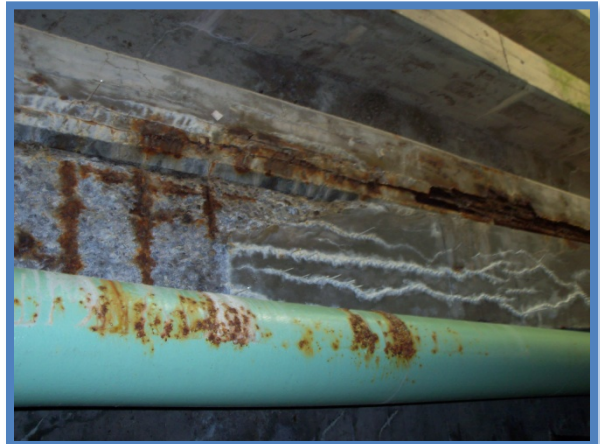
The bridge inspection report indicated three underground utilities are attached to the bridge. There is a 36 inch waterline on the north side of the bridge. A concrete arch was built to help support this line. To the north of the bridge, a 12 inch waterline was noted that runs along the creekbed. It appears that this line was encased in concrete at one point in time. Furthermore, there is a 12 inch waterline that runs through the north wingwall. At this time, it is not clear if any of these lines are still in service. A survey should be conducted to determine if more utilities are present in the area and which utilities are active lines. There will likely be quite a bit of utility relocation involved with this project.

Close-up of Waterline Going Through the Bridge

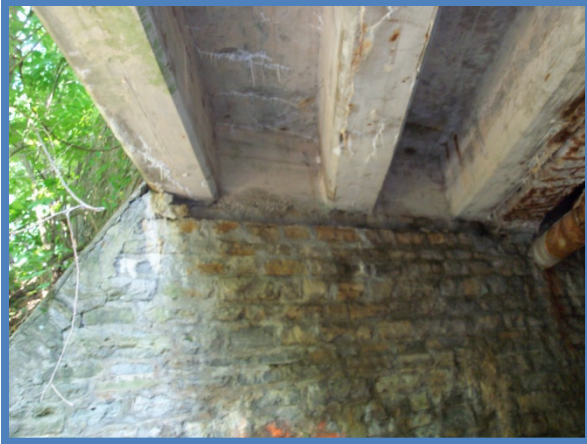
- The tee beam section of the bridge is experiencing severe spalling and the structural steel is exposed and rusting. Cracking and staining is evident throughout this portion of the structure

South Side of Bridge, Concrete Tee Beam Portion

1	110/1	R/Conc Open Girder	Concrete Beams- Left most side of structure (extension) is of Tee Beam design. Tee beam elements have moderate to heavy cracking (diagonal, transverse and longitudinal) throughout fascias with spalling, efflorescence and exposure of primary reinforcing steel material, which has a great amount of section loss as well. Left most exterior beam has large areas of spalling in random locations throughout exterior fascia with exposed and rusting reinforcing steel. Exterior face along the lower section at rear location has a 3.0' long area of horizontal cracking with seepage. Top edge near mid span and forward half has small areas of deterioration and spalling with seepage. Bottom flange has longitudinal cracking with stalactites at the rear abutment, longitudinal cracking and delamination at mid span, random cracking and spalling at the forward abutment location. Interior face has a few vertical cracks with seepage. Second beam from the left has varying degrees of longitudinal cracking in lower section with leakage, stalactites, delamination and one spalled area with exposed rusting reinforcing steel. Beam has dark damp areas from leakage, with horizontal, vertical and random cracking throughout. Third beam from left, you can not see the right most fascia, which is against beam #4. The left most face has a lot of longitudinal and random cracking with dark damp stained areas. The entire length along the bottom of this beam has longitudinal cracking and is damp from leakage. Bottom section at the rear end of beam has a 10' long area of spalling with six exposed rusting steel reinforcing bars and another 10.0' is delaminated and cracked. Fourth beam from left at the forward abutment location has a 10.0' area where the entire bottom is spalled off (2" deep) and has both vertical and longitudinal reinforcing steel exposed. Bottom section throughout this beam has longitudinal cracking, delamination, deterioration and a heavy amount of stalactites. (See Photos)

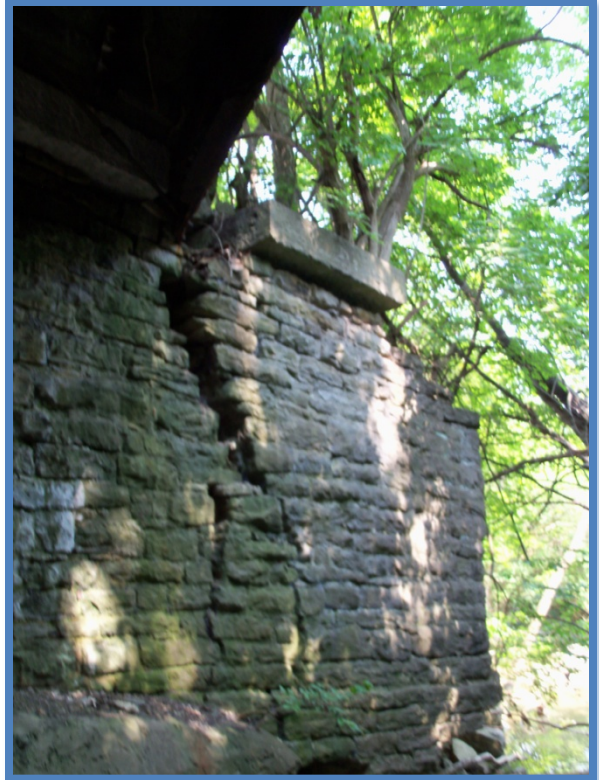
- The wingwalls are of a stone masonry design.
- There is a large vertical crack in the north-west abutment under the bearing of one of the girders. This crack is approximately six feet tall and one foot wide.

North/East Wingwall with large Crack

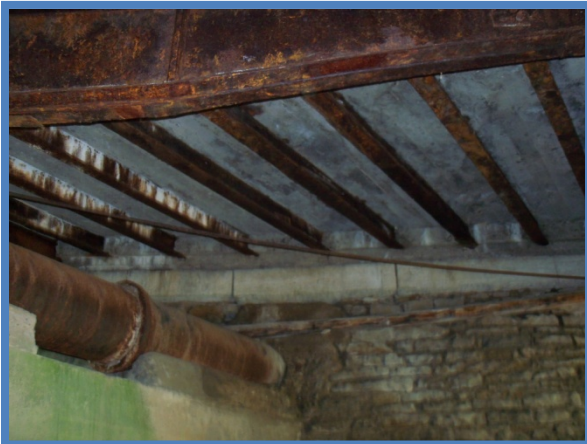
- The northern half of the structure is comprised of an unpainted steel open girder system. This was the original bridge.
- The steel girders on the bridge are in critical condition from severe rusting and significant section loss. The top and bottom flanges of the northern-most girder have almost 100% section loss, and severe section loss is occurring throughout the steel elements of the bridge.

- Floor beams on the bridge have severe rusting and major section loss.
- The southern half of the structure is comprised of a tee beam design. This newer portion of the bridge was constructed when the bridge was widened.

North Side of Bridge, Steel Girder Floorbeam System

1	151/1	Unpnt Stl Floor Beam		<p>Floor Beam- Floor beam element is under the right most section of this structure in between steel multi plate girders. Floor beam was found to be completely covered with severe rust and a major amount of section loss. Floor beam is of riveted buildup plate design, which has a severe amount of pack rust in between plate members, causing separation and deformation of elements.</p> <p>Floor beam element has anchor bolts which extend down through the deck, through timber runners and are connected to the top flange of this floor beam. All anchor attachment bolts are in very poor condition, but are all in place at this time. A timber runner is placed between the top flange of floor beam and bottom of beams. This runner is very rotten and decayed (very poor condition). Floor beam element continues to show swag and is swayed downward towards channel, which is approaching utility/waterline. Floor beam element was found to be in very poor condition at this time. (See Photos)</p>

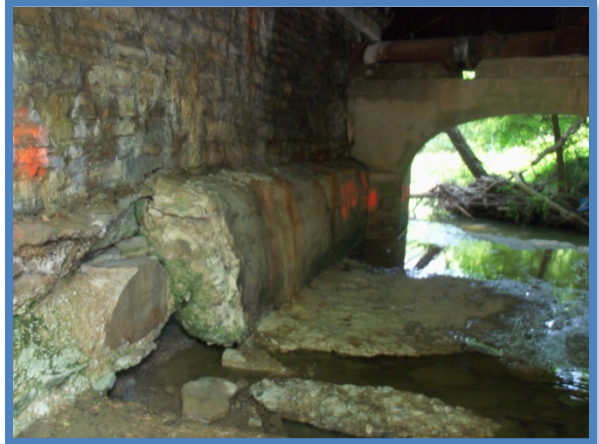
- Both of the south wingwalls have masonry failure. The north-east wingwall is completely missing. The north-west wingwall is completely undermined and several rows of masonry are completely gone.
- Sever scour is evident on the east and west ends of the bridge.

Scour Under East Side of Bridge

There is significant scour under the abutments and wingwalls of the existing bridge. In order to prevent future scour issues, the design team should consider countermeasures. This could include, but is not limited to, revising the skew of the bridge, and increasing the span length of the bridge.

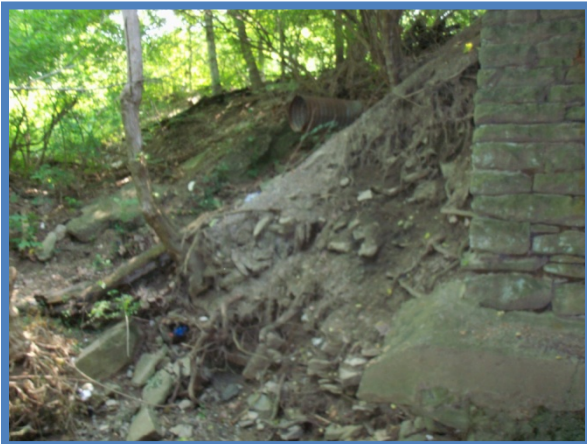
North/West Area with Missing Wingwall

The right rear wingwall is missing, the right forward wingwall is quickly falling off, and both abutments and right forward wingwall have scour. A large gap has developed between the right forward wingwall and forward abutment breastwall because the wingwall is pulling away. This gap is directly under the end of the right outside girder. If the wingwall pulls away much further the girder loses its bearing seat. THIS BRIDGE NEEDS TO BE REPLACED. FROM NOW ON AS LONG AS IT IS IN SERVICE IT SHOULD BE MONITORED OFTEN.

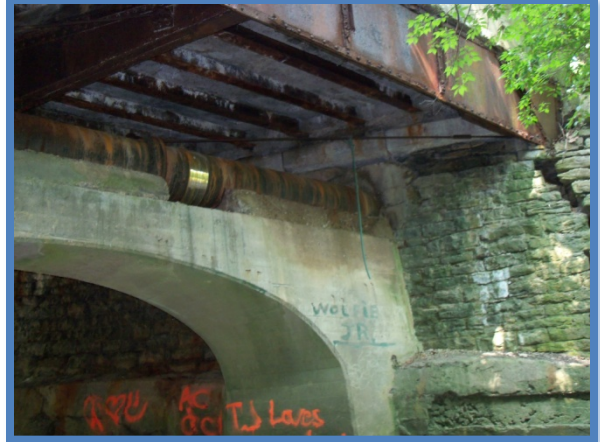
North Side of Bridge Showing Utility, Crack and I-Beam Section Loss

1	363/1	Section Loss SmFlag	Section Loss-	(See random notes throughout Element Description Steel Girders and Floor Beam.) A severe amount of section loss was found typical in random locations throughout this structure. (See Photos)
1	607/1	Utilities	Utilities-	Under the left half of span is a very large water line, approximately 3.0 feet in diameter. Because of the massive size of this line a concrete arch has been built under the bridge for this line to rest on. The concrete arch has some minor to moderate cracking and deterioration throughout. Under right half is an approximately 1.0 foot pipe; my guess is a gas line, which is slightly bent near the forward abutment location. This line has some random areas of rust where holes should be coming through shortly. This line has been repaired next to rear abutment in the past. Upstream from bridge approximately 5.0 feet going under the wingwall's in channel is another very large water line. Utility owners should be contacted for review of these lines/conduits, due to poor conditions noted. (See Photos)
