KYTC - Division of Environmental Analysis
Section 404 and 401 Permit Application Preparation Guidelines

Revision 10-31-2013

Marion County, KY
 Salt River Basin
 KYTC Item #4-192.2
 Reconstruction of US-68 from 4600' west of Hourigan Lane 1200' west of Beech Fork Church Road.
 HUC 14: 05140103-100-020

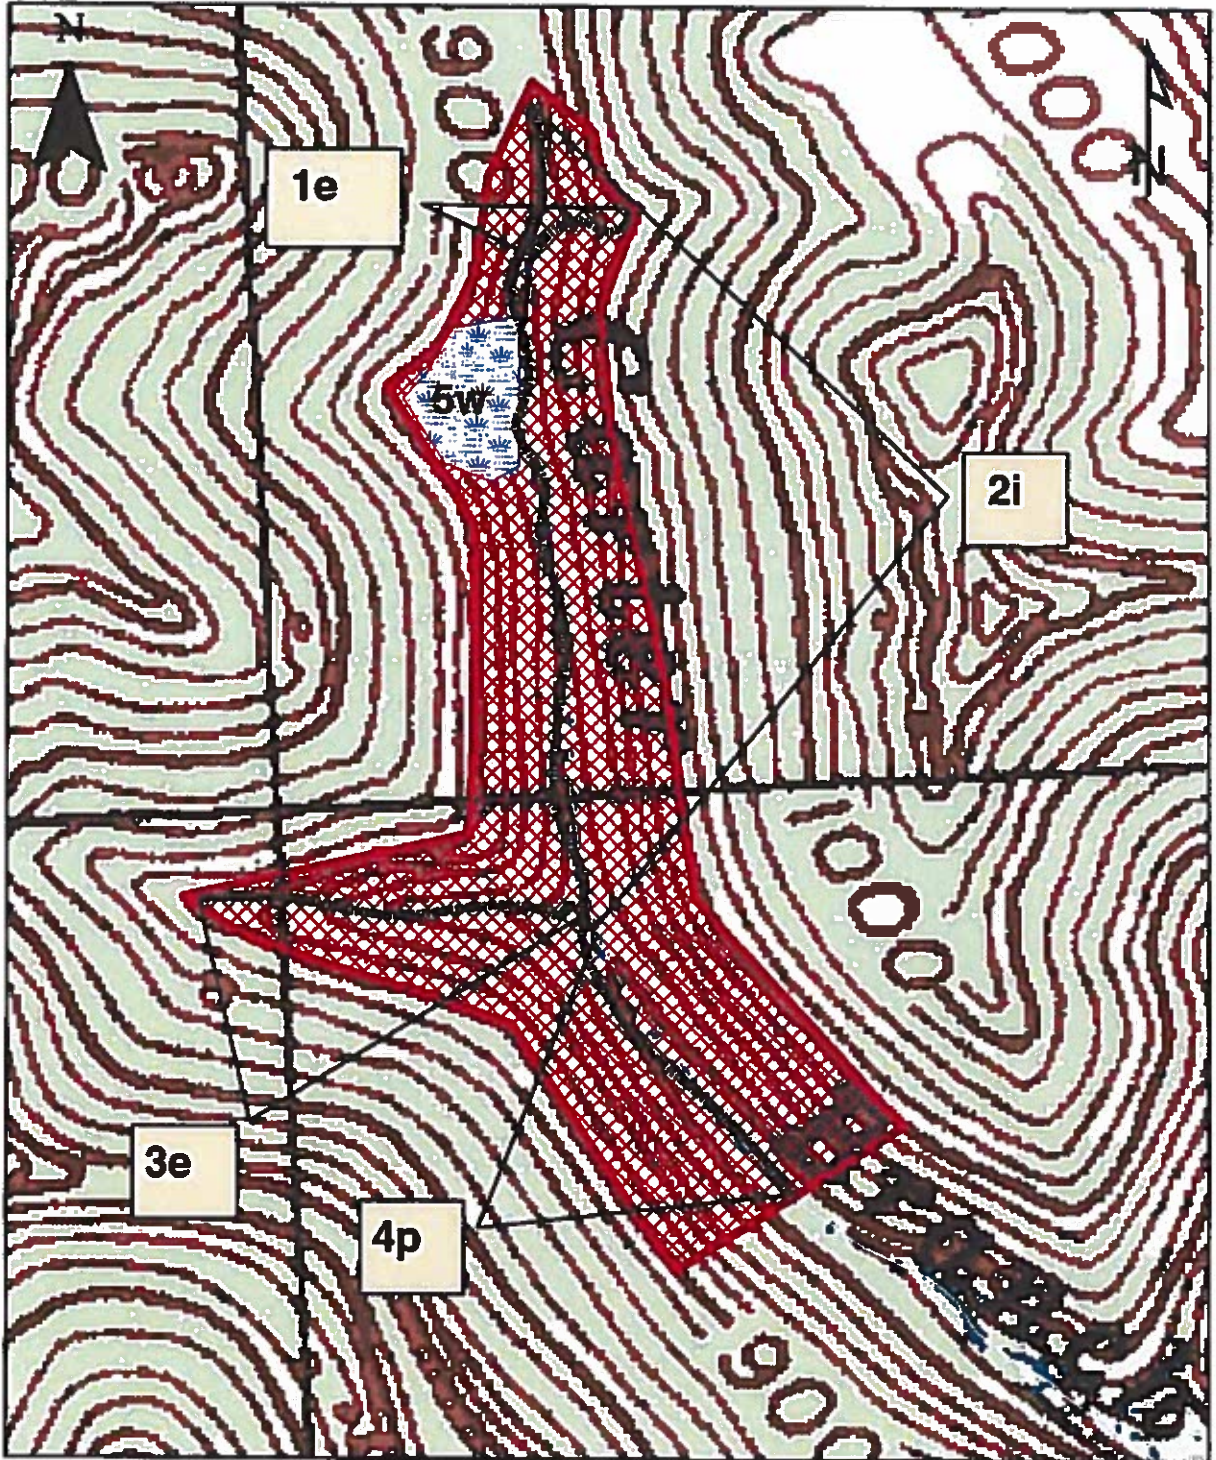
Carter Branch Excess Material Site Map

Marion County, KY
Salt River Basin
KYTC Item #4-192.2
Reconstruction of US-68 from 4600'
west of Hourigan Lane to 1200' west of
Beech Fork Church Road
HUC 14: 05140103-100-020

Excess Material Site Boundary

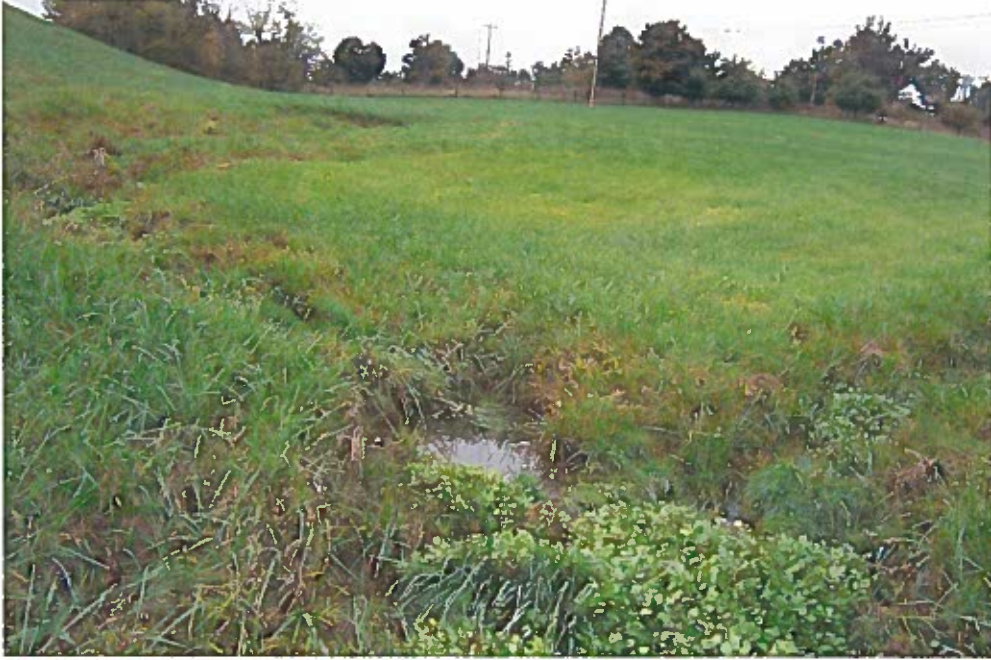
Station 71+55, Sheet R5, Intermittent, RBP score 35/poor

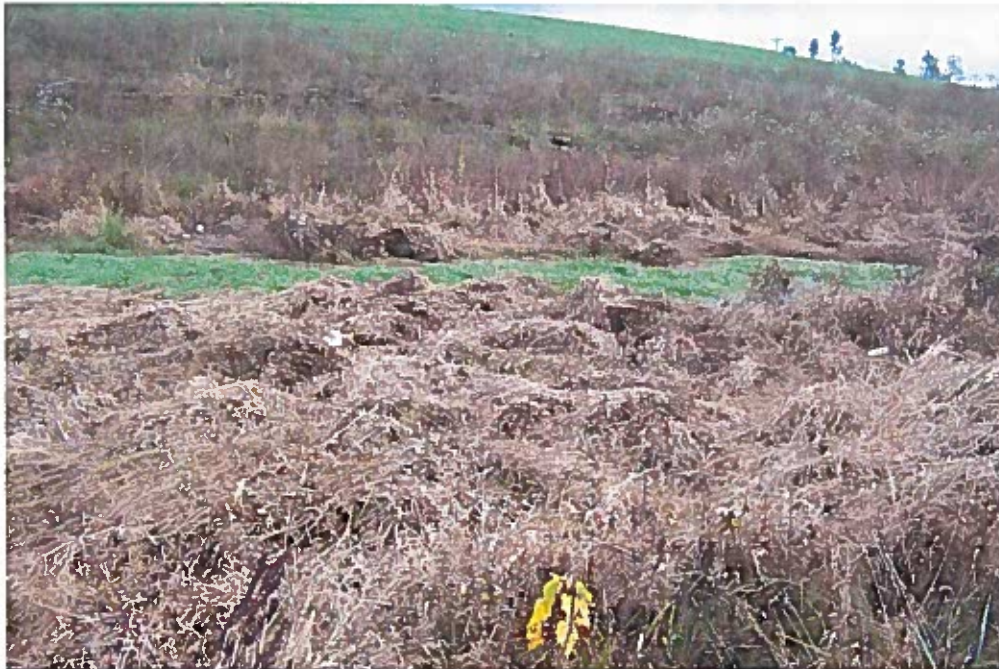
Station 72+75 Sheet R5, Wetland

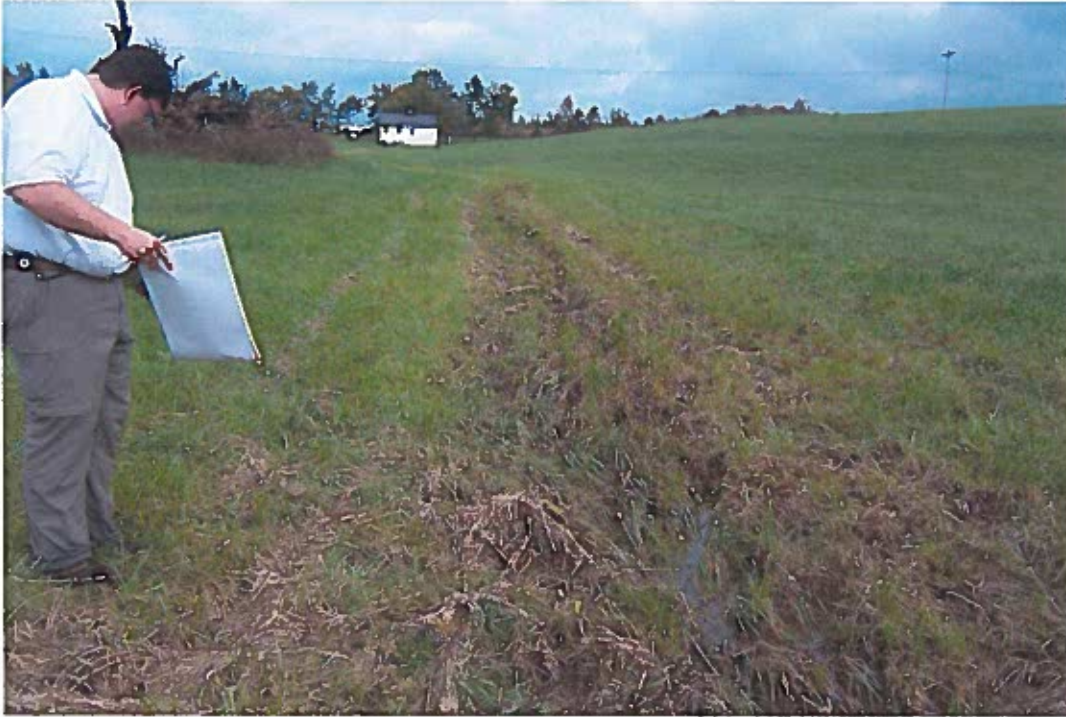
Station 75+72, Sheet R5, Intermittent, RBP Score 33/poor

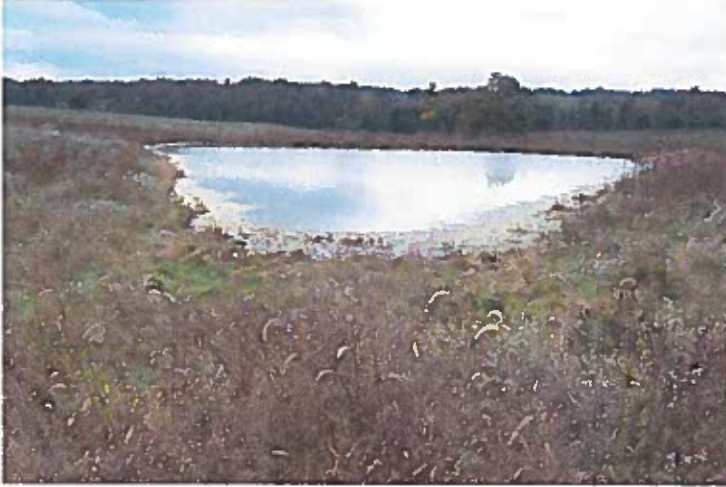
Station 97+00, Sheet R9, Pond, no defined channel leading into pond

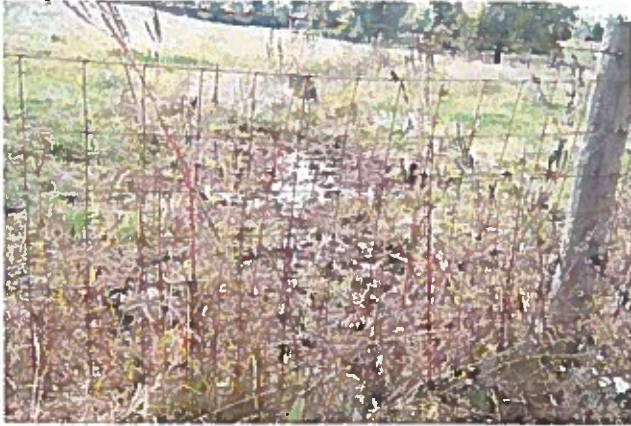
97+00 Pond outlet channel, Ephemeral, downstream of below photograph, RBP score 49/poor

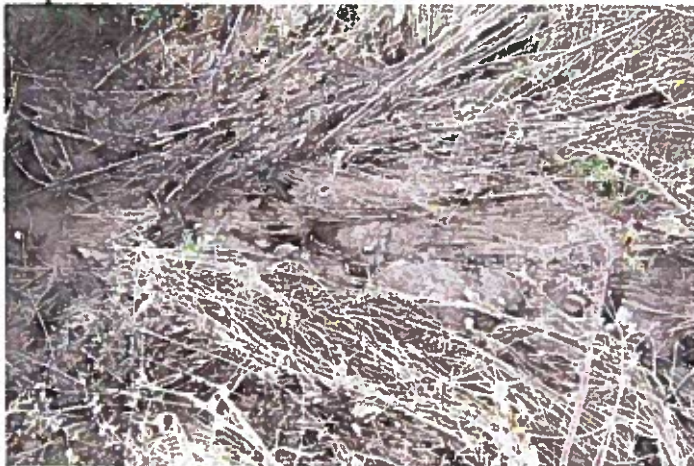
97+00 Substrate of channel leaving pond at immediate outlet, Ephemeral, RBP score 49/poor

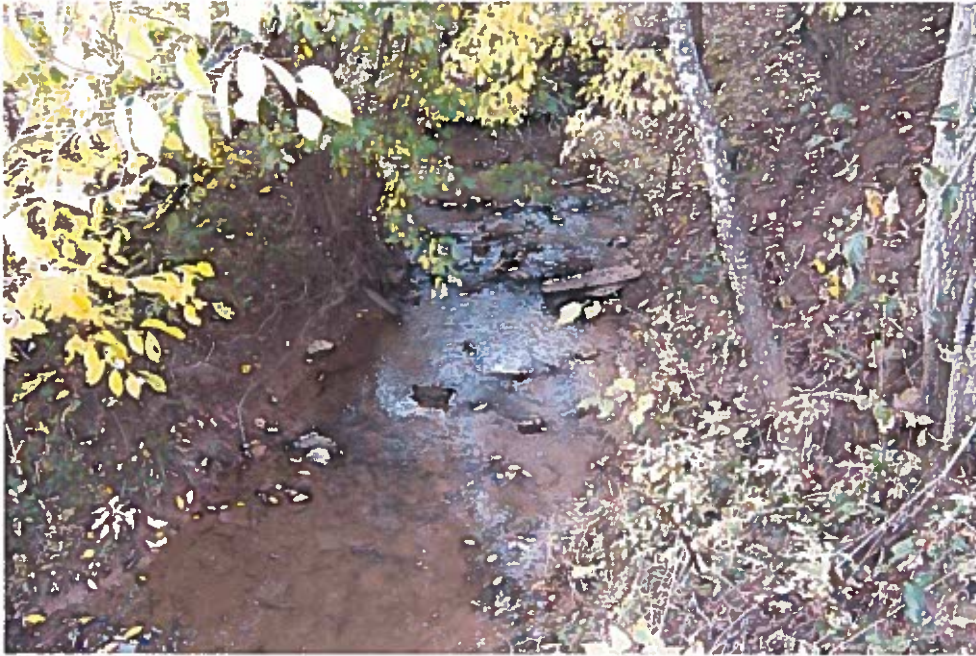
Station 150+37, Sheet R15, Intermittent, RBP score 117/poor

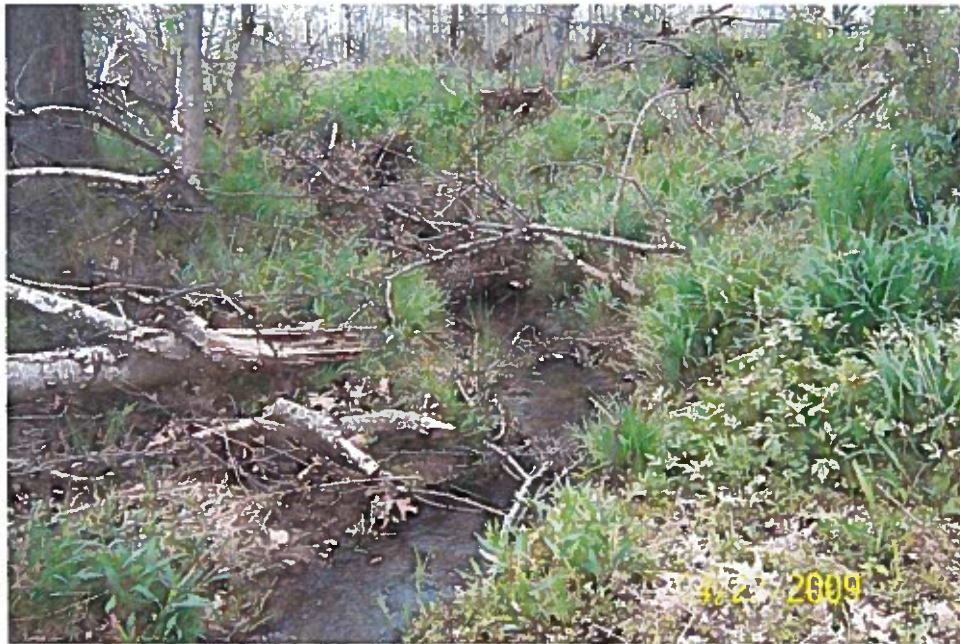
Station 154+49, Sheet R15, Intermittent, RBP score 110/poor

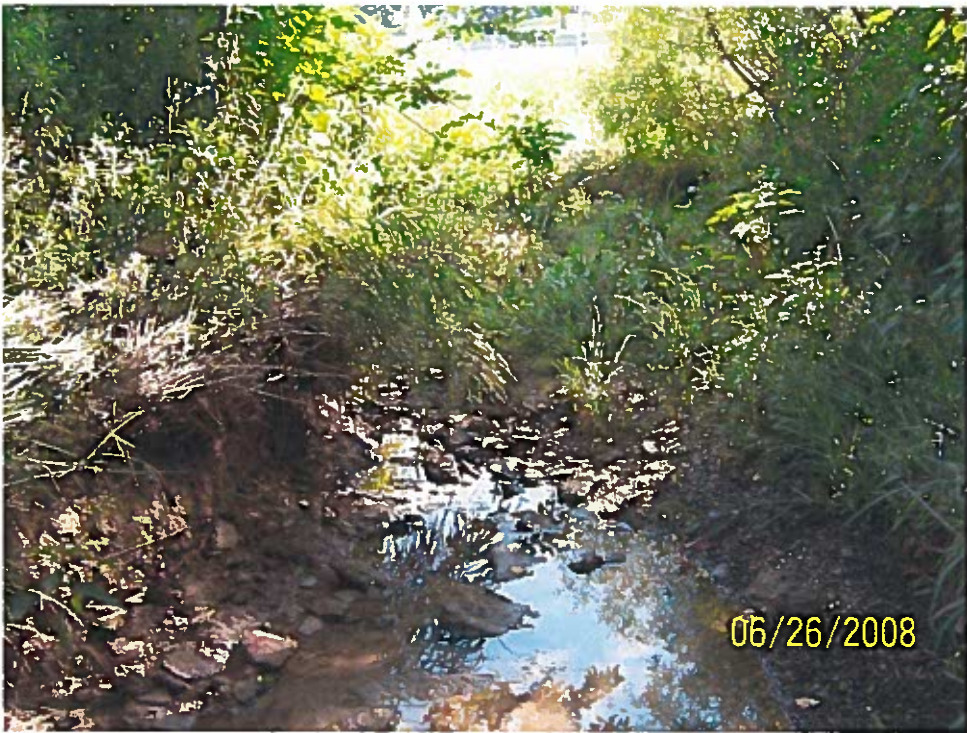
Station 42+00, Sheet R19, Intermittent, RBP score 113/poor

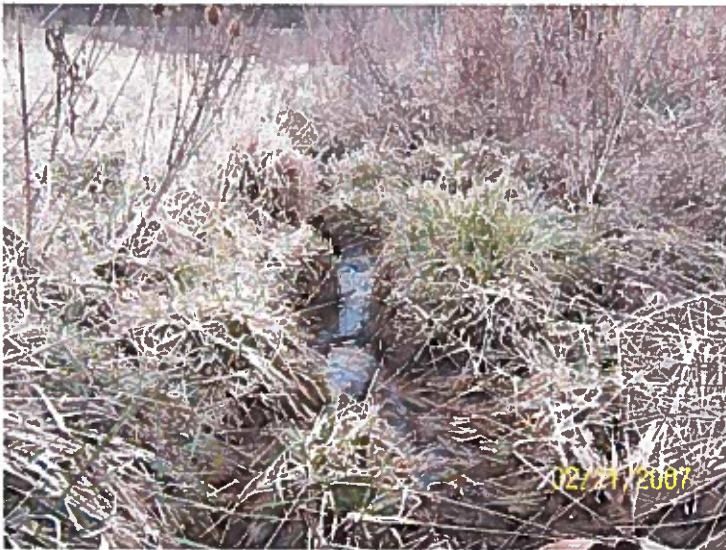
1e, see Carter Branch map sheet, Ephemeral, RBP score 103/poor

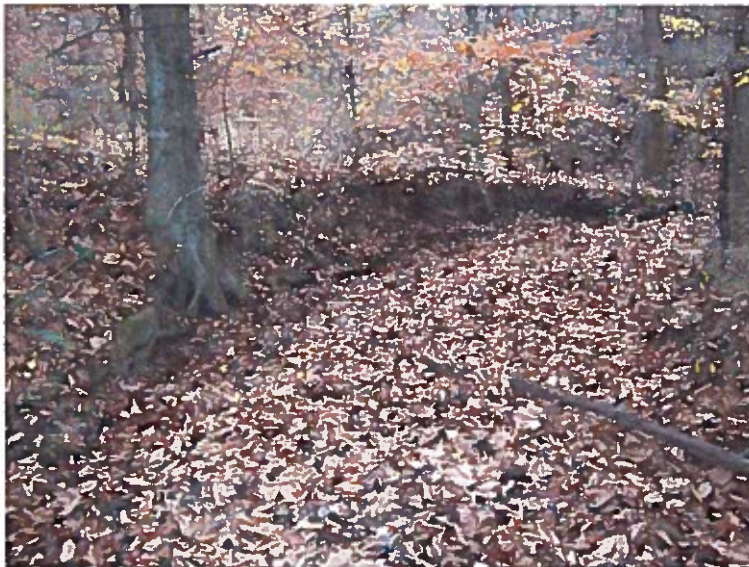
2i, see Carter Branch map sheet, Intermittent, RBP score 114/poor

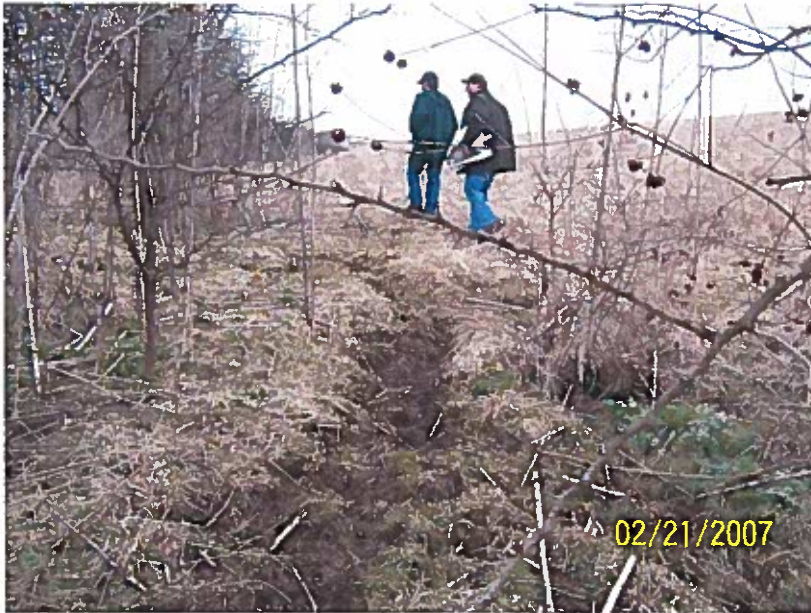
3e, see Carter Branch map sheet, Ephemeral, RBP score 110/poor

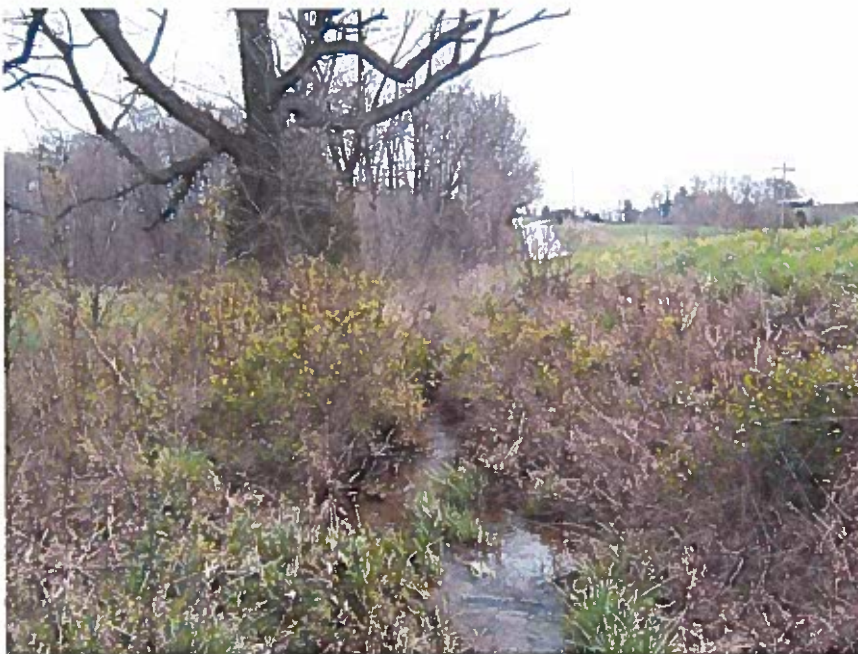
4p, see Carter Branch map sheet, Perennial, RBP score 100/poor

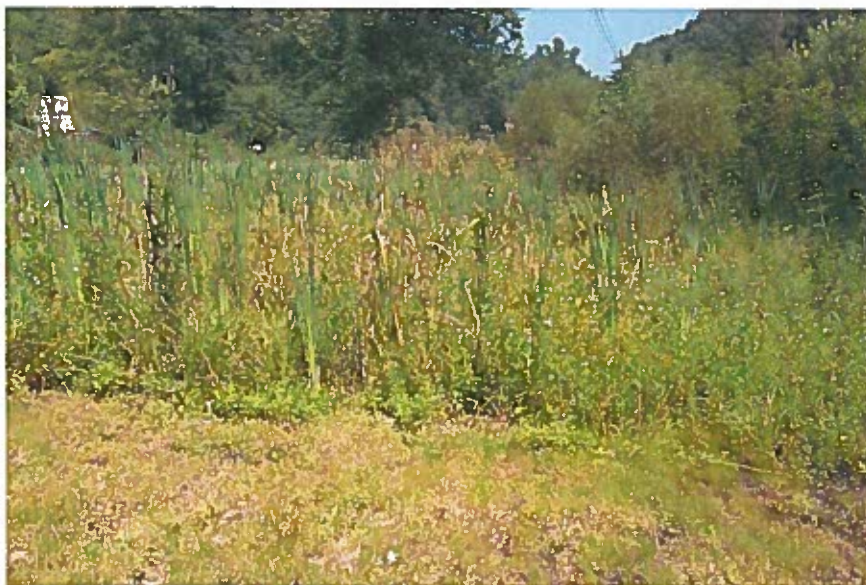
5w, see Carter Branch map sheet, Wetland
