ARCHAEOLOGICAL
SURVEY FOR A BRIDGE
REPLACEMENT AND
APPROACHES ON PR 1015
OVER ROCKCASTLE CREEK,
MARTIN COUNTY,
KENTUCKY (KYTC ITEM #
12-1092.00)

**Phase I Archaeological Survey for the Bridge Replacement and Approaches on PR 1015 over
Rockcastle Creek, Martin County, Kentucky (KYTC Item # 12-1092.00)**

Archaeology Report

August 2014

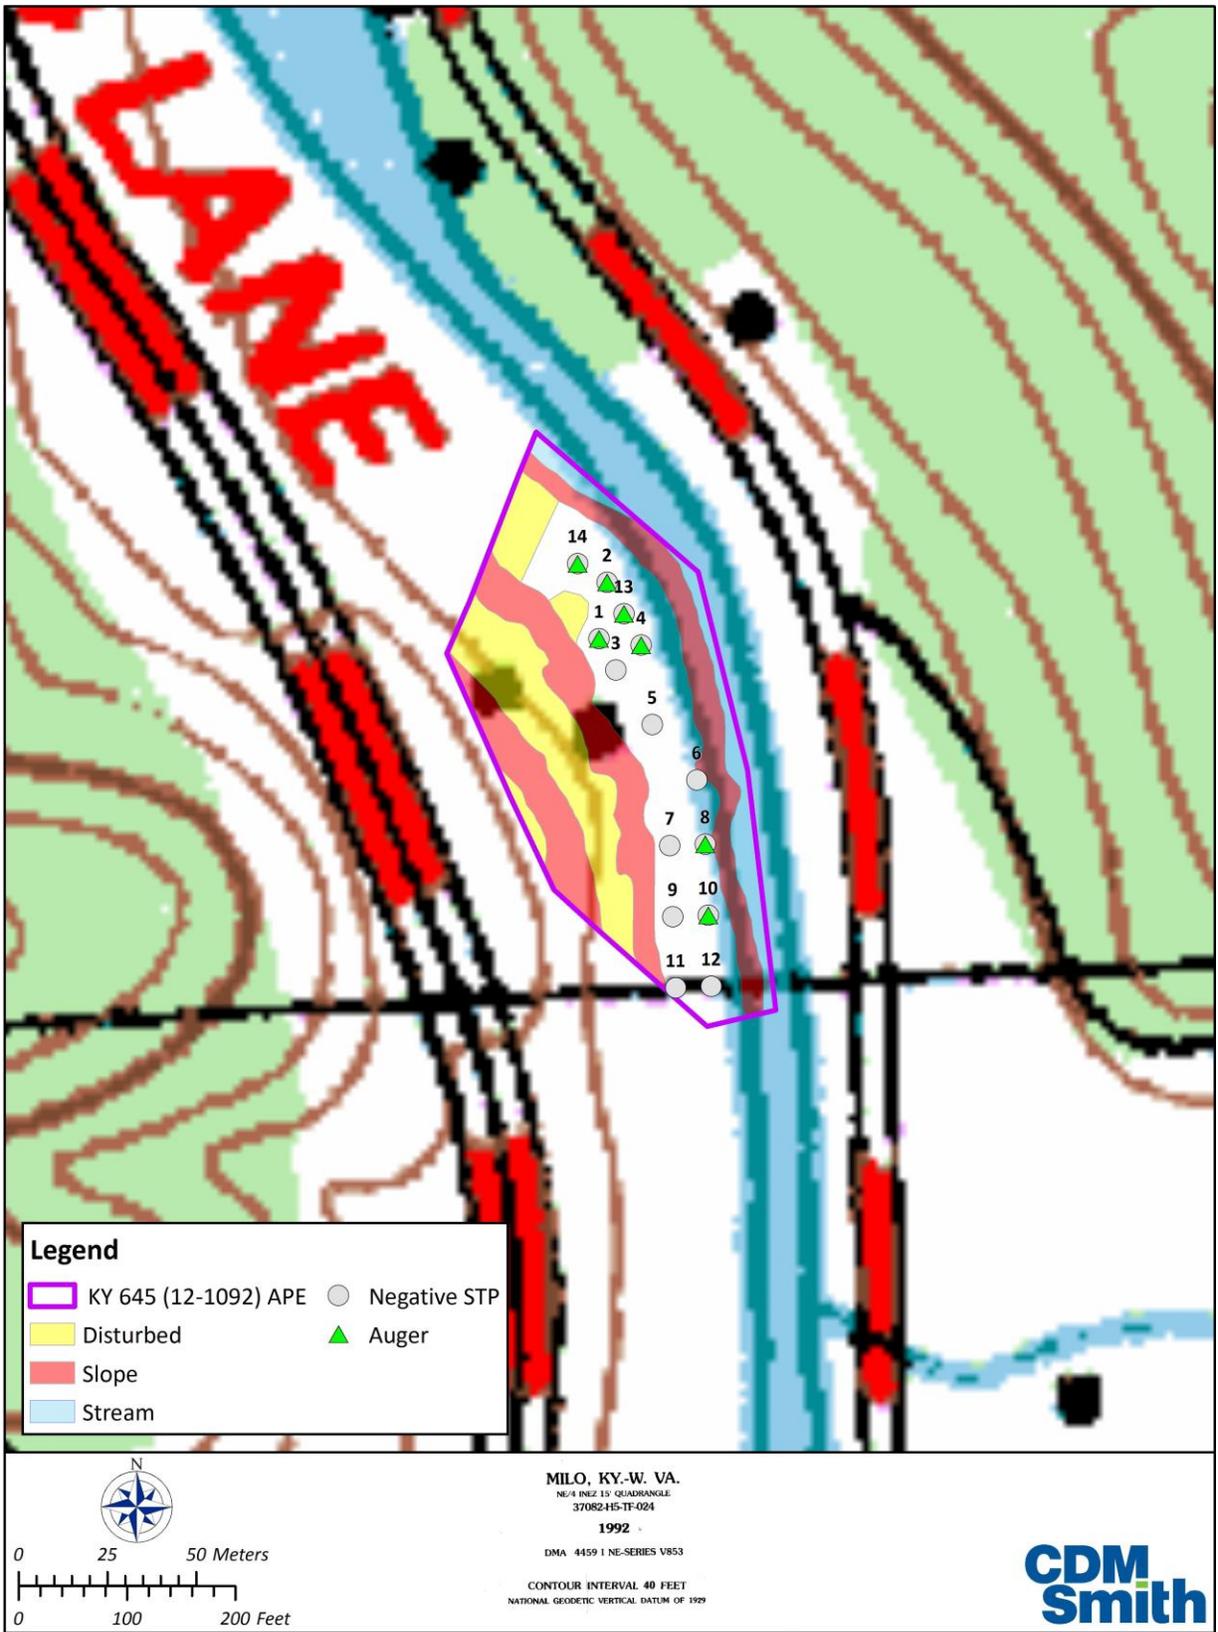
Figure 3-1. Location of STPs on USGS Topographical Map.

The Rockcastle Creek floodplain north and south of PR 1015 was shovel probed on a 10 and 20m interval grid (Figure 3-2). Fourteen shovel probes were excavated in this portion of the project area. Seven of these were augured to depths below one meter in order to test for buried cultural deposits in the deeper alluvial sands; none were present. Shovel Probes 1 and 2 produced cultural material from the topsoil down to 150 cm below surface. These materials included small, unidentifiable metal fragments (n=3), an unidentifiable nail fragment (n=1), and coal/cinders (n=25). Eight of the coal/cinder fragments were collected from the disturbed top 60 cm of STP 1, excavated just beyond a septic leech area serving the older house above. The property owner, Gertie Cox, provided some valuable information in a personal communication on August 19, 2014. Mrs. Cox stated that the older house had originally been located down on the floodplain portion of the APE prior to construction of KY 645. During the road construction the terrace area was created from fill and the house was moved up to its current location. Additionally, Mrs. Cox informed us of the presence of the two leech fields and her in-ground septic system at the northern end of the project APE. A single shovel probe was placed up on the terrace in a garden area that was covered in mown grass. This probe verified the area as filled in with rock and subsoil.

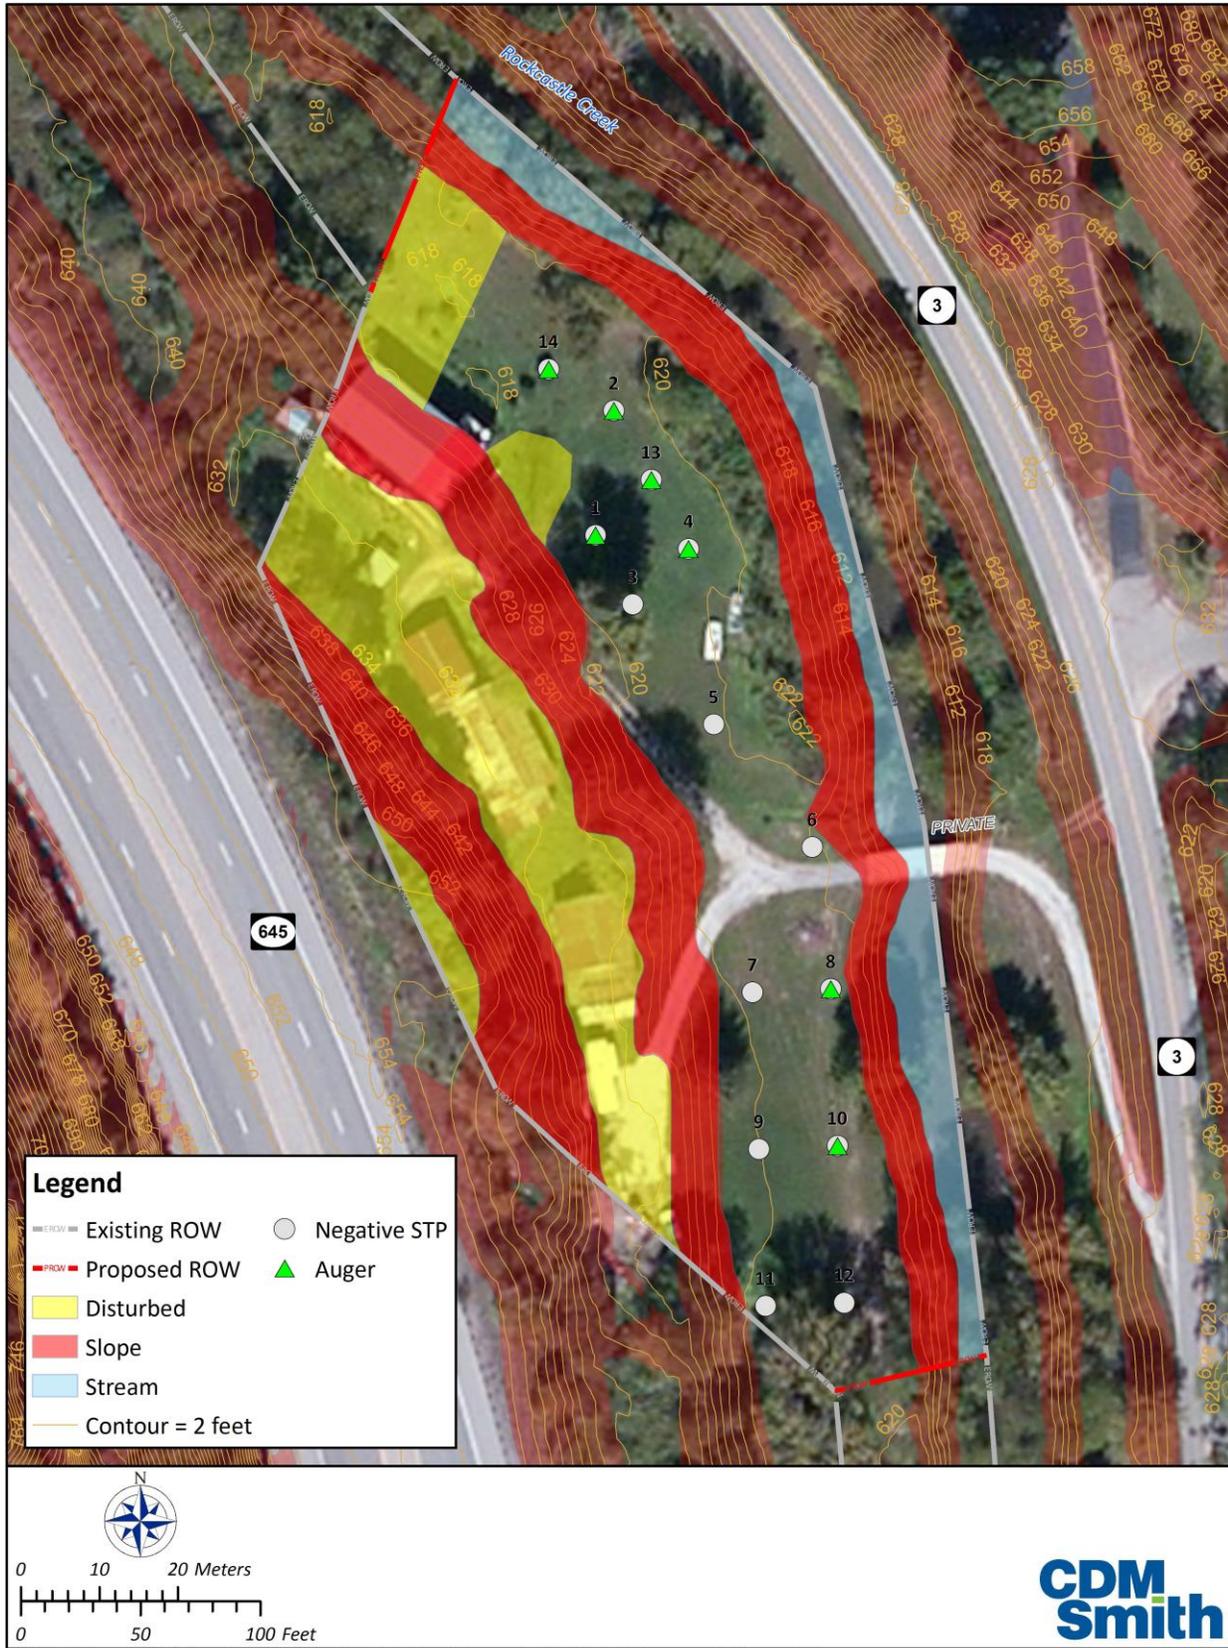
Figure 3-2. Location of STPs on Aerial Photograph.

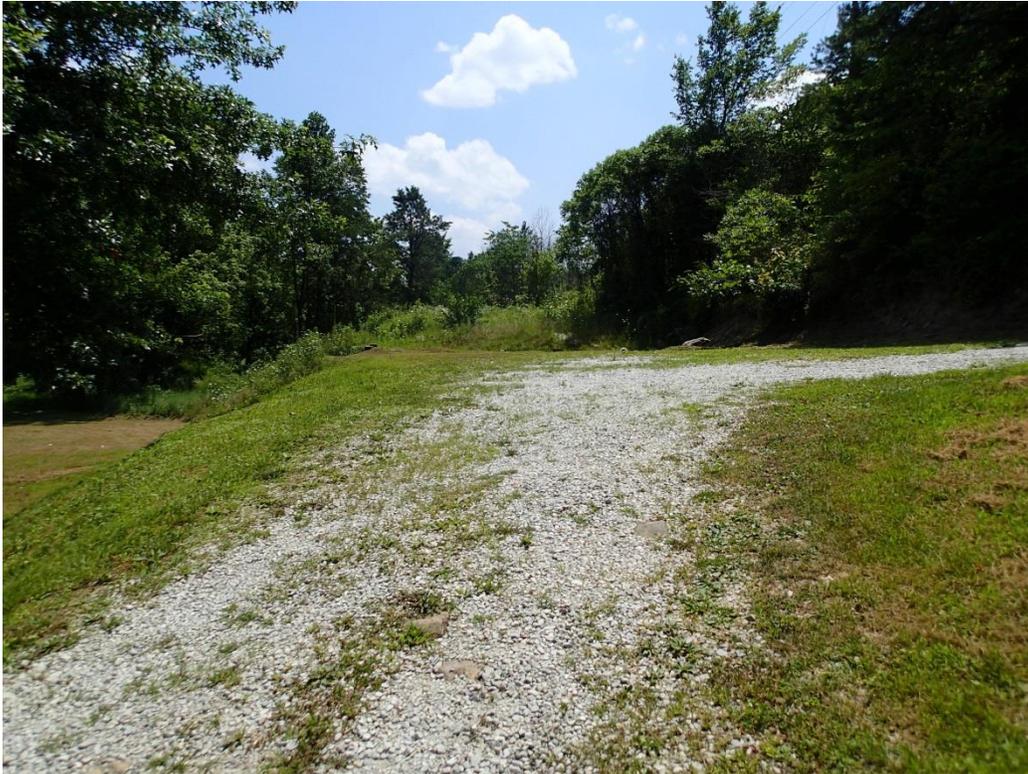
Figure 3-7. Residential Development Within APE, Looking South.

Visual Inspection concluded that no rock overhangs or rockshelters existed within the APE. Residential disturbances were photo-documented on the terrace in the northern half of the APE. These included driveway construction, graveling of parking areas, cutting into the banks, a water meter indicating the location of a water line, and landscaped areas. Subsoil was visible at the surface in all level areas surrounding the three residences, with the exception of one grassy garden area at the northern end. The terrace edge was very steeply sloped down to the floodplain, and the portion of APE between the houses and KY 645 was also very steeply sloped.

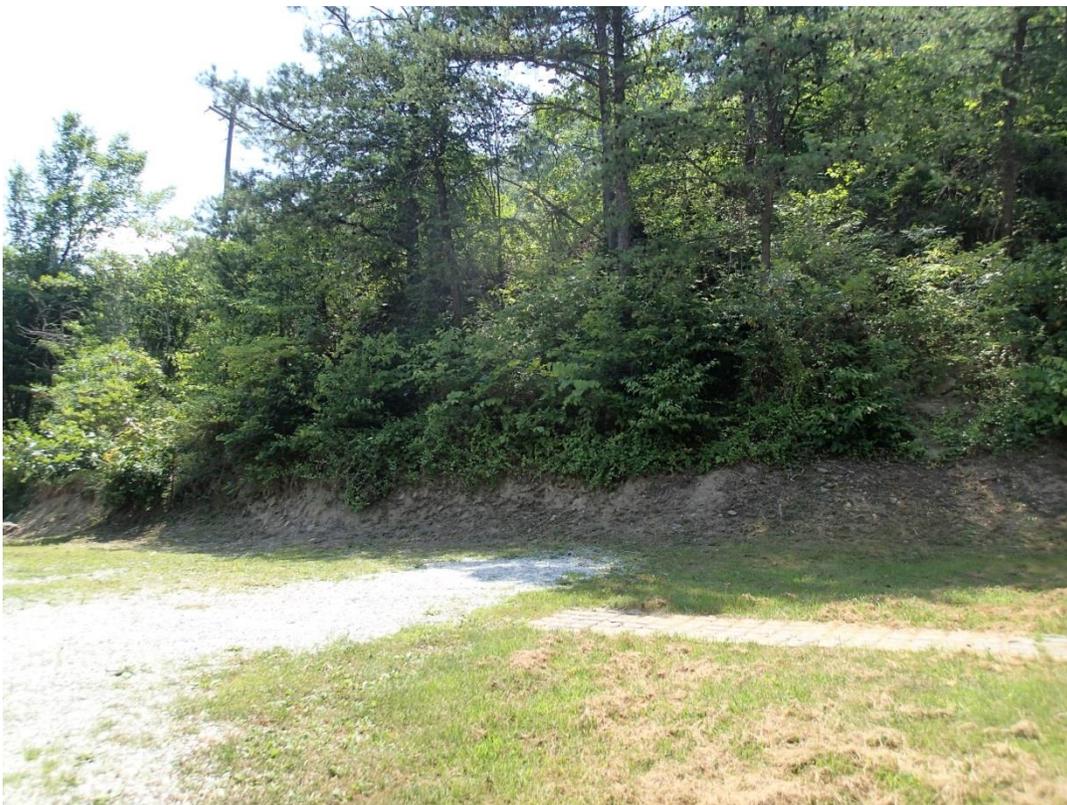
Figure 3-8. View of Residential Disturbances on Terrace, Looking West.

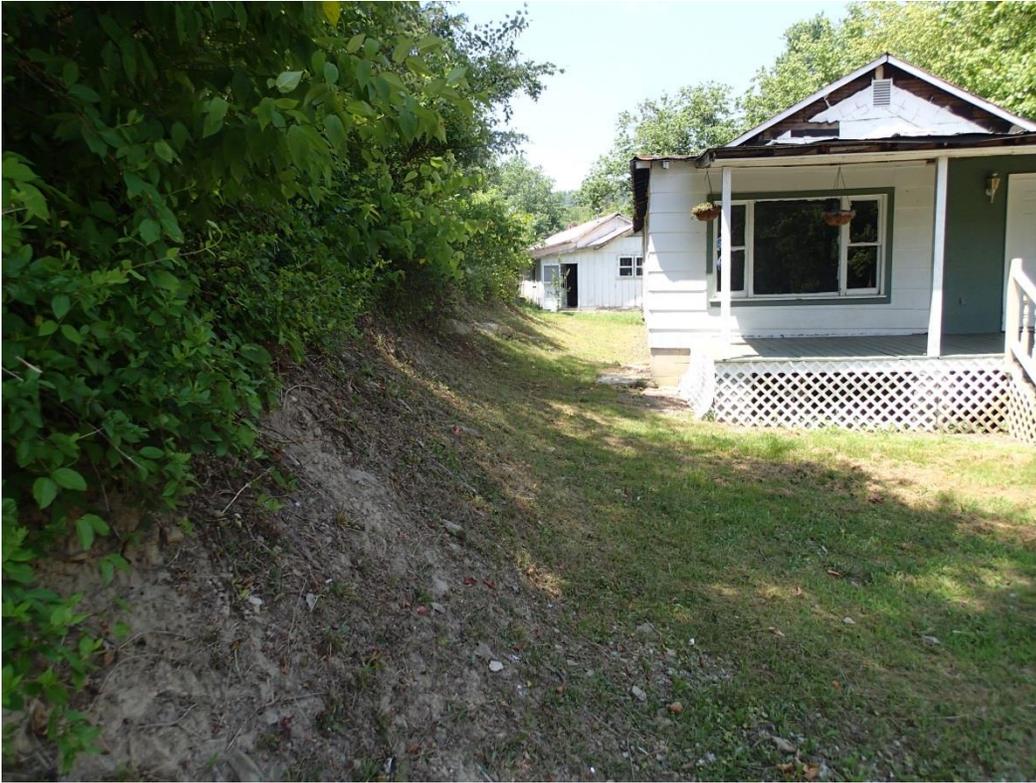
Figure 3-9. Residential Disturbances Within APE, Looking North Northwest.

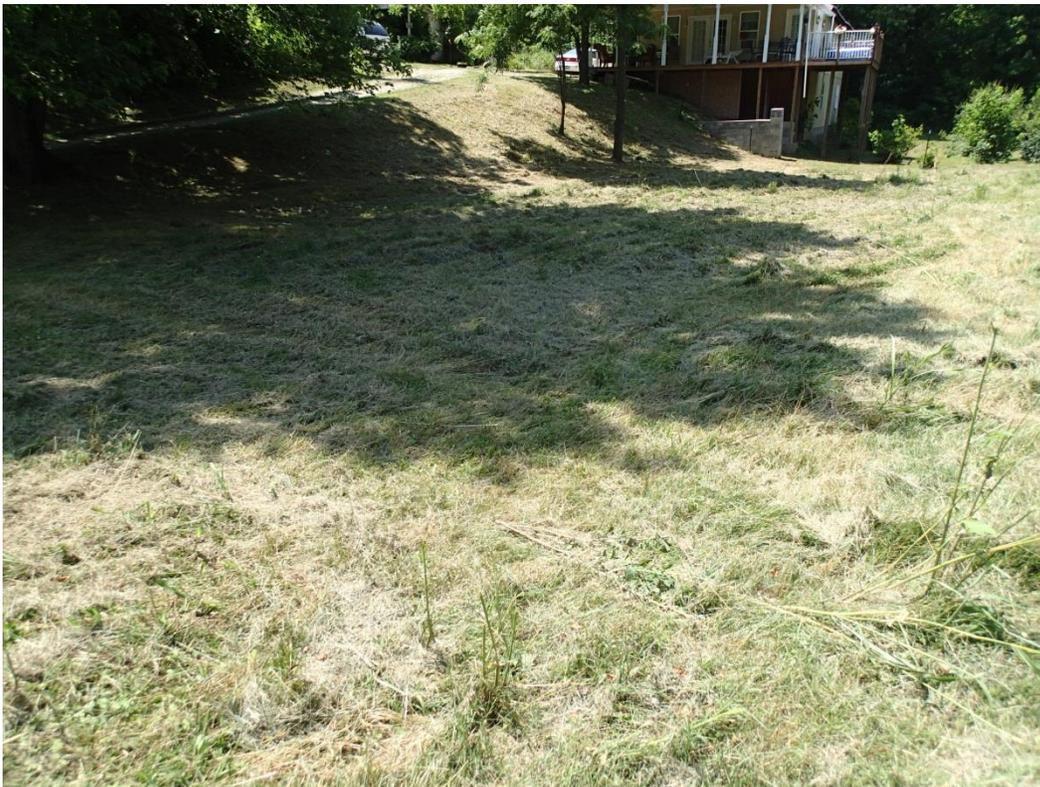
Figure 3-10. Residential Disturbances Within the APE. Looking Northwest Towards Most Modern House and Septic Leech Area Just Right of the Two Trees in the Center.

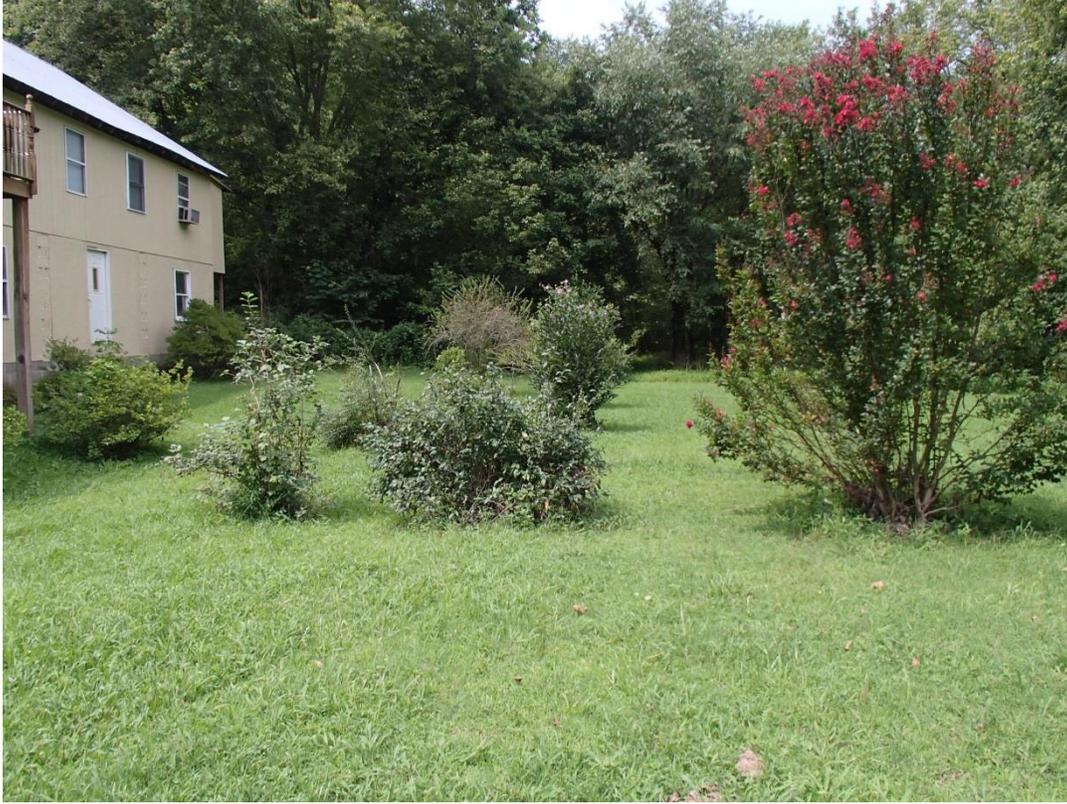
Figure 3-11. View of Modern Septic Leech Area and Tank Area, Looking North.

The findings were submitted to the Office of State Archaeology (OSA) for review as a possible archaeological site. Kentucky's OSA concluded that these materials did not constitute an archaeological site "due to the paucity of artifacts, the thoroughly mixed/disturbed deposits, and the use of the site area for a septic system" (Christina Pappas, personal communication 2014). Based on this determination, all probes were all negative, the only cultural material being produced from disturbed soils around two leech fields and a modern house.
