Pike County US 460 ARC Corridor Q

Preliminary Design (1995-1996)

1998 - Final Design Begins

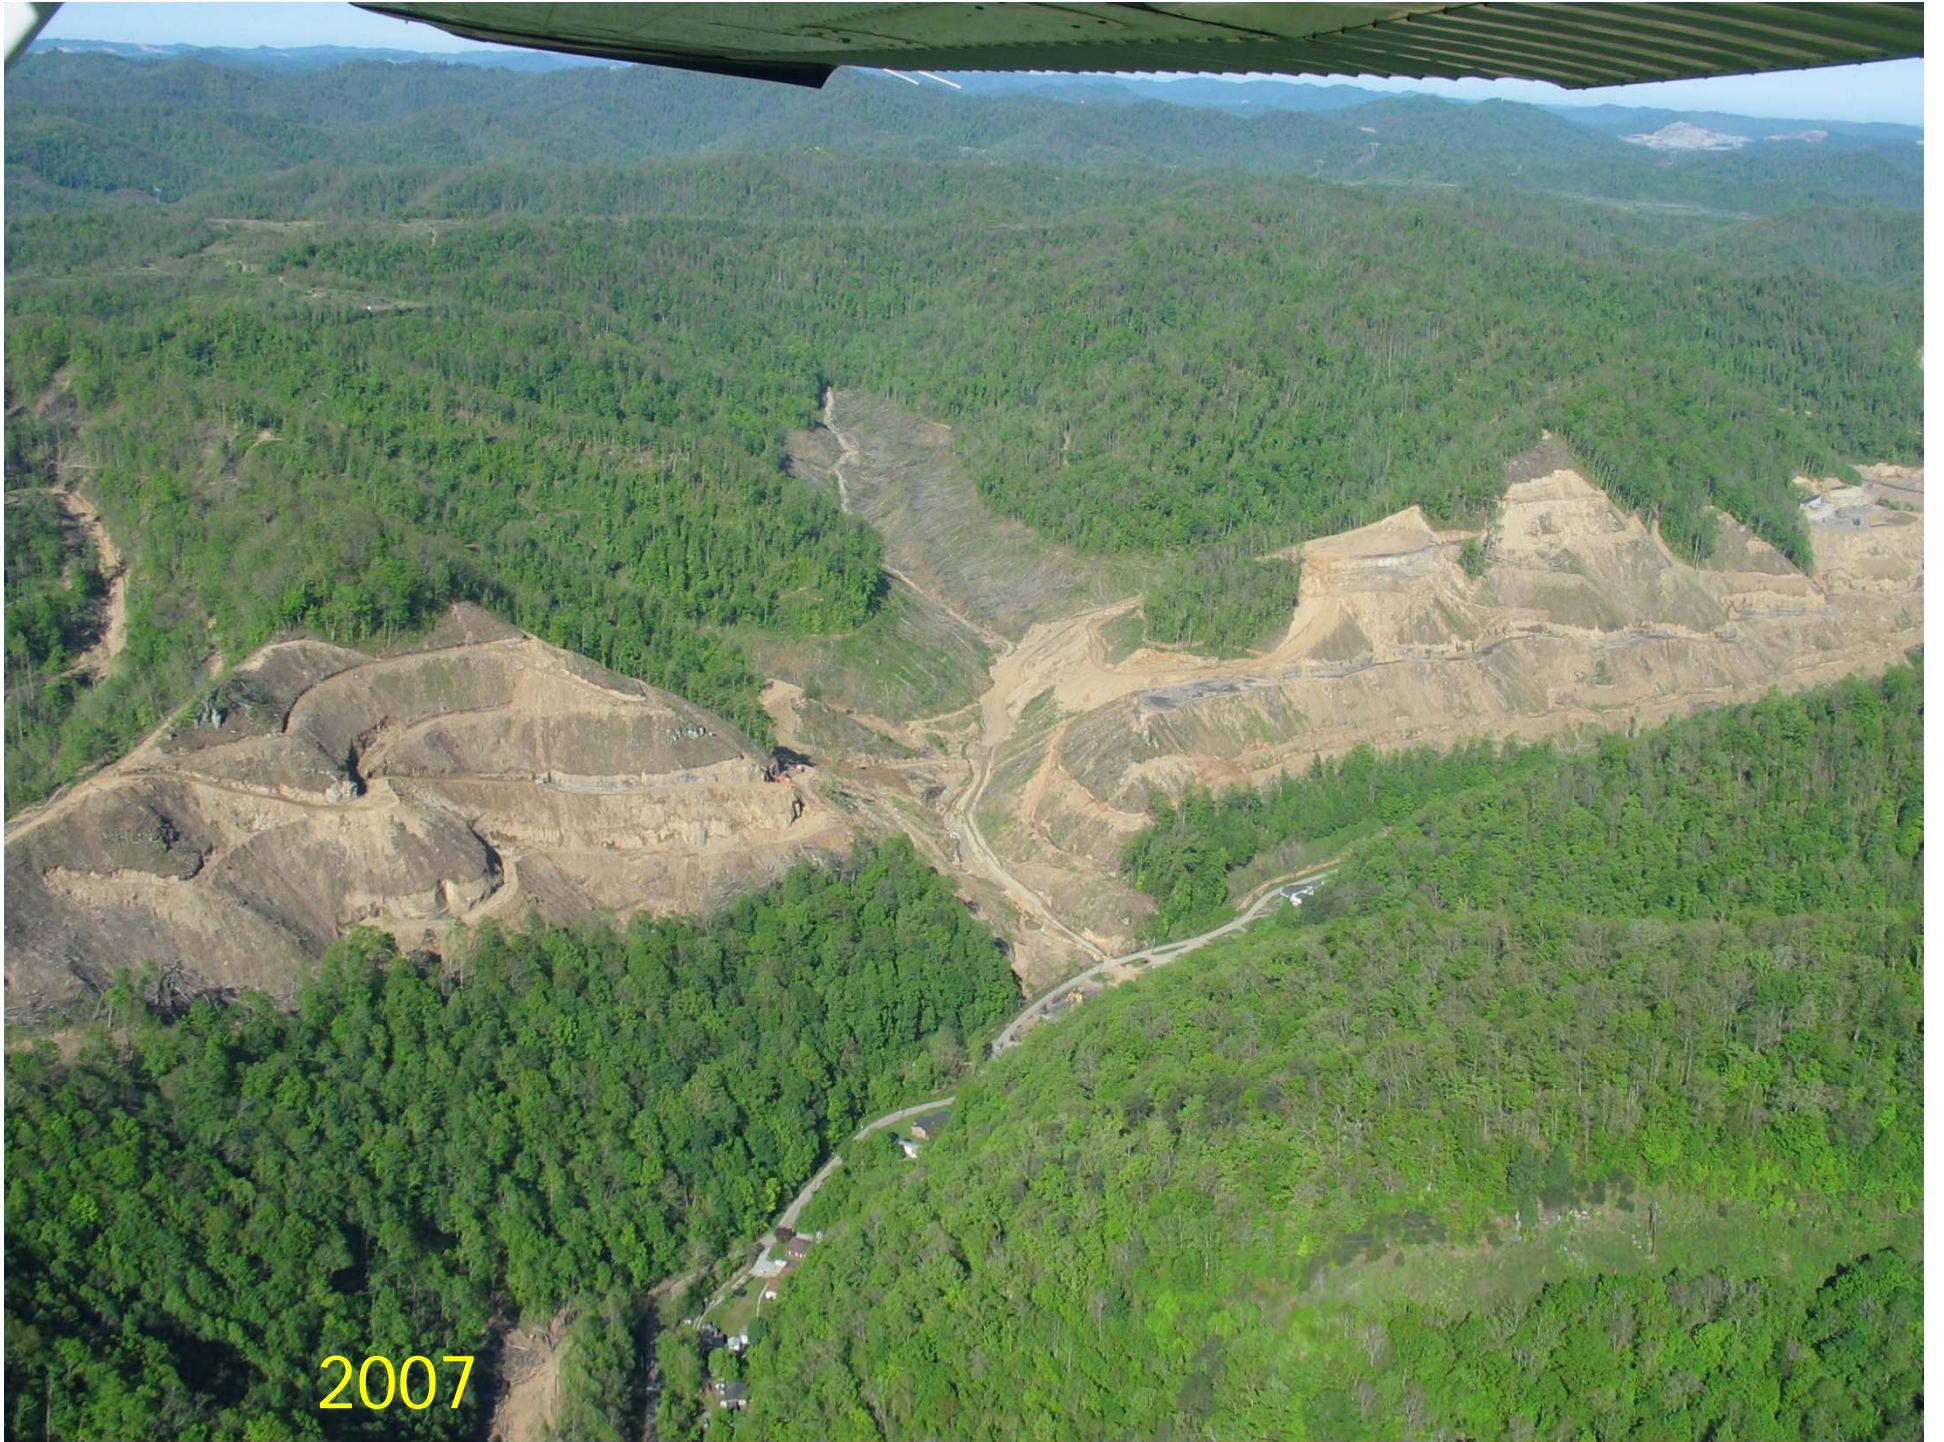
109 acres acquired (44 developable)

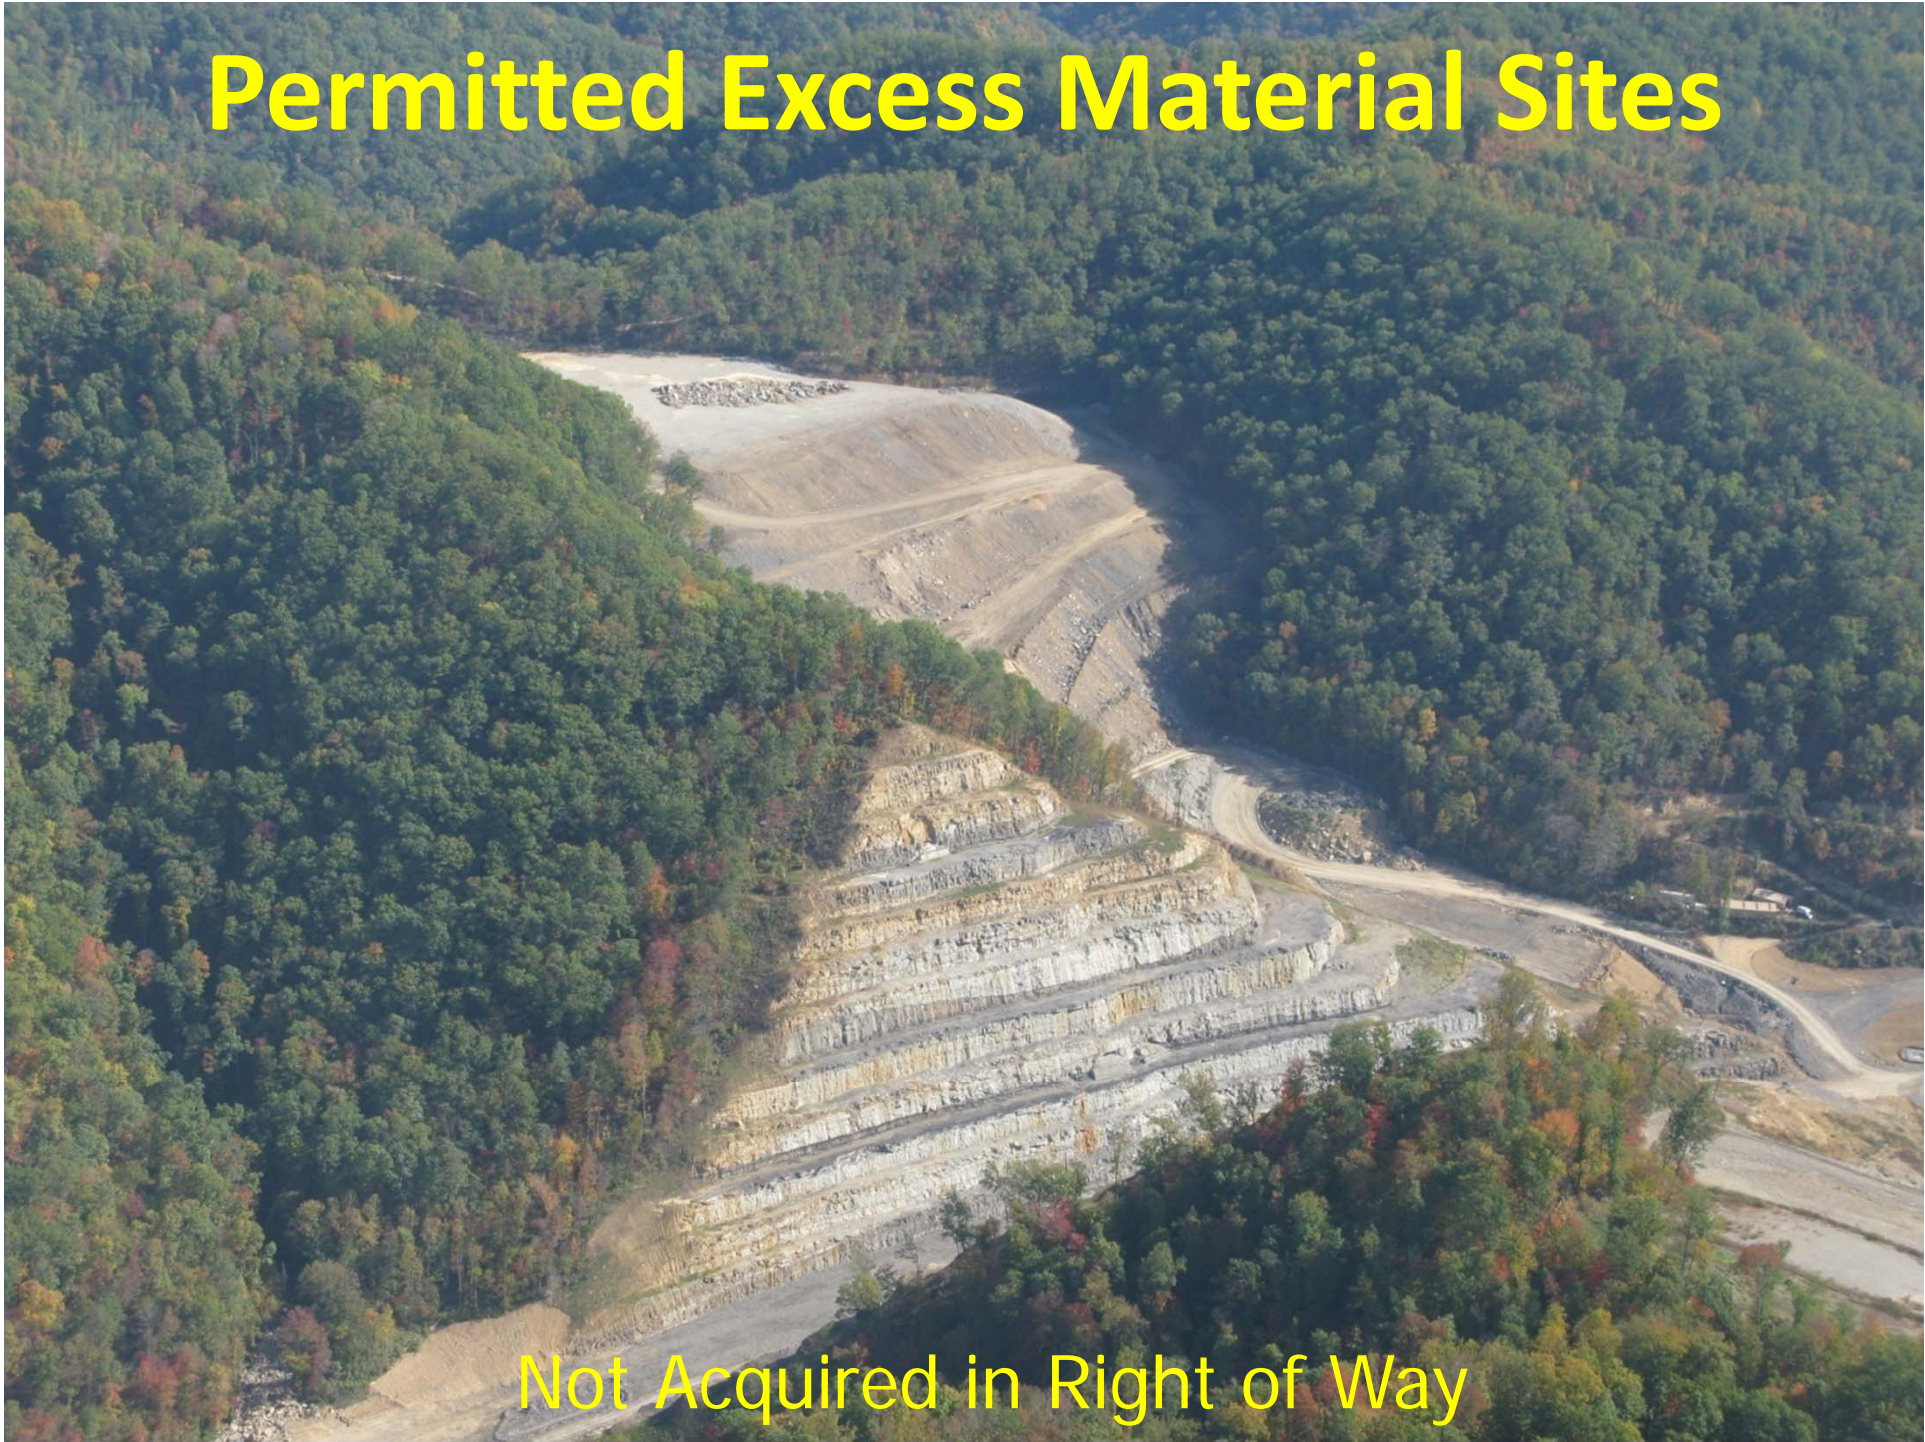
Permitted Excess Material Sites

Not Acquired in Right of Way

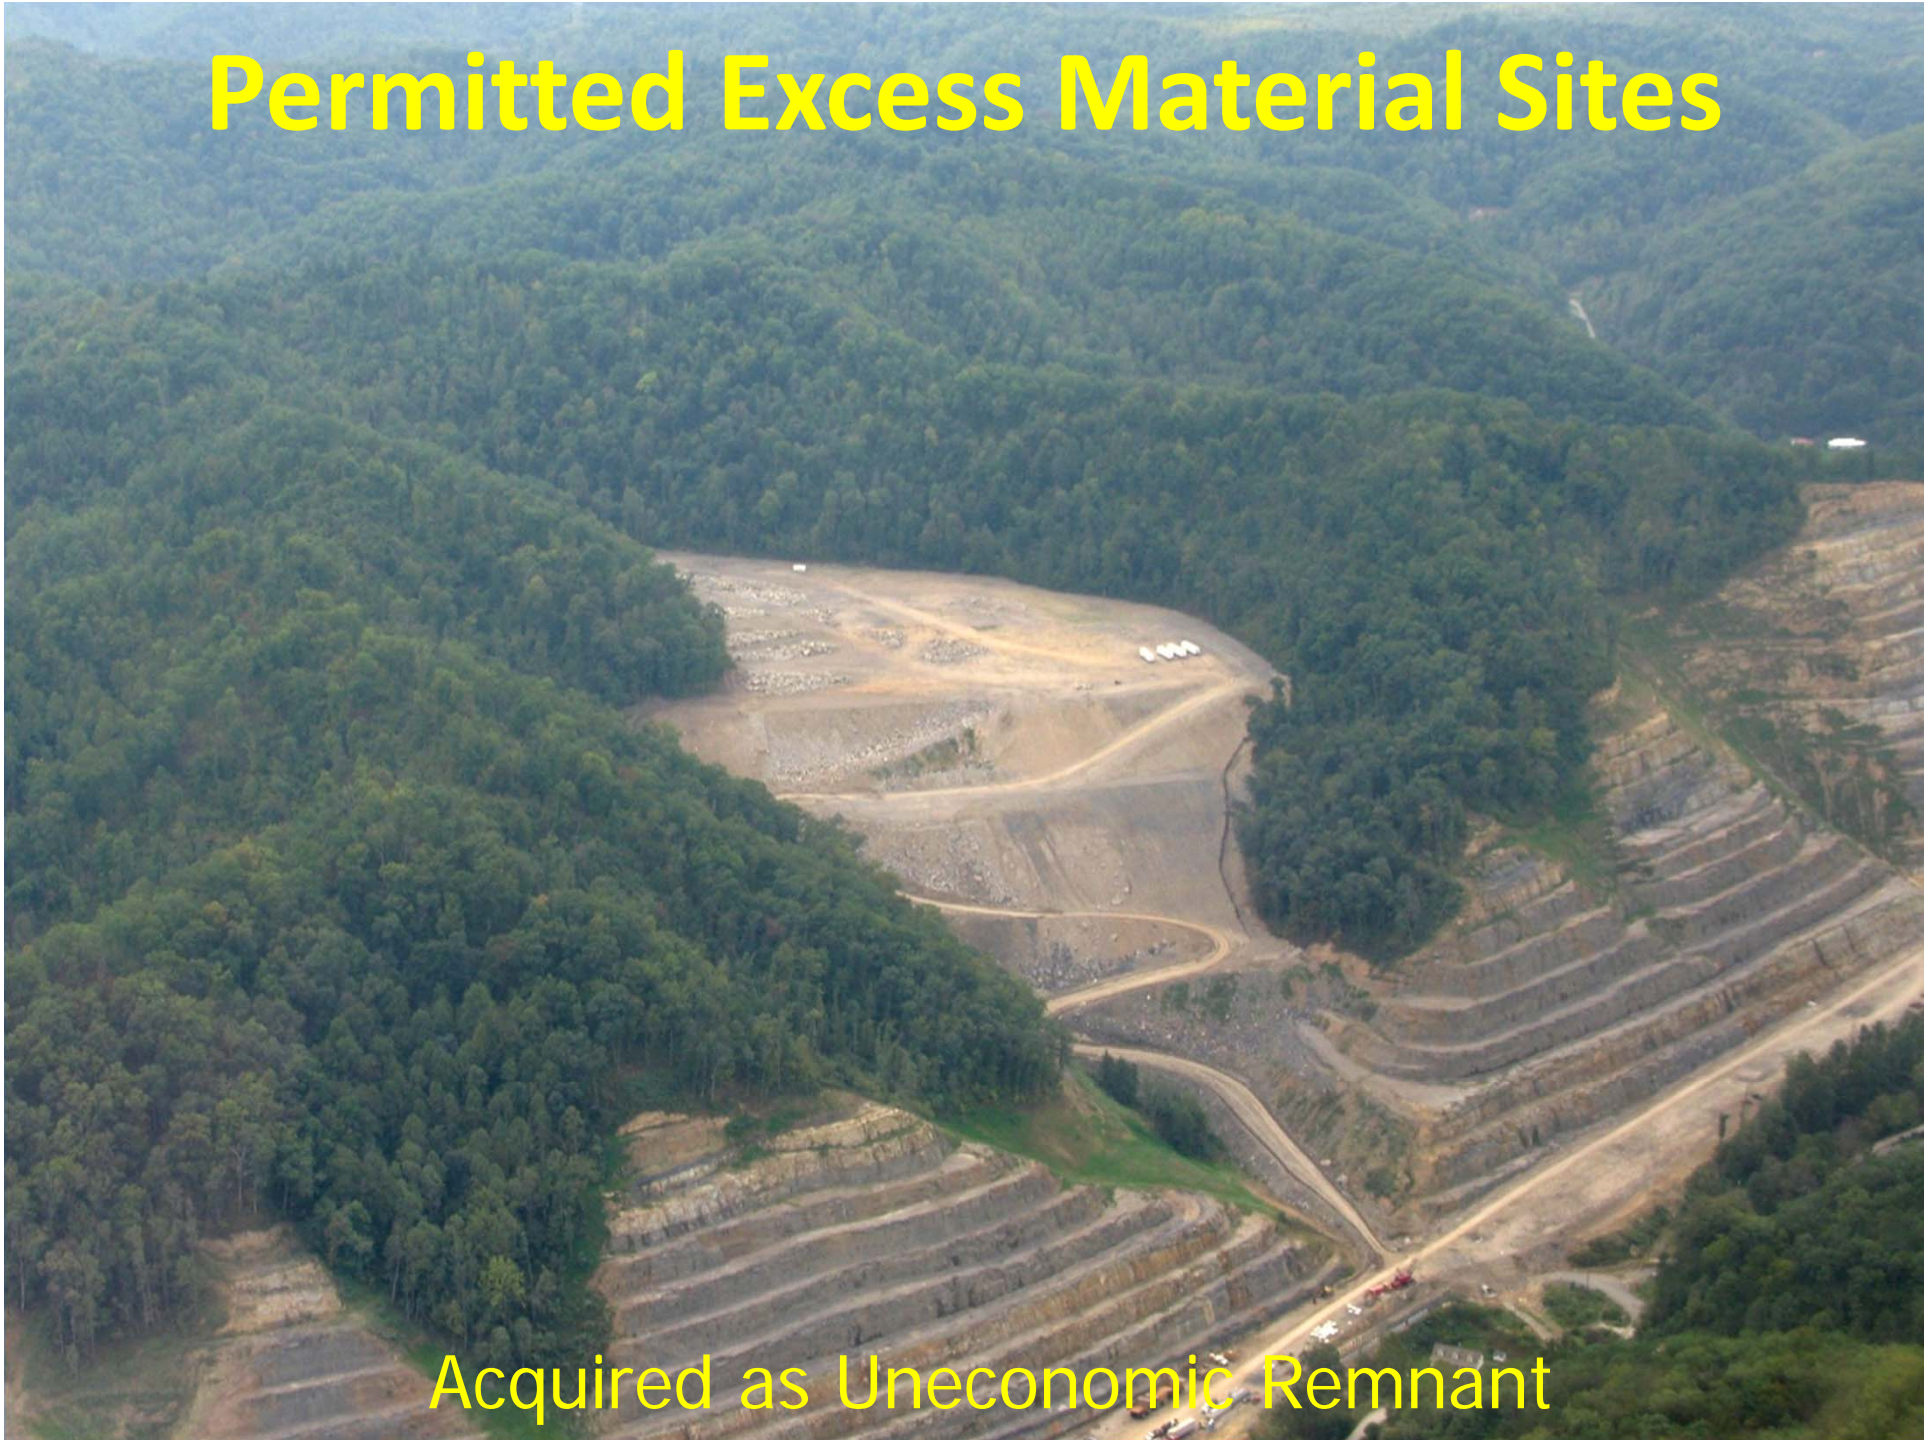
Permitted Excess Material Sites

Acquired as Uneconomic Remnant

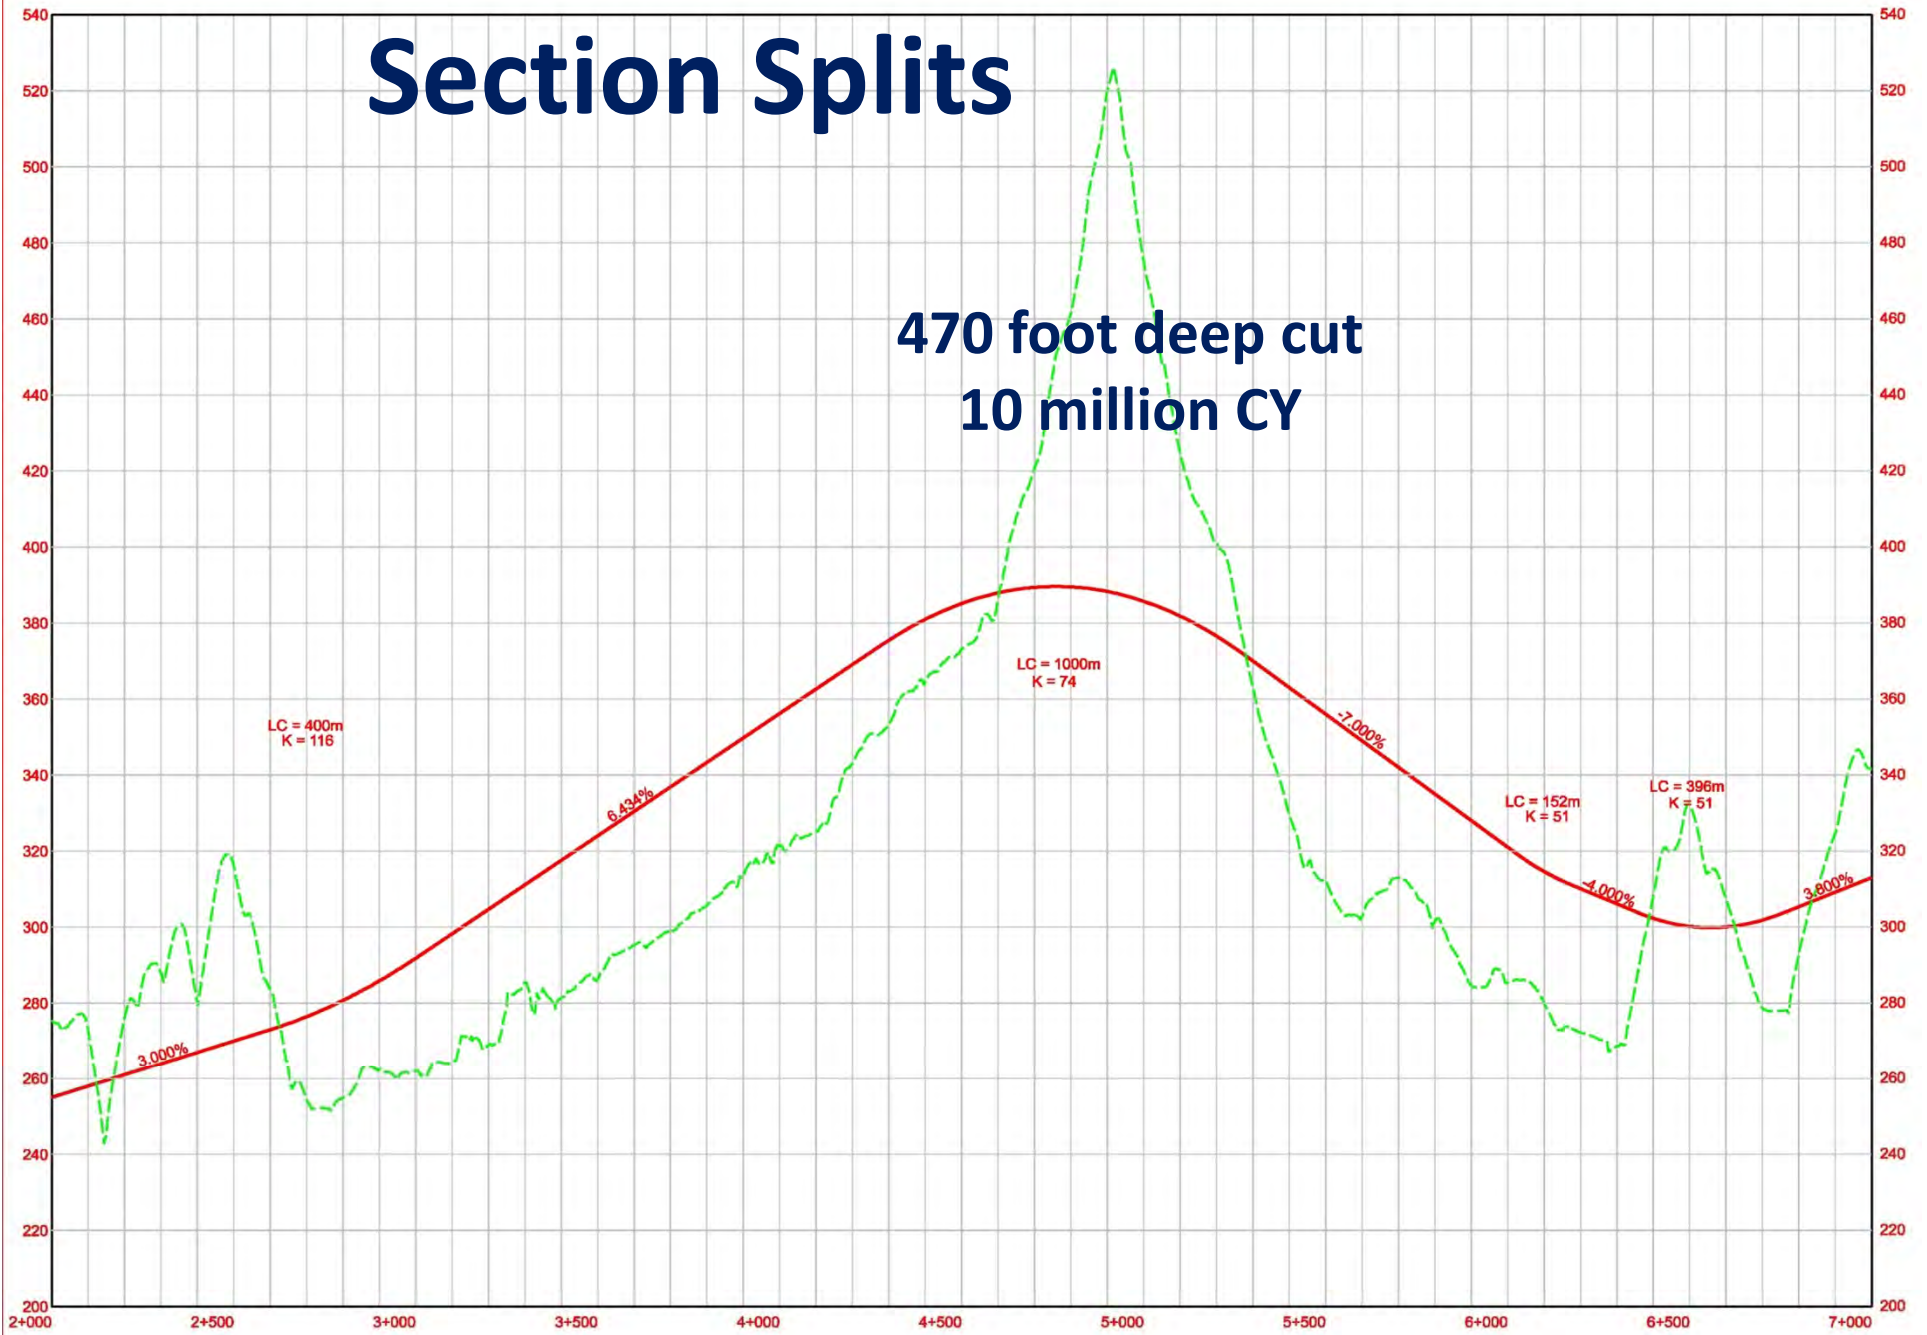
470 foot deep cut
10 million CY

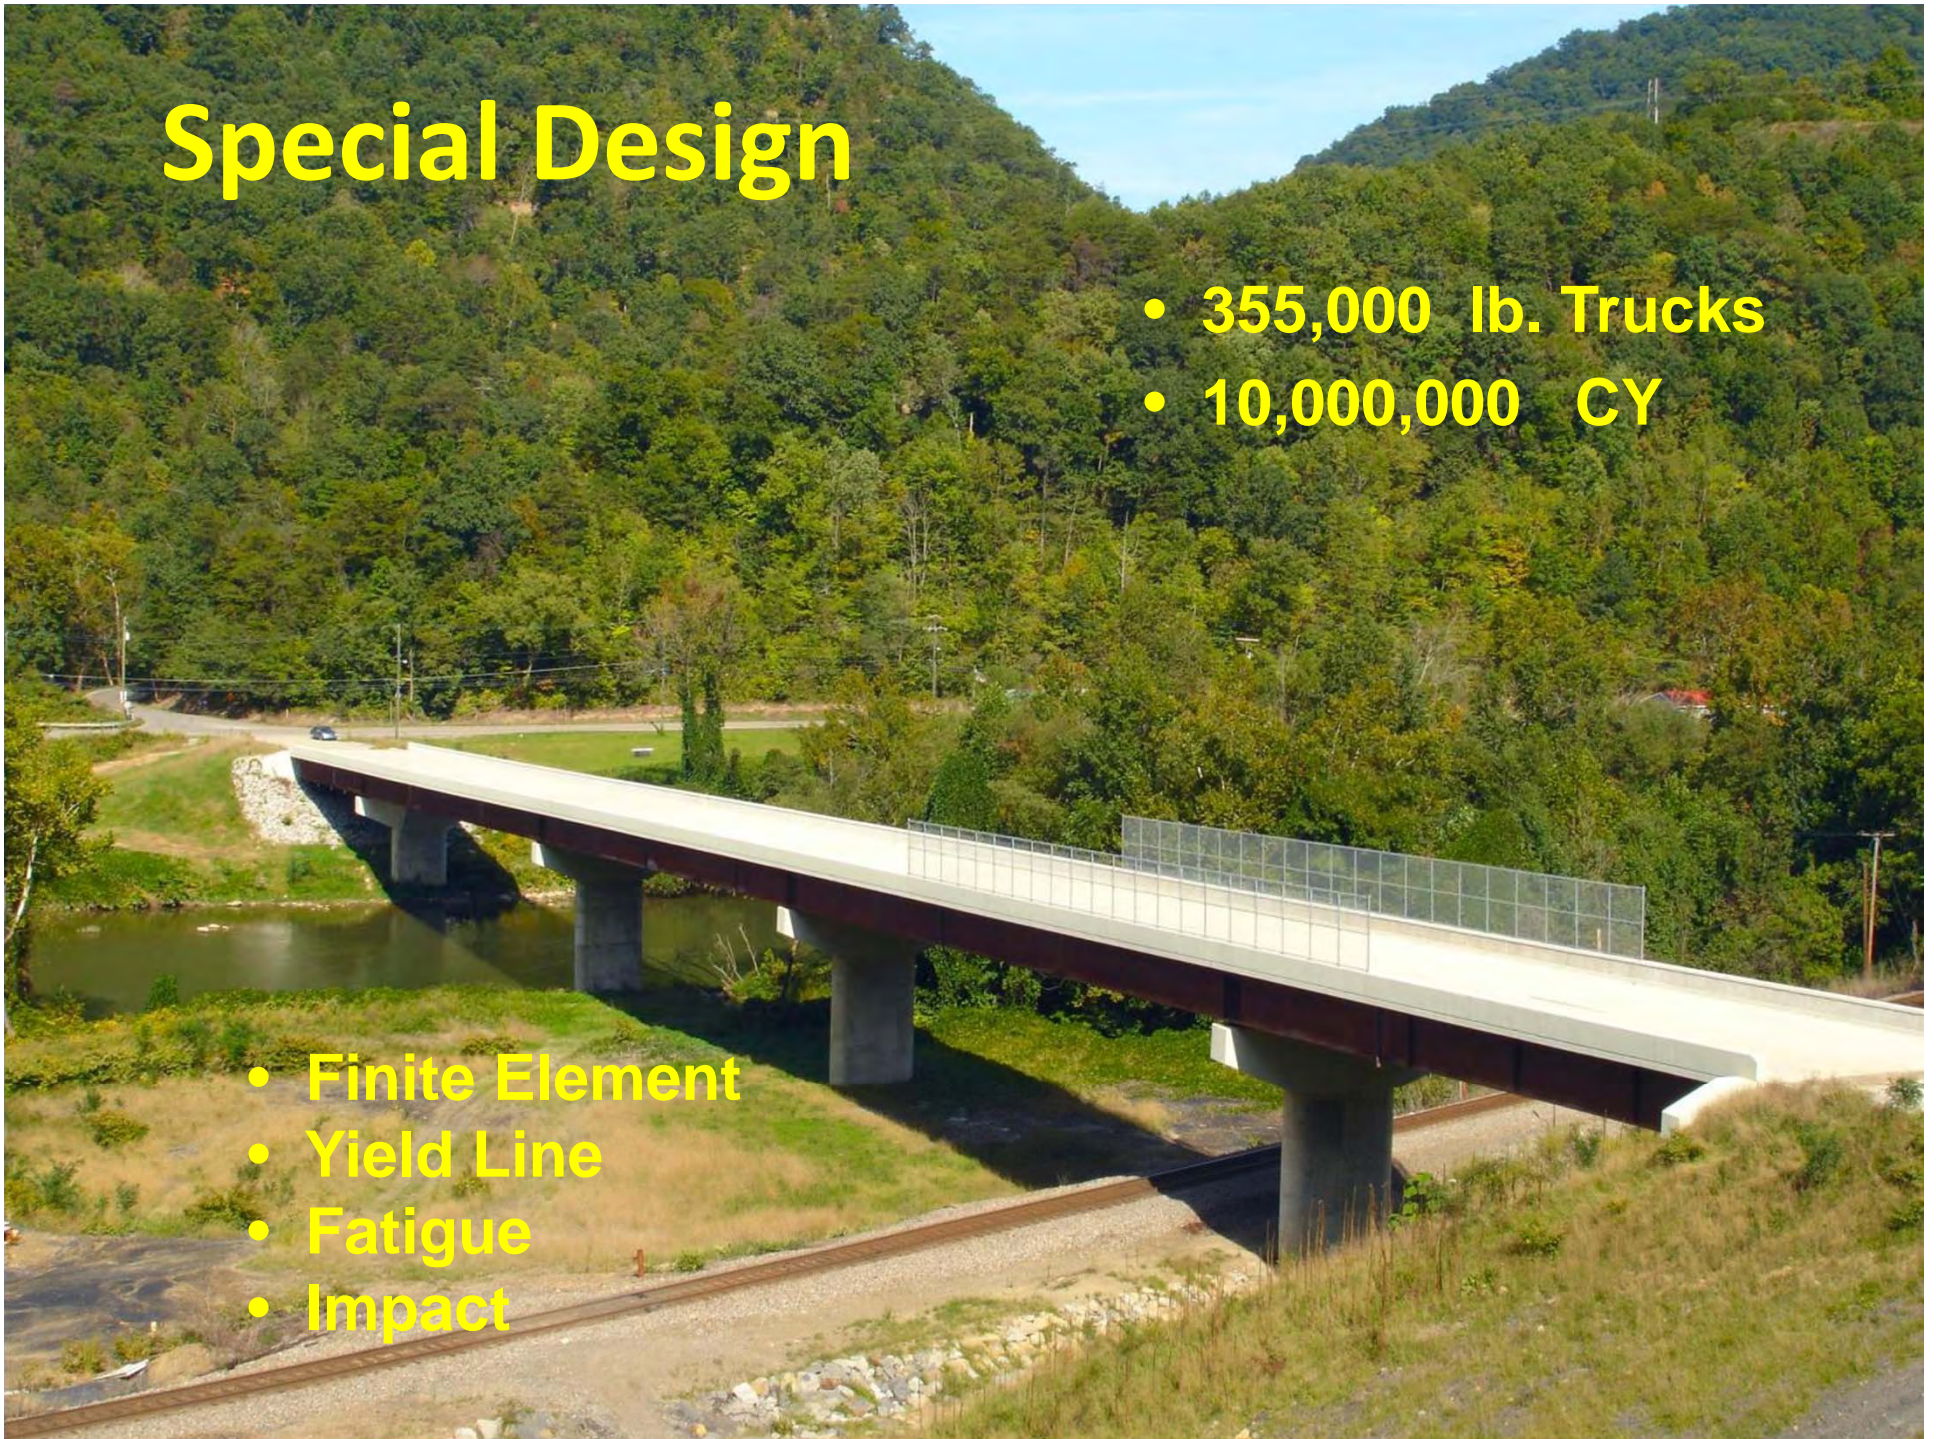
Special Design

- 355,000 lb. Trucks
- 10,000,000 CY

- Finite Element
- Yield Line
- Fatigue
- Impact

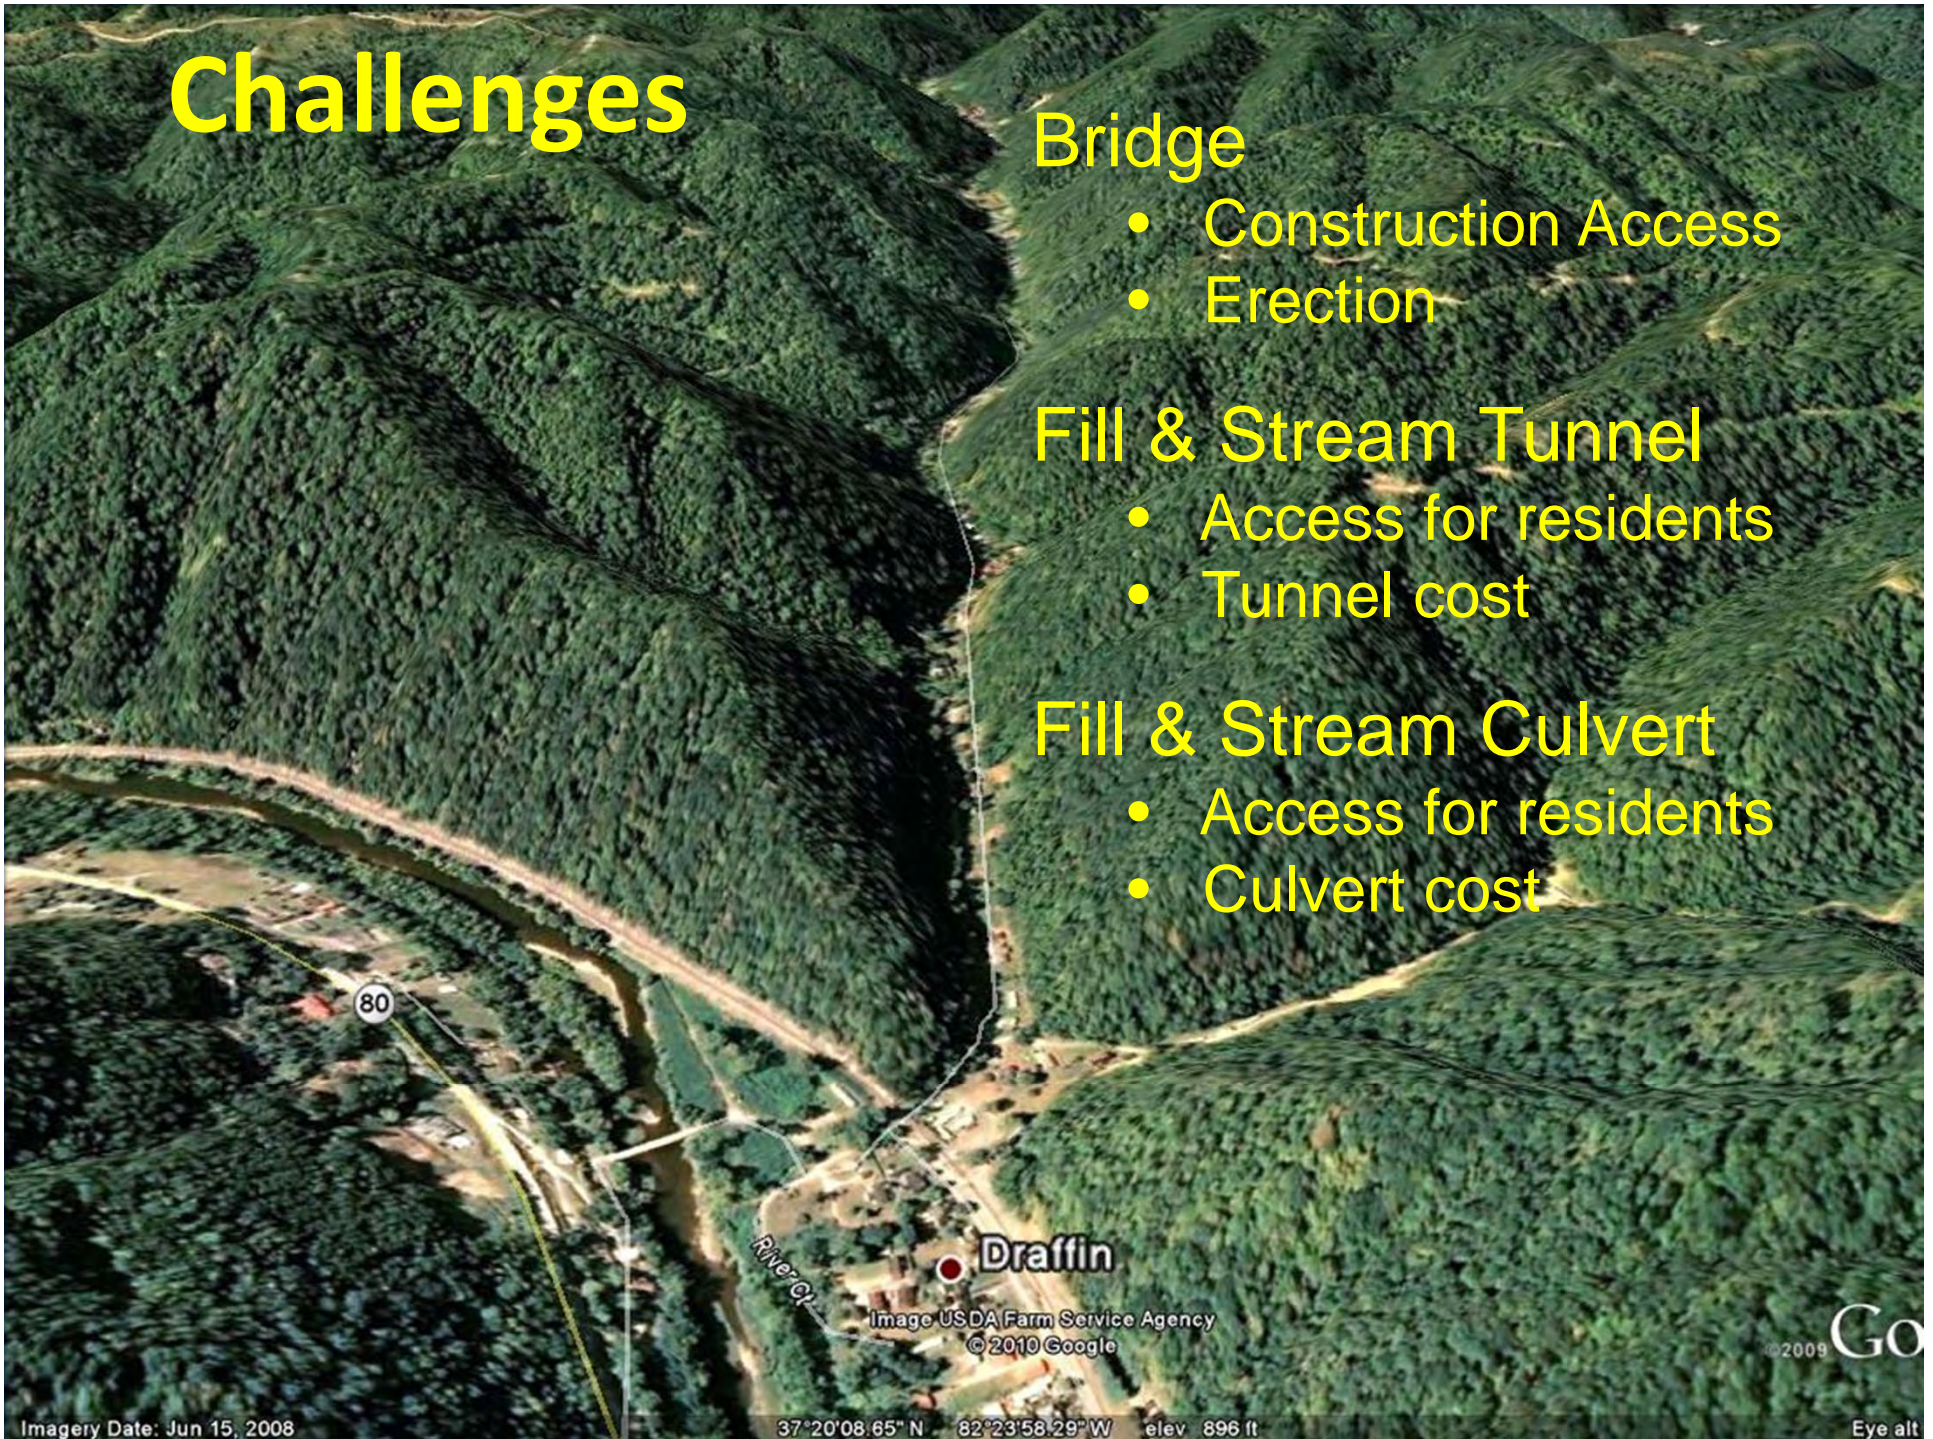
#3 - Bridge vs. Tunnel vs. Culvert

Challenges

Bridge

- Construction Access
- Erection

Fill & Stream Tunnel

- Access for residents
- Tunnel cost

Fill & Stream Culvert

- Access for residents
- Culvert cost

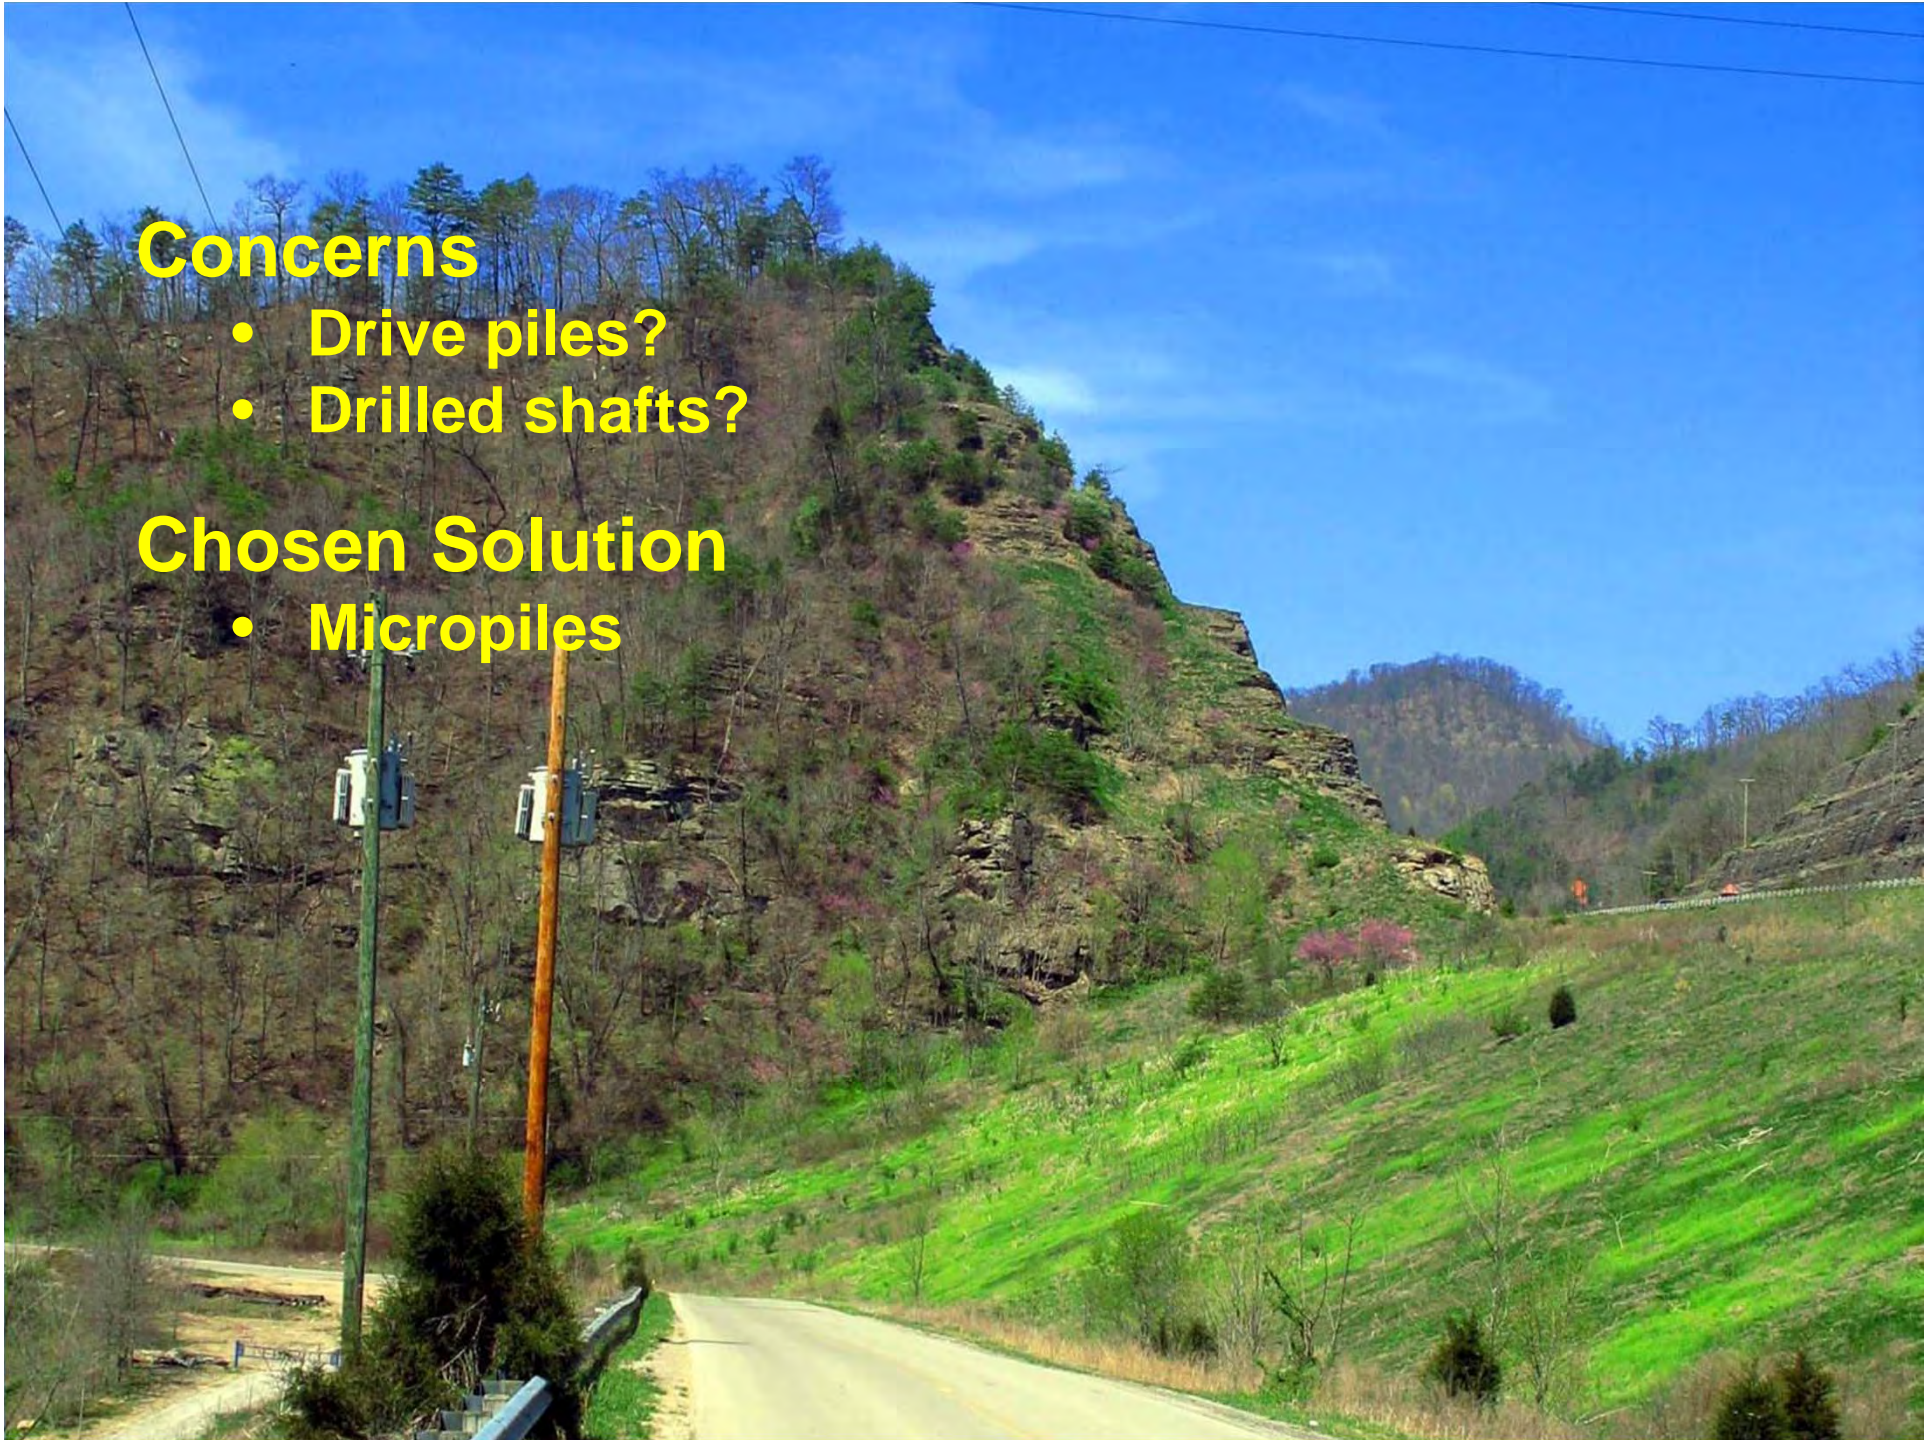
#8 – Piers in Existing Fill

Concerns

- Drive piles?
- Drilled shafts?

Chosen Solution

- Micropiles
