Scoping Study

CR 1062, Harrison County
Bridge Replacement over
Curry Creek
Item No. 6-8710.00

Prepared by the KYTC
Division of Planning and
KYTC District 6

July 2013

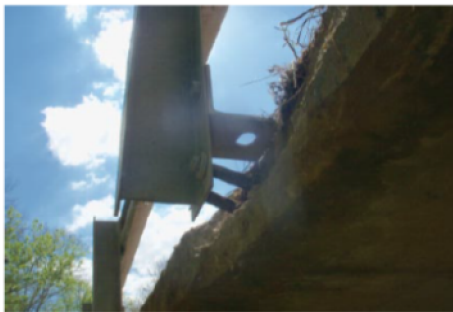
2

Vertical post #3 along the left side of
the structure was found to be broken
away from the slab.

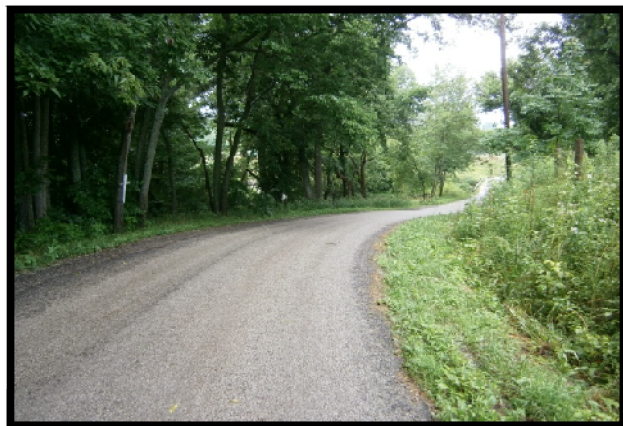
Sharp curve on south approach to bridge
where fatality occurred

There has been one crash reported between 2007 to 2012 according to the Kentucky State Police website. This crash was on the southern approach at the abutment of the bridge. The bridge is located in an S-curve. At the southwestern curve there is a cross indicating a fatality occurred at the location, however it does not show on the State Police Report.
