## **GEOTECHNICAL OVERVIEW**

**MEMORANDUM**

**SUBJECT: Franklin County  
US 60 Traffic Study in Frankfort, KY  
Mars # 7743401P  
Item # 5-275.00  
1100 C35 D625 05 FD04 0410 C037 E143  
Geotechnical Overview**

**P-004-2014**  
**Franklin County**

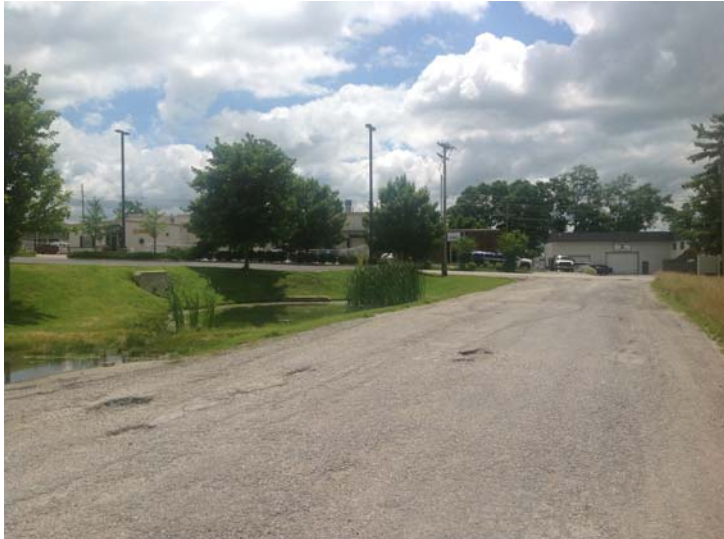
Wet area and possible subgrade problems on connector road near Early Learning Village.

California Bearing Ratio (CBR) values used in pavement design generally range from 2-5 for soils subgrades in the area. The use of rock roadbed is a common practice in the area. Wet areas could require undercutting and/or rock stabilization for embankment construction. It is likely that subgrade under existing pavements could be very wet and might require some type of stabilization if pavements are removed.

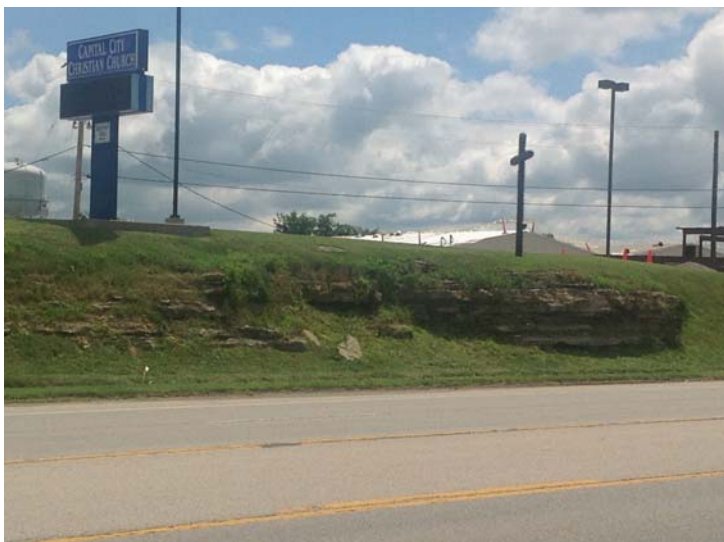
Rock Outcrop on US 60 @ Capital City Christian Church
