Data Needs Analysis

Boyle County
Bridge Replacement
Curtis Road (CR 1226)
Item No. 7-1133

Prepared by
KYTC District 7 Planning

October 9, 2012

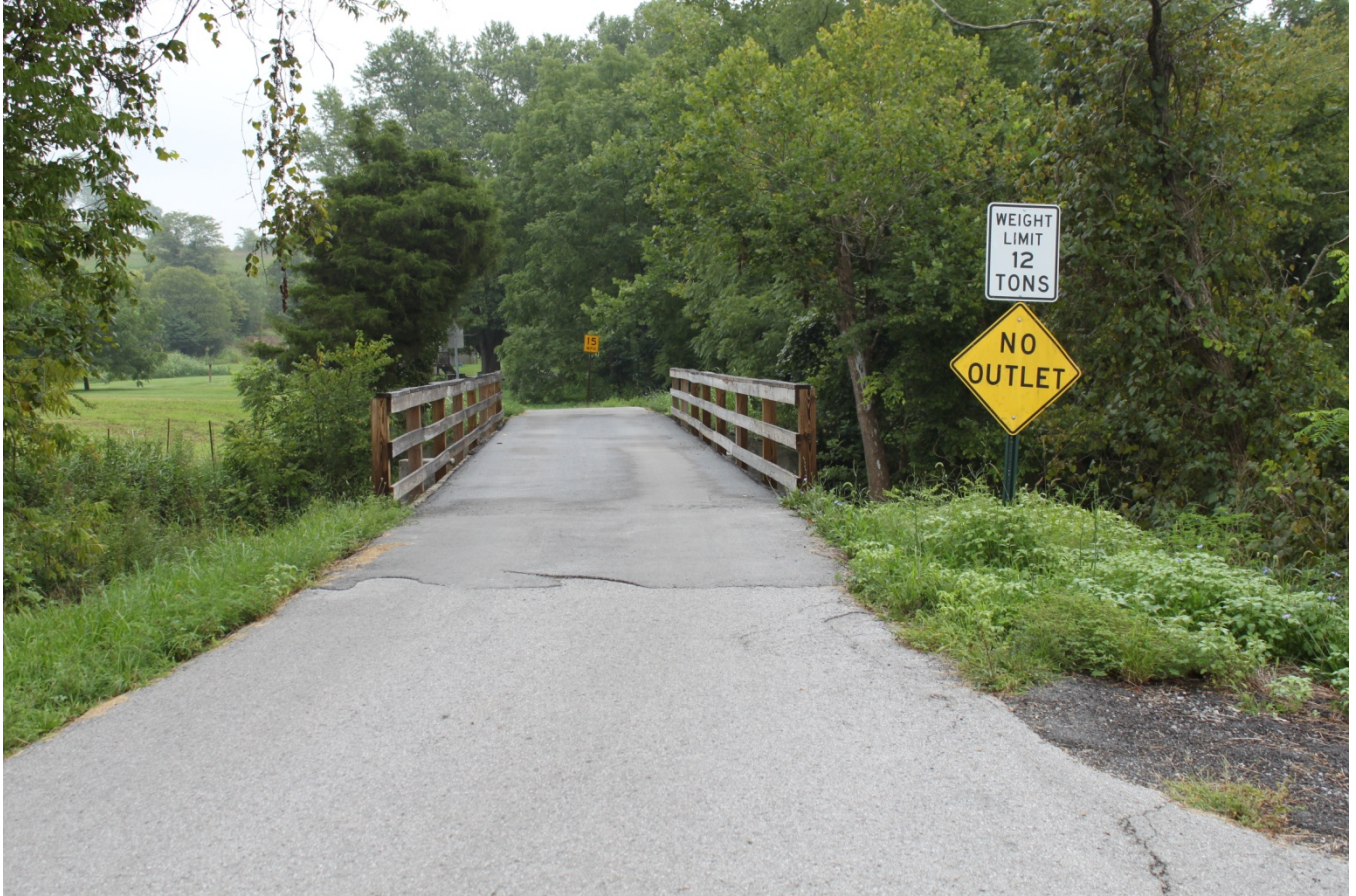
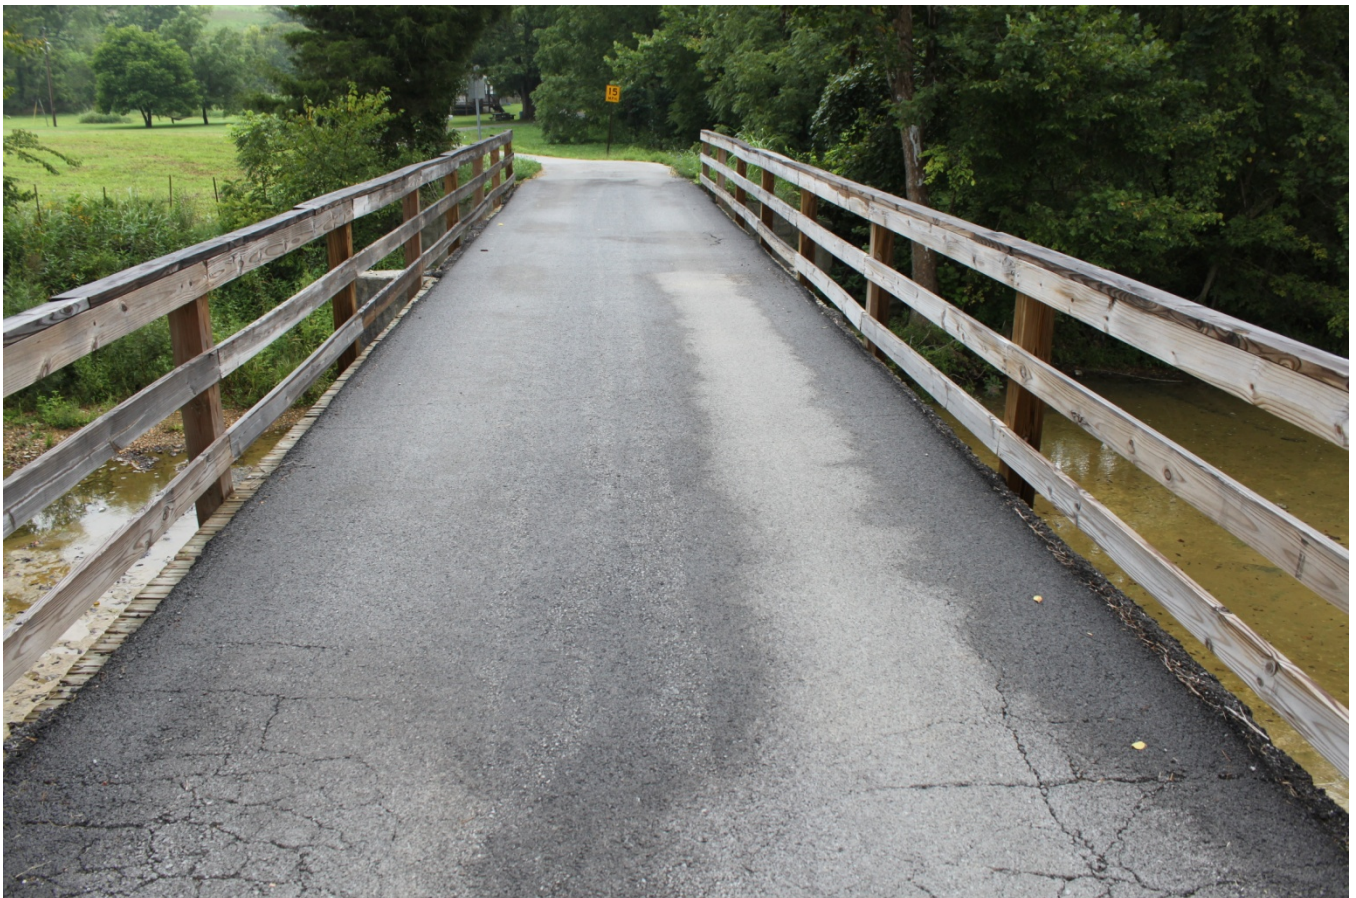
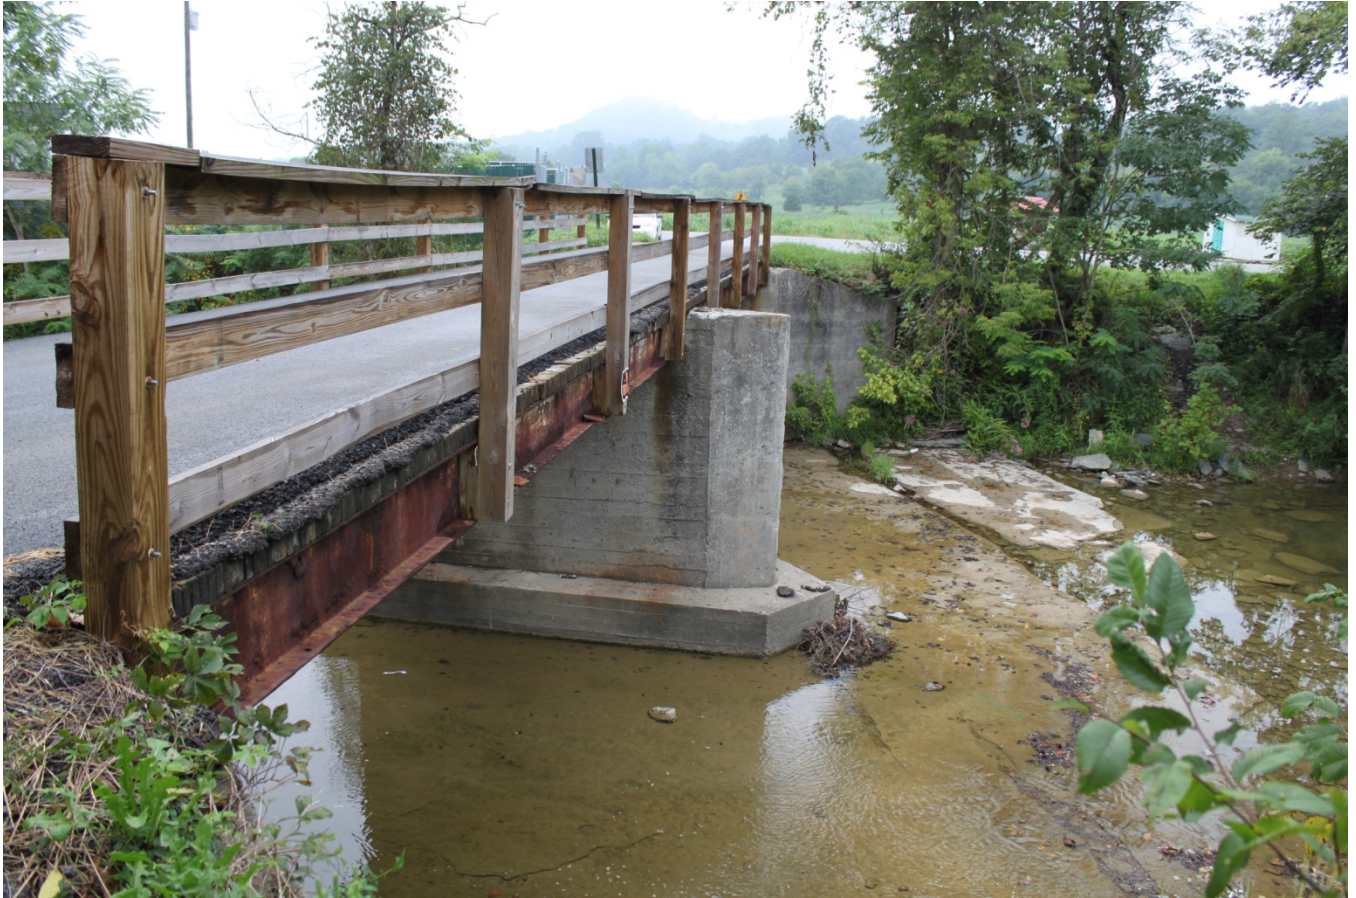
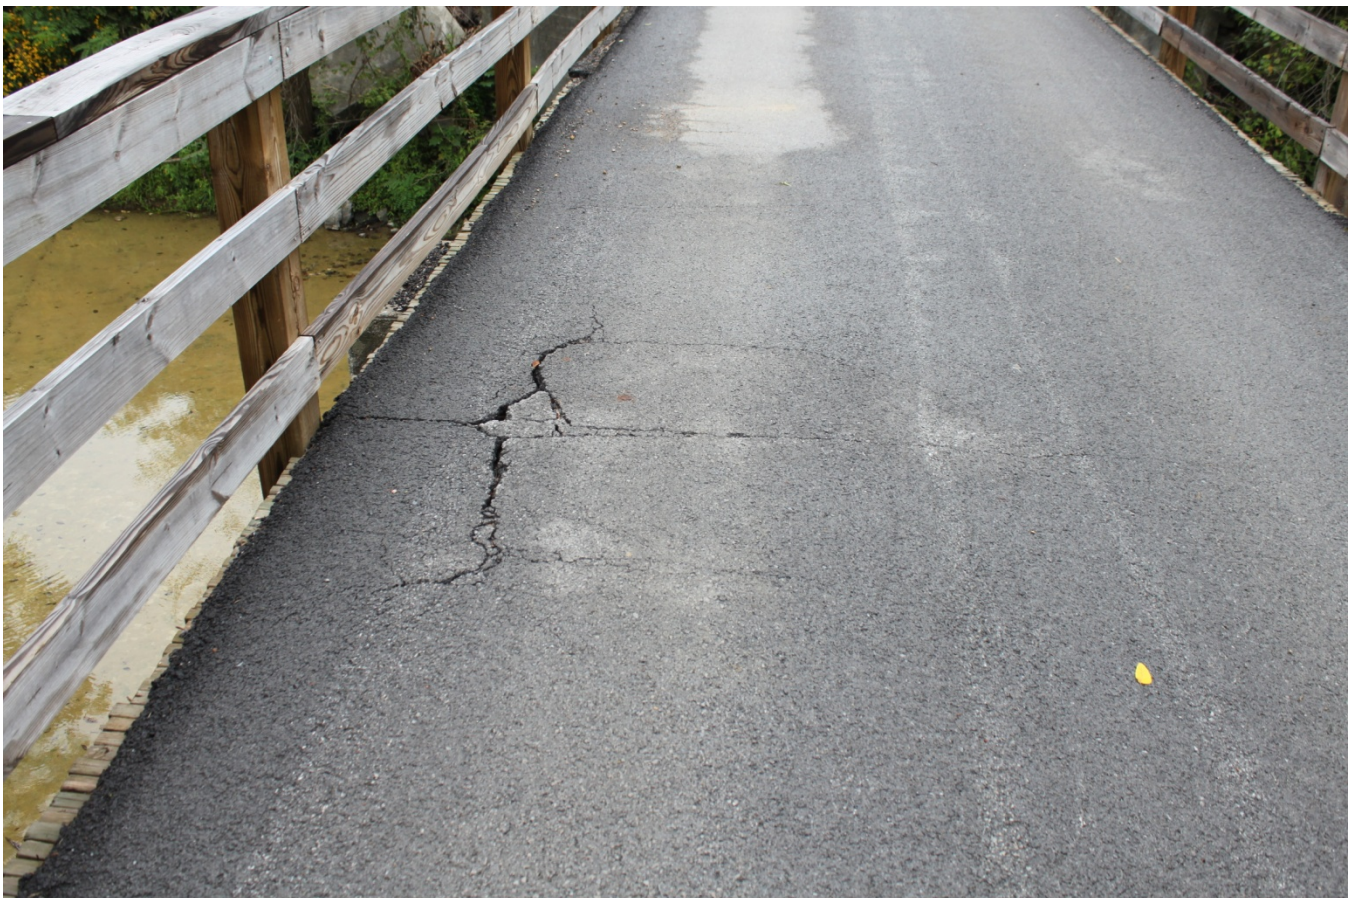
August 2012

The bridge is located on a rural local route over North Rolling Fork Creek in southwestern Boyle County. A bridge inspection was completed in November 2011. Based on the report, this bridge has a sufficiency rating of 19.2 and is structurally deficient. The structural deficiencies are reported in the 'Element Condition State Data' section of the inspection report (Appendix A). From a field reivew in August 2012, there appeared to be a broken rail and cracked pavement along the bridge (Appendix B).
