I-69, I-66/I-65 Spurs, and US 60 Connection Strategic Planning Corridor Study

Overview of Existing Conditions

William H. Natcher Parkway, Audubon Parkway, and US 60 Wendell Ford Expressway

May 2014

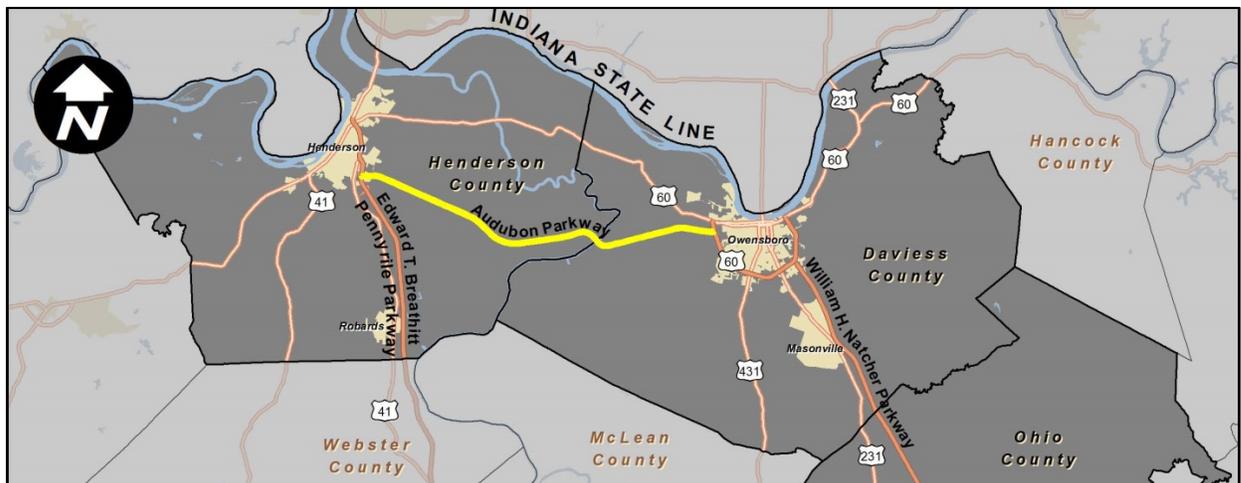
- **Option 1 - I-69 Spur**

This option designates the I-69 Spur to follow along the Audubon Parkway from Henderson to the US 60 interchange in Owensboro. The interstate spur would begin at I-69 south of Henderson and would terminate at the US 60 interchange in Owensboro. At the time of this report, the I-69 alignment through Henderson is under evaluation, and the intersecting location with the Audubon Parkway is undetermined. The Audubon Parkway cannot be designated as an interstate spur until it connects with a route that has been designated as I-69.

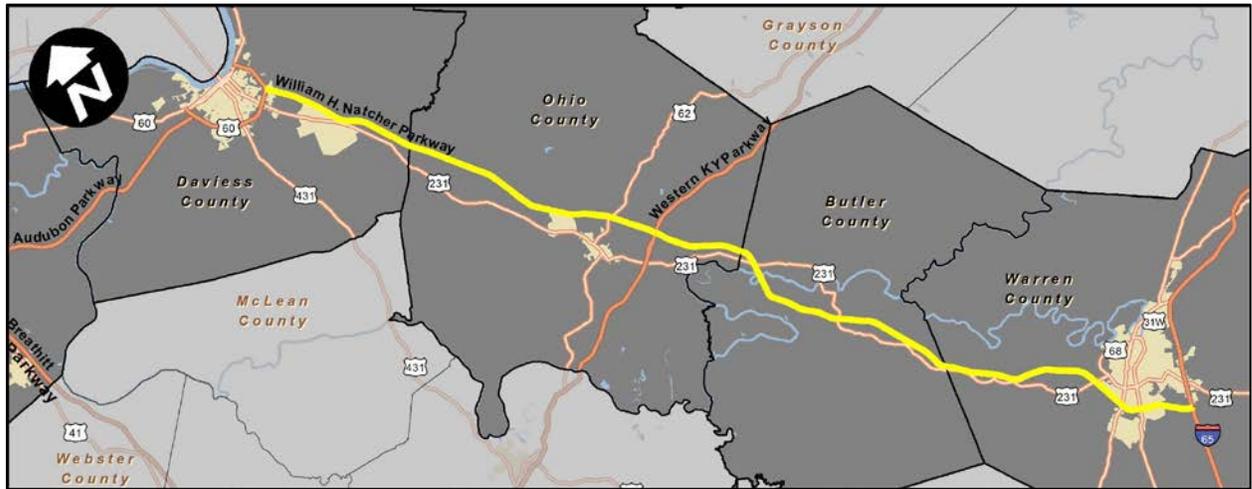
- **Option 2 - I-66/I-65 Spur**

This option designates the I-66/I-65 Spur along the Natcher Parkway from I-65 in Bowling Green to the US 60 interchange in Owensboro. The I-66/I-65 Spur would begin at the existing I-65 and Natcher Parkway interchange and terminate at the existing Natcher Parkway and US 60 interchange at the east side of Owensboro.

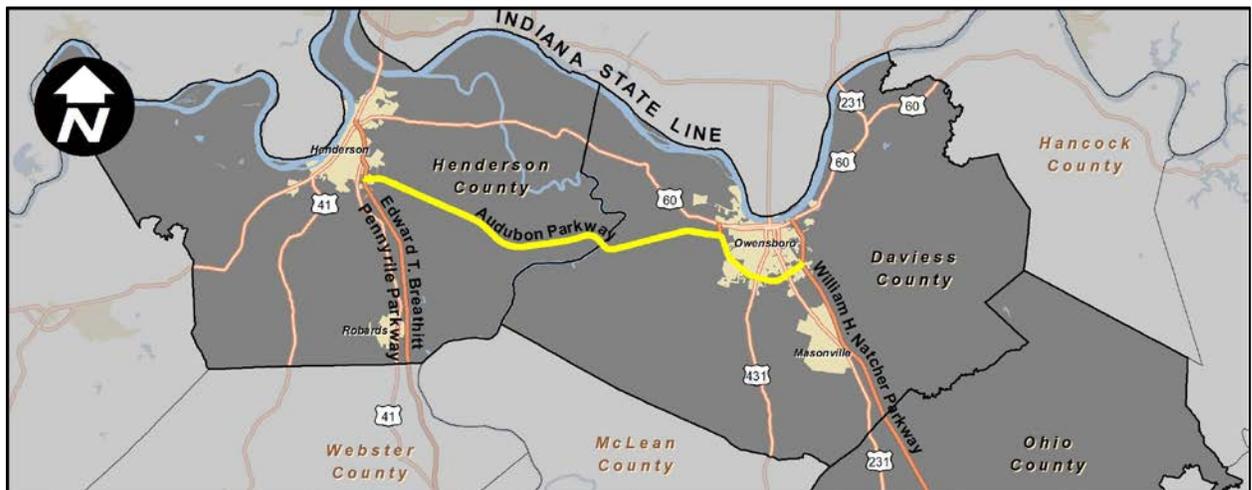
- **Option 3 - I-69 Spur including US 60**

The third option designates the Audubon Parkway and US 60 as I-69 Spur. Similar to Option 1, the I-69 Spur would follow along the Audubon Parkway from south of Henderson to the US 60 interchange in Owensboro. The spur would continue along US 60 and terminate at the US 60 and Natcher Parkway interchange on the east side of Owensboro. At the time of this report, the I-69 alignment through Henderson is under evaluation, and the intersecting location with the Audubon Parkway is undetermined. The Audubon Parkway and US 60 cannot be designated as an interstate spur until the Audubon Parkway connects with a route that has been designated as I-69.

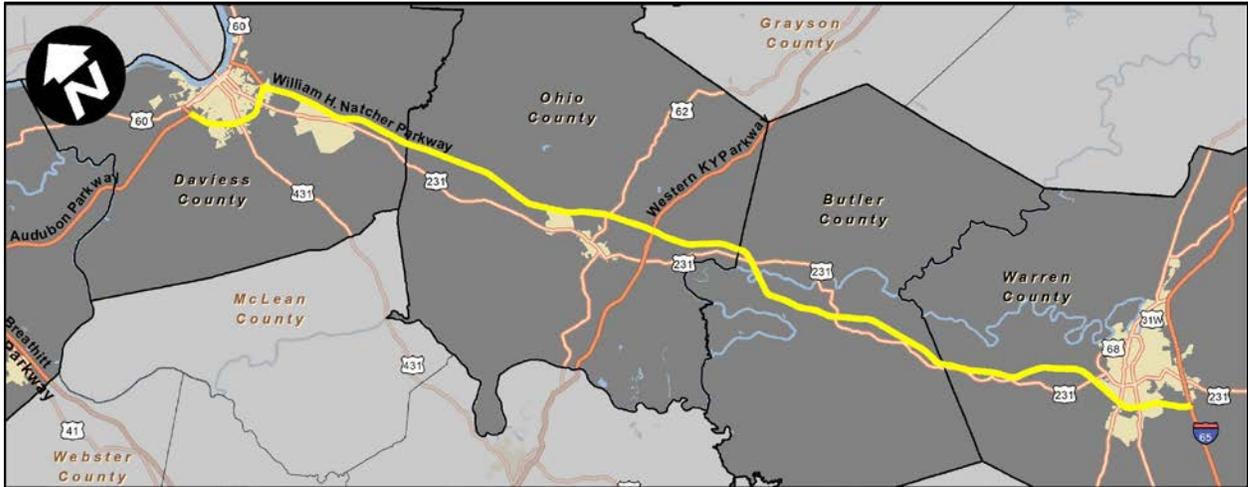
- **Option 4 - I-66/I-65 Spur including US 60**

This option designates the Natcher Parkway and US 60 as I-66/I-65 Spur. Similar to Option 2, the I-66/I-65 spur would follow along the Natcher Parkway from I-65 in Bowling Green to the US 60 interchange in Owensboro. The spur would continue on US 60 and terminate at the US 60 and Audubon Parkway interchange on the west side of Owensboro.

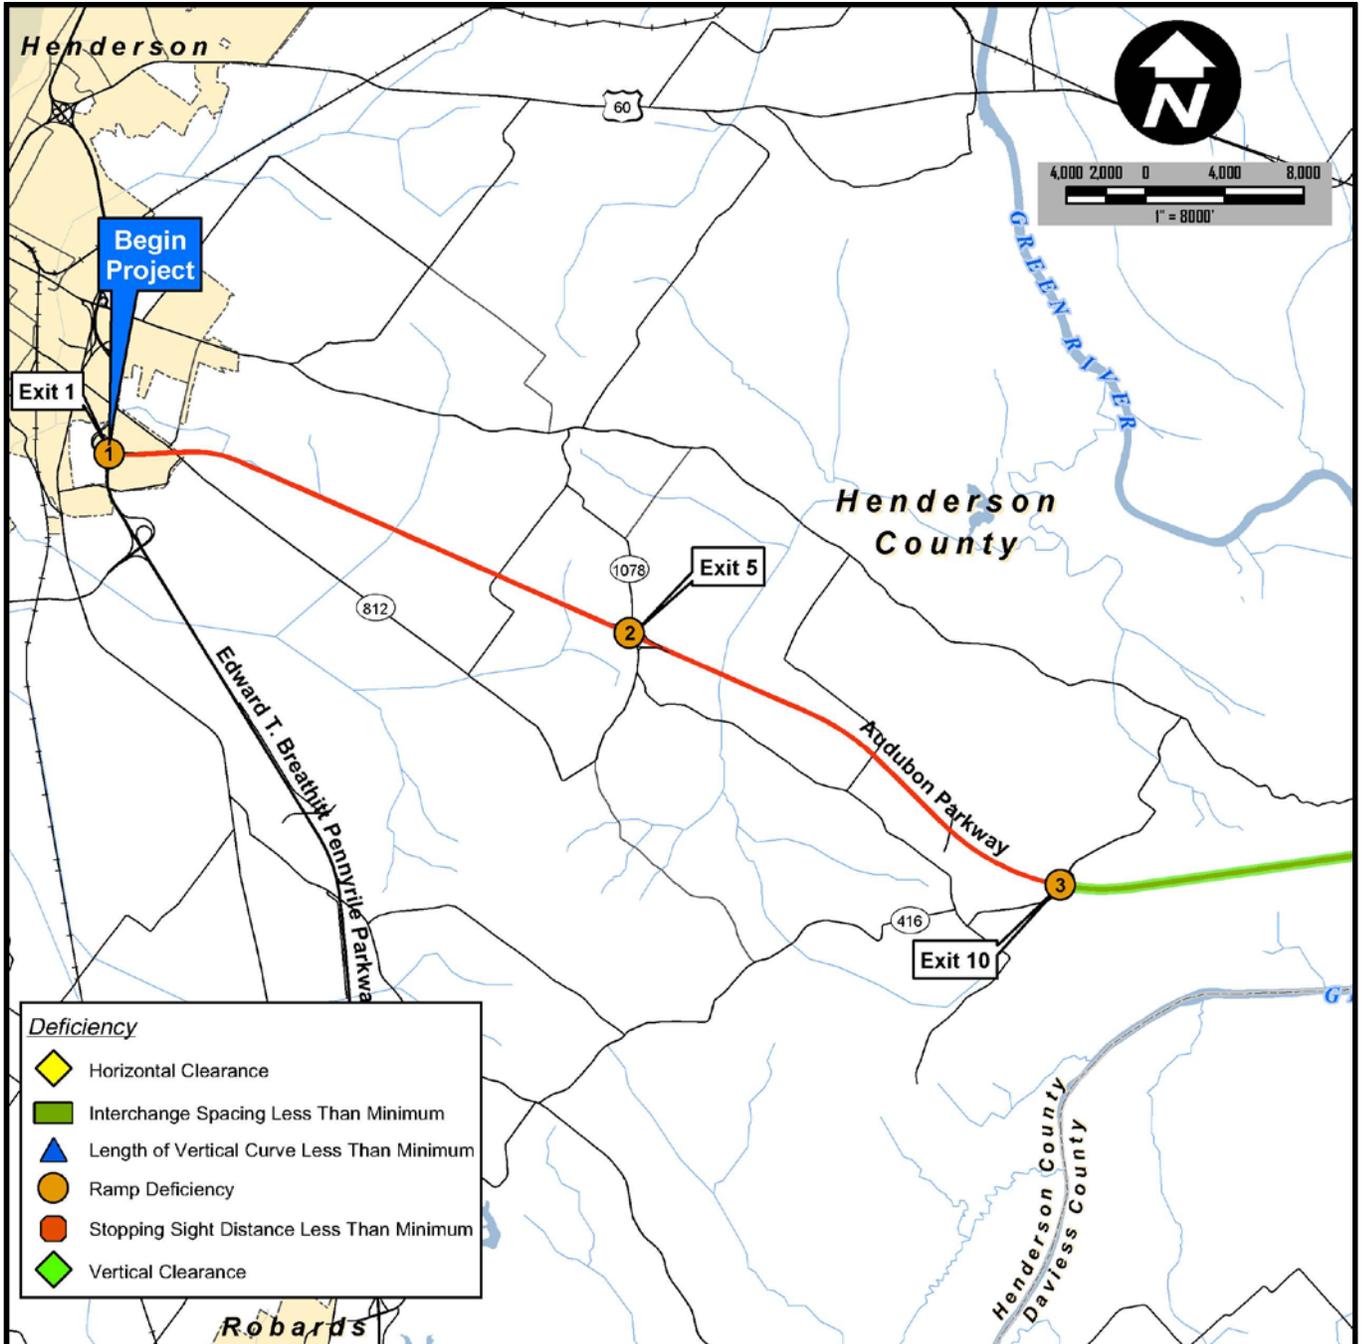
Figure ES-1
Existing Deficiencies
I-69 SPUR, I-66/I-65 SPUR
AND US 60

- Deficiency**
- Horizontal Clearance
 - Interchange Spacing Less Than Minimum
 - Length of Vertical Curve Less Than Minimum
 - Ramp Deficiency
 - Stopping Sight Distance Less Than Minimum
 - Vertical Clearance

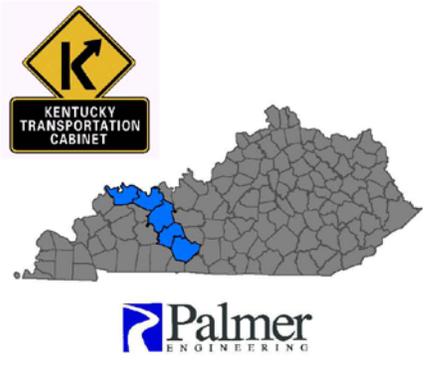
Figure ES-2
Existing Deficiencies
I-69 SPUR, I-66/I-65 SPUR
AND US 60
 Butler, Daviess, Henderson
 Ohio, and Warren Counties
 Kentucky

- Horizontal Clearance
- Interchange Spacing Less Than Minimum
- Length of Vertical Curve Less Than Minimum
- Ramp Deficiency
- Stopping Sight Distance Less Than Minimum
- Vertical Clearance

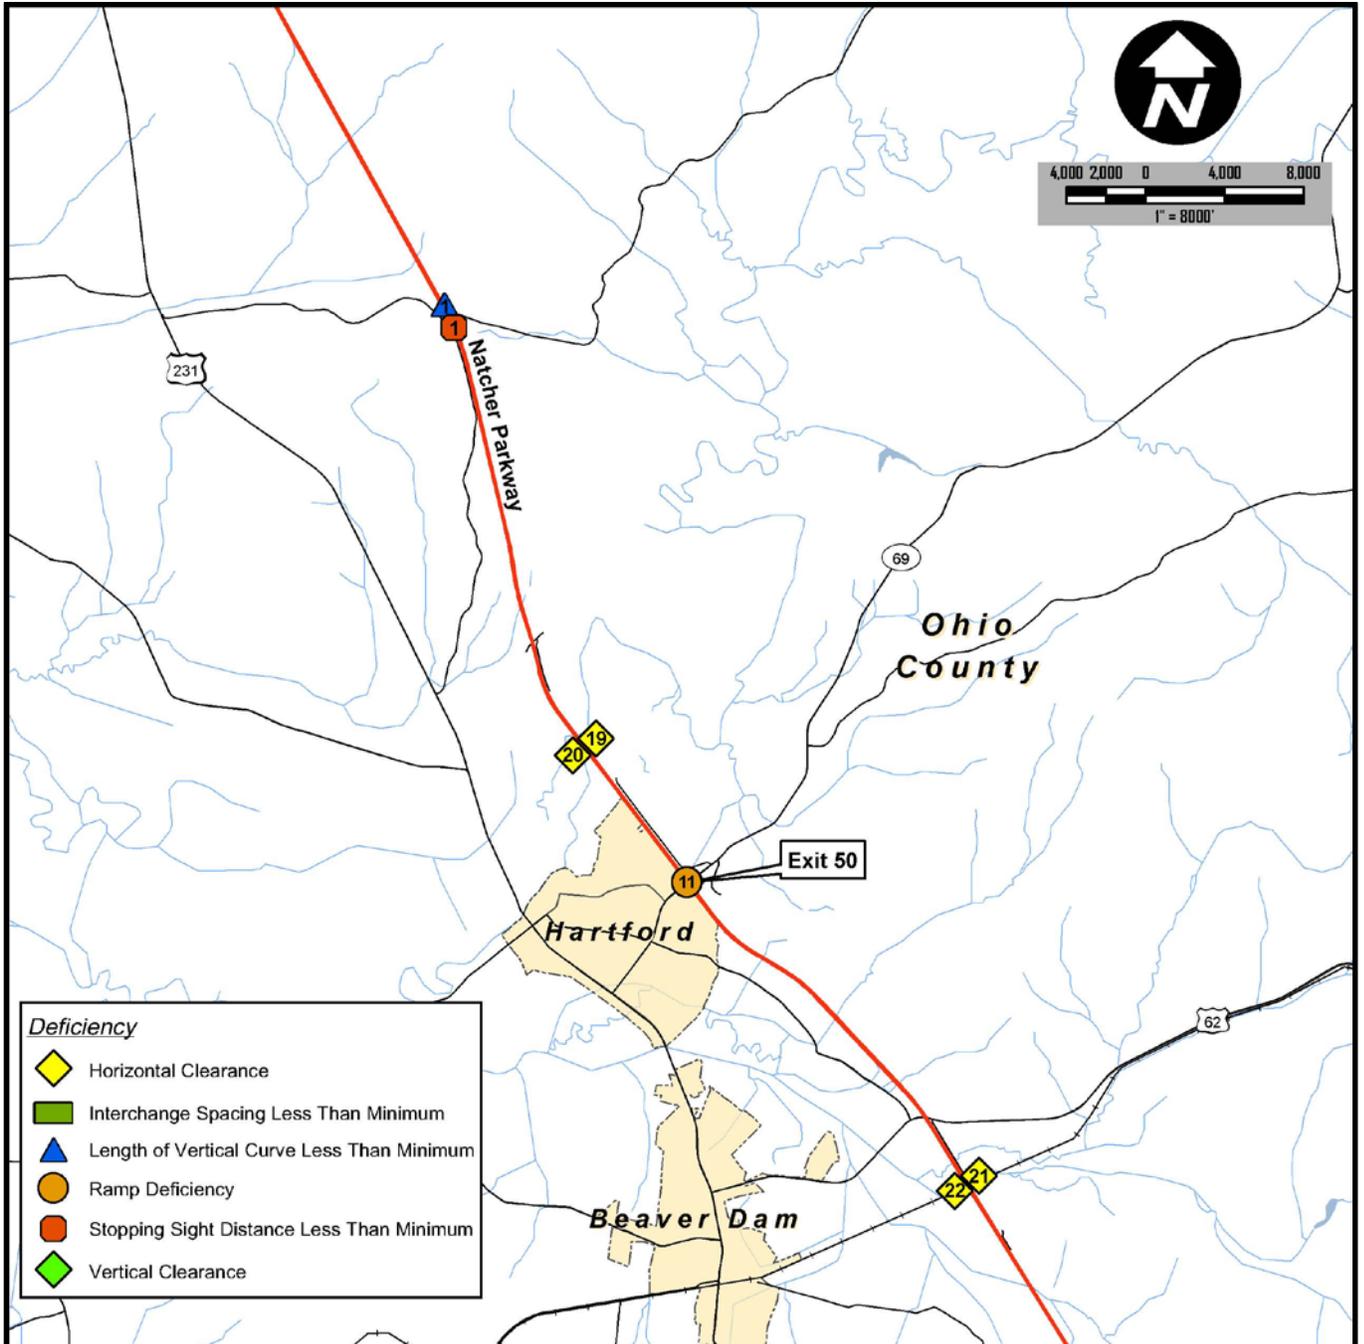
Figure ES-4
Existing Deficiencies
I-69 SPUR, I-66/I-65 SPUR
AND US 60
 Butler, Daviess, Henderson
 Ohio, and Warren Counties
 Kentucky

Deficiency	
	Horizontal Clearance
	Interchange Spacing Less Than Minimum
	Length of Vertical Curve Less Than Minimum
	Ramp Deficiency
	Stopping Sight Distance Less Than Minimum
	Vertical Clearance

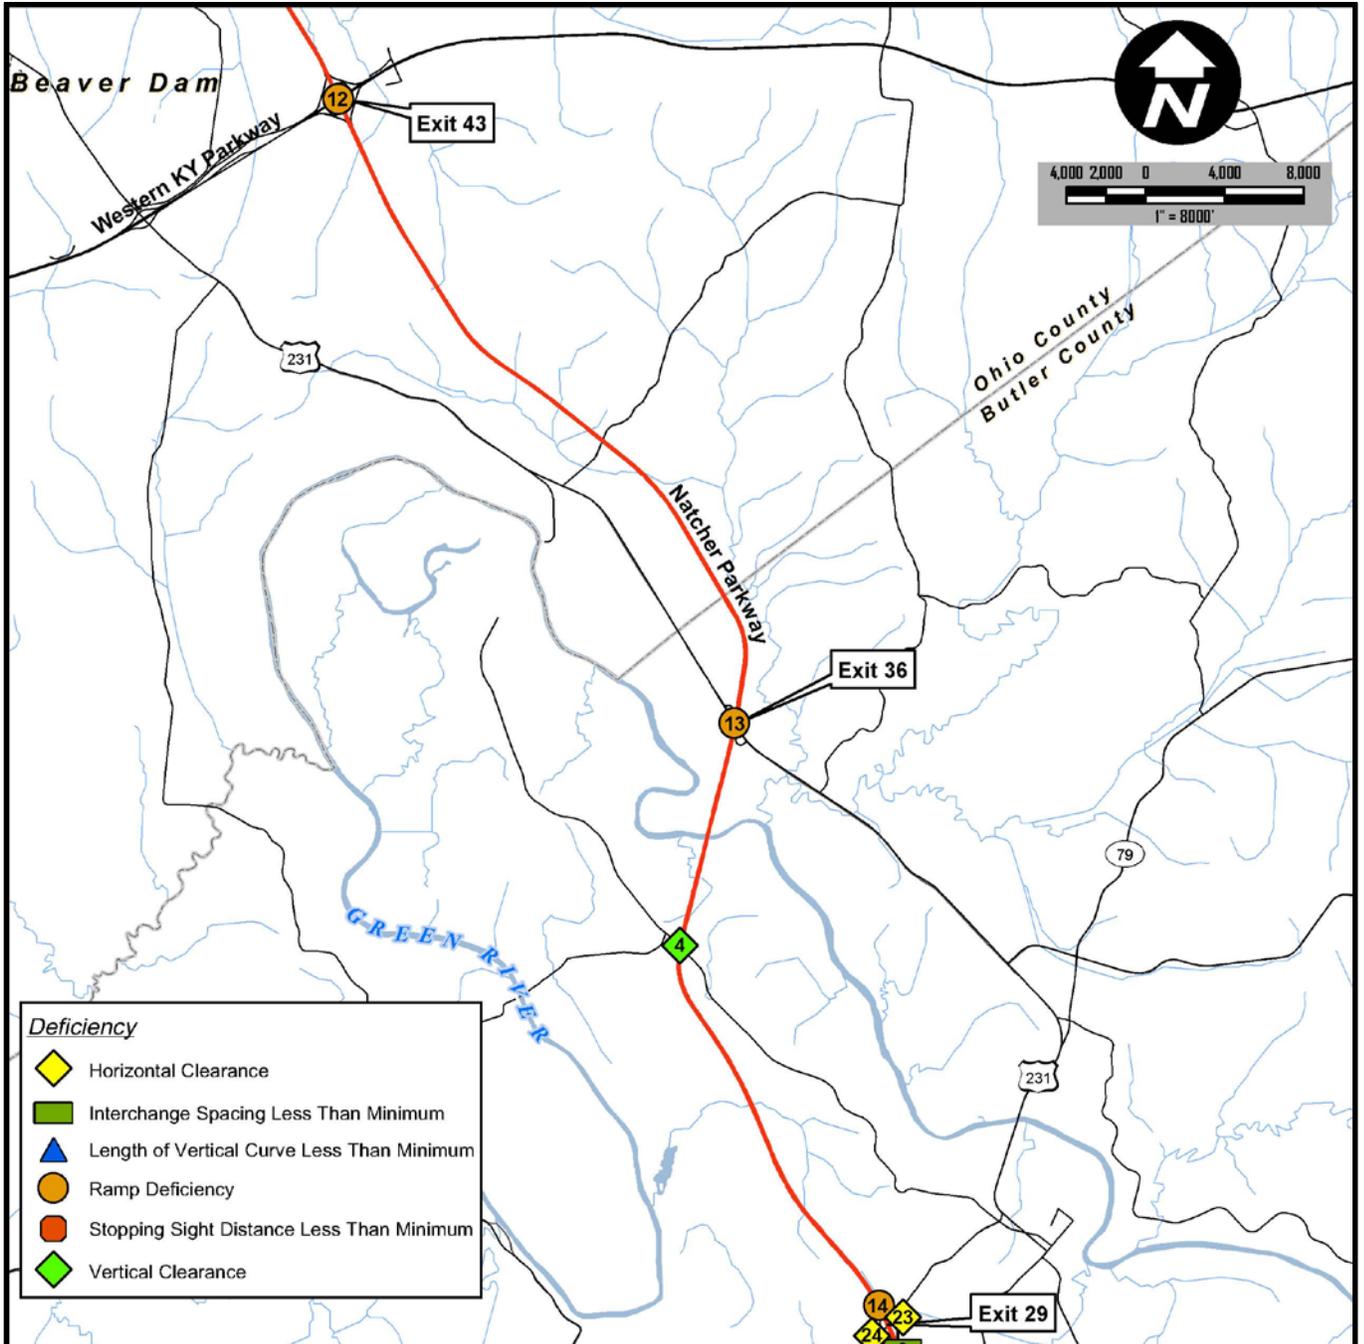
Figure ES-5
Existing Deficiencies
I-69 SPUR, I-66/I-65 SPUR
AND US 60
 Butler, Daviess, Henderson
 Ohio, and Warren Counties
 Kentucky

Horizontal Clearance
	Interchange Spacing Less Than Minimum
	Length of Vertical Curve Less Than Minimum
	Ramp Deficiency
	Stopping Sight Distance Less Than Minimum
	Vertical Clearance

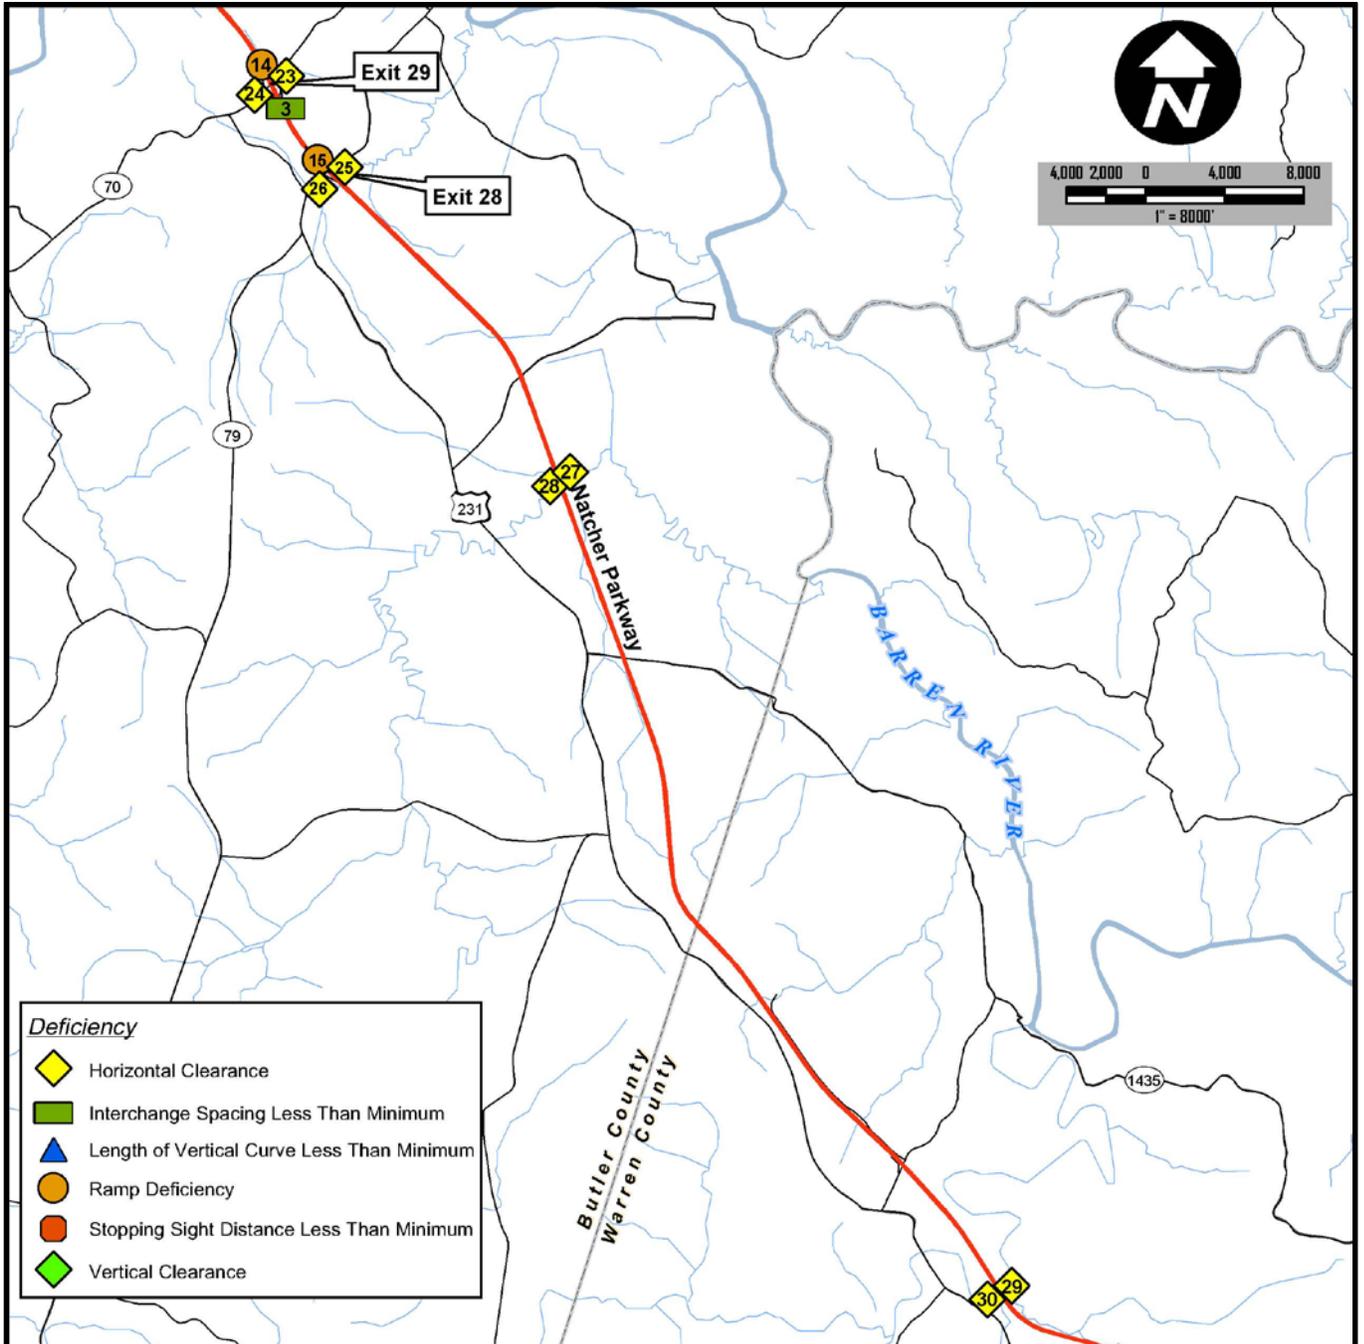
Figure ES-6
Existing Deficiencies
I-69 SPUR, I-66/I-65 SPUR
AND US 60
 Butler, Daviess, Henderson
 Ohio, and Warren Counties
 Kentucky

Deficiency	
	Horizontal Clearance
	Interchange Spacing Less Than Minimum
	Length of Vertical Curve Less Than Minimum
	Ramp Deficiency
	Stopping Sight Distance Less Than Minimum
	Vertical Clearance
