KY 151 Safety Study

Anderson and Franklin Counties

From US 127 to I-64
Alton Road/Graefenburg Road

Prepared by
Kentucky Transportation Cabinet
Division of Planning
November 2016

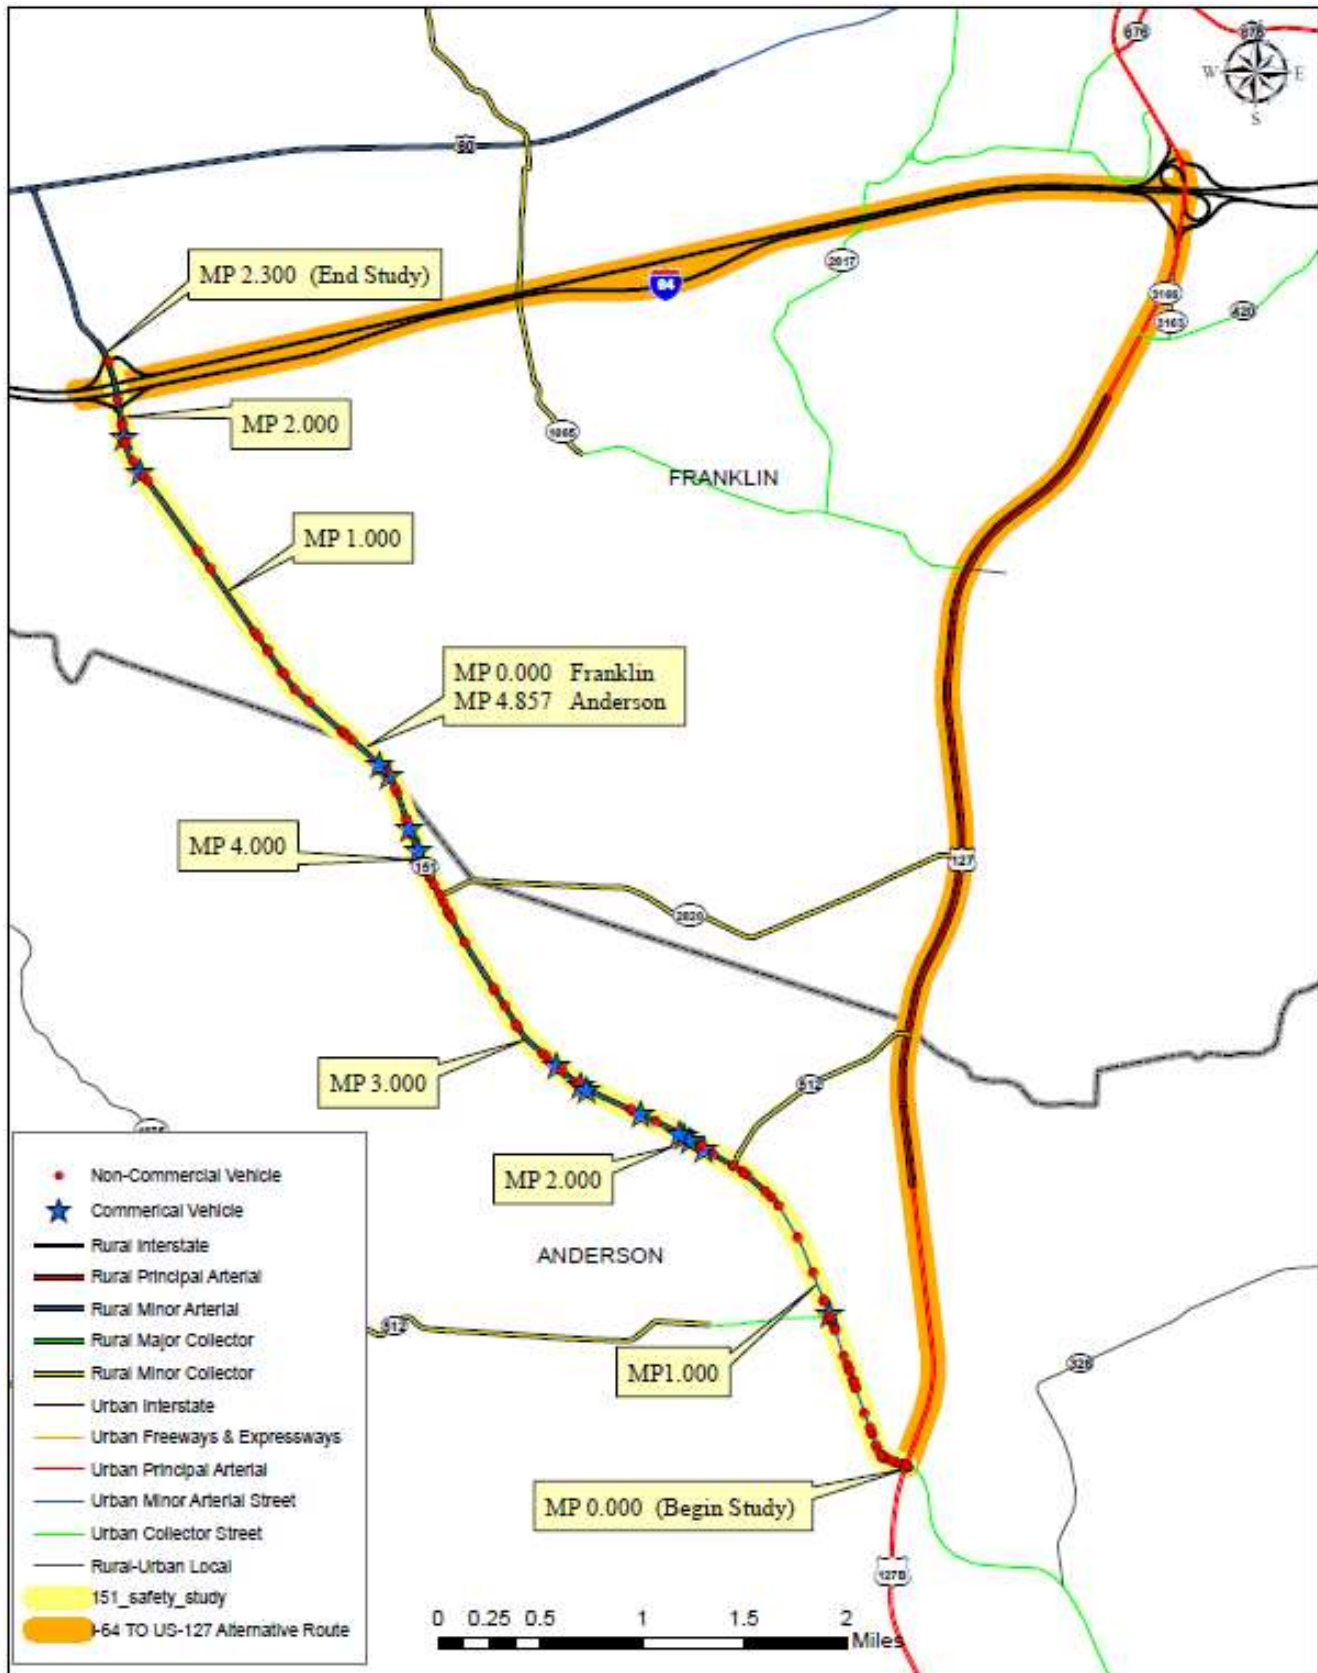
Figure 1 – KY 151 Safety Study Corridor

The KY 151 study corridor is a two-lane roadway which connects US 127 in Anderson County north of Lawrenceburg to I-64 in Franklin County west of Frankfort as shown in **Figure 1 (p.2)**. The study corridor is approximately 6.9 miles in length and runs approximately south to north. The southern section of the roadway is locally known as Alton Road, while the northern part is known as Graefenburg Road. KY 151 in Anderson County begins at milepoint (MP) 0.0 at the US 127 intersection, and ends at the Anderson/Franklin County line, MP 4.587. The KY 151 study area in Franklin County begins at MP 0.0 at the Anderson/Franklin County line, and continues to MP 2.3 at I-64. KY 151 continues north of the I-64 interchange and ends at US 60 (MP 3.22).

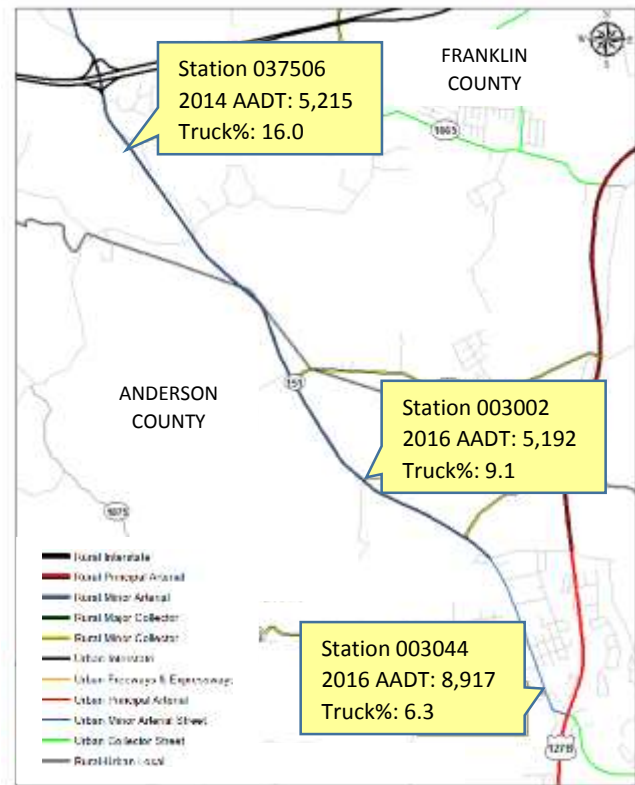
Figure 2 – Map of KY 151 Functional Classification and Traffic Counts

The KYTC Traffic Count Reporting System has three traffic counting stations along KY 151 between US 127 and I-64. The Average Annual Daily Traffic (AADT) varies from 8,917 vehicles per day (vpd) at the southern end of the corridor towards US 127, to 5,215 vpd at the northern section by I-64. These counts, along with the corresponding truck percentages, can be seen in **Figure 2**, right, in **Table 3**, below, and are detailed in **Appendix B**.

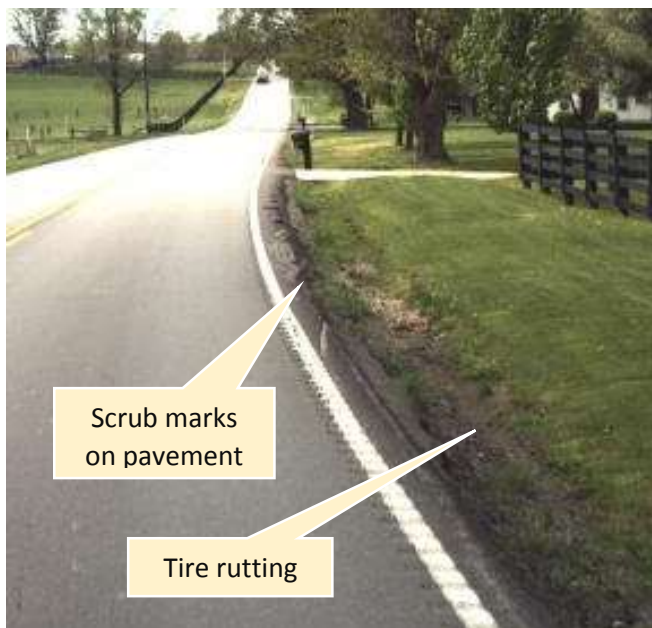
Figure 3: Scrub marks at MP 2.6, Anderson County

The KY 151 was also reviewed for physical evidence of offtracking. As shown in **Figure 3**, below, the curve located at MP 2.6 in Anderson County shows some evidence of scrubbing and tire rutting. This evidence, along with the calculated pavement widening for offtracking, supports the decision to remove KY 151 from the National Truck Network and prohibiting STAA vehicles.

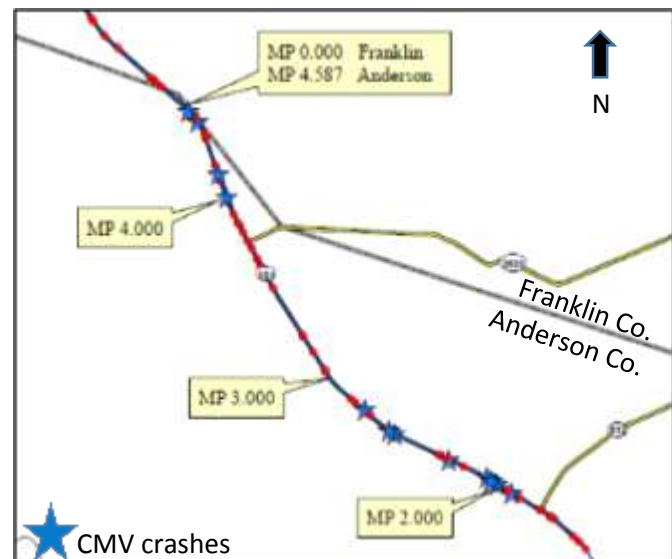
Figure 7 – CMV Crash Clusters

When the CMV crashes are mapped by milepoint, as seen in **Figure 7**, the CMV crashes appear to be clustered in three locations in Anderson County: at approximately MP 2.0, MP 2.6, and MP 4.1. When the contributing cause from **Table 17 (p.25)** is reviewed at each of these three locations, along with the geometric analysis and the physical evidence, it appears that the low and/or narrow shoulders may be contributing to the CMV crashes.

Due to the relatively low number of CMV crashes, it is difficult to clearly establish a statistical cause. The CMV crashes located close to MP 4.1 in Anderson County are unusual because the roadway is generally straight, the terrain is open, and the horizontal curves in proximity to this area have relatively large radii. All three of the CMV crashes attributed to shoulder drop-offs in this location were southbound on KY 151 in the vicinity of an abrupt change in pavement width where the travel lane changes from 12-foot lanes to 11-foot lanes, and the shoulders change from approximately 10-foot paved shoulders to 0- to 2-foot combination shoulders. This suggests that CMVs exiting from I-64 and traveling southbound on KY 151 may be surprised by the abrupt change in pavement width.

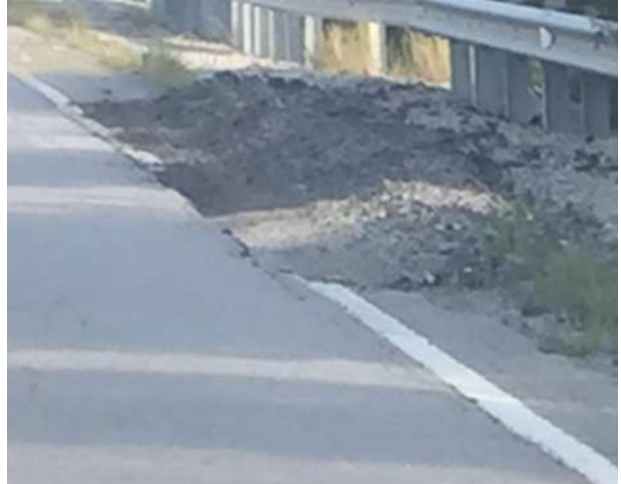
Since the 2014 inspection, minor localized spots of asphalt pavement mat tearing and shoulder failure caused by the turning movements of garbage trucks were noted in the southbound right turn lane in close proximity to the landfill in Franklin County. This type of distress is considered a materials application related failure.

Shoulder failure
