Data Needs Analysis

Scoping Study

KY 945
Graves County
Brush Creek
Bridge Replacement
Item No. 1-1146.00

Prepared by
KYTC District 1

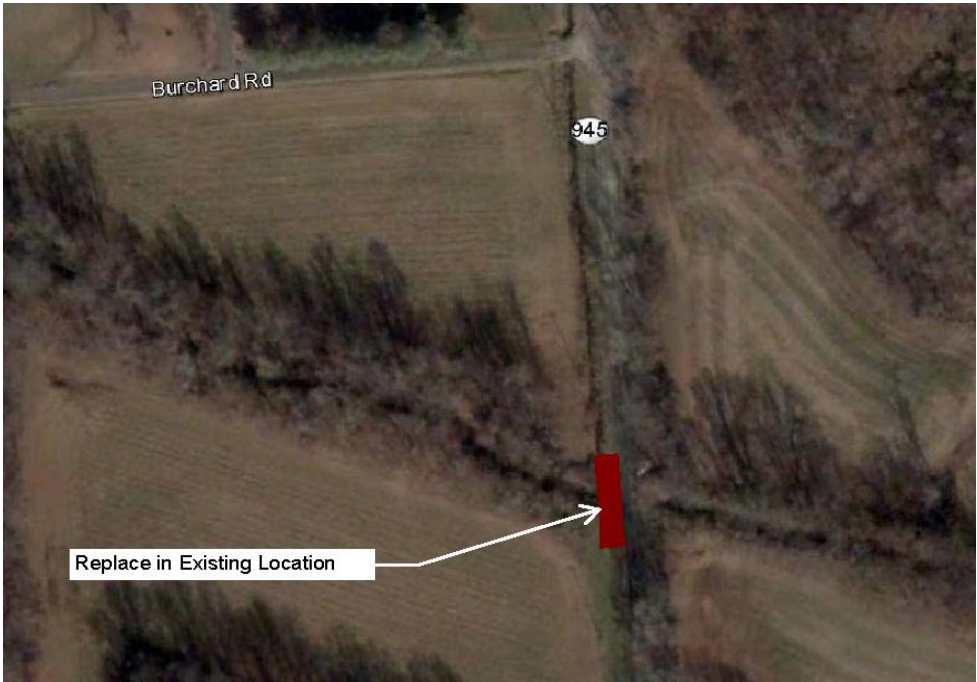
Replace the two lane rural roadway approaches on KY 945 and bridge over Brush Creek in the same location as the existing. The new bridge may need to be widened to allow for the recommended geometrics. This alternate will not change the horizontal alignment. Since the existing bridge cannot remain open during construction, the road will be closed to through traffic during construction. Traffic will be detoured onto other roads. A sketch of the proposed project can be seen below.

Included in the alternatives were a no build recommendation, a replace in the existing location alternative, and a replace to the East or West of the existing location alternative. After review of the data and discussion at the project team meeting, it was determined that Alternative #2, Replace in the existing location would best address the purpose and need for the project. The estimate for this alternative is \$30,000 more than the funding listed in the current Highway Plan (see phases D, R, U, and C).

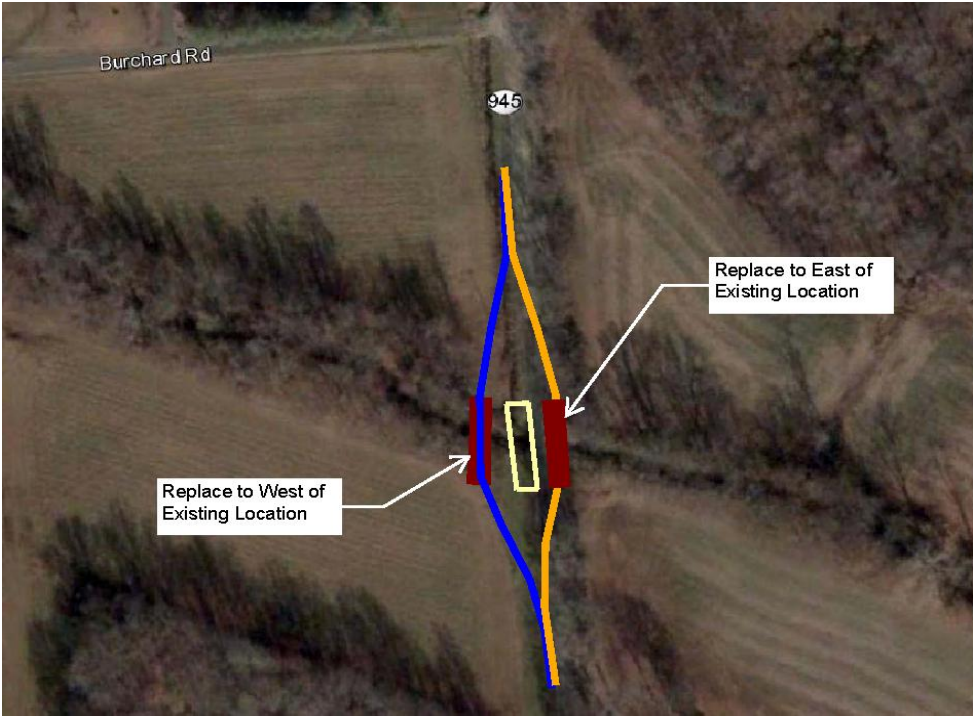
Replace the two lane rural roadway approaches on KY 945 and bridge over Brush Creek shifting the alignment West or East of the existing. Since the new bridge will be constructed away from the existing bridge, traffic could remain on the existing bridge during construction. Temporary diversions will be necessary to construct tie-ins. A sketch of the proposed project can be seen below.

Due to the low ADT (325ADT, 2012) the DNA Studies Team finds this alternative "fiscally not feasible".
