# Data Needs Analysis

Madison County  
Bridge Replacement  
KY 3376 over Hays Fork Creek  
Item No. 7-1126

Prepared by  
KYTC District 7 Planning

## KYTC Bridge Inspection Report

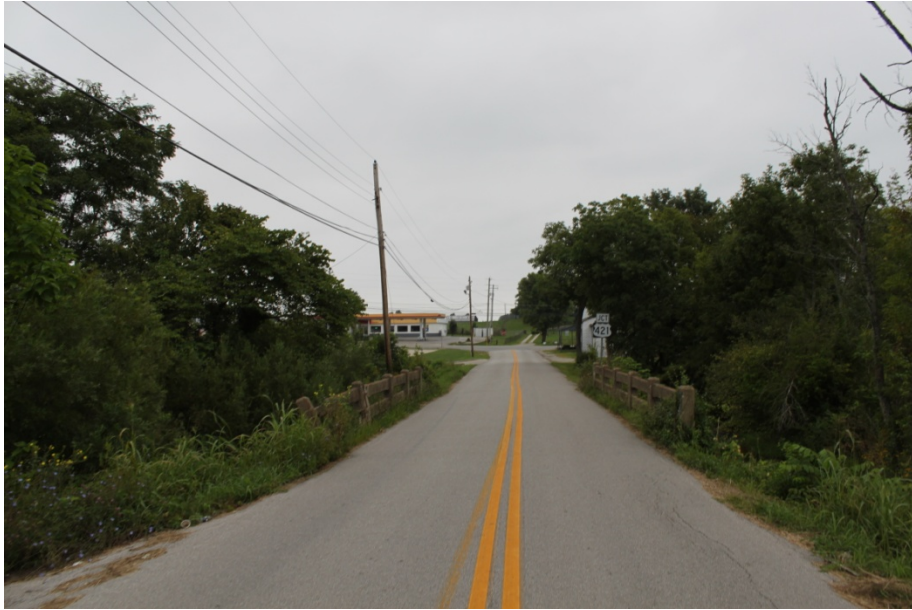
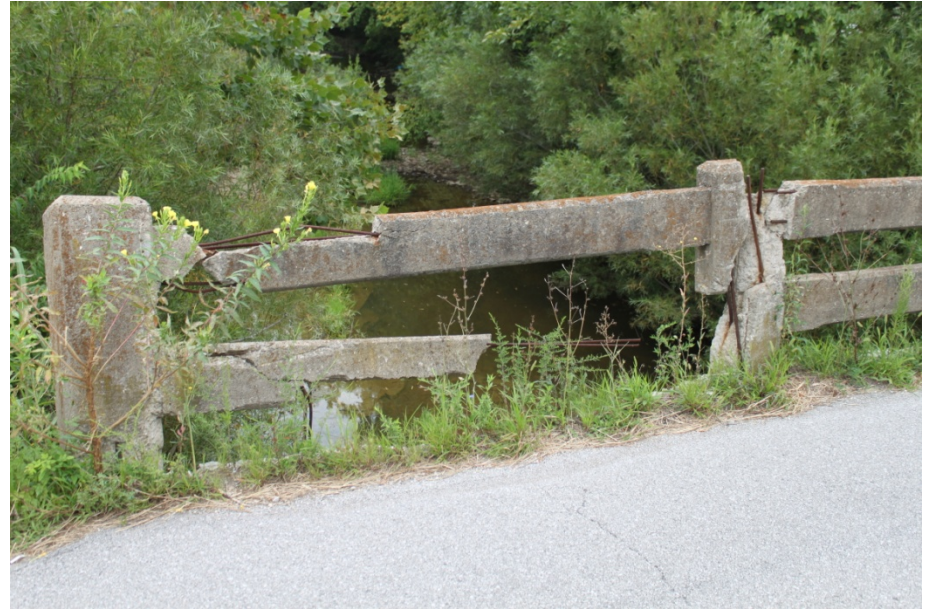
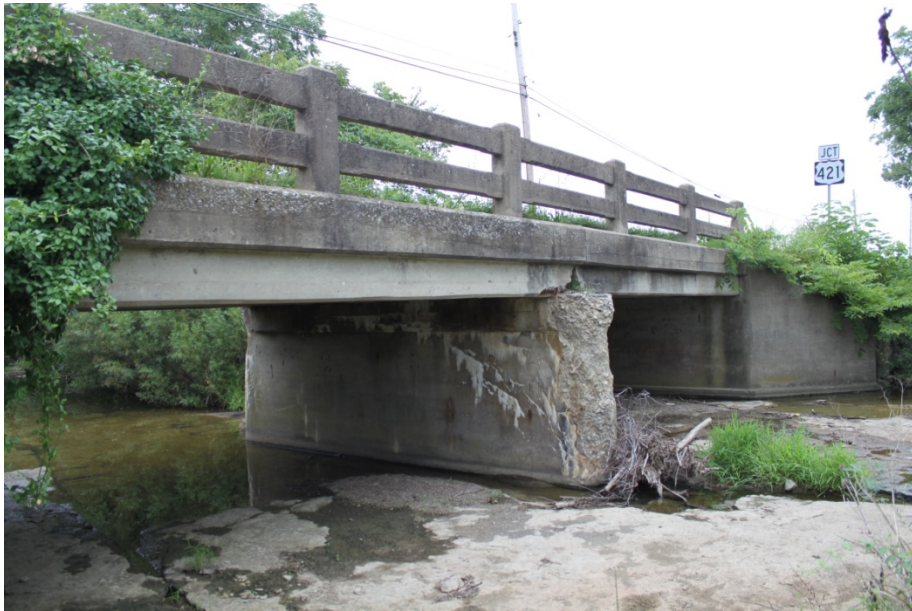
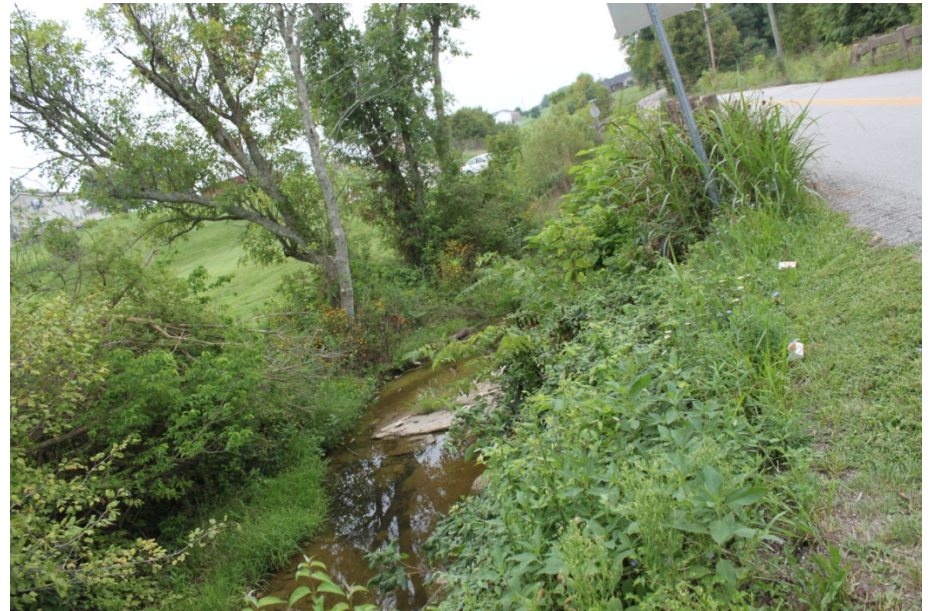
**Need:** The existing bridge is around 90 years of age and has experienced much girder deterioration and cracking. The bridge width is narrow at only 18 feet from curb to curb putting the concrete railing close to the traffic lanes. The current sufficiency rating is 23.10 with the structure being recognized as functionally deficient.

Str Unit	Elm/Env	Description	Description
1	110/1	R/Conc Open Girder	GIRDERS DETERIORATING AT PIER JOINTS & OLD DRAIN SPOUTS.GIRDER CRACKING AND EFFLORESCENCE THRU-OUT.EXTERIOR BEAM IS SPALLING AND REINFORCEMENT IS EXPOSED. THIS STRUCTURE SHOULD BE CONSIDERED FOR REPLACEMENT.BUILT IN 1922.
1	13/1	Unp Conc Deck/AC Ovl	
1	210/1	R/Conc Pier Wall	MODERATE TO HEAVY CRACKING, IN THE PIER WALL. THE UP-STREAM AND DOWN-STREAM FACE OF THE PIER WALL, HAS HEAVY SPALLING, SCALING AND LEACHING.
1	215/1	R/Conc Abutment	MODERATE TO HEAVY CRACKING, IN BOTH ABUTMENTS, ESPECIALLY THE WINGWALLS OF ABUTMENT #3.
1	234/1	R/Conc Cap	THE ENDS OF THE CAPS HAVE MODERATE SPALLING.
1	331/1	Conc Bridge Railing	MAJOR DAMAGE TO CONCRETE RAILING DUE TO TRAFFIC IMPACT AND IT IS FUNCTIONLESS.
1	359/1	Soffit Smart Flag	MODERATE CRACKING WITH EFFLORESCENCE IN THE SOFFIT.
1	361/1	Scour Smart Flag	MINOR SCOUR AT PIER .

Candidate ID:	Status	Priority	Assigned	Action	Elem	Date Recommended
REPLACE RAILING.	Approved	High	Unassigned	31	331	3/26/2008
REPLACE STRUCTURE.	Under Review	High	Unassigned	11	0	3/26/2008
