Scoping Study

# US 60 BRIDGE

## *Replacement*

at Cumberland River

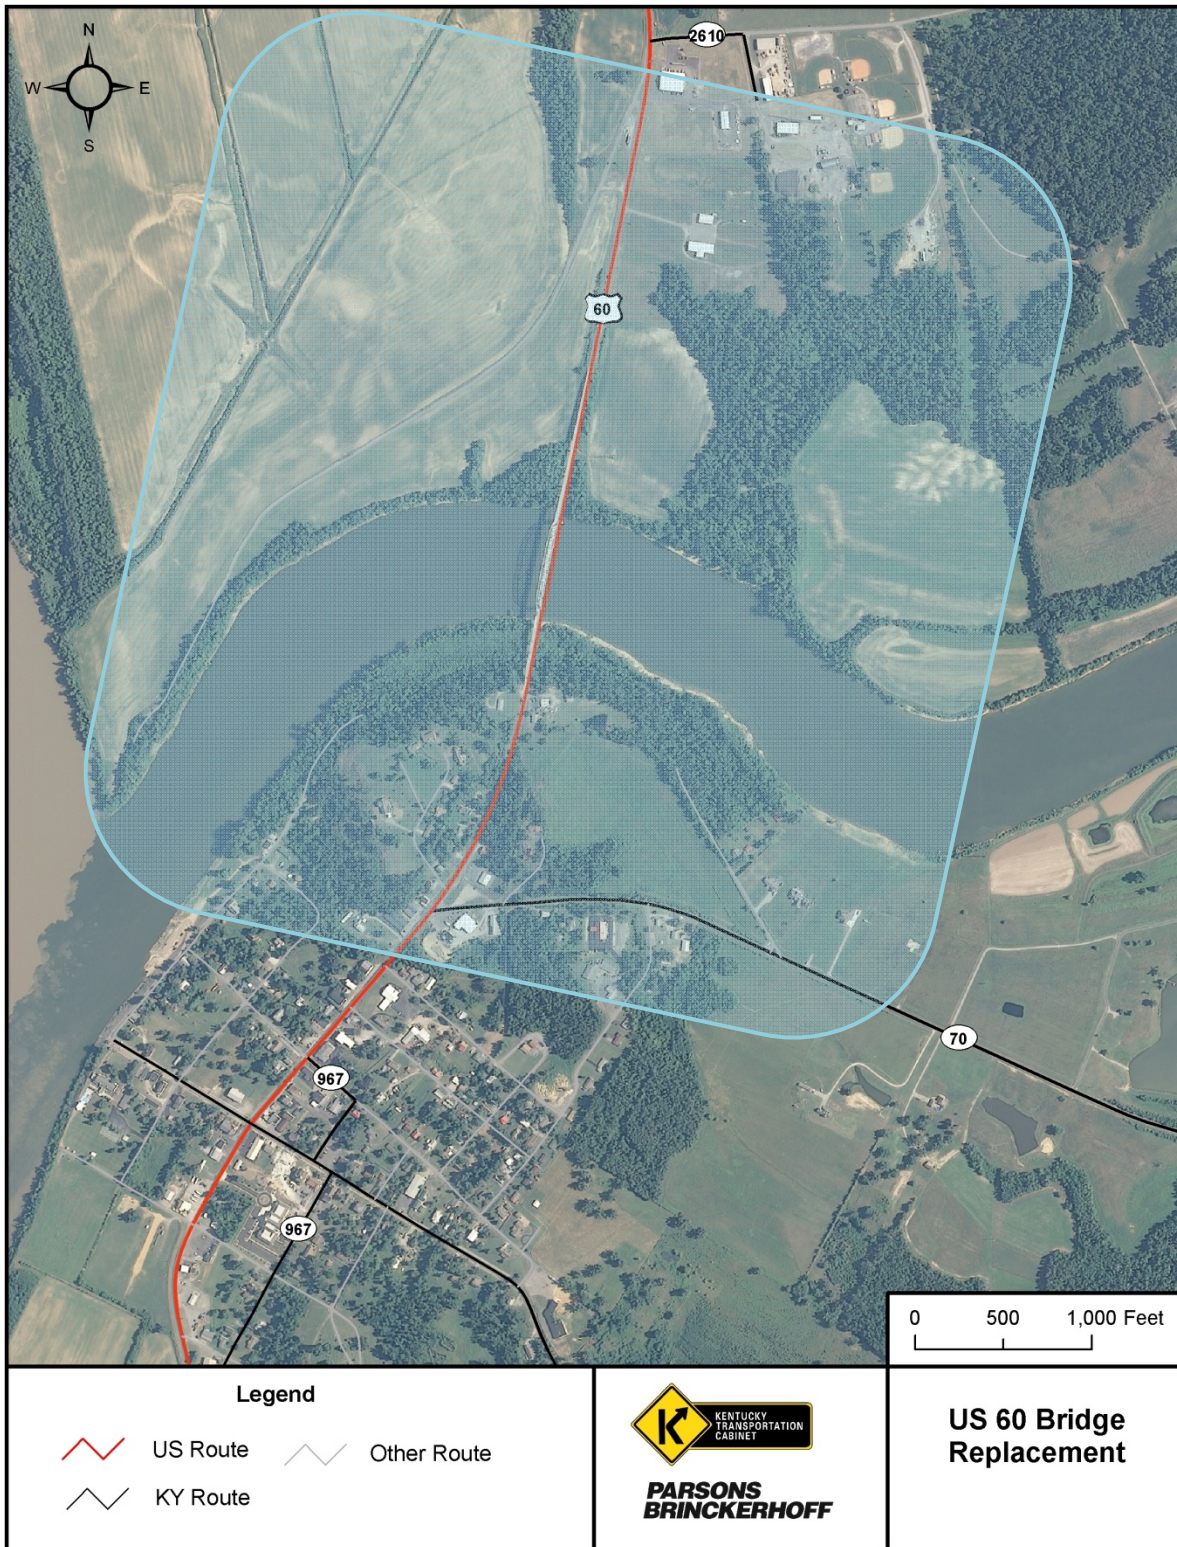
Figure 1: Study Area

The study area included the US 60 bridge itself as well as the roadway approaches on either side. It is bounded by KY 70 in the south to KY 2610 in the north and extends approximately a half mile to the east and west of the existing bridge. There has been consideration of a bypass around the City of Smithland, where the bridge is located; therefore a potential connection to a bypass was studied if a new bridge is recommended. **Figure 1** on Page 2 shows the study area.

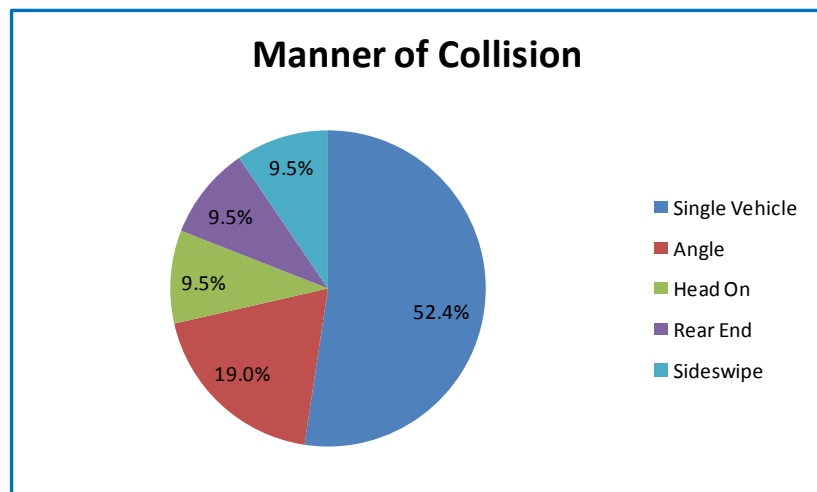
**Figure 2: Manner of Collision**

The crash analysis performed for US 60 shows in **Table 6** on Page 10, that the critical crash rate is greater than one, indicating that crashes do not appear to be occurring at random. **Figure 2** (shown here) shows the various manners of collision for the 21 crashes that occurred in the three year period.

Further review of individual crash records showed that for the single vehicle collisions, many were a result of driver error (i.e. driver fatigue or the influence of drugs and alcohol). Collisions with animals were also a factor for several crashes. The crash that involved a pedestrian was the result of a first responder being struck while out in the roadway. As the majority of the crashes reviewed are not related to documentable geometric issues, there are not any recommendations for altering the future design of the Smithland side of the approach due to crashes. The fact that 52% occurred at night could be an indication that improving lighting could reduce crashes.

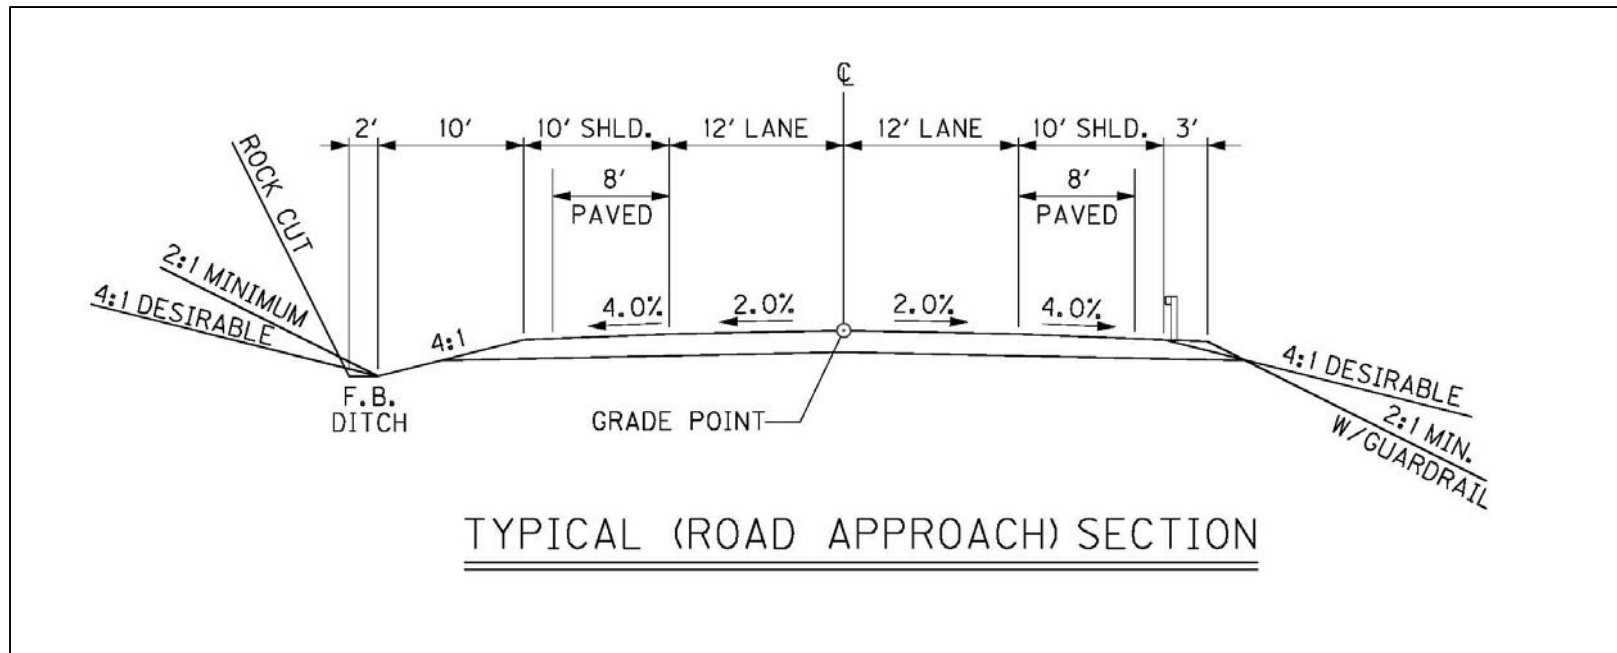
Figure 4: Roadway Approach Typical Section

The typical section for the approaches on US 60 both north and south of the bridge include two 12-foot travel lanes and 10-foot shoulders, with 8-feet paved. A typical section is shown in **Figure 4** (on page 29). The US 60 bridge typical section also consists of two 12-foot travel lanes with 10-foot shoulders, and is shown in **Figure 5** (on page 30). It should be noted that while the bridge typical section is shown as a truss in the figure, the bridge type has not yet been determined, and is subject to change.
