Scoping Study

Bridge Replacement on US 60A Over South Fork Beargrass Creek Jefferson County MP 5.698 to 5.738 Item No. 5-1064.00

Prepared by the KYTC Division of Planning and KYTC District 5

February 2013

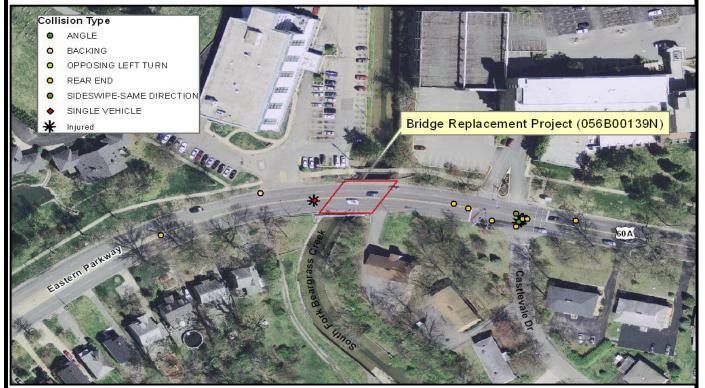
Exhibit 3: Collision Data

Refer to Table 1 and Exhibit 3, shown on page 8 of this report. The collision data shown was drawn from the KY State Police Analysis Database from the dates 1/16/10 - 1/16/13 (3 years). There were a total of 18 collisions within approximately 0.2 miles on each side of the bridge location. A single vehicle collision with injury occurred on the western side bridge approach. Most of the other collisions were rear-end or sideswipe/angle type due to the traffic signal located just east of the bridge at Castlevale Dr.
