Pre-Design Scoping Study

US 421 Franklin County Bridge Replacements

Kentucky Transportation Cabinet

August 15, 2011

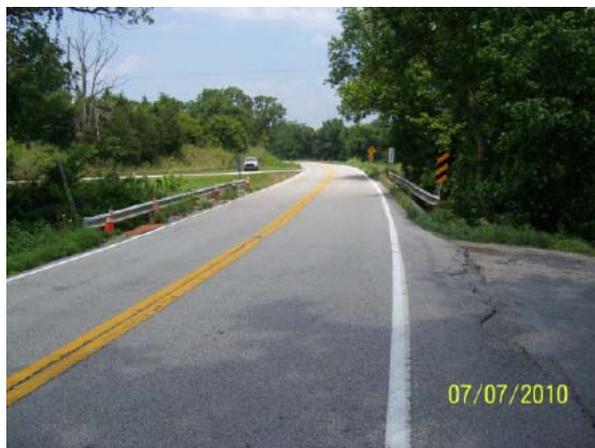
Figure 9: Bridge #037B00023N Looking North

Bridge #037B00023N is 66 feet long and 26 feet wide out to out (23 feet wide curb to curb). It is structurally deficient with a sufficiency rating of 46.8 and does not meet the guidelines stated above of 11 ft lanes and 6 ft shoulders. The deck is rated as serious, the superstructure is rated as poor, and the substructure is rated as fair. Furthermore, the bridge has severe spalling and deterioration with resteel exposed in areas. Steel plates have been placed on the edge of the bridge deck to protect motorists from traveling over the severely deteriorated areas. The guardrail is loosely attached to the sides of the bridge due to deterioration and cones are placed on the edge of the bridge to warn motorists of the area. A Structure Inventory and Appraisal Sheet for this bridge can be found in Appendix H. Photographs of this bridge can be seen below in Figures 9 and 10.

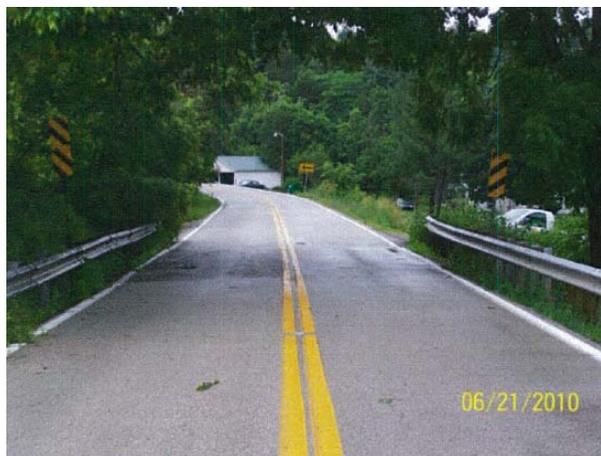
Figure 11: Bridge #037B00024N Looking North

Bridge #037B00024N is 23 feet long and 22 feet wide out to out (22 feet wide curb to curb). It is structurally deficient with a sufficiency rating of 48.9 and does not meet the guidelines stated above of 11 ft lanes and 6 ft shoulders. The deck and superstructure are rated as poor. The substructure is rated as fair. Furthermore, the bridge has severe spalling and deterioration with resteel exposed in areas. The guardrail posts on both sides are no longer anchored to the bridge due to the condition of the concrete that they were anchored in. A Structure Inventory and Appraisal Sheet for this bridge can be found in Appendix H. Photographs of this bridge can be seen below in Figures 11 and 12.

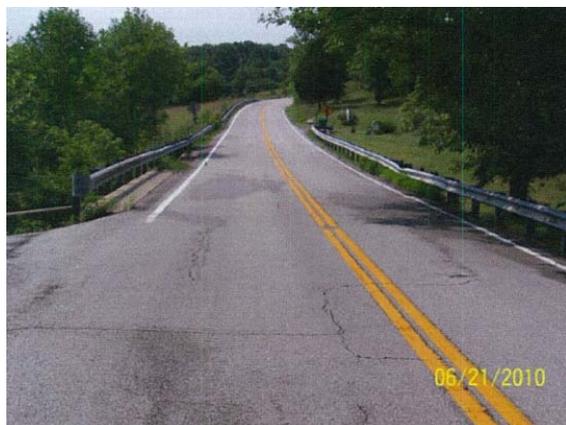
Figure 13: Bridge #037B00025N Looking North

Bridge #037B00025N is 35 feet long and 29 feet wide out to out (27 feet wide curb to curb). It is structurally deficient with a sufficiency rating of 48.7 and does not meet the guidelines stated above of 11 ft lanes and 6 ft shoulders. The deck, superstructure, and substructure are all rated as poor. Furthermore, the bridge has severe spalling and deterioration with resteel exposed in areas. Box beams have been previously added to each side of the bridge. The old beams to the inside of these are heavily spalled and resteel is exposed. In addition, recent maintenance work has been done to the southwest wingwall. A Structure Inventory and Appraisal Sheet for this bridge can be found in Appendix H. Photographs of this bridge can be seen below in Figures 13 and 14. The recent maintenance work can be seen below in Figure 15.

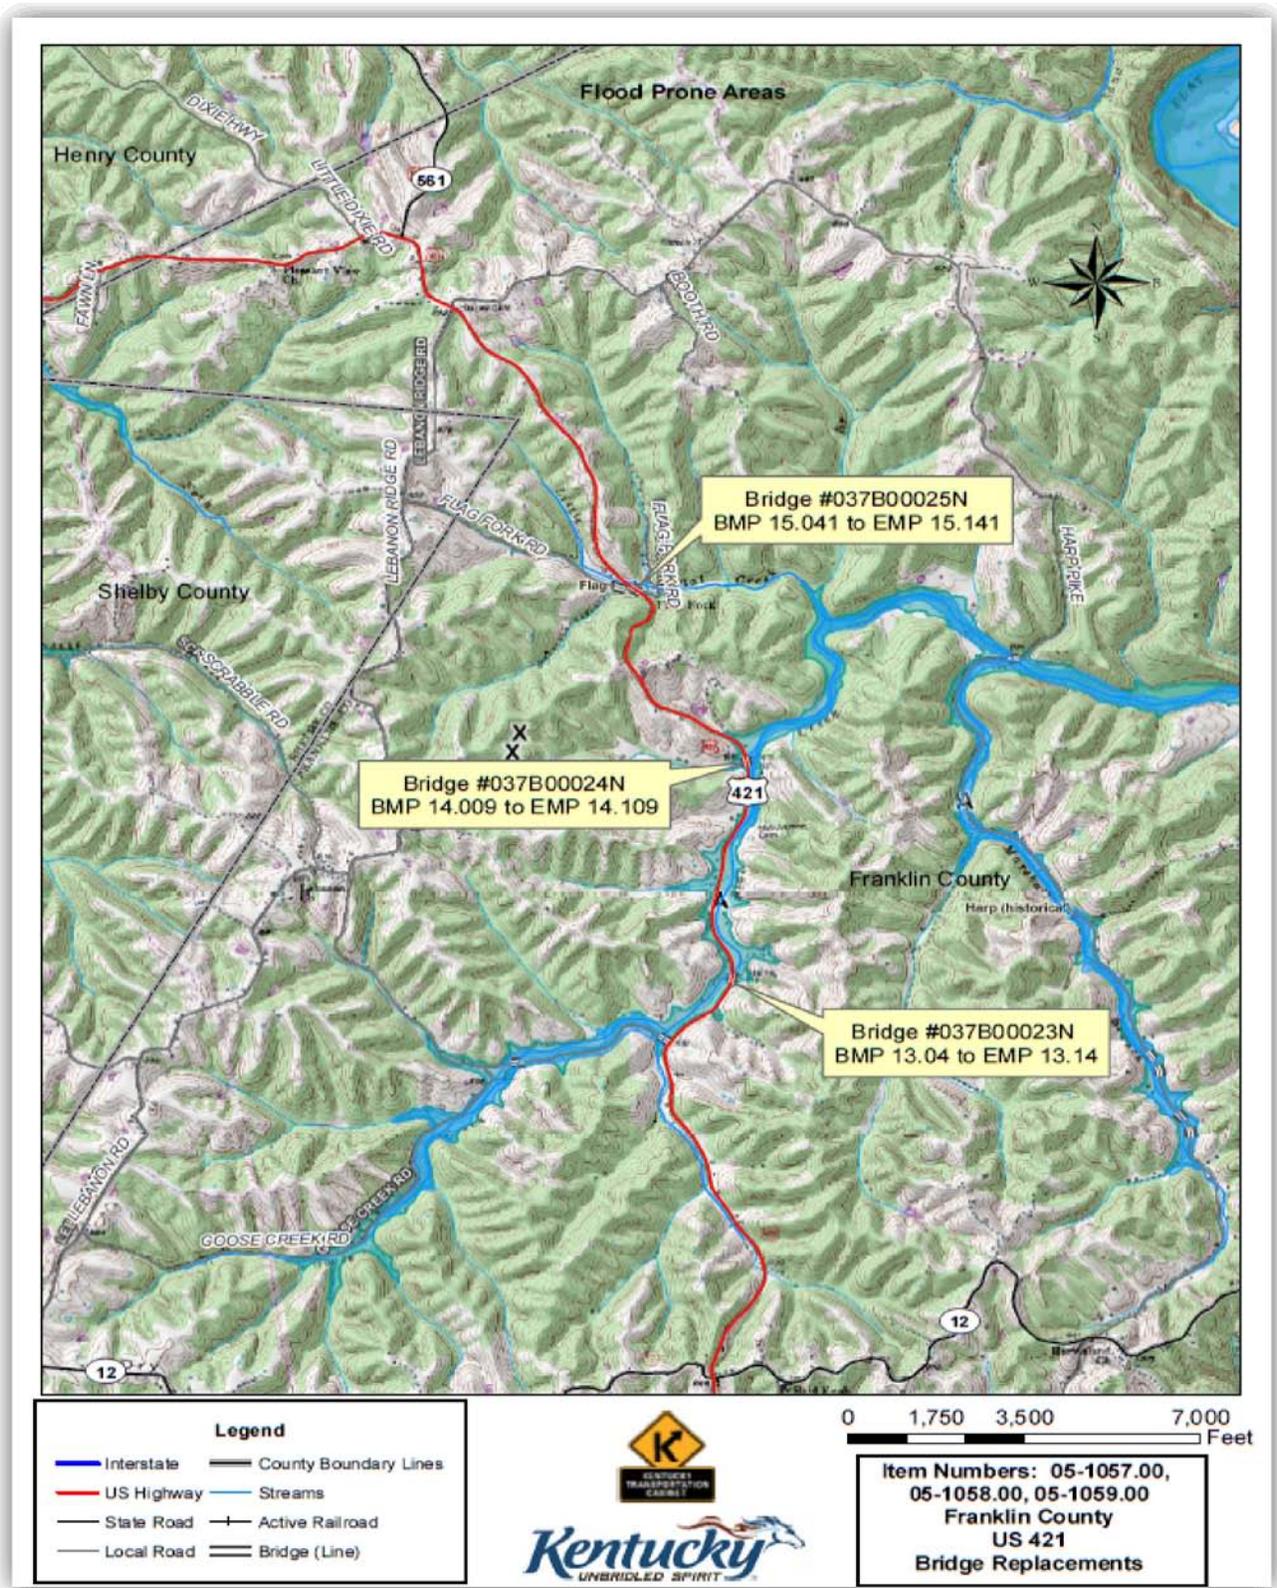
Figure 16: Flood Prone Areas Map

Flooding over the bridges has not been reported. Also there does not appear to be a problem with debris catching the bridges. A flood prone areas map can be seen in Figure 16. According to the Flood Insurance Rate Maps (FIRM), Bridge # 037B00023N and # 037B00024N are both located in the special flood hazard zone A. This area is subject to flooding by the 1% annual chance flood (100 year flood). FIRM's of the project area are included in Appendix J. A floodway analysis may be performed in future project phases to determine the needed hydraulic opening for water under the bridges.

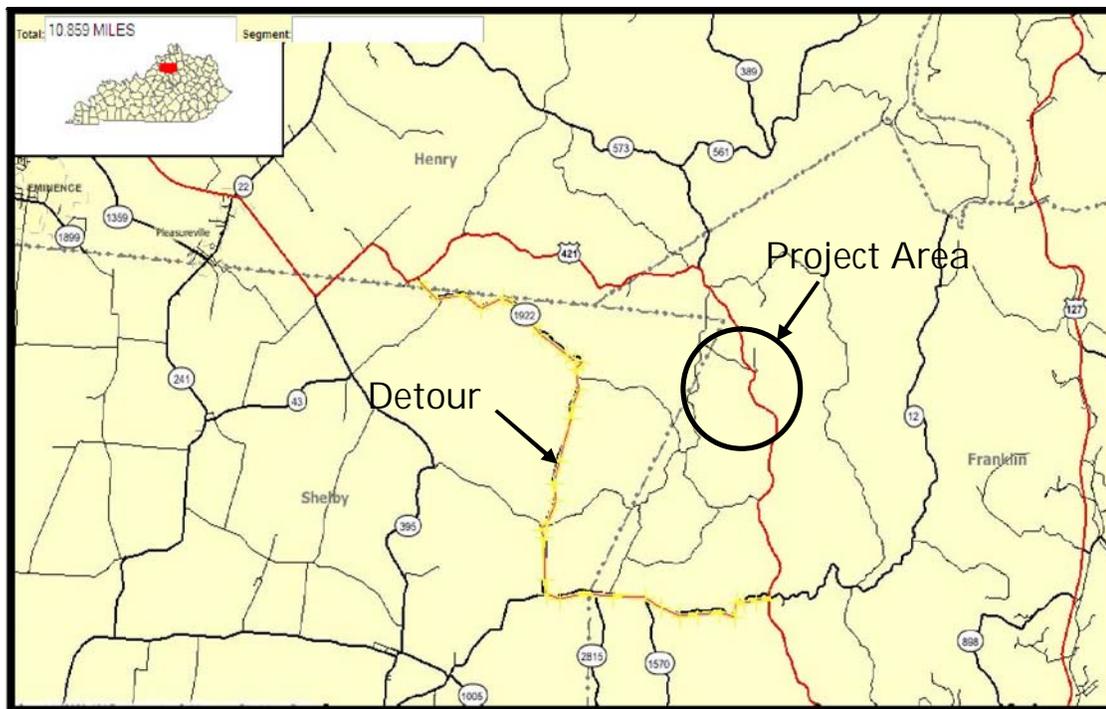
Figure 24: Detour Using Existing State Routes

The detour would use KY 12 and KY 1922. The detour length is approximately 11 miles. The same stretch of US 421 between KY 12 and KY 1922 is approximately 10 miles. For vehicles traveling through the project area the detour would be minimal. However, for those that live within the stretch of US 421 affected a detour length of up to 20 miles could occur. Figure 24 details the detour.

The problem with this detour is that KY 12 is narrow, has no striping, and has multiple sharp curves for approximately the first two miles of the detour. Past this section the detour has striping and lesser degree curves but continues to be narrow. It would be less than desirable to send the amount of traffic and any large trucks that use US 421 on this detour.

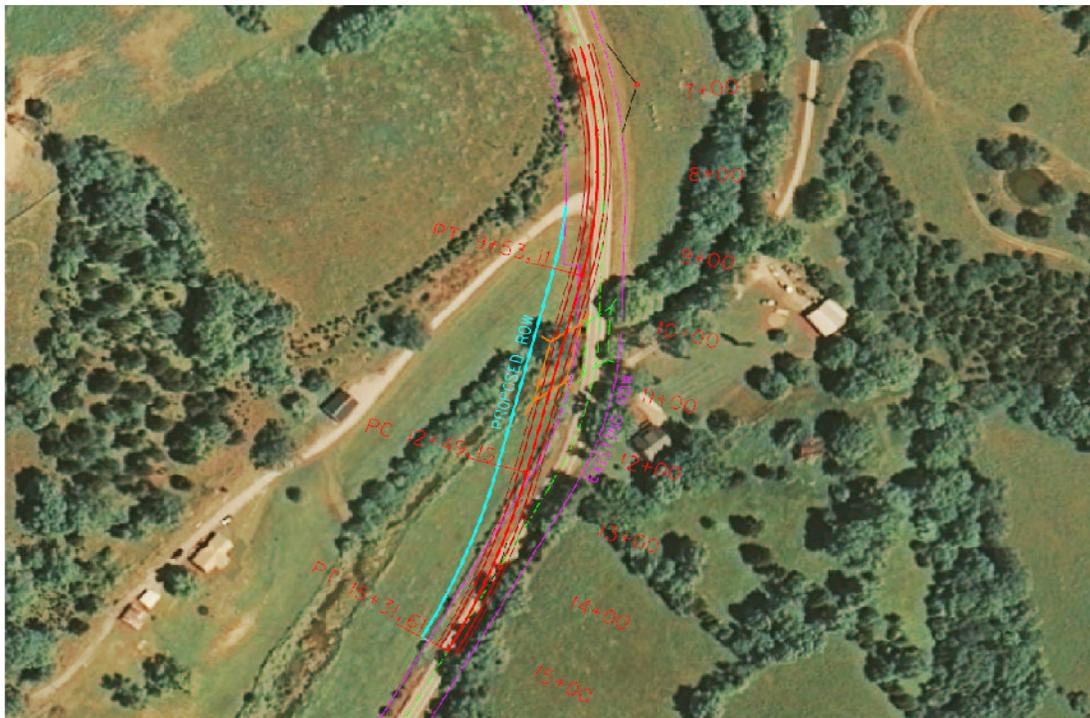
Figure 25: Proposed Realignment for Bridge #037B00023N

This alternative would build the bridges on a new alignment. For Bridge #037B00023N fill would be needed to bring the realignment up to the current level of US 421. The proposed realignment for this bridge can be seen below in Figure 25. The total length from tie in to tie in is 900 ft with 500 ft of this consisting of new roadbed. Approximately $\frac{1}{2}$ acre of right of way would need to be purchased with this scenario. The curve to the south meets a 55 MPH design criteria while the curve to the north only meets a 45 MPH design criteria. However, a design exception for this curve should not be a problem considering that the existing curve is not any better. Considering that a diversion at this bridge would be similar to realignment, building the bridge on a new realignment should be considered.

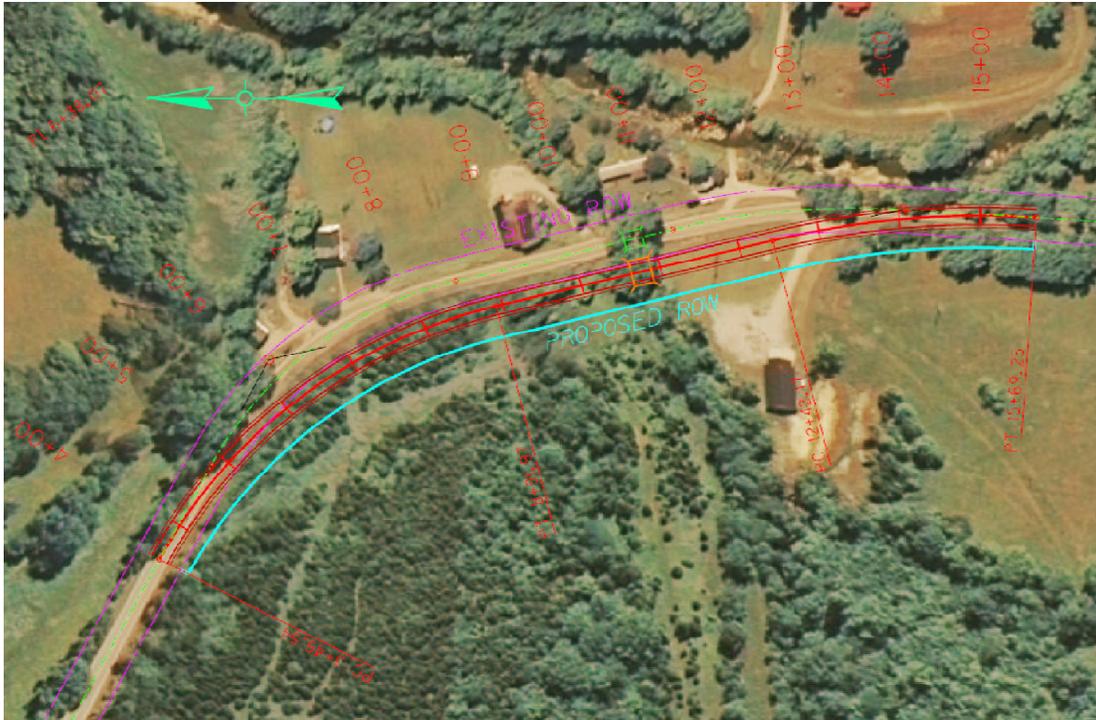
Figure 26: Proposed Realignment for Bridge #037B00024N

For Bridge #037B00024N excavation work would be required. The proposed realignment for this bridge can be seen below in Figure 26. The total length from tie in to tie in is 1100 ft with the majority of this consisting of new roadbed. Approximately 1 acre of right of way would need to be purchased with this scenario. The curve to the south meets a 55 MPH design criteria while the curve to the north only meets a 45 MPH design criteria. However, a design exception for this curve should not be a problem considering that the existing curve only meets a 35 MPH design criteria. The cost for this realignment is greater due to a longer length of new roadbed required. A diversion at this bridge may be more feasible.

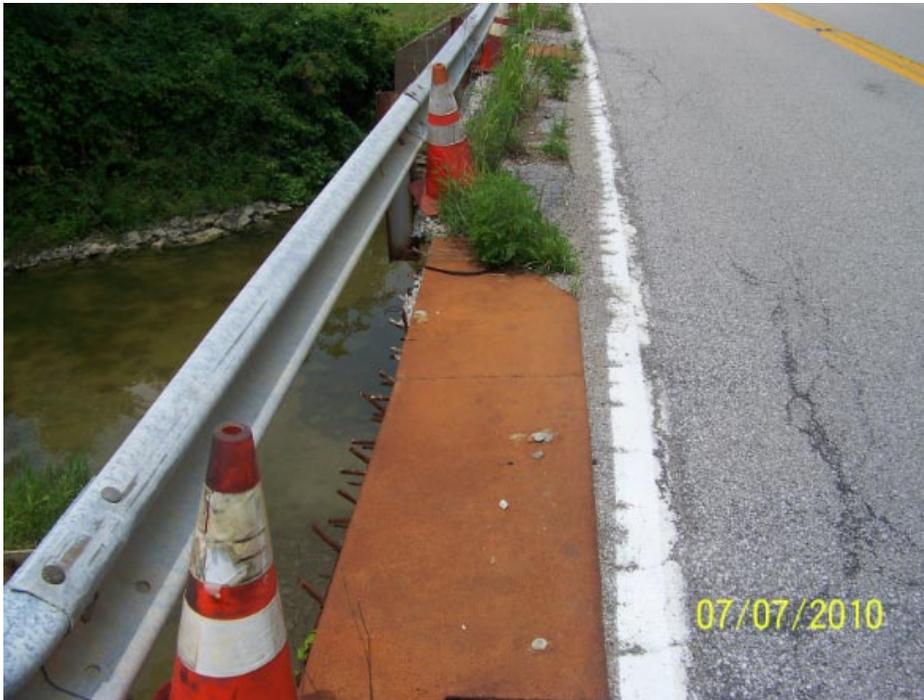
West edge supported by steel plates.

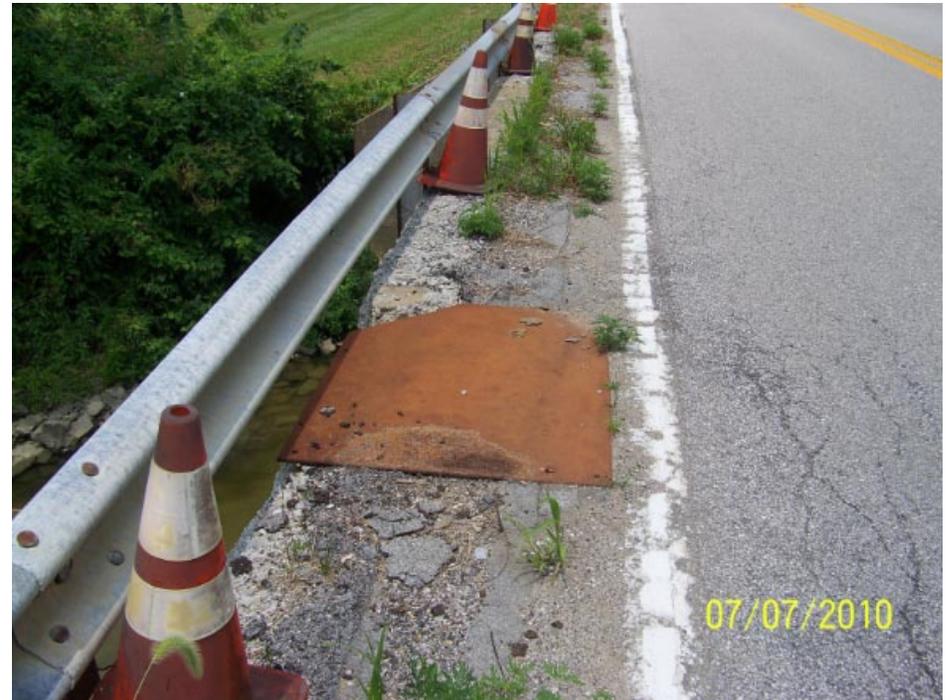
West edge supported by steel plates.

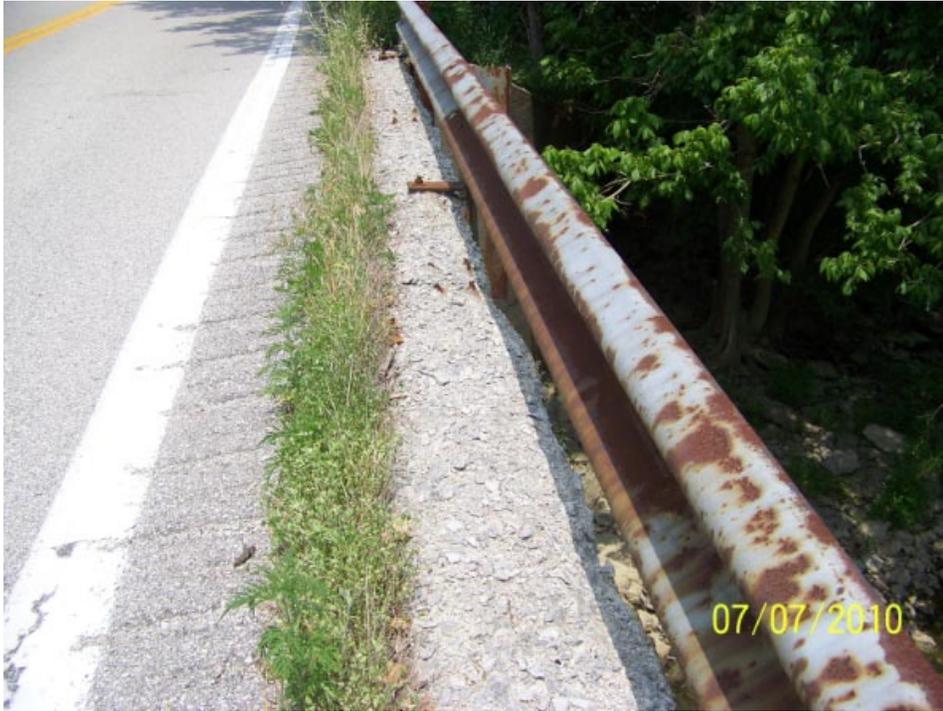
East curb spalled away.

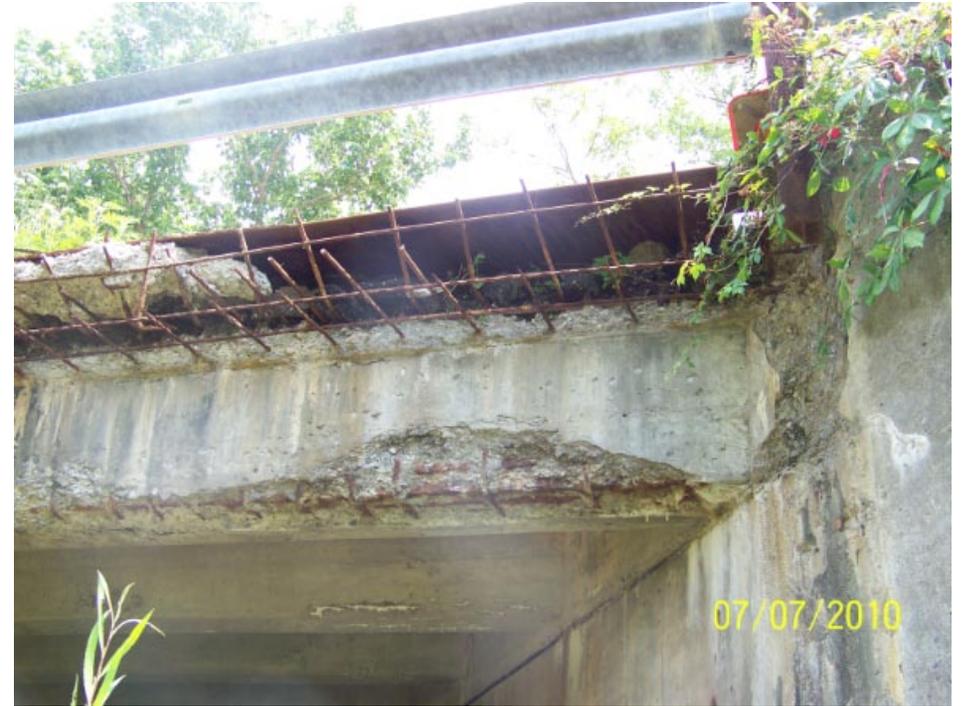
Span 1 west edge; Girder 1 spalled.

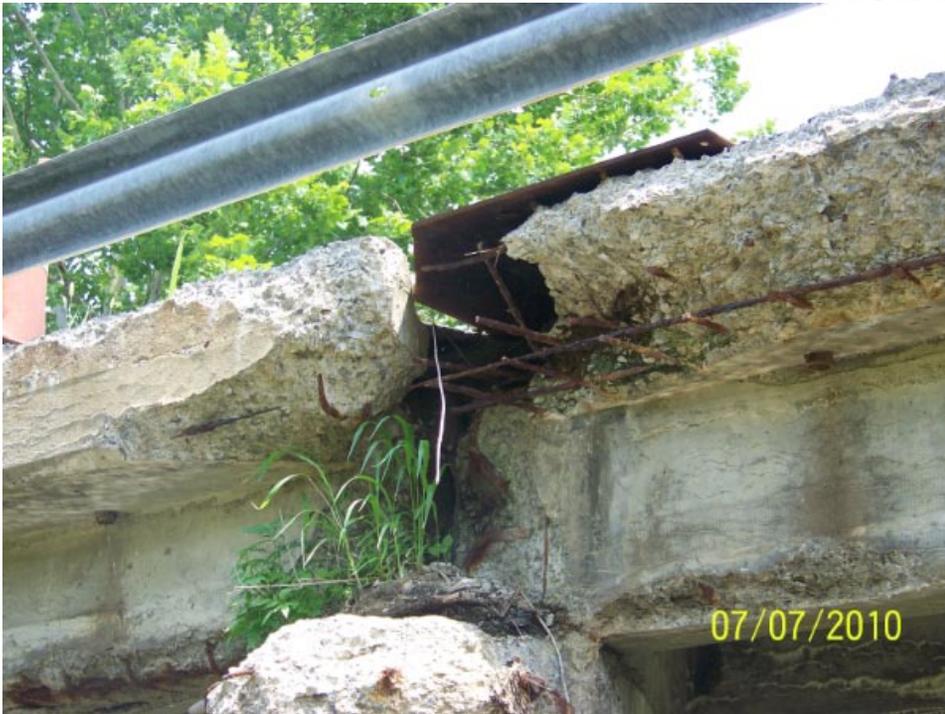
Span 1 G5 spalled.

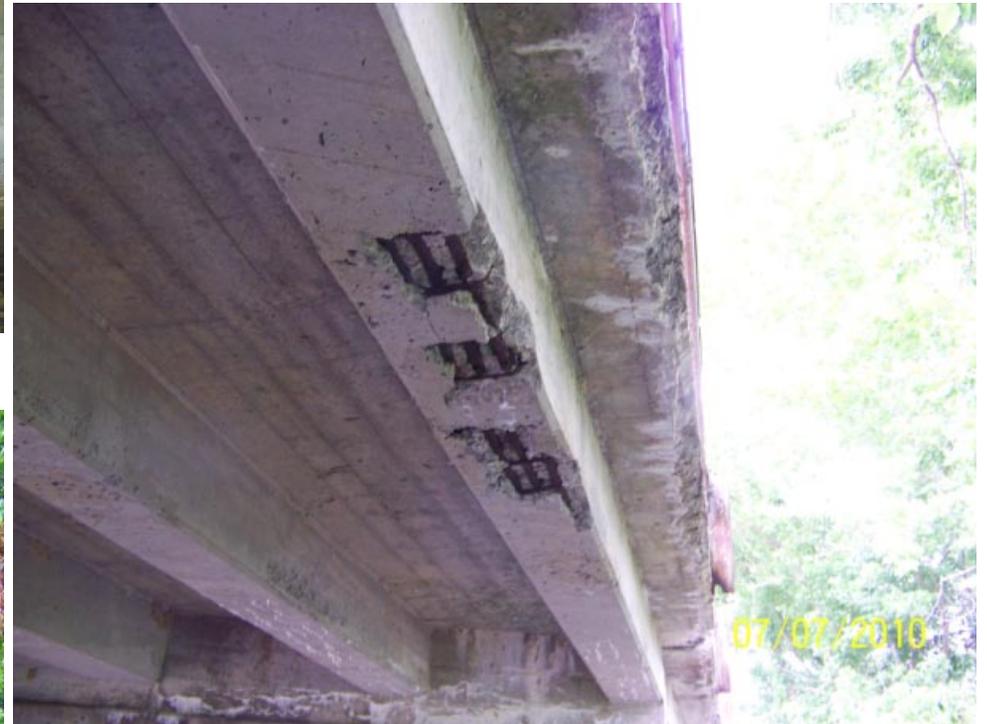
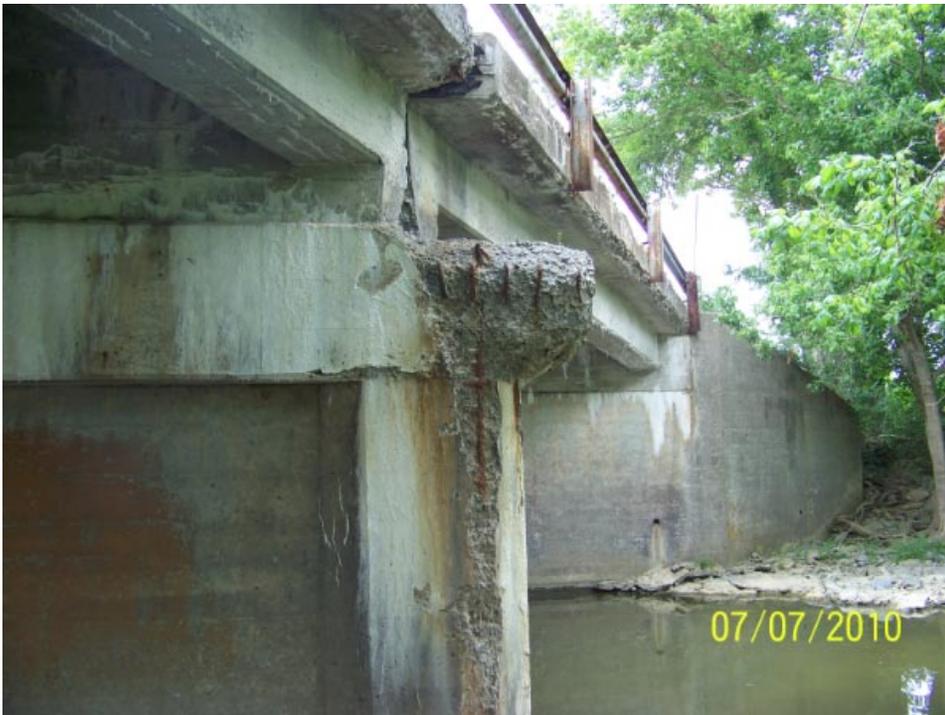
West edge at P2: pier column & cap spalled, G1 spalled.

East edge at P2: pier column & cap spalled.

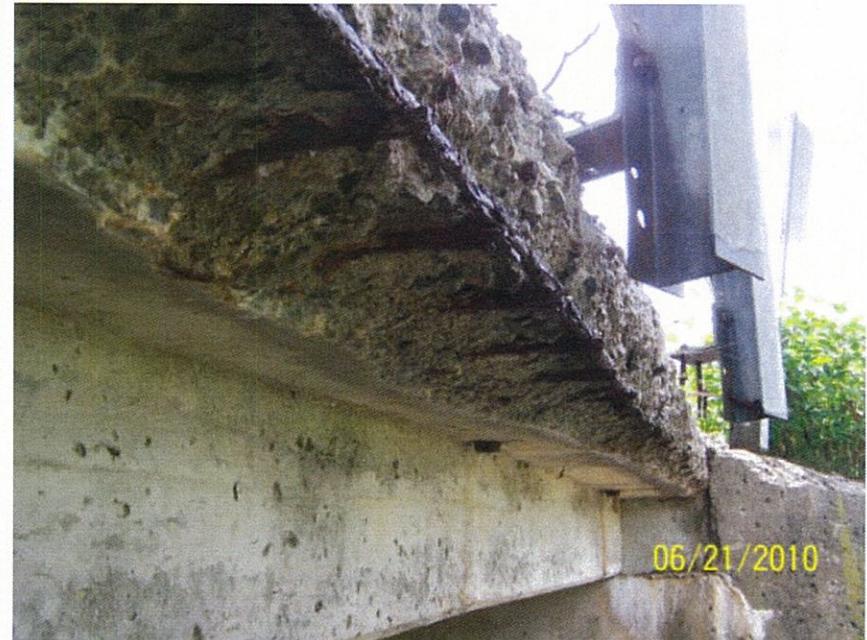
Railing posts are hanging from the rails

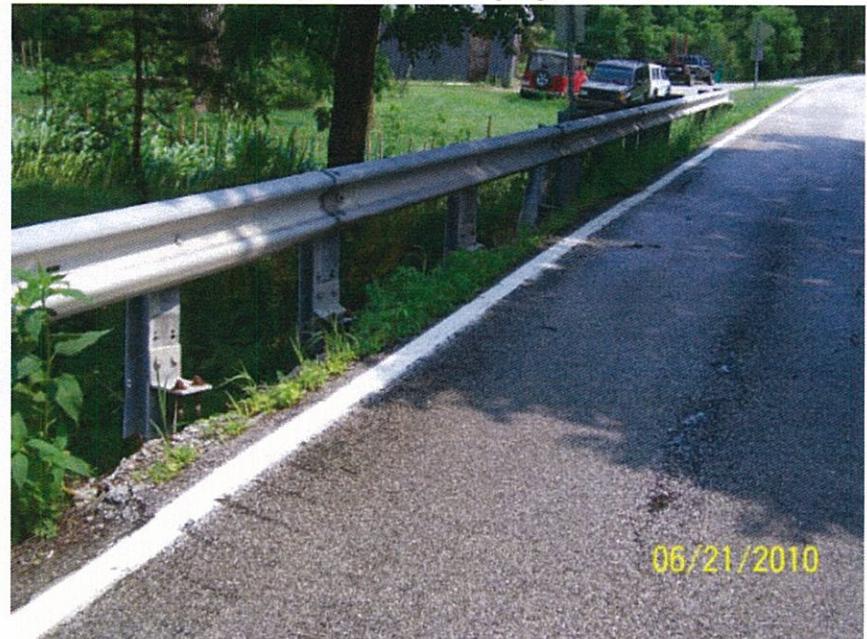
Rail posts are dangling from the railing

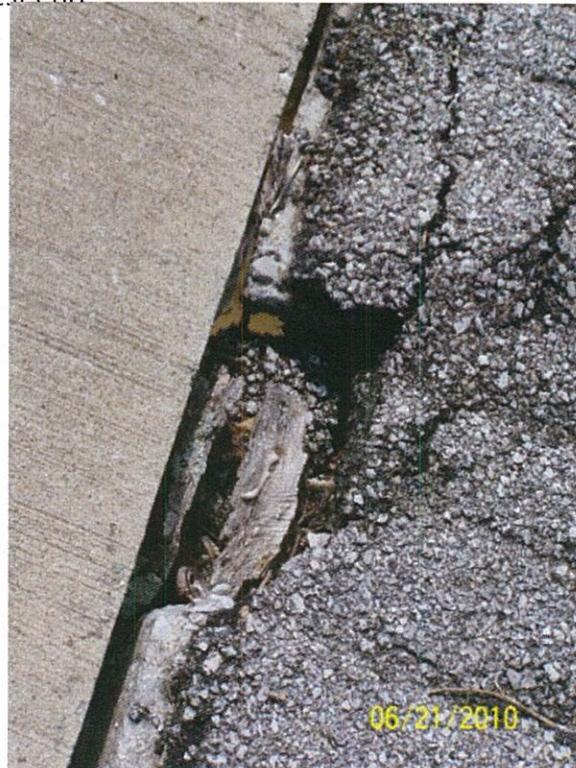
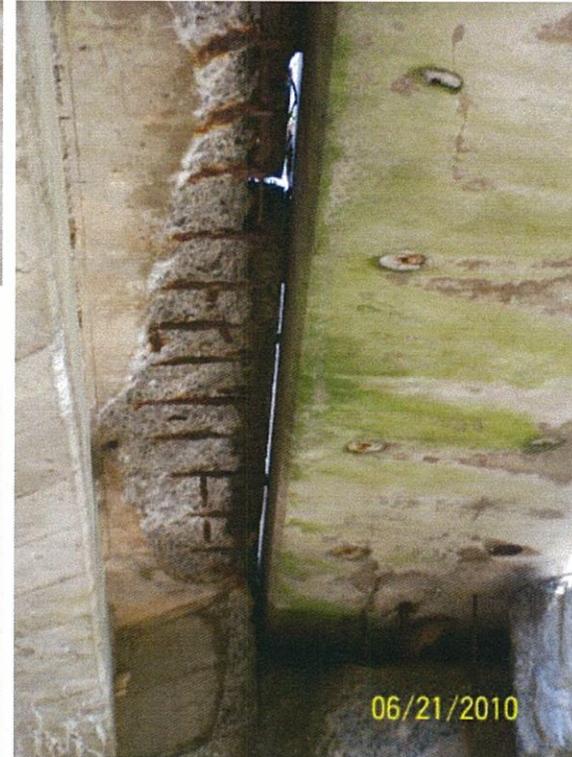
< Steel exposed in west beam (and deck)

Exposed resteel in bottom of deck at west end

< Smaller (8" X 24") spall and hole in deck at west side
