**FLEMING COUNTY
SPECIAL CREW FACILITY
CORRECTIVE ACTION
REPORT
KYTC# 370, AI# 102112**

March 10, 2009

Lee Engineering, LLC
Environment & Infrastructure

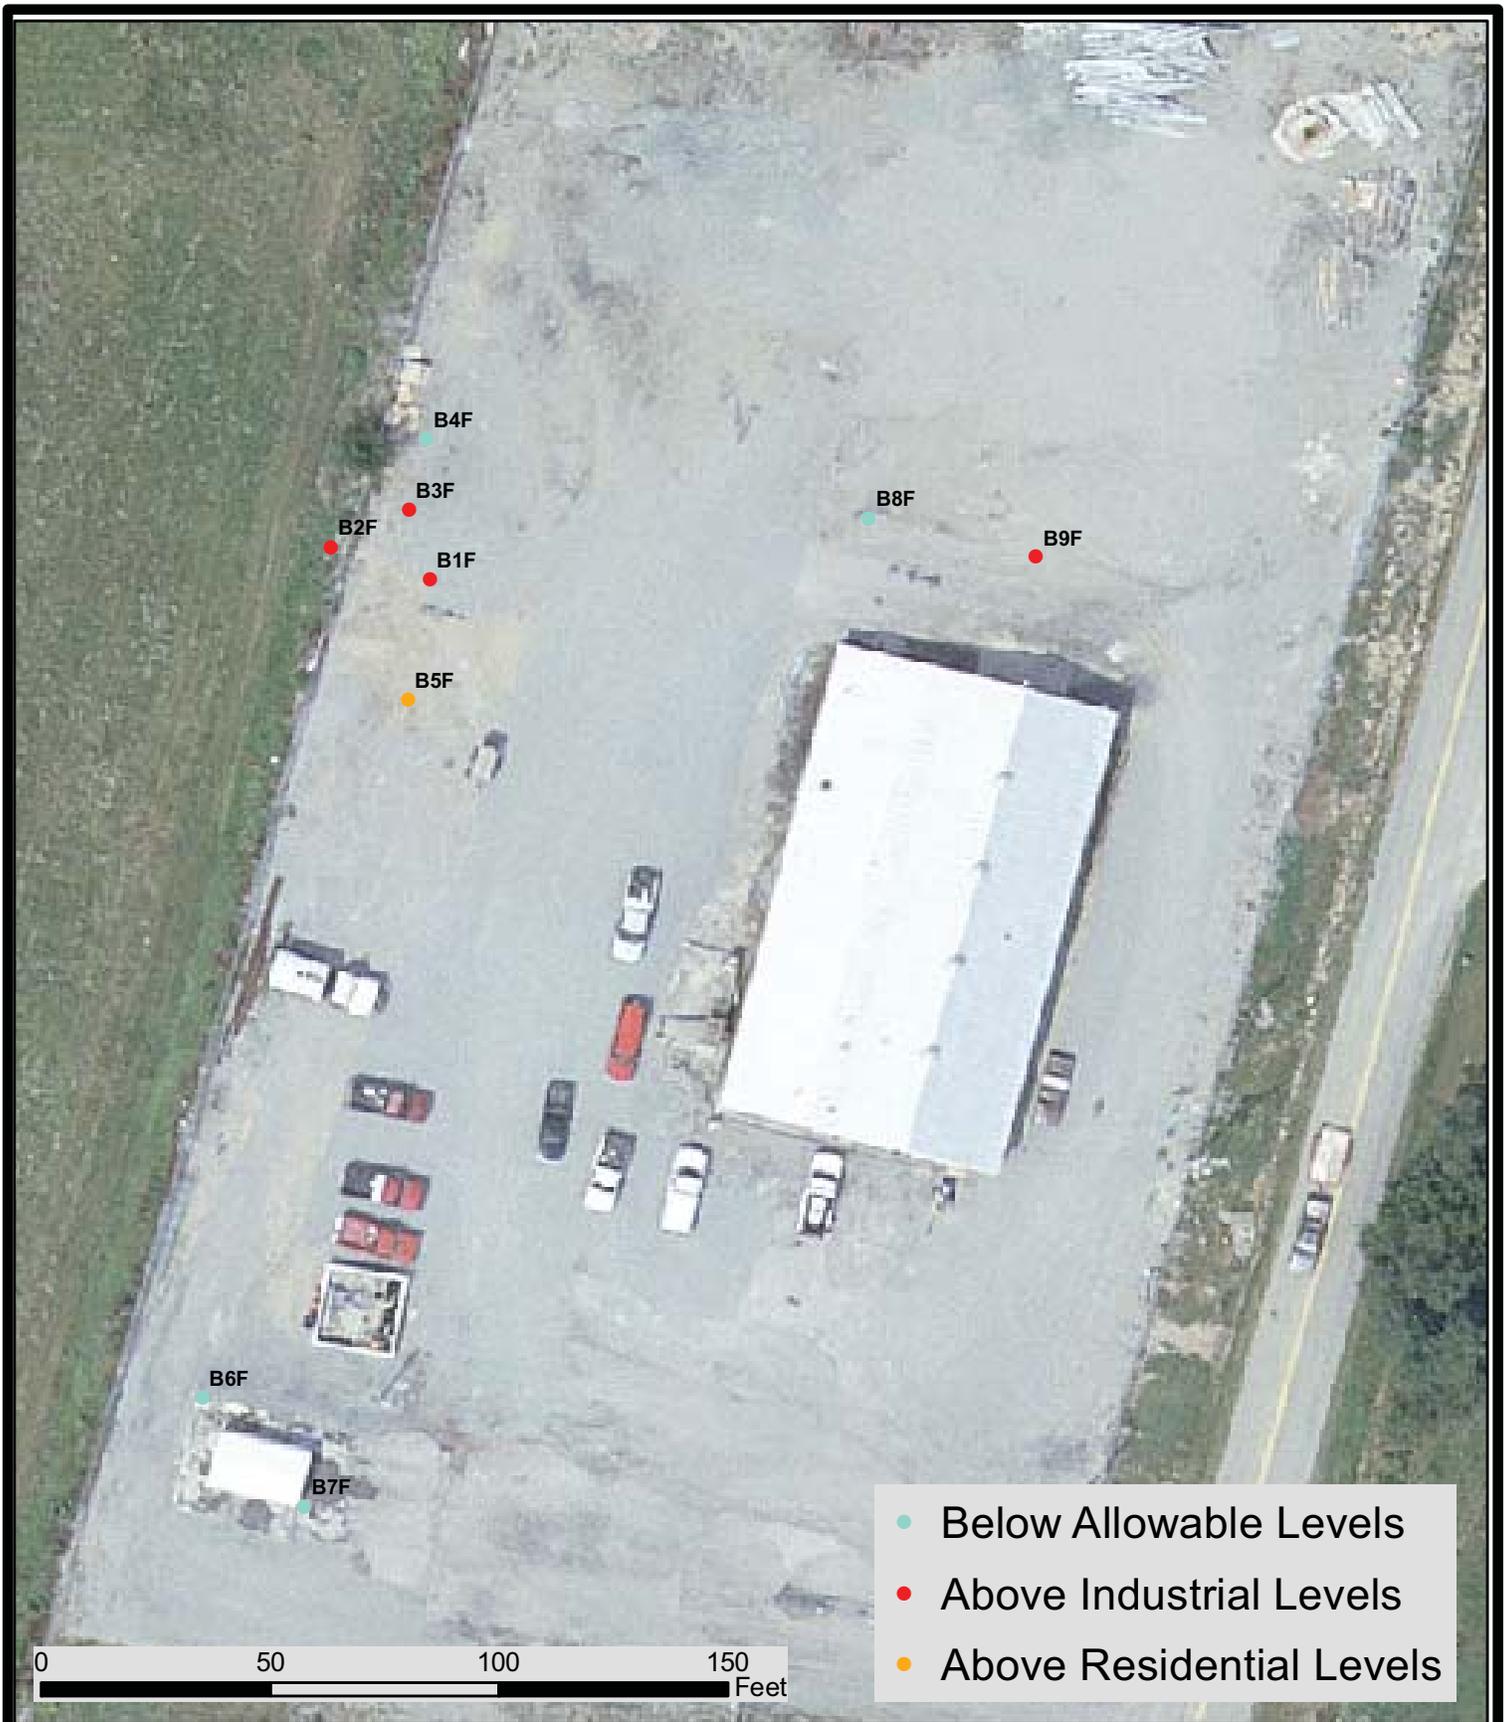
FIGURE 2

Location on Aerial Map
 Environmental Site Characterization
 Fleming County Special Crew Facility
 Flemingsburg, Fleming County, Kentucky

A tack oil tank had been present in the area shown on Figure 2 where borings B1-B5 were collected. Sampling of the soils in the obviously tack oil contaminated areas in this location showed that the contamination was contained in the areas of B1, B2 and B3. The tack oil layer visible at 2-3' bgs and tack oil contaminated soils were removed and disposed of at Rumpke Landfill in Jeffersonville, Kentucky. Photographs included in Appendix A show the remediation in progress and complete. Figure 3. shows the areas of remediation. Approximately 200 tons of contaminated soils were removed. Waste tracking documentation is included in Appendix C. Confirmatory samples showed the formerly contaminated areas are now below the industrial regulatory limits for TPH and PAHs. Analytical results from confirmatory sampling are included in Appendix B, and samples FCS-1 and FCS-2 are the samples related to this remediation.

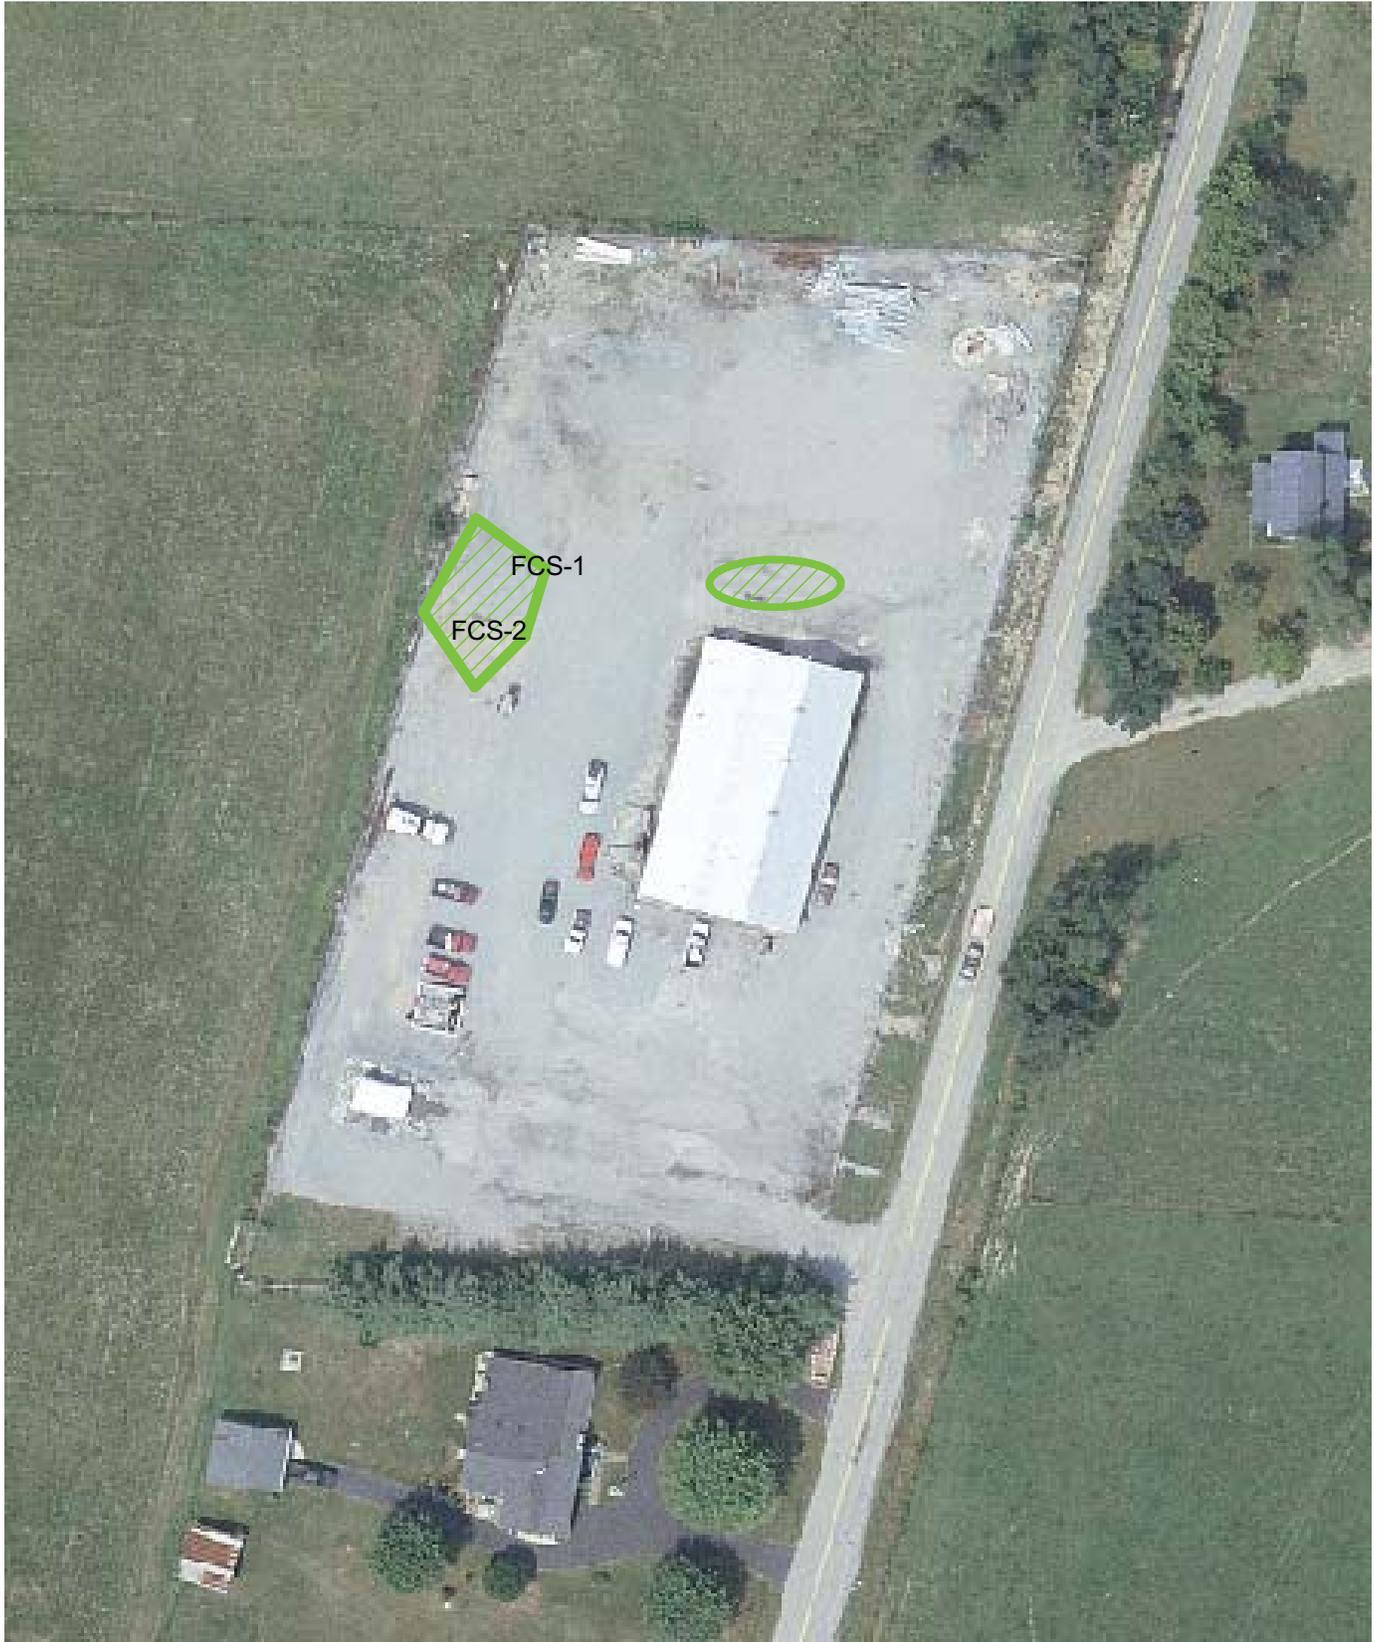
FIGURE 3

Remediated Areas
 Fleming County Special Crew Facility
 Flemingsburg, Kentucky

Contaminated soils as discovered during site characterization activities have been removed from the property. No further action is recommended at this time for all remediated areas. Site closure is requested.

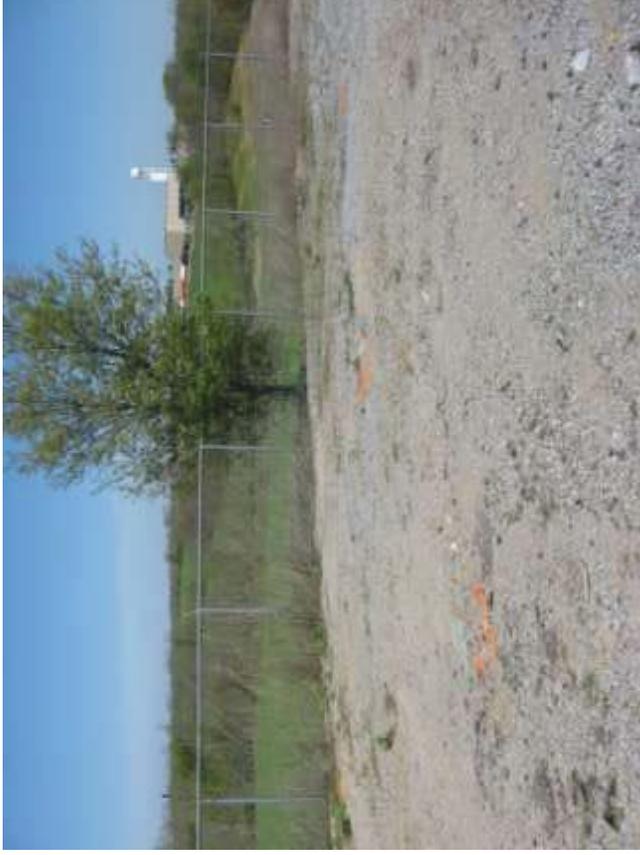
Photo No. 1: Former tack oil tank area (B1F-B5F)

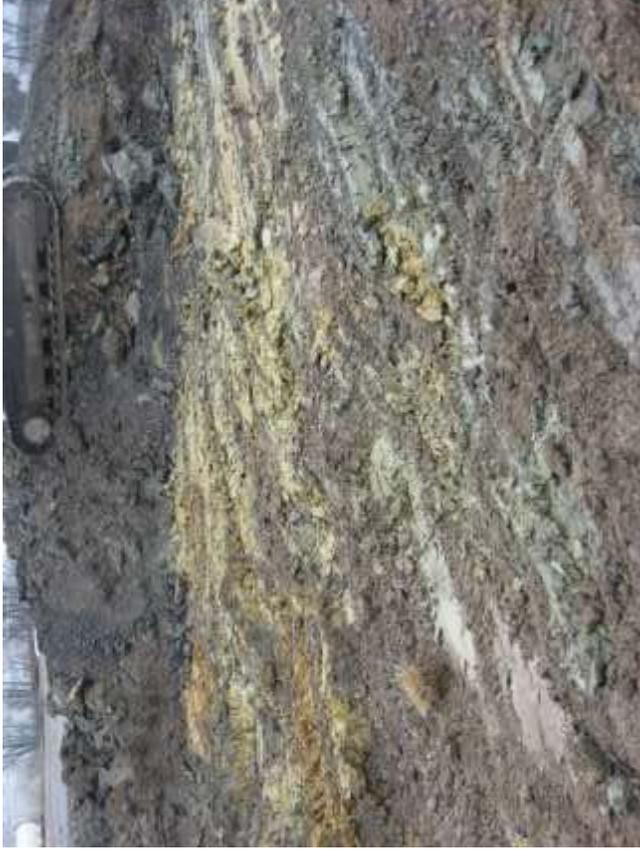
Photo No. 2: Former tack oil tank location after tack oil removal

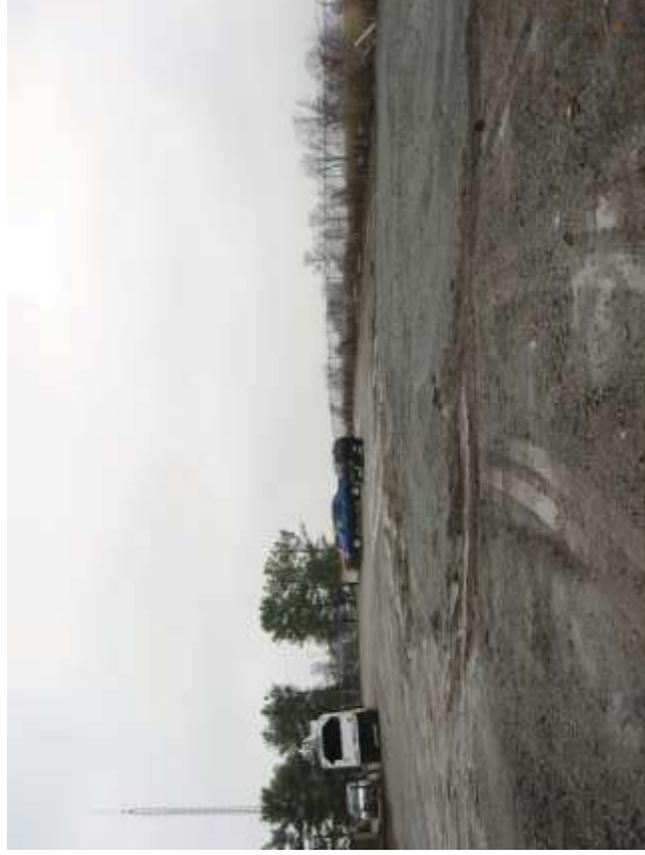
Photo No. 3: Former tack oil tank area after remediation and fill
