PHASE I
ARCHAEOLOGICAL
SURVEY FOR THE US 60
OVER UPPER STINSON
CREEK BRIDGE
REPLACEMENT, CARTER
COUNTY, KENTUCKY.
KYTC ITEM # 9-1072.00

Kentucky Office of State Archaeology
Archaeological Project Number: FY14-7919

Archaeology Report

February 2014

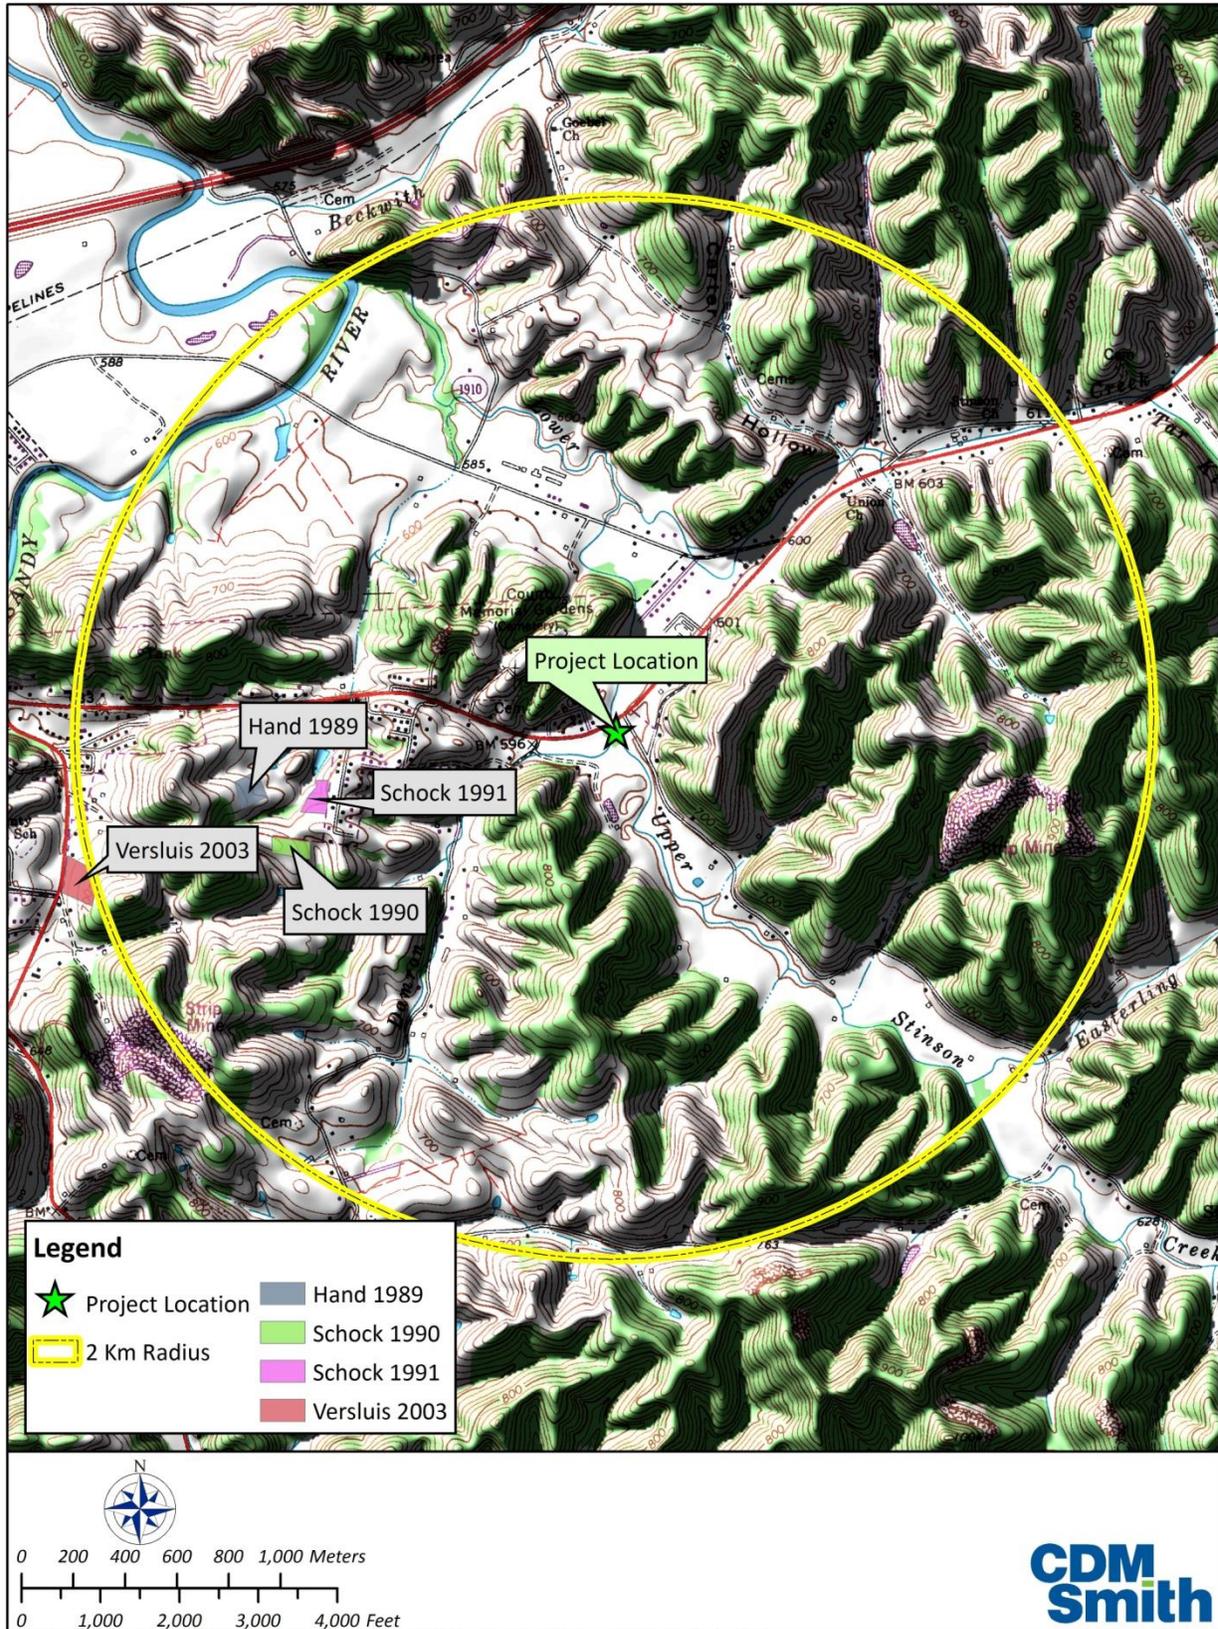
Figure 2-1. Previous Archaeological Surveys within 2km of Project Area.

The survey reports at the OSA were consulted on February 4, 2014. Within a two kilometer buffer of the current survey area, four previously conducted surveys were identified: Hand (1989), Shock (1990), Shock (1991), and Versluis (2003) (Figure 2-1).

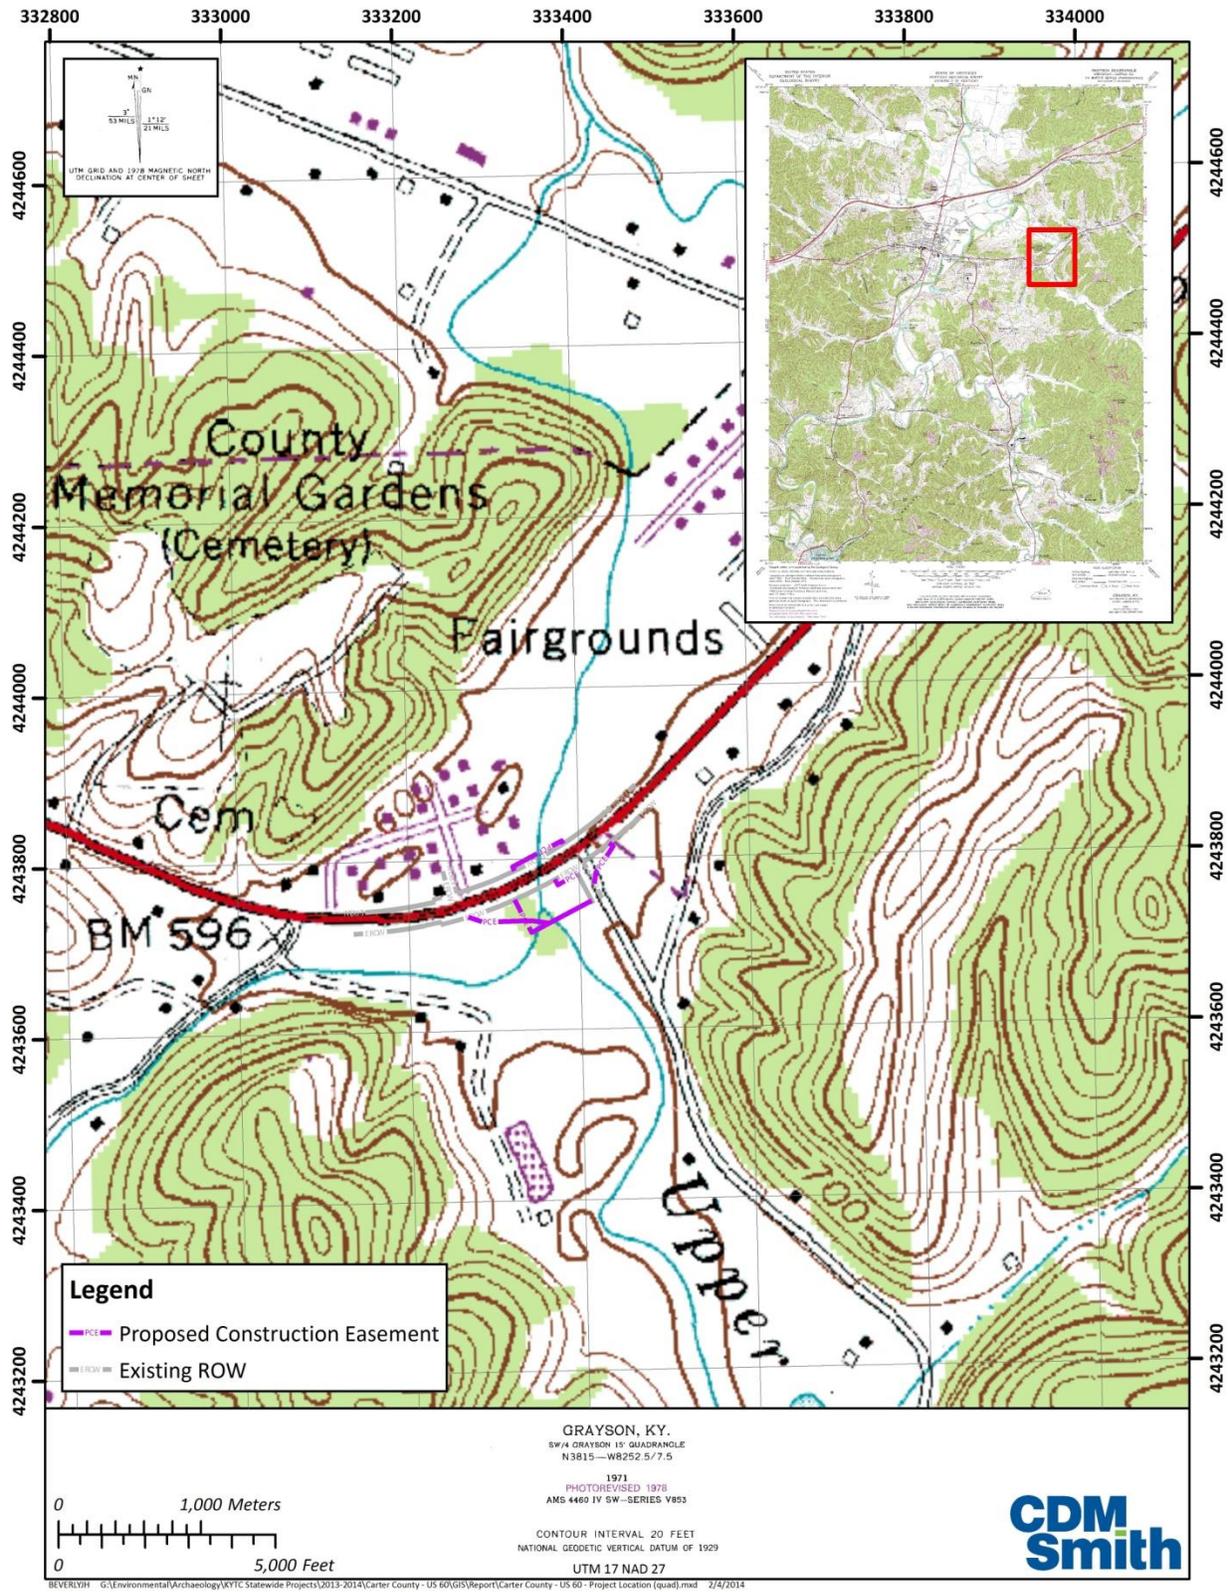
Figure 3-1. Topographic Map showing extent of APE.

The APE consists of the proposed temporary easement for construction for the proposed bridge replacement and approaches along US 60 (Main Street), totaling approximately 1.29 acres (0.5 ha) in size. The APE is located on a gently sloping floodplain of Stinson Creek with an elevation range between approximately 590 and 600 ft. AMSL (Figure 3-1). The physical setting of the APE is shown in Figure 3-2 through Figure 3-7.

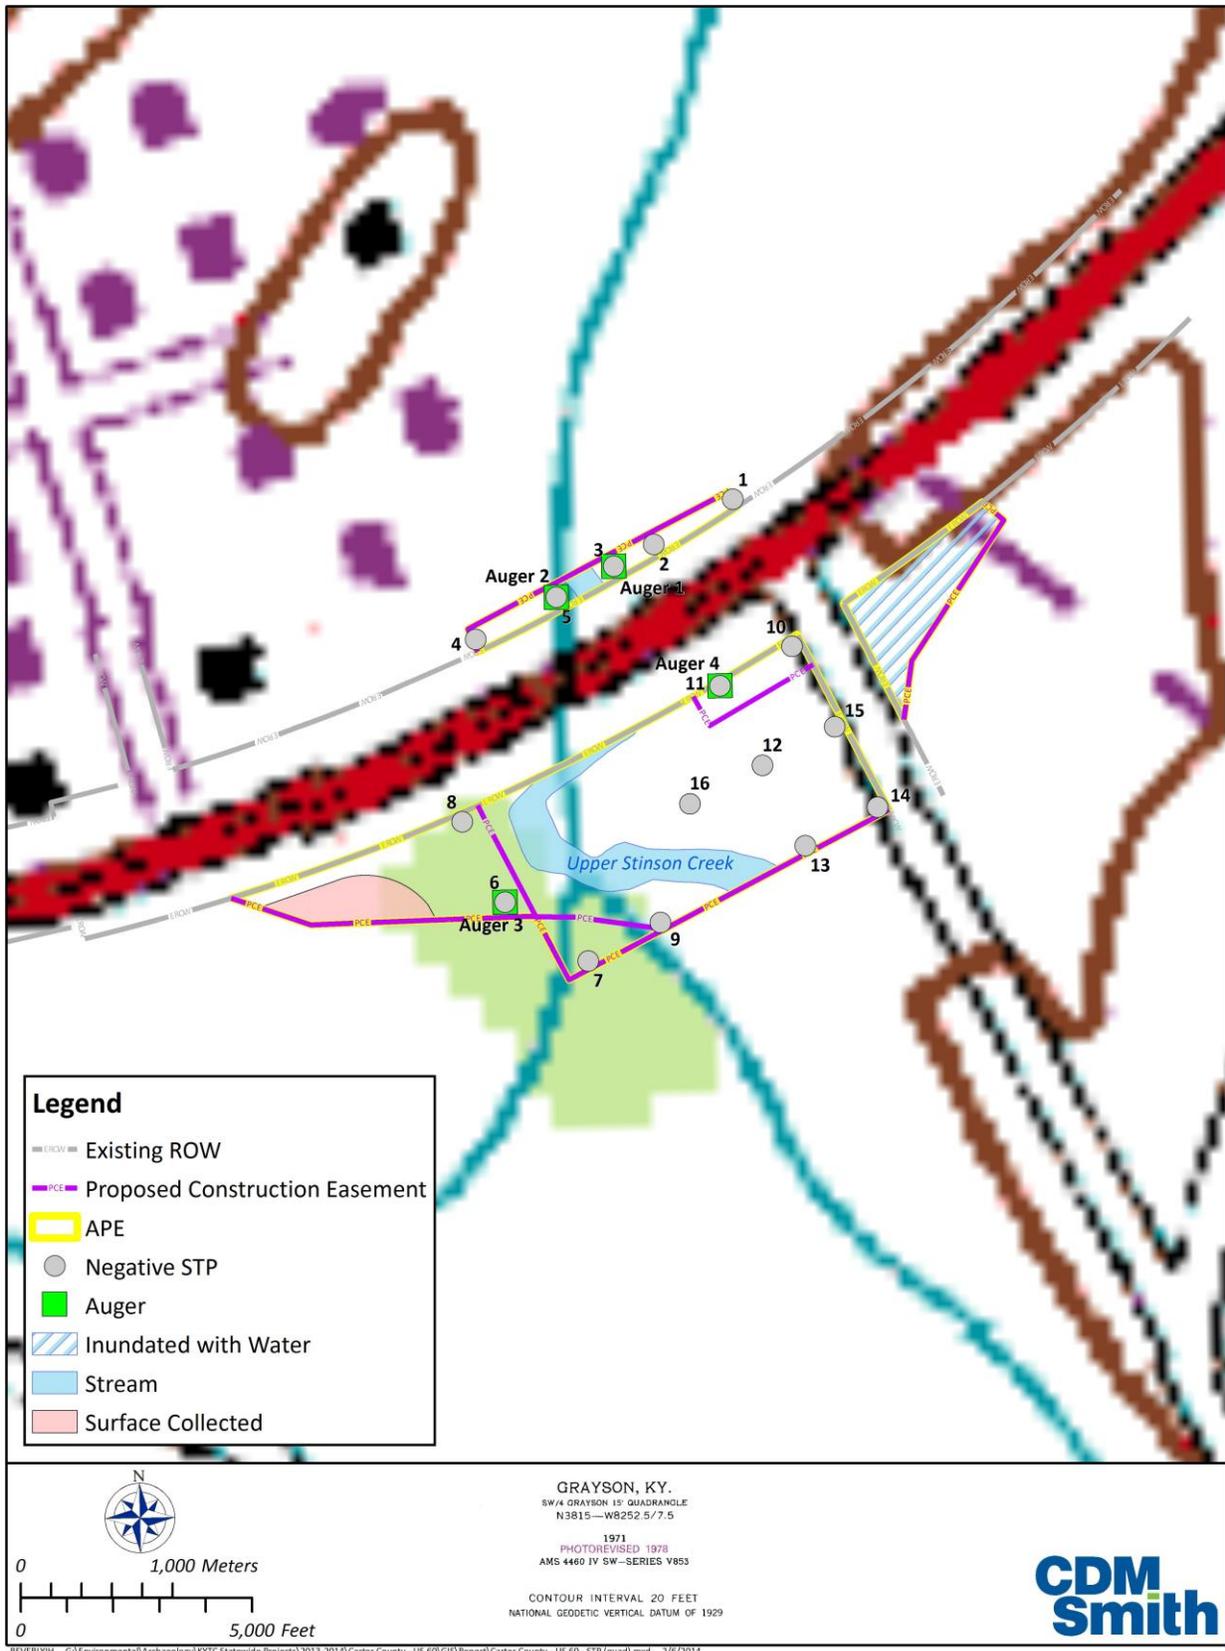
Figure 3-8. . Location of Shovel Probe 2 on USGS Map.

Sixteen shovel probes and four auger probes were excavated within the APE. STP and auger locations were mapped and are shown on a topographic quadrangle in Figure 3-8 and on an aerial photograph in Figure 3-9. All STPs were negative for cultural remains. STP 3/Auger 1 and STP 6/Auger 3 are described below as representative of the project area (Figure 3-10 and Figure 3-11).

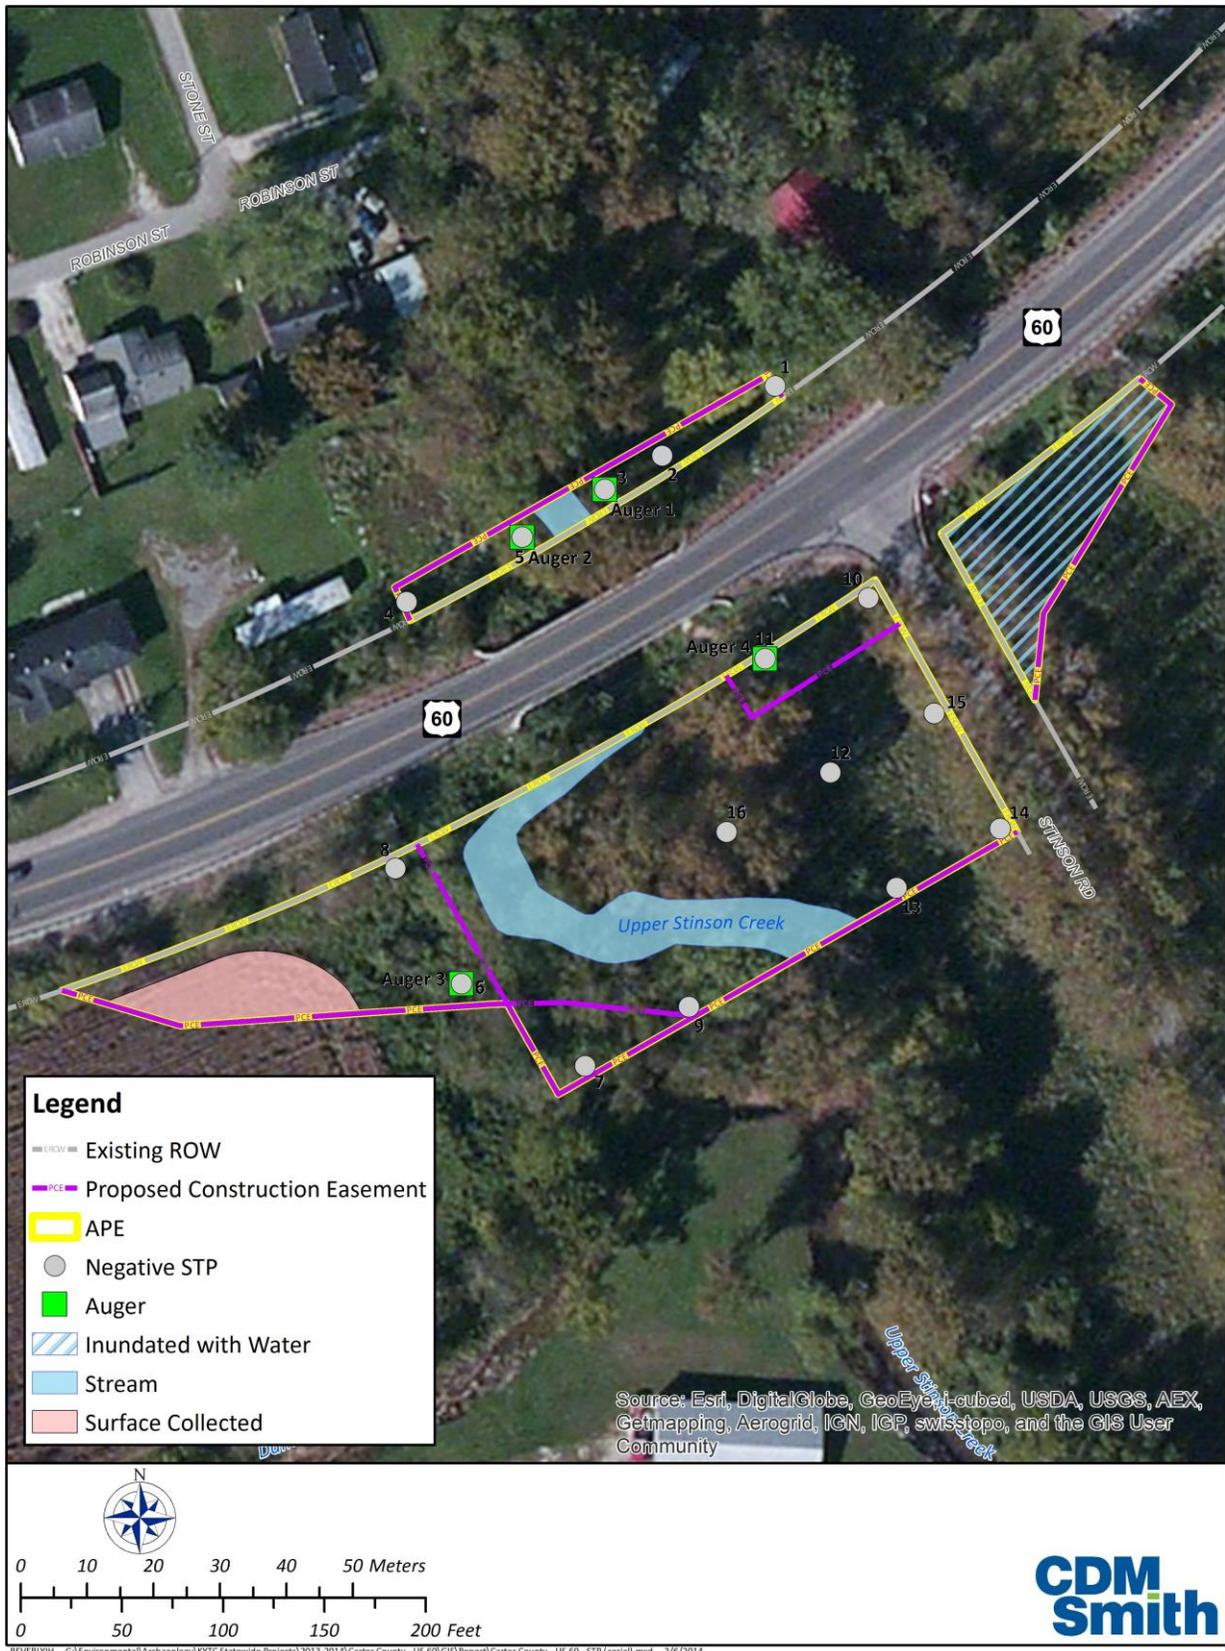
Figure 3-9. Location of Shovel Probe 2 on Aerial Photograph.

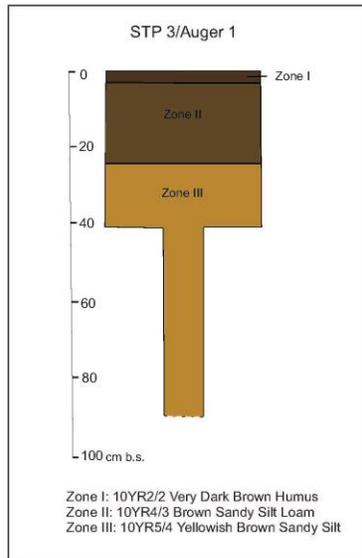
STP 3/Auger 1 consists of three zones. Zone I began at the surface and went to a depth of 4 cm below surface. It consisted of 10YR2/2 very dark brown humus layer. Zone II began at 4 cm below surface and continued to 24 cm below surface. This zone consisted of 10YR4/3 brown, sandy, silt loam. Zone III began at 24 cm below surface and continued to 91 cm below surface. This zone consisted of 10YR5/4 yellowish brown, sandy silt.

Figure 3-10. Representative Shovel and Auger Probe, STP 3/Auger 1.

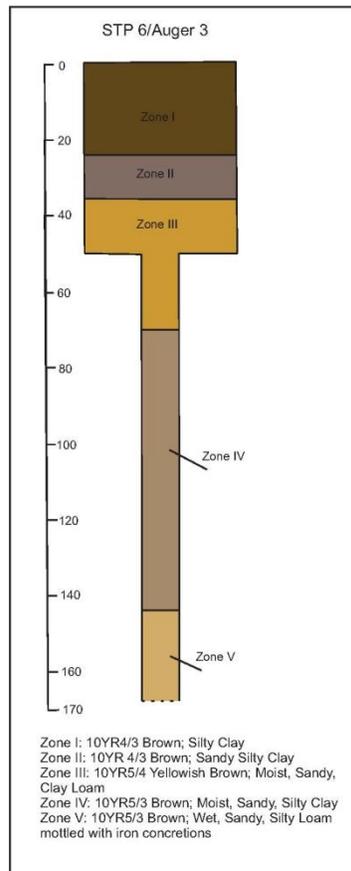
STP 6/Auger 3 consists of five zones. Zone I began at the surface and went to a depth of 24 cm below surface. It consisted of 10YR4/3 brown, silty clay. Zone II began at 24 cm below the surface and continued to 36 cm below surface. This zone consisted of 10YR4/3 brown, sandy, silty clay. Zone III

Figure 3-11. Representative Shovel and Auger Probe, STP 6/Auger 3.

began at 36 cm below surface and continued to 70 cm below surface. This zone consisted of moist, 10YR5/4 yellowish brown, sandy, clay loam. Zone IV began at 70 cm below surface and continued to 144 cm below the surface. This zone consisted of 10YR5/3 brown, moist, sandy, silty clay. Zone V began at 144 cm below the surface and continued to 167 cm below the surface where the auger hit the water table. This zone consisted of wet 10YR5/3 brown, sandy, silty loam mottled with iron concretions.
