**A  
DATA  
NEEDS  
ANALYSIS  
STUDY**

**Item 7-1116.00 Bridge Replacement on Herrington Lake,  
KY 152 at Mercer/Garrard County line**

**Prepared By: Division of Planning & District 7  
Kentucky Transportation Cabinet  
June 6, 2011**

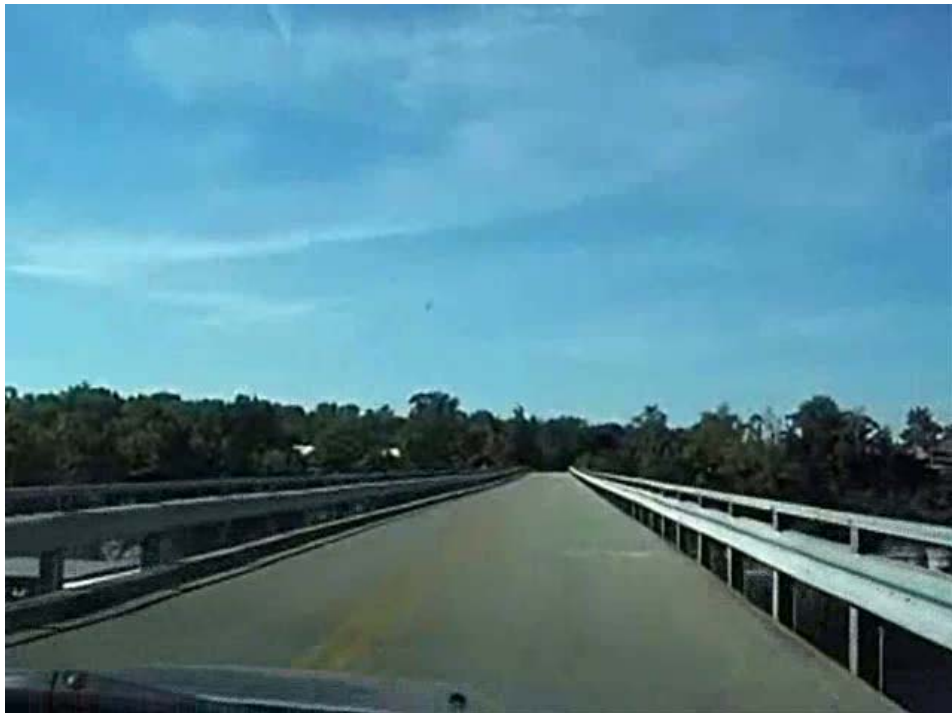
**Figure 3: Roadway on Herrington Lake Bridge**

The current roadway approach is two 9-10 foot lanes. Shoulder width is 1-3 feet. There are no shoulders on the bridge. There is guardrail at the edge of the pavement on the bridge. Bridge width is 20 feet. KYTC Common Geometric Practices for Rural Collector Roads suggest a lane width of 12 feet and 8 feet shoulders for a speed limit of 35 mph with an ADT over 2000 (Appendix E).

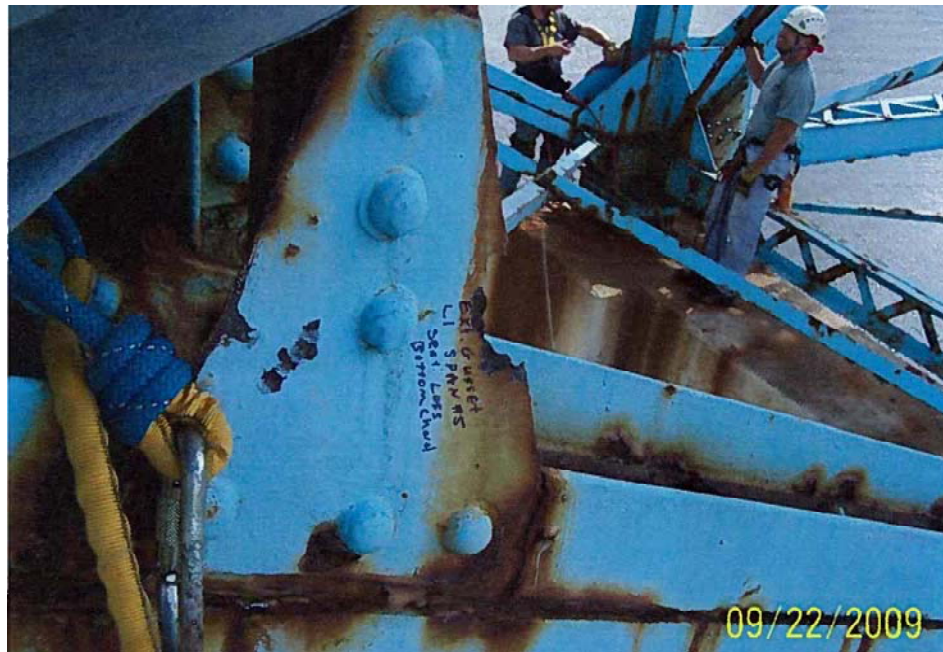
**Figure 5: Structural condition of the bridge in 2009**

The 797.9 foot bridge was built in 1924. It has six spans total; there are 4 main spans and 2 approach spans (one approach span on each end of the bridge). The main spans are steel deck truss and the approach spans are a girder/floorbeam system. Repairs were done in 1940, 1944, 1991, 2003 and 2009. The bridge had a Sufficiency Rating of 2.00 before the 2009 repairs. The interim repairs improved the Sufficiency Rating to 28.9. The bridge is functionally obsolete because of the geometric deficiencies.

Federal funds (BRO) have been authorized at the time of this report. See below current Project status. Previously, a bridge repair project was completed in 2009 which increased the Sufficiency Rating from 2.0 to 28.9.

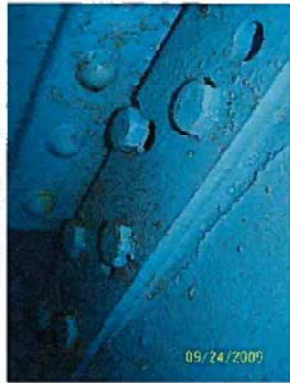
Typical view of previously rehabed diagonals. Having problems were the bolt holes had to be redrilled during the rehab.

**Figure 6: Severe rusting seen on the bridge before 2009 repairs**

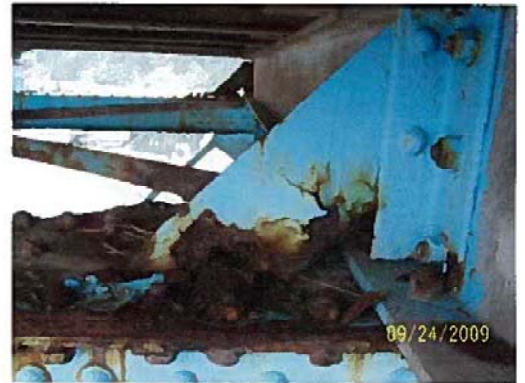
Typical view of floor beam bracing. Most have heavy section loss and some braces are completely gone or broken.

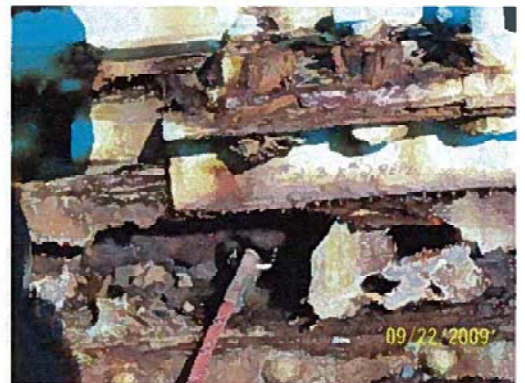
Exterior view of bearing device #2 at Pier #2. Bearing device needs to be replaced.

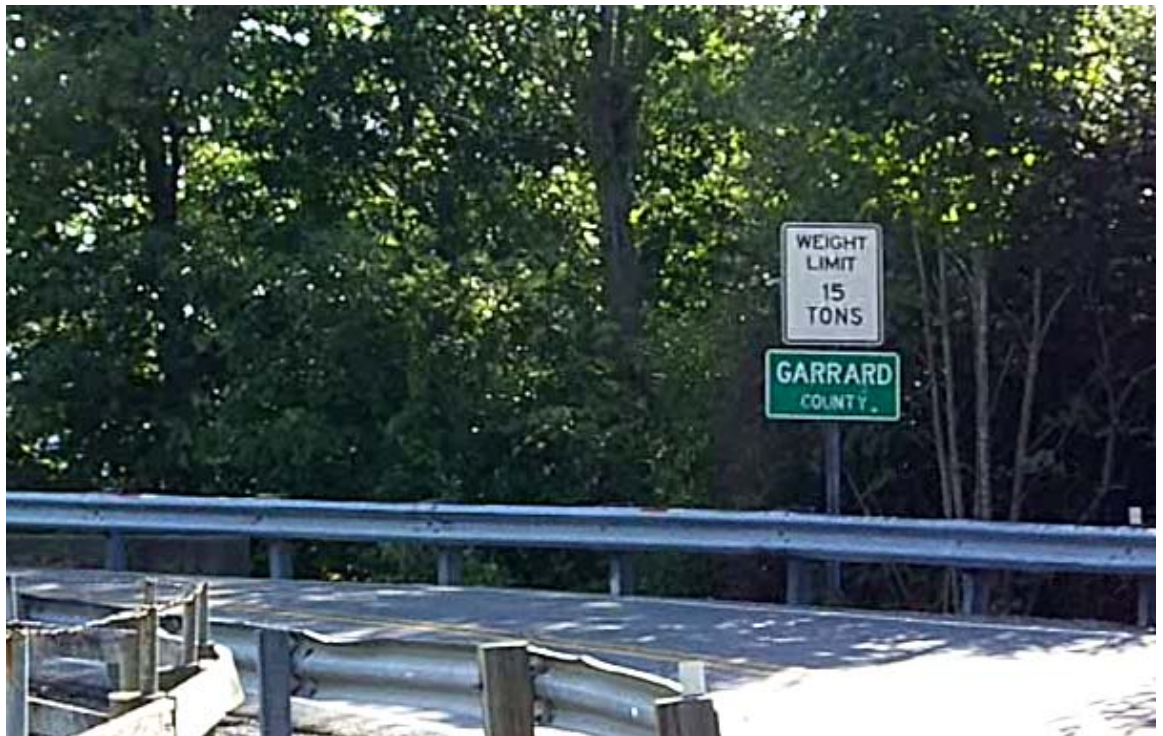
Due to the condition and changes in the weight carrying capacity of the bridge, the posted weight limit is 15T (see Figure 7). A memo was released on June 1, 2010 by District 7 Office to this effect (Appendix G).

**Figure 7: Current posted weight limit on the bridge is 15T**

A Purpose and Need Statement is the foundation for project decision making. The need for the Bridge Replacement is to improve the current posted weight limit of 15 tons and improve the bridge's geometric deficiencies.

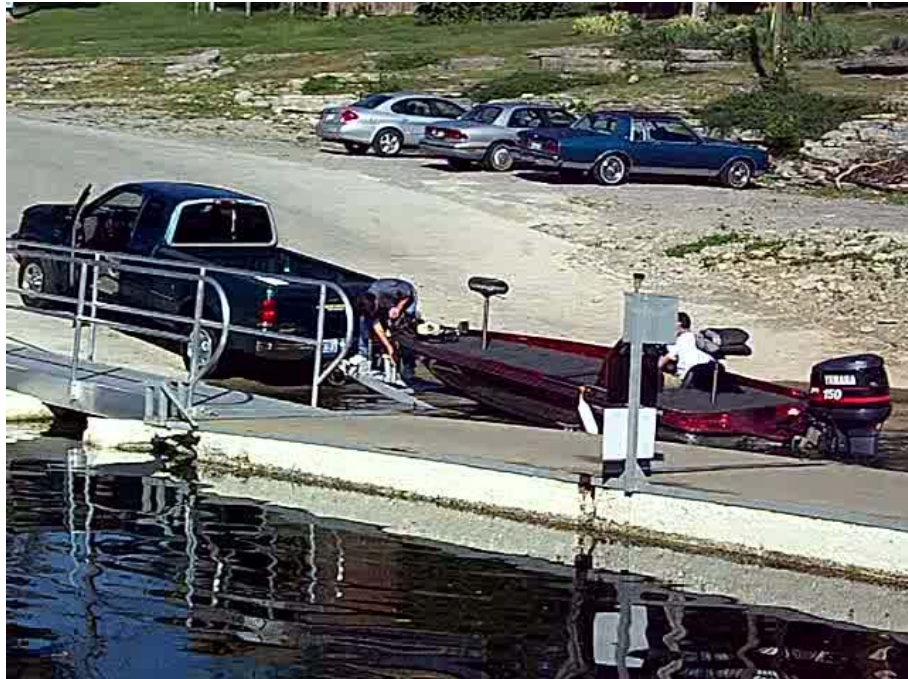
**Figure 13: Chimney Rock Road and Boat launch ramp may be used as access road for Ferry Service during construction**

The proposed detour route discussed in the previous section would put motorists over 30 miles out of their way. That was a primary area of concern to the motorists when the bridge was closed for repairs in 2009 (Appendix M). The possibility of using ferry service to transport motorists and their vehicles during construction was discussed at the Project Team meeting.

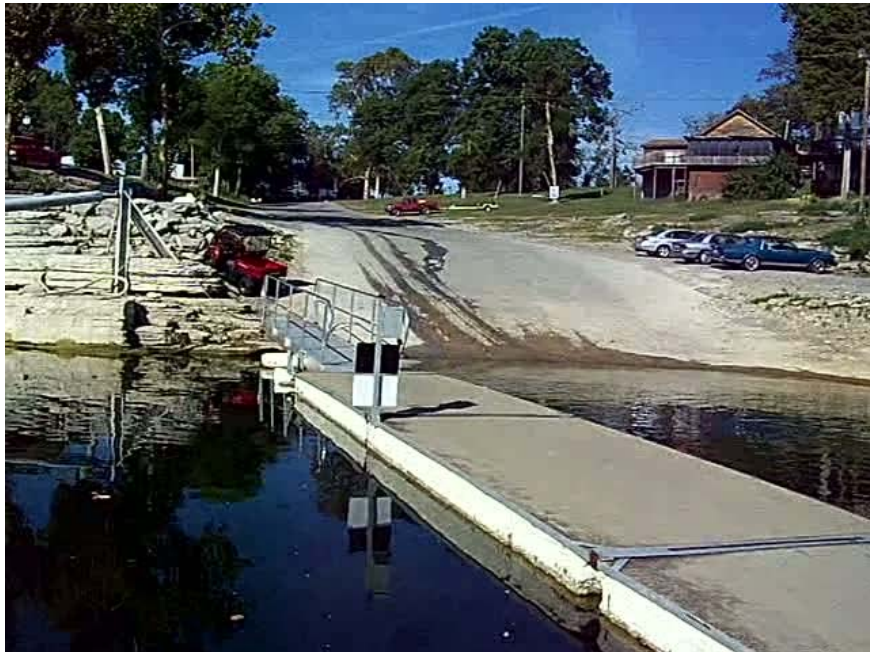
**Figure 14: Another view of Chimney Rock Road and Boat launch ramp**
