FLEMING COUNTY SPECIAL CREW FACILITY LOT ENVIRONMENTAL SITE CHARACTERIZATION KYTC# 370, AI#

Lee Engineering, LLC
Environment & Infrastructure

August 15, 2008

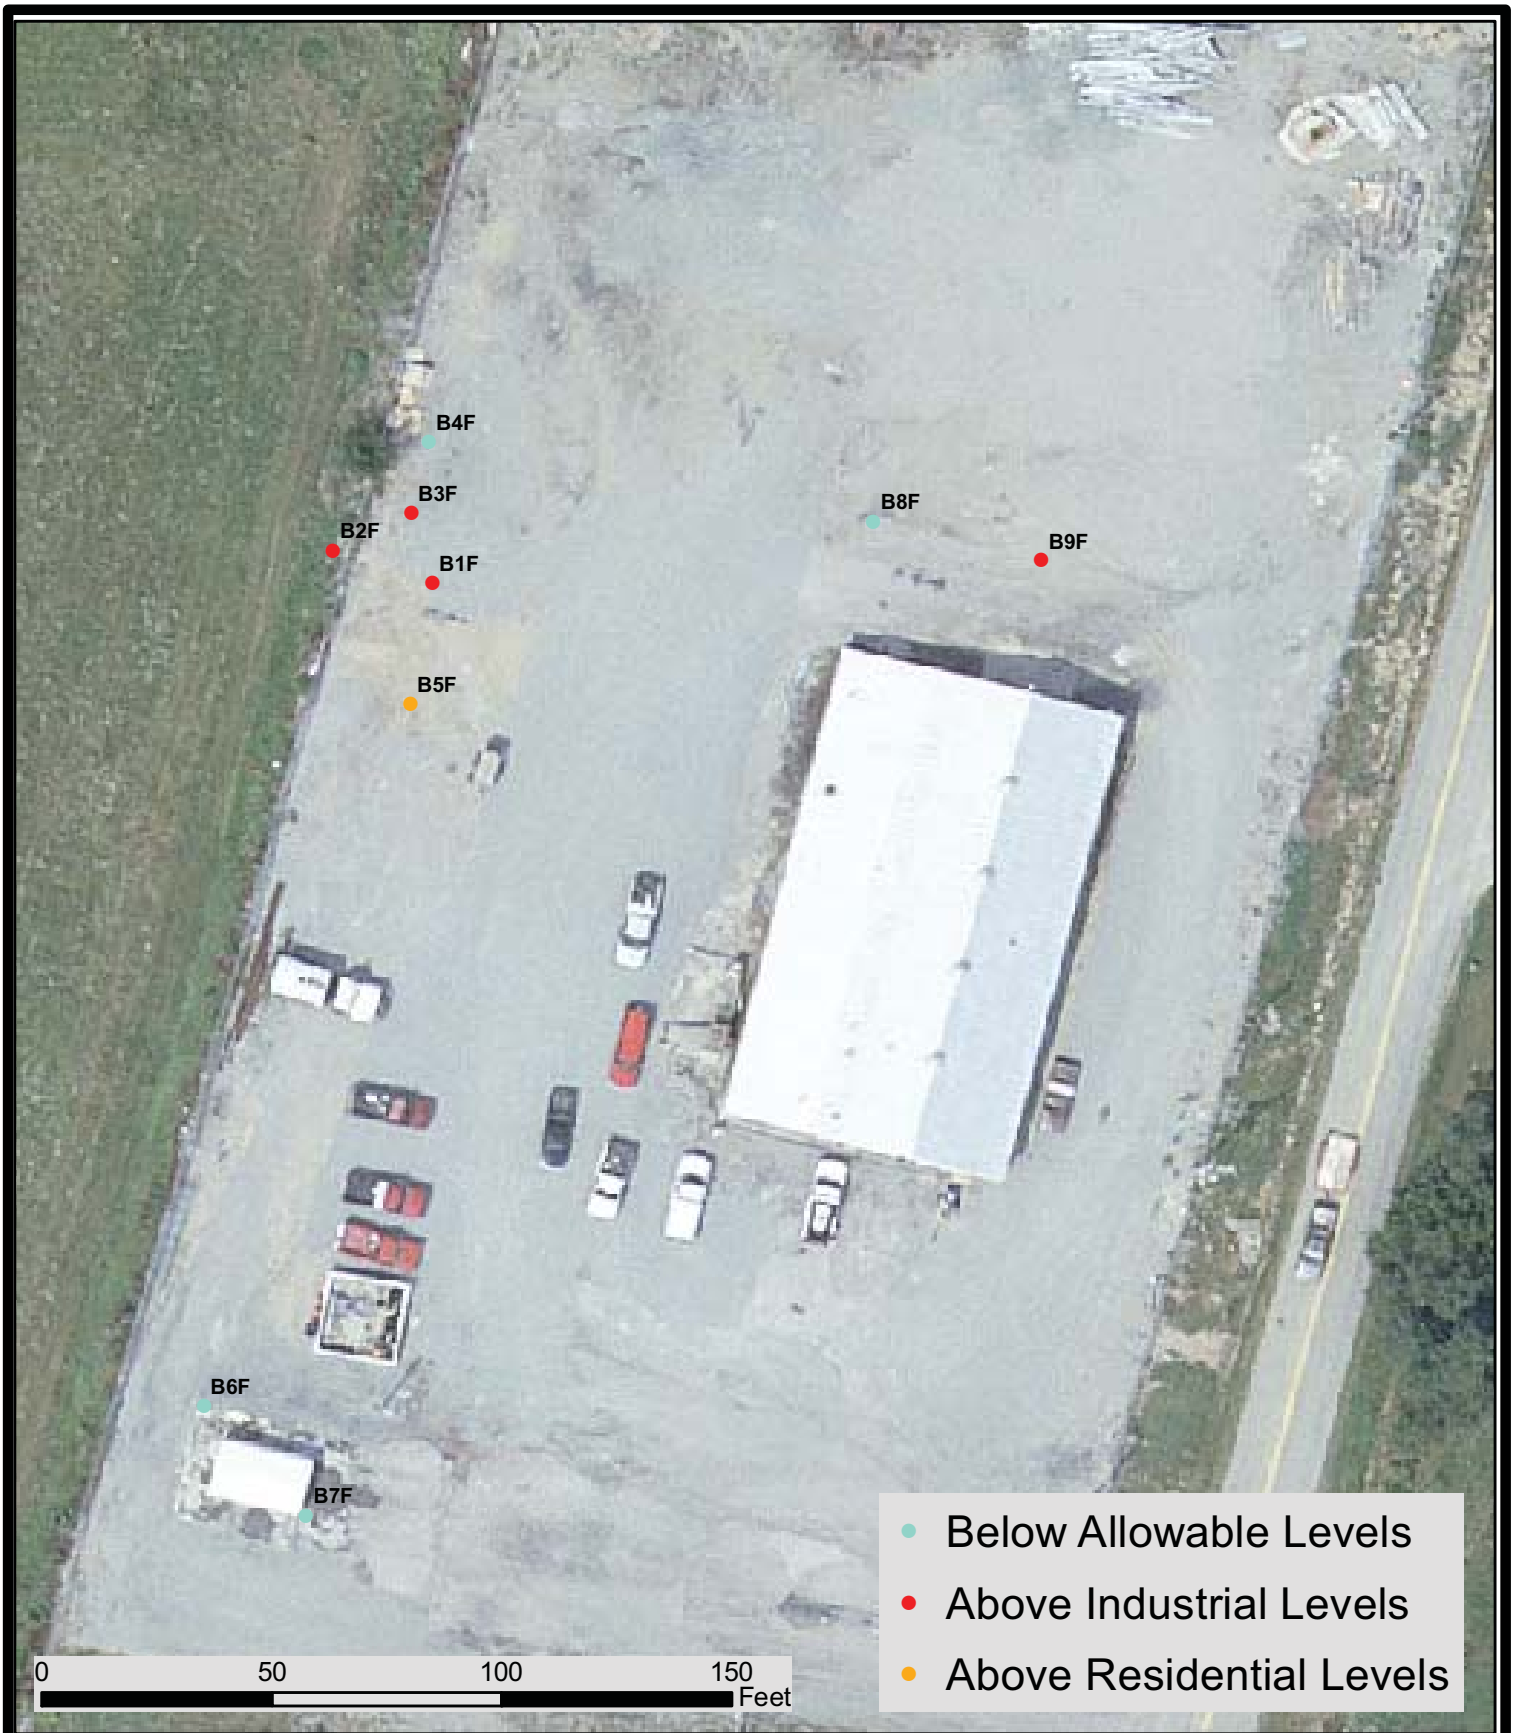
FIGURE 2

Nine soil samples were collected during the sampling event on April 22, 2008. The soil samples were collected using a geoprobe. The Site Map included in Figure 2. of this report shows the location and result of all samples collected. Depending upon the location of sample collection, the samples were analyzed for polyaromatic hydrocarbons (PAHs), total petroleum hydrocarbons (TPH) as diesel range organics (TPH DRO) and RCRA Metals. All samples were collected according to the procedures set forth in sections 10.2.1, 11.2.1, 12.3 and 12.4 the U.S. EPA Environmental Investigations Standard Operation Procedures and Quality Assurance Manual [November 2001]. The samples were analyzed using the following methods:

Location on Aerial Map
 Environmental Site Characterization
 Fleming County Special Crew Facility
 Flemingsburg, Fleming County, Kentucky

Four soil borings taken in the former tack oil tank location (B1F-B4F) exceeded the Region 9 PRG industrial limits for PAHs, as well as the limits for TPH. One boring in this area (B5F) only exceeded residential limits.

All soil borings in the area of visible staining by a newer concrete pad (B6F and B7F) were below regulatory levels.

One soil sample (B9F) collected in the former sandblast area exceeded Region 9 PRG industrial limit for arsenic.

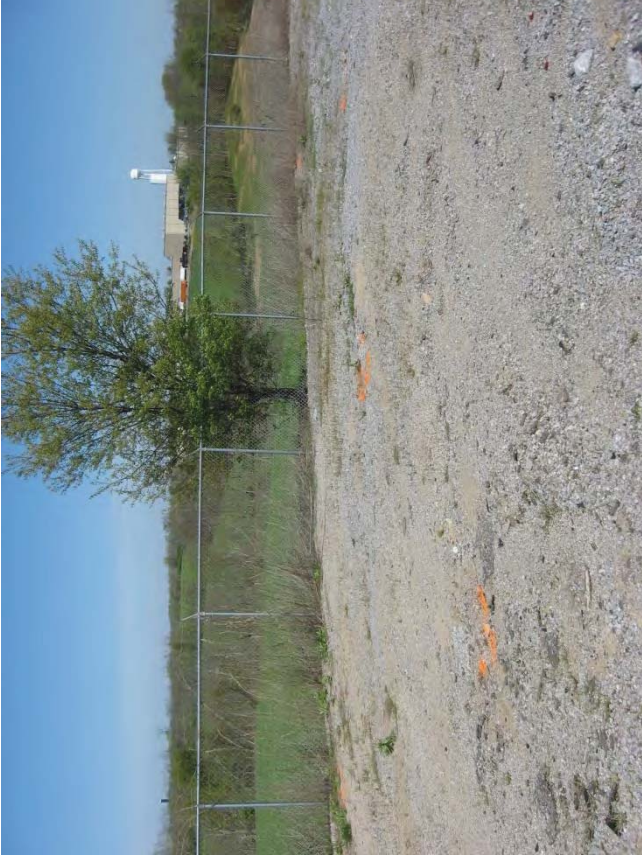
Photo No. 1: Former tack oil tank area (B1F-B5F)

PAHs found in the soils are believed to originate with tack oil that was used in the past in and around the location of the former tack oil tank. Soil borings collected show that tack oil staining occurs at approximately 2-3 feet. Soils below the tack oil contamination appear to be very tight clays with PAHs/TPH below regulatory levels. It is recommended that the tack oil be removed to clean soils on a visual basis during cooler weather when the material is in a less fluid state. This should eliminate or dramatically reduce the incidence of PAHs in the soils.

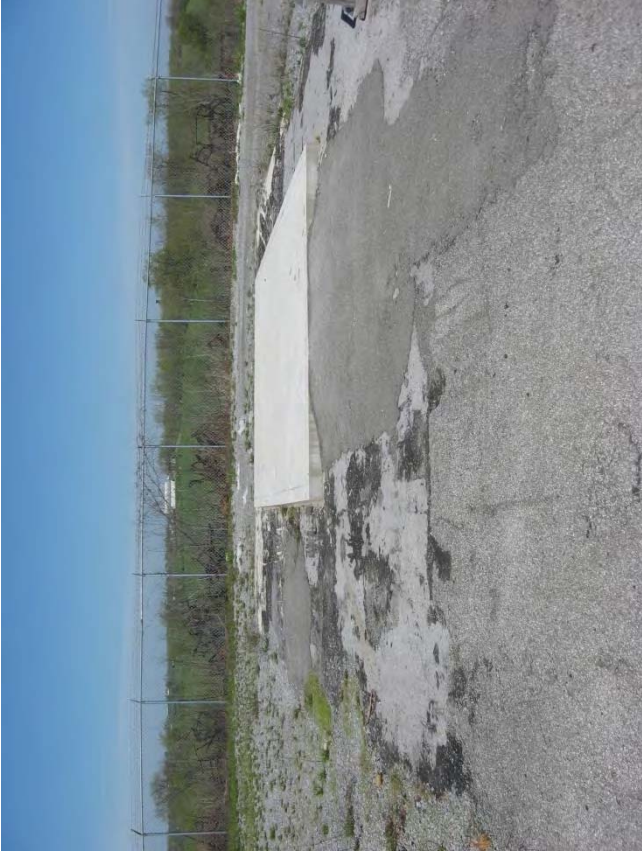
Photo No. 2: Visible staining (B6F-B7F)

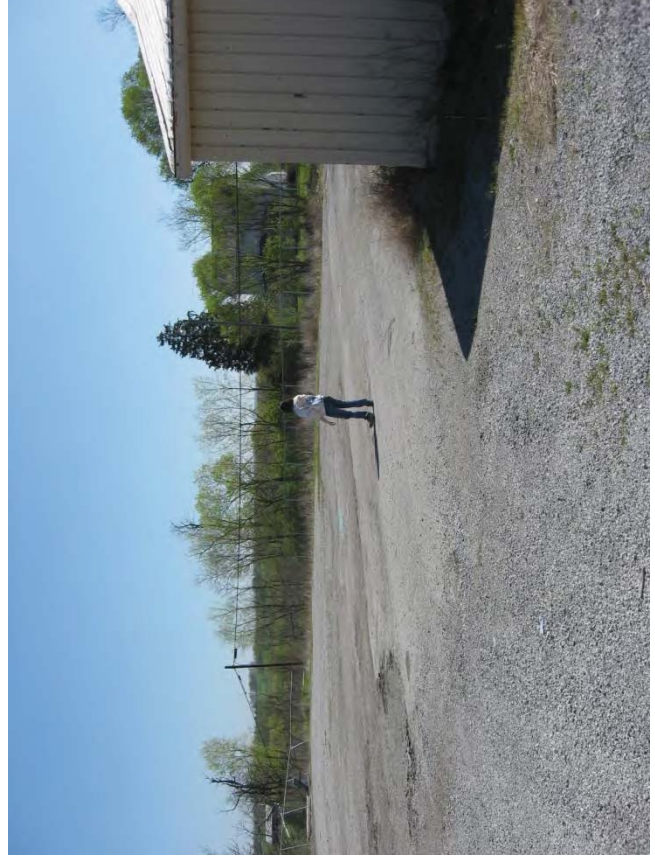
Photo No. 3: Sandblast area (B8F-B9F)

Arsenic in the soil is believed to be the result of natural processes. Nonetheless, as excavation will be necessary to remove the tack oil contaminated soils, the removal of the soils in the area of B9F to a depth of approximately 1.5 feet is recommended when the other area is remediated. This should eliminate elevated arsenic levels in that area.
