400 Blankenbaker Parkway | Suite 300 | Louisville, KY | 502.254.2344

February 9, 2018

From: Randy Kill, PE, PTOE
Kendra Schenk, PE, PTOE
Burgess & Niple, Inc.

Subject: KY 185 Relocation Safety Analysis

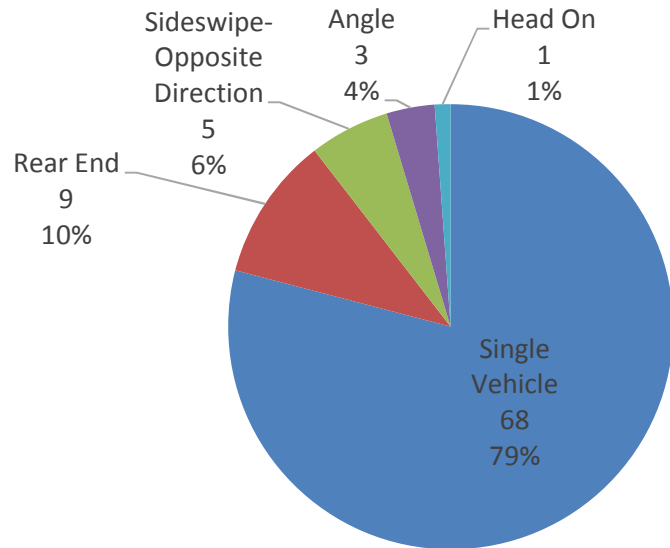
Figure 2: Crash Type on KY 185

The vast majority of crashes involved only one vehicle as shown in **Figure 2**. However, as previously discussed, two of the three fatalities were not single vehicle and were rear end and head on collisions, respectively.

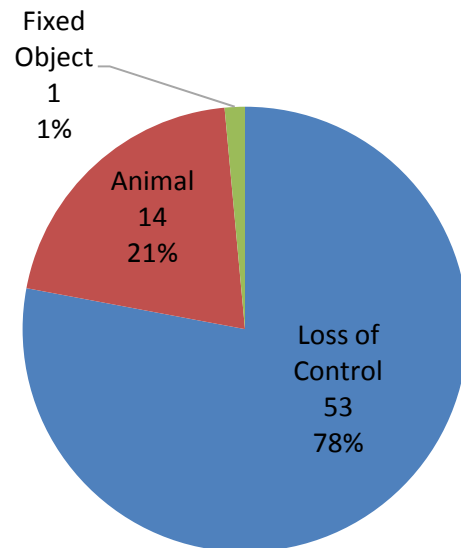
Figure 3: Types of Single Vehicle Crashes on KY 185

The single vehicle crashes can be further broken down into the type of collision as illustrated in **Figure 3**. In the majority of the single vehicle crashes, the driver lost control of the vehicle and left the roadway and collided with an embankment, guardrail, or other fixed object outside the roadway or overturned. The one fixed object crash occurred when a pickup truck’s trailer struck several mailboxes as it was traveling along KY 185.

There were also a number of animal crashes along the corridor. Animal crashes made up 16% of the total crashes and 21% of the single vehicle crashes.

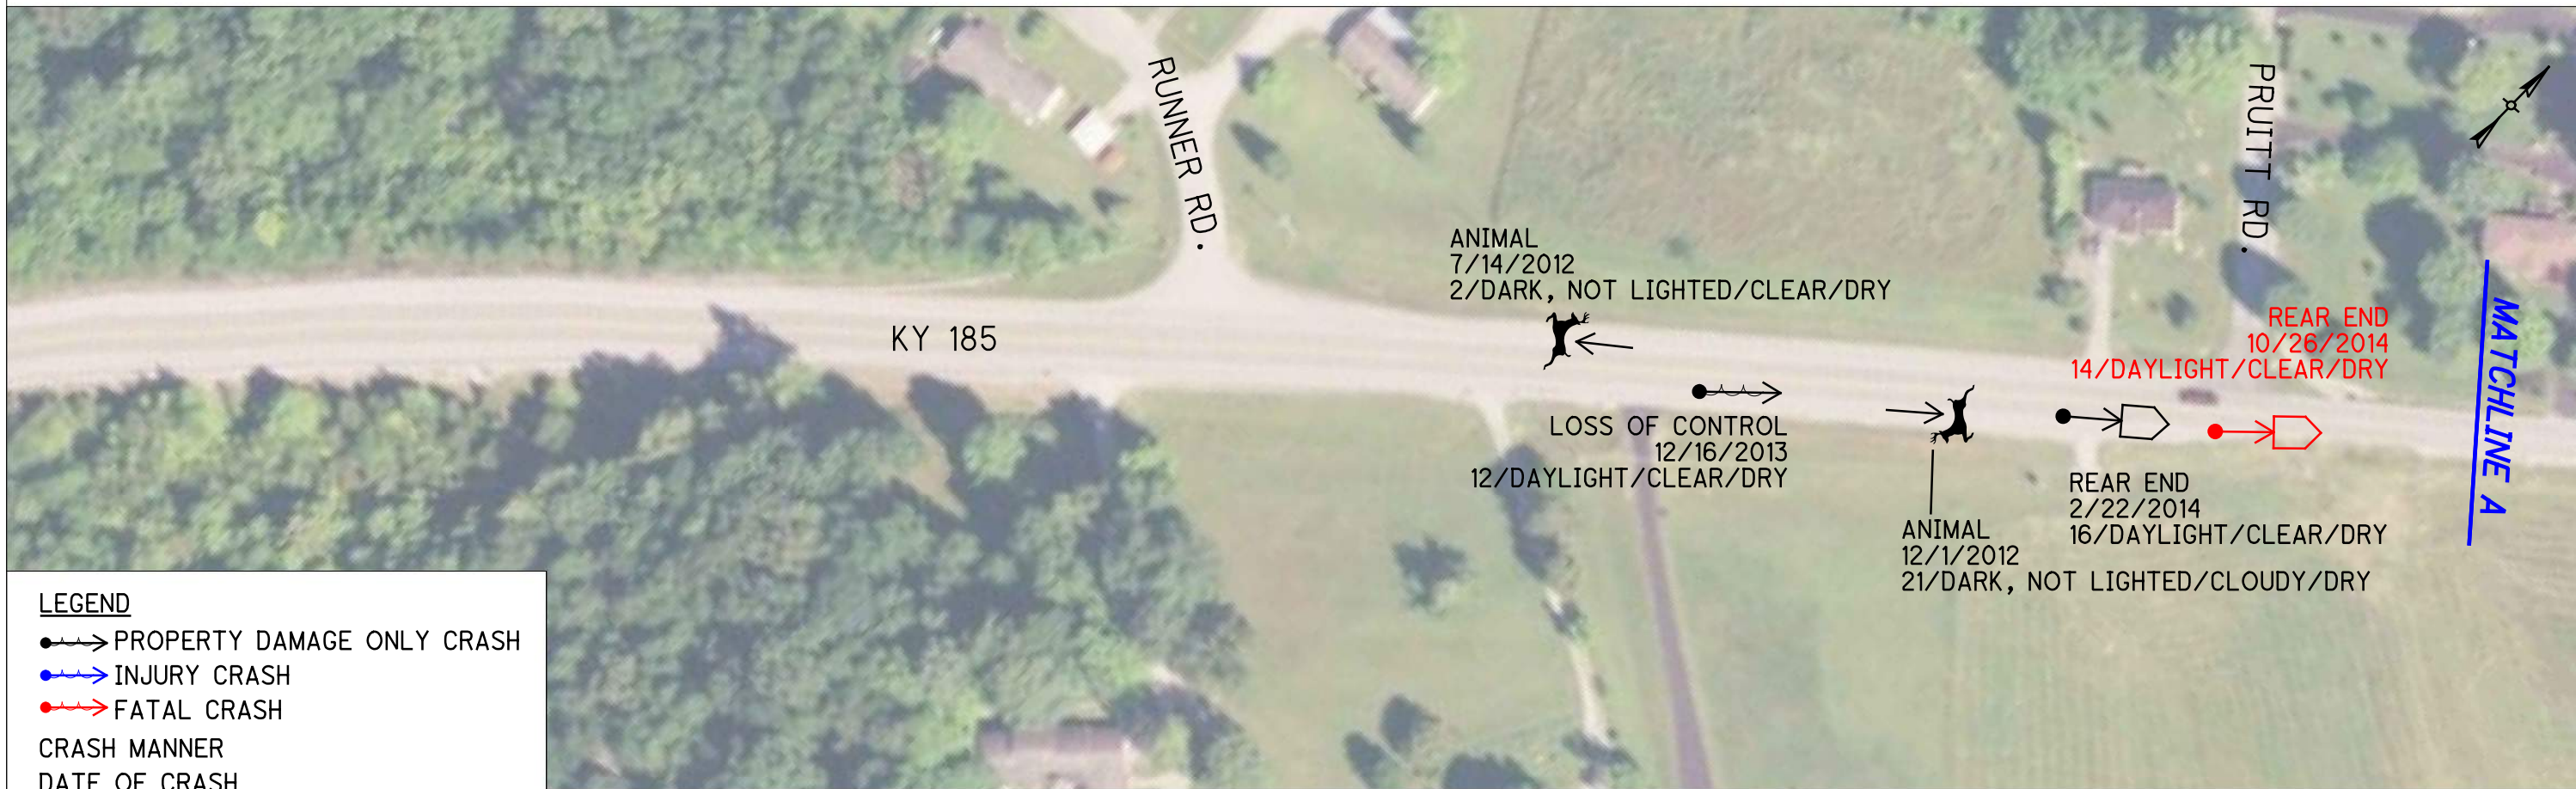
KY 185 RELOCATION SAFETY ANALYSIS
 COLLISION DIAGRAM
 FIGURE 8A

A collision diagram that shows crash patterns by illustrating the approximate location of each reported crash along the corridor is provided in **Figure 8**.

There were six loss of control crashes in the curve north of Pruitt Road (see **Figure 8A**). Two property damage only crashes occurred in the southbound direction and one property damage only and three injury crashes occurred in the northbound direction. In three of the crashes, the roadway was wet or snow-covered which in addition to the curve is a likely contributing factor to these crashes. In addition to the horizontal curve in the roadway alignment, there is also a vertical curve that crests near the center of the horizontal curve.

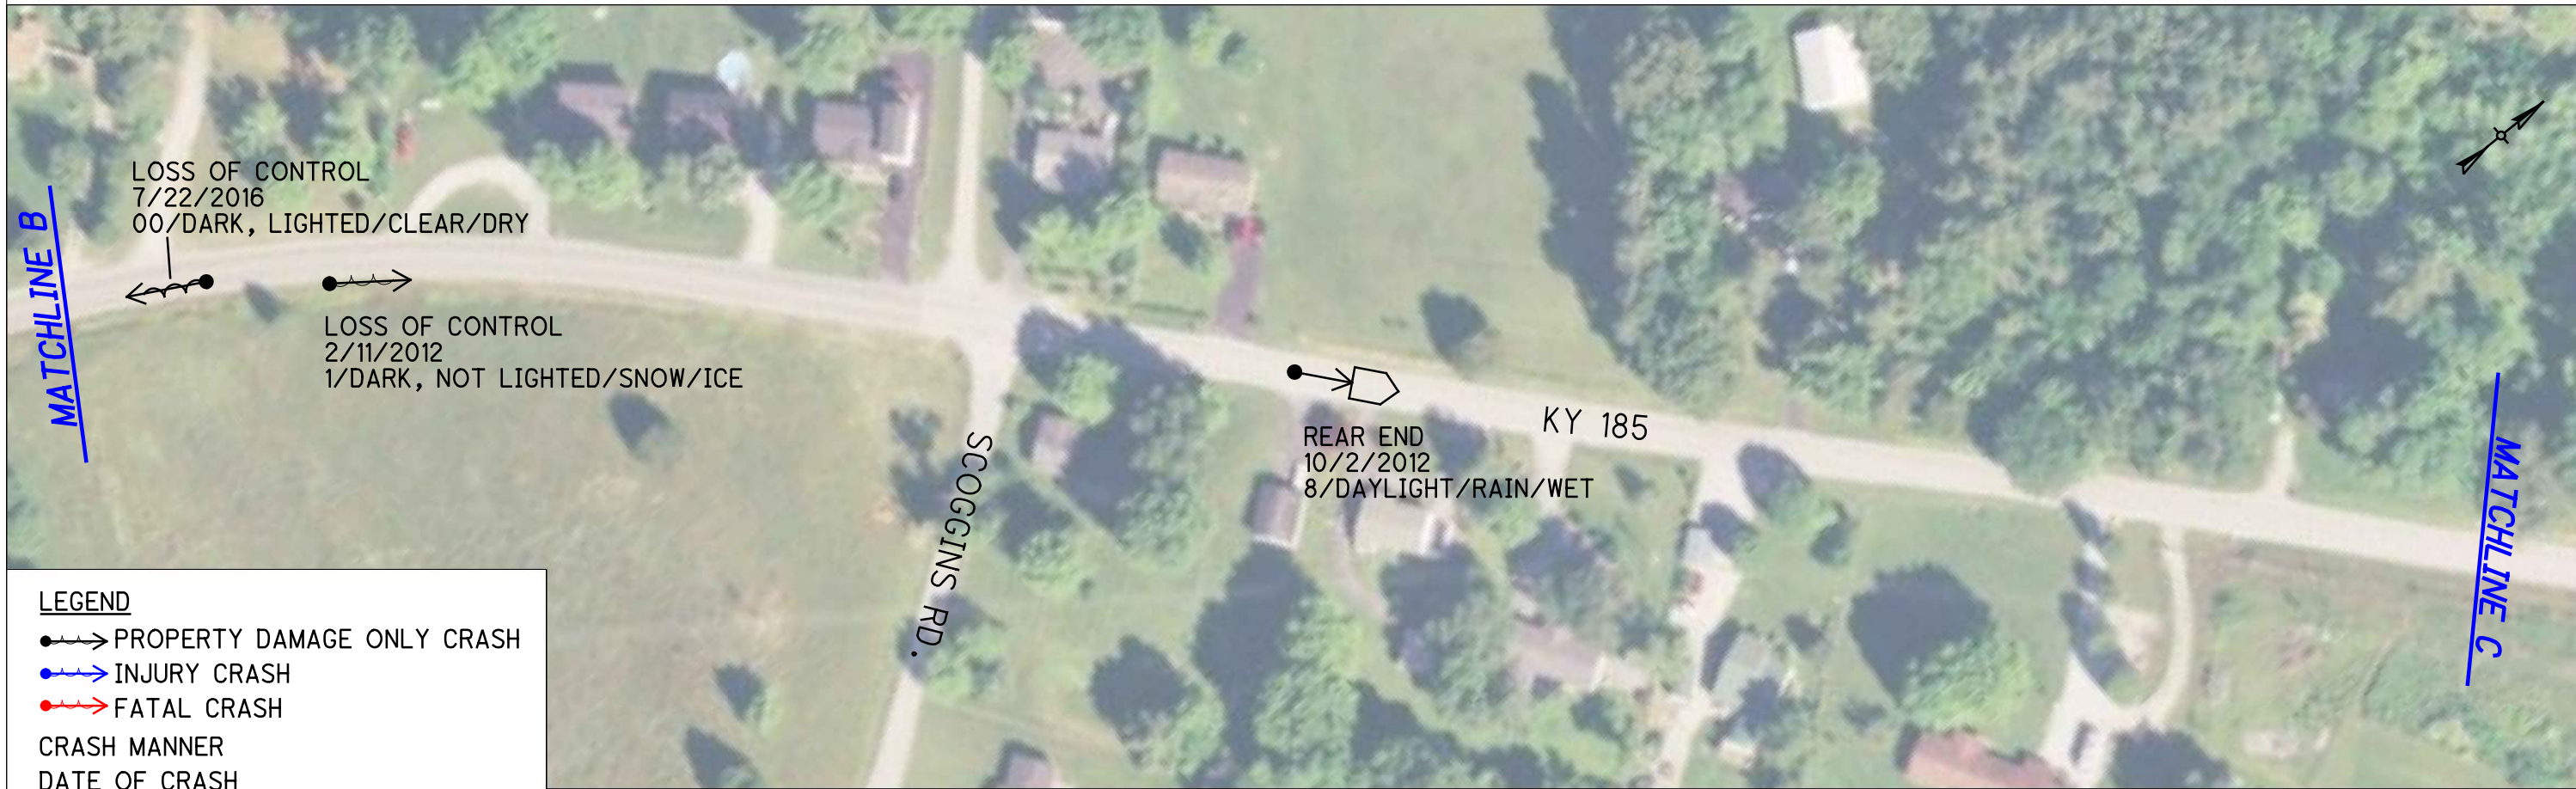
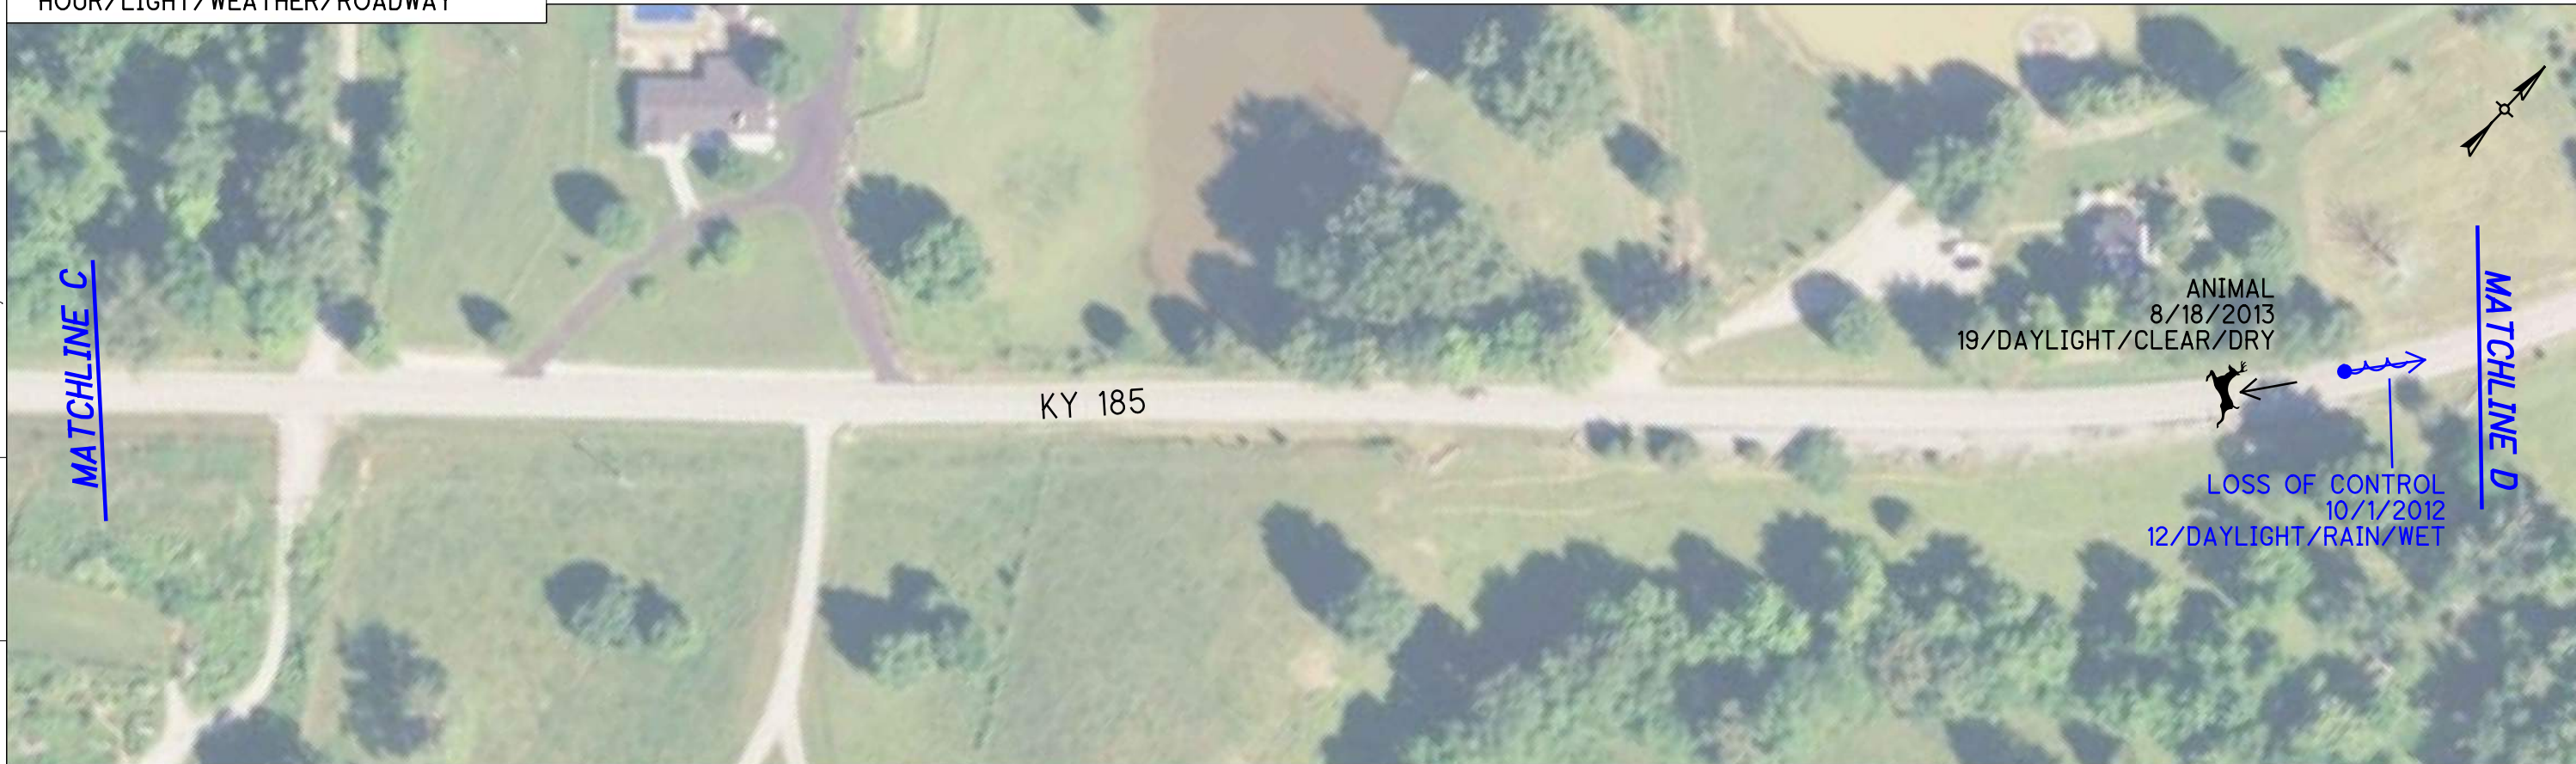
KY 185 RELOCATION SAFETY ANALYSIS
COLLISION DIAGRAM
FIGURE 8B

There were a number of loss of control and rear end crashes in the curves just north of Scoggins Road (see **Figure 8B** and **Figure 8C**). Two loss of control crashes occurred in each the northbound and southbound directions in this area. Two northbound rear end crashes were also reported along this segment of KY 185. The horizontal and vertical curvature were likely contributors to the crashes in this location.

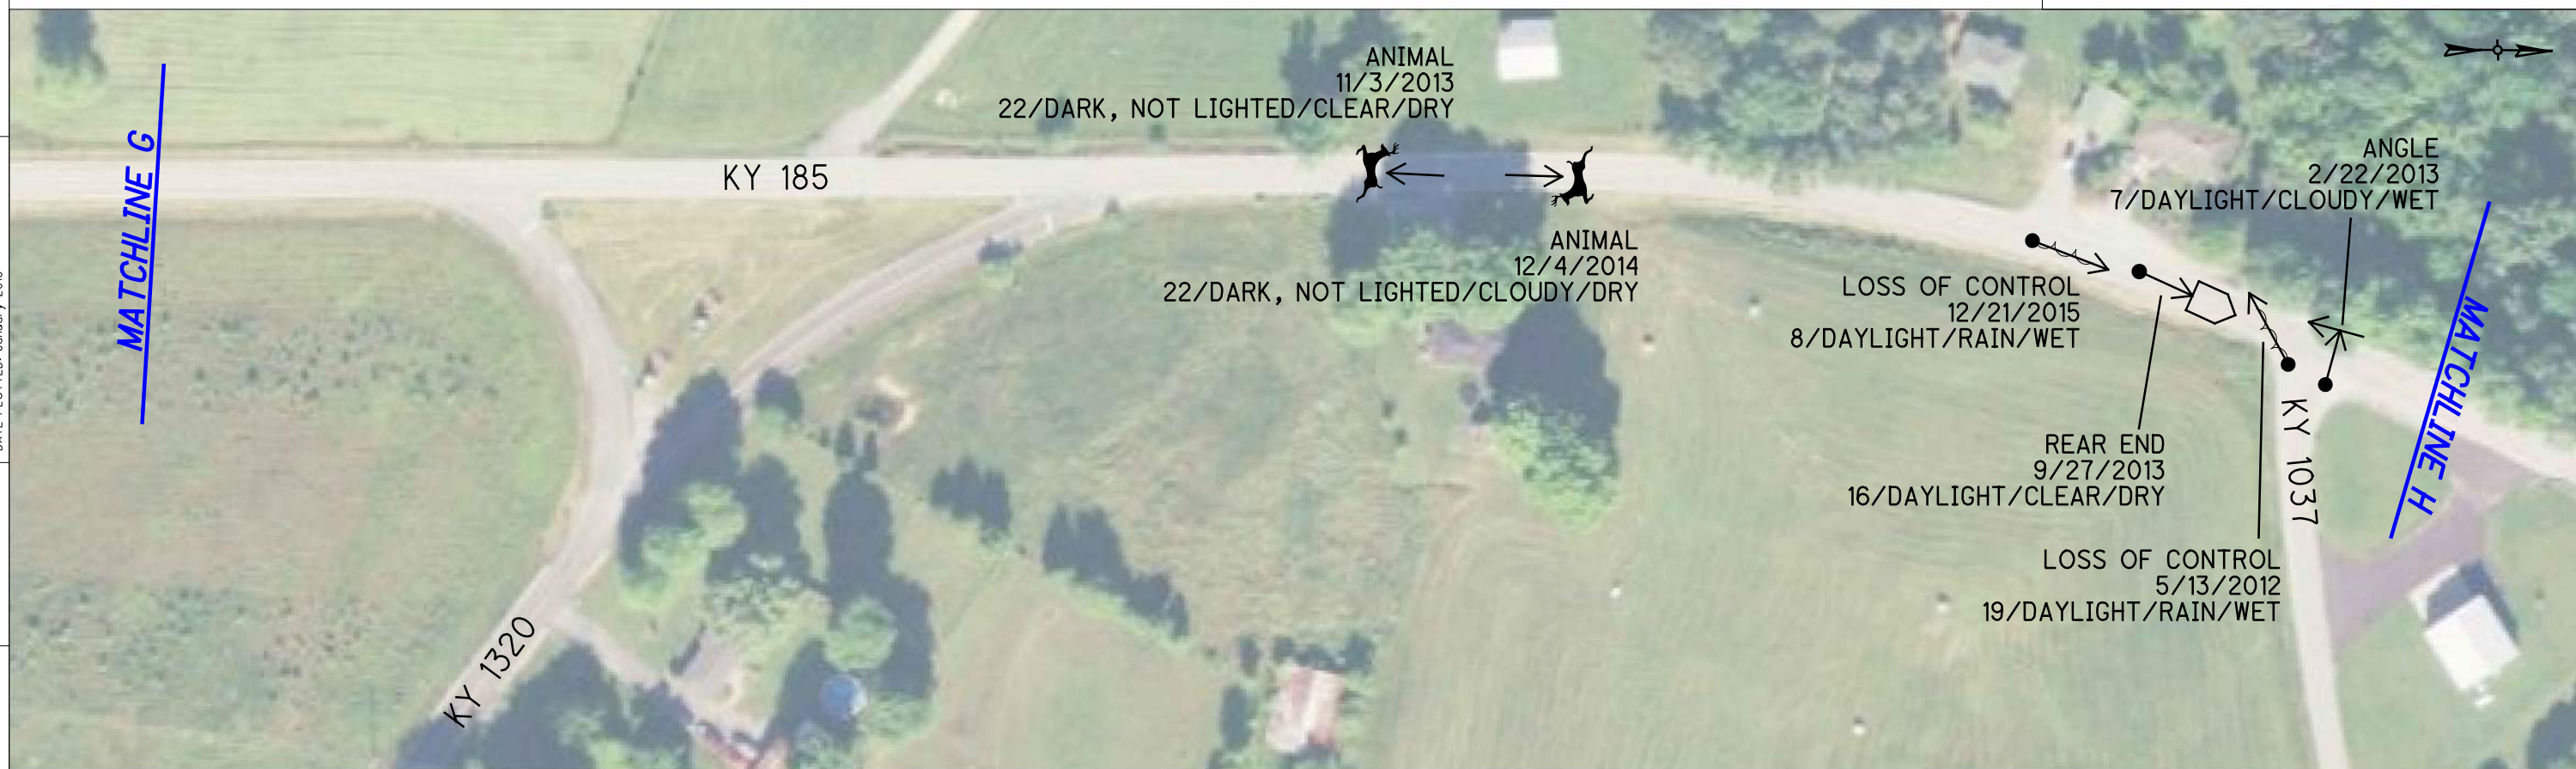
KY 185 RELOCATION SAFETY ANALYSIS
COLLISION DIAGRAM
FIGURE 8D

Five loss of control crashes occurred in the southbound direction in the curve south of KY 1320 (see **Figure 8D**). Two of these crashes resulted in injury. The sharp horizontal curve coupled with the downgrade in the southbound direction likely contribute to the number of crashes at this location.

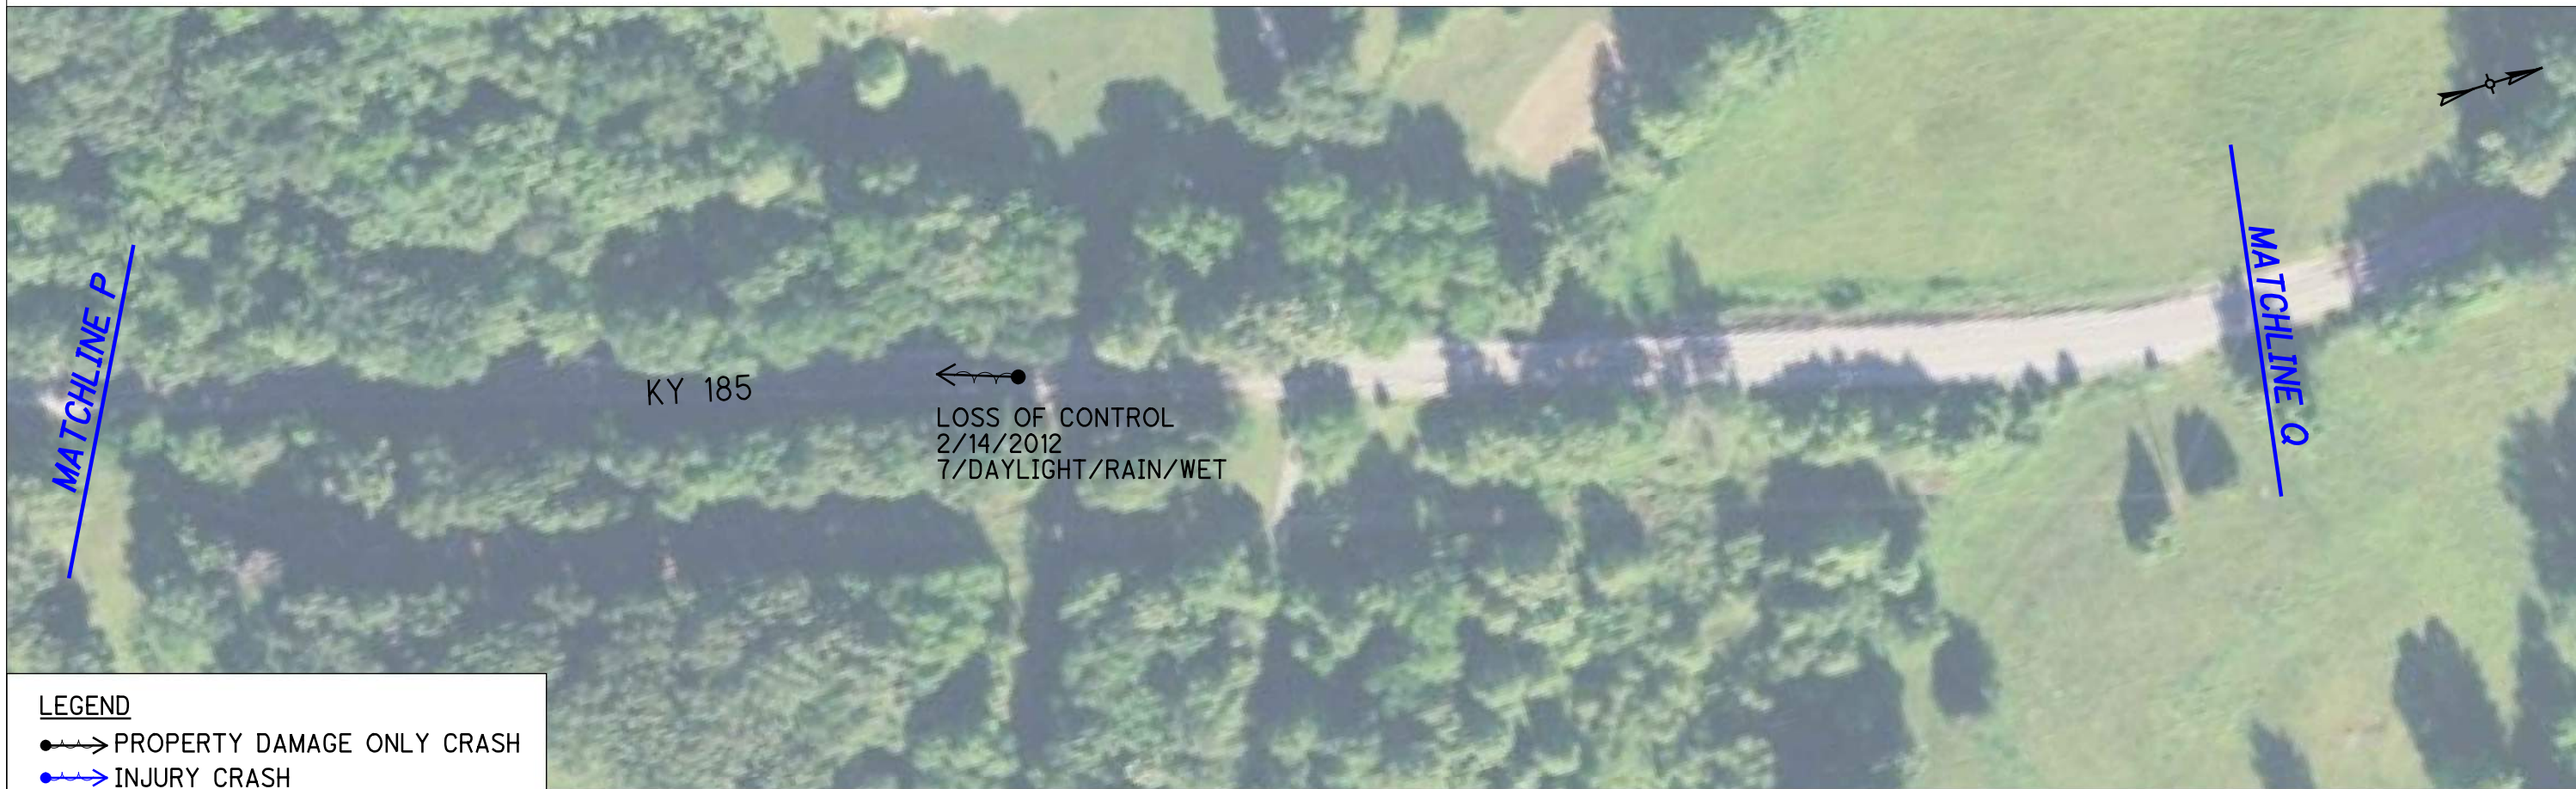
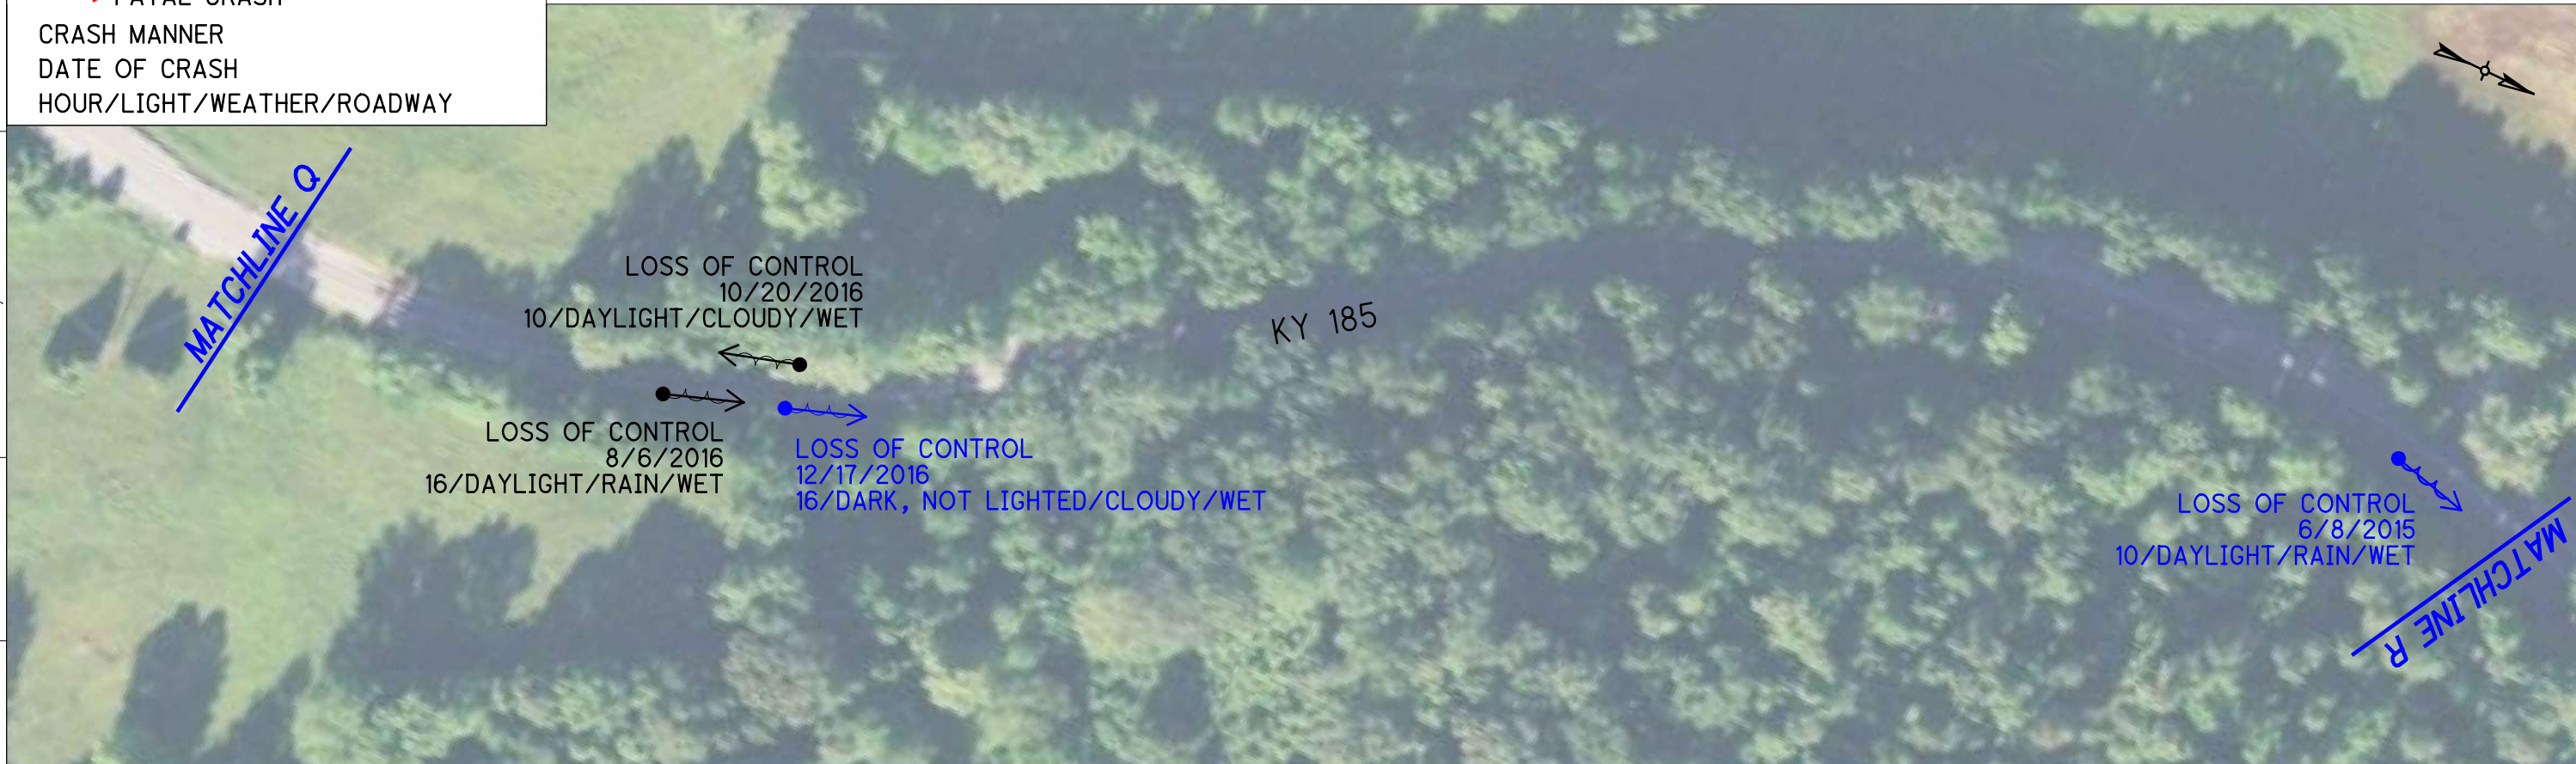
KY 185 RELOCATION SAFETY ANALYSIS
COLLISION DIAGRAM
FIGURE 8H

In the curves north of the cemetery, there were seven loss of control crashes in the southbound direction and five in the northbound direction (see **Figure 8H**). There were also two sideswipe crashes in this segment that occurred when a vehicle left its travel lane, crossed the centerline, and struck a vehicle in the opposing direction. In 11 of the 14 crashes in this segment, the pavement condition was wet, which when coupled with sharp horizontal curves and steep vertical grades contributes to the number of crashes in this area. Eight of the 14 crashes resulted in injury.
