**ARCHAEOLOGICAL INTERPRETATION OF RESULTS
OF SIDE-SCANNING SONAR SURVEY OF
SECTIONS 2 AND 5 OF THE OHIO RIVER BRIDGES
PROJECT IN JEFFERSON COUNTY, KENTUCKY**

Technical Report No. 573

30 April 2007

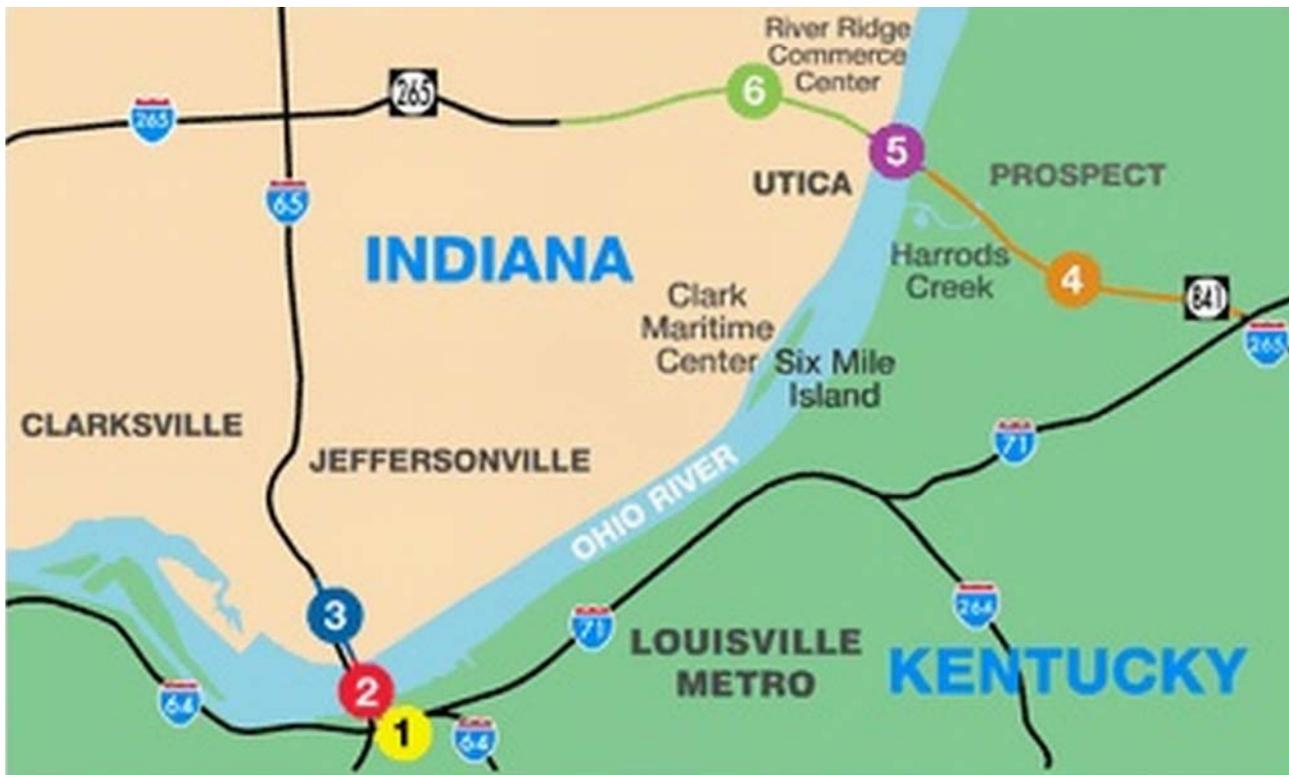
Figure 1.2. General Location Map of Sections of the Louisville-Southern Indiana Ohio River Bridges Project. Downtown Crossing is Section 2, and East End Crossing is Section 5. Map taken from KYTC web site <http://www.kyinbridges.com/>

Sections 2 and 5 of the LSIORBP are also referred to as the Downtown Crossing and the East End Crossing, respectively (Figure 1.2). Each of these crossings is about 800 meters in length, and each has a proposed right-of way about 500 feet (150 meters) wide. The actual surveyed area of Section 2 is about 180 meters wide, while the Section 5 survey area averages 220 meters in width. The precise boundaries of rights-of-way and bridge construction design had not been established at the time the survey was conducted, so precise locations of bridge support footings and related cofferdam construction areas were unknown. As a result, the entire length of both sections was subjected to the side-scanning sonar survey, while the width of the surveyed areas covered slightly more than the proposed right-of-way- width to account for potential shifts in right-of-way location. The total area surveyed in Section 2 is about 14.4 ha, while the Section 5 survey covers about 17.6 ha. Anomalies of potential cultural significance may be avoided if these survey data can be incorporated into planning for the bridge construction. Both sections are on the 1982 (photorevised 1987) Jeffersonville, Indiana-Kentucky 7.5' USGS quadrangle. Section 2 runs parallel to and just east of the present location of the John F. Kennedy Memorial Bridge, near the southwest corner of the quadrangle (Figure 1.3). Section 5 traverses the Ohio River near Transylvania Beach on the Kentucky side, running north-northwest and intersecting the Indiana shore just north of the town of Utica (Figure 1.4).

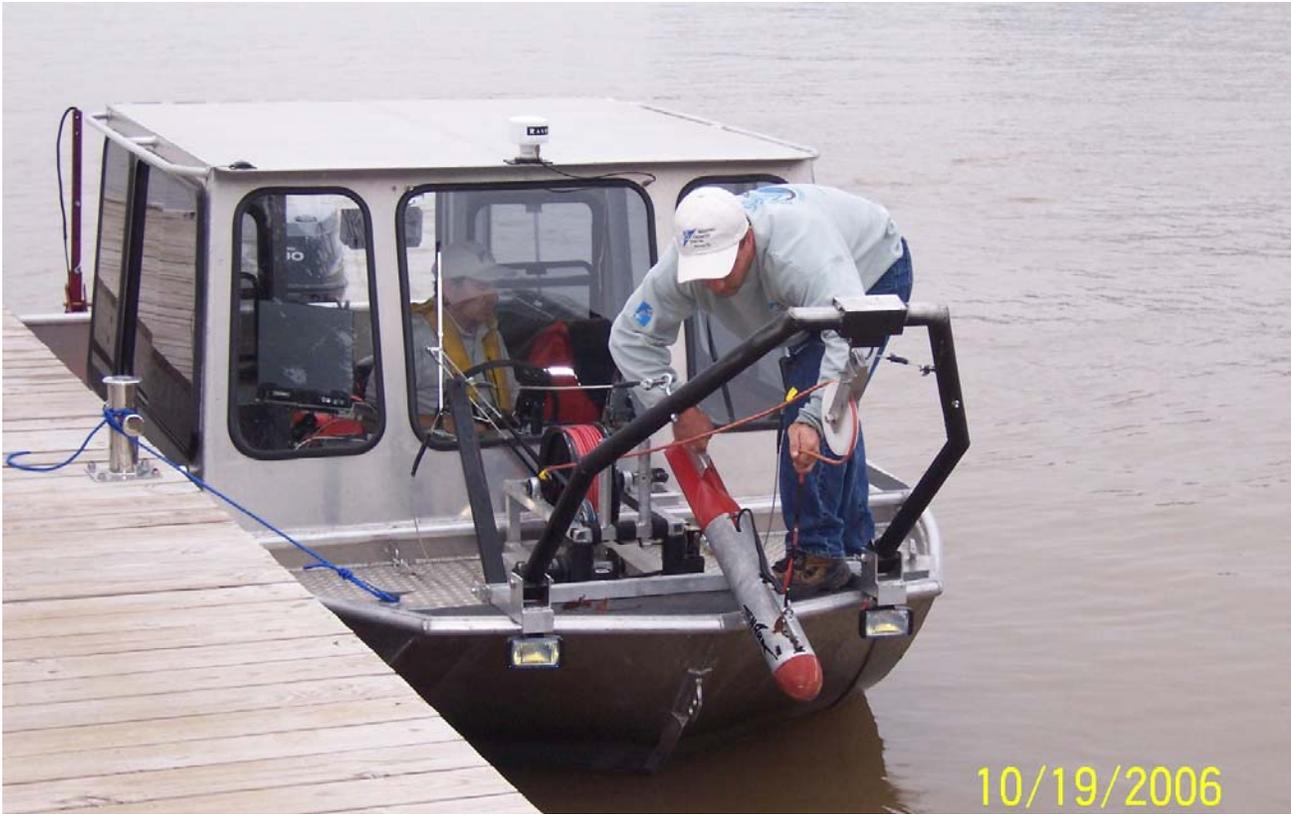
Figure 4.1. Aluminum Survey Boat Used by MCDI for Side-scanning Sonar Surveys. Torpedo-shaped item is the side-scanning sonar transponder.

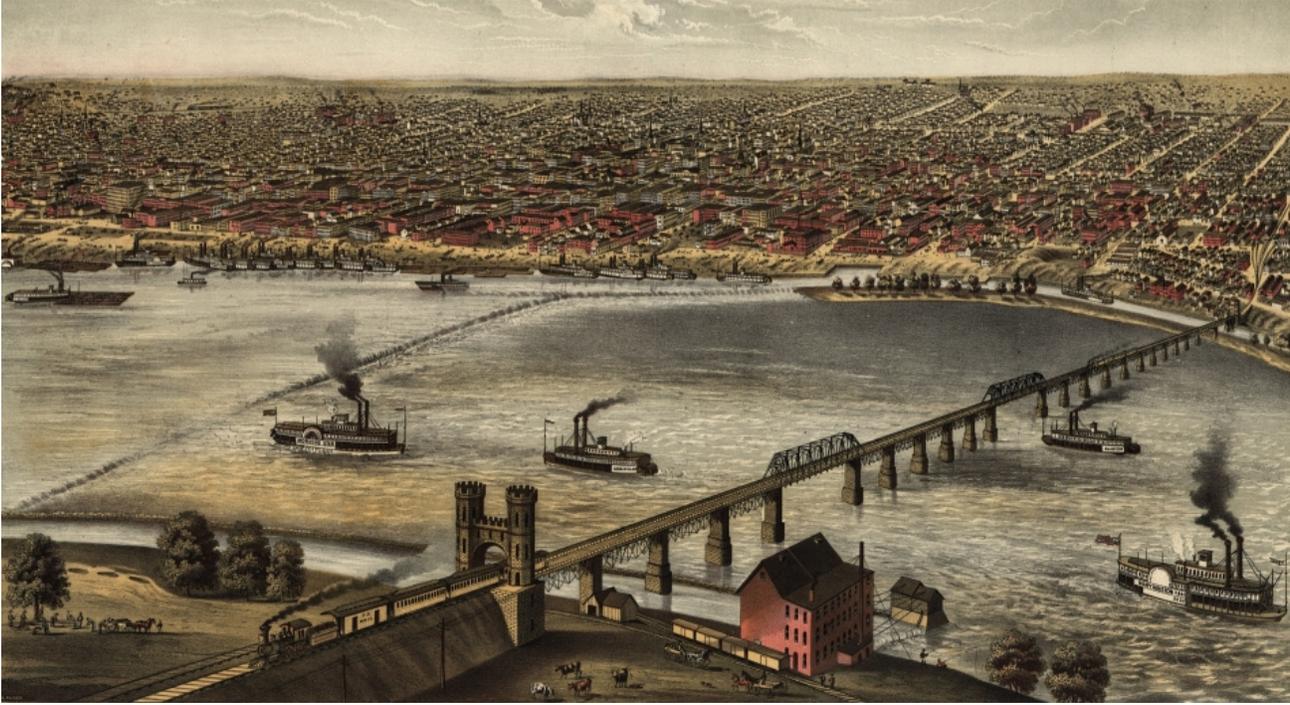
Figure 5.12. 1876 Birdseye View of Louisville (published by Chas. Shober & Co, Chicago). Of interest is the mill in the foreground (Jeffersonville side of the river) with millrace that has a retaining wall running parallel to the Ohio River shoreline (from Thomas 1971).

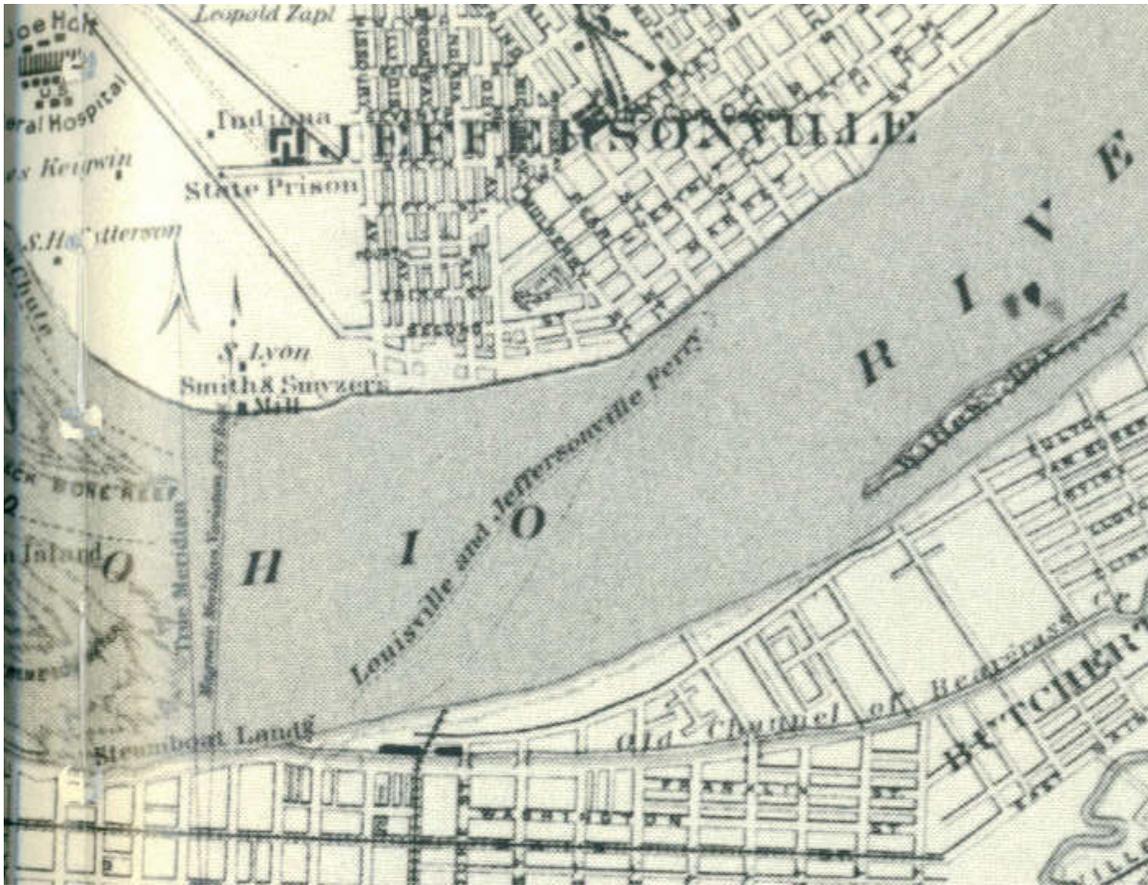
Figure 5.13. Portion of 1865 *Louisville and its Defenses* Map (Simpson and Slayton 1895) Showing Smith and Smyzers Mill. The Louisville and Jeffersonville Ferry course may be offset to avoid crossing the millrace.
