# Phase I Archaeological Site Detection Survey in Support of a Proposed Bridge Replacement over the Little Kentucky River on KY 2871 (KYTC Item No. 5-1075)

Trimble County, Kentucky

November 2015

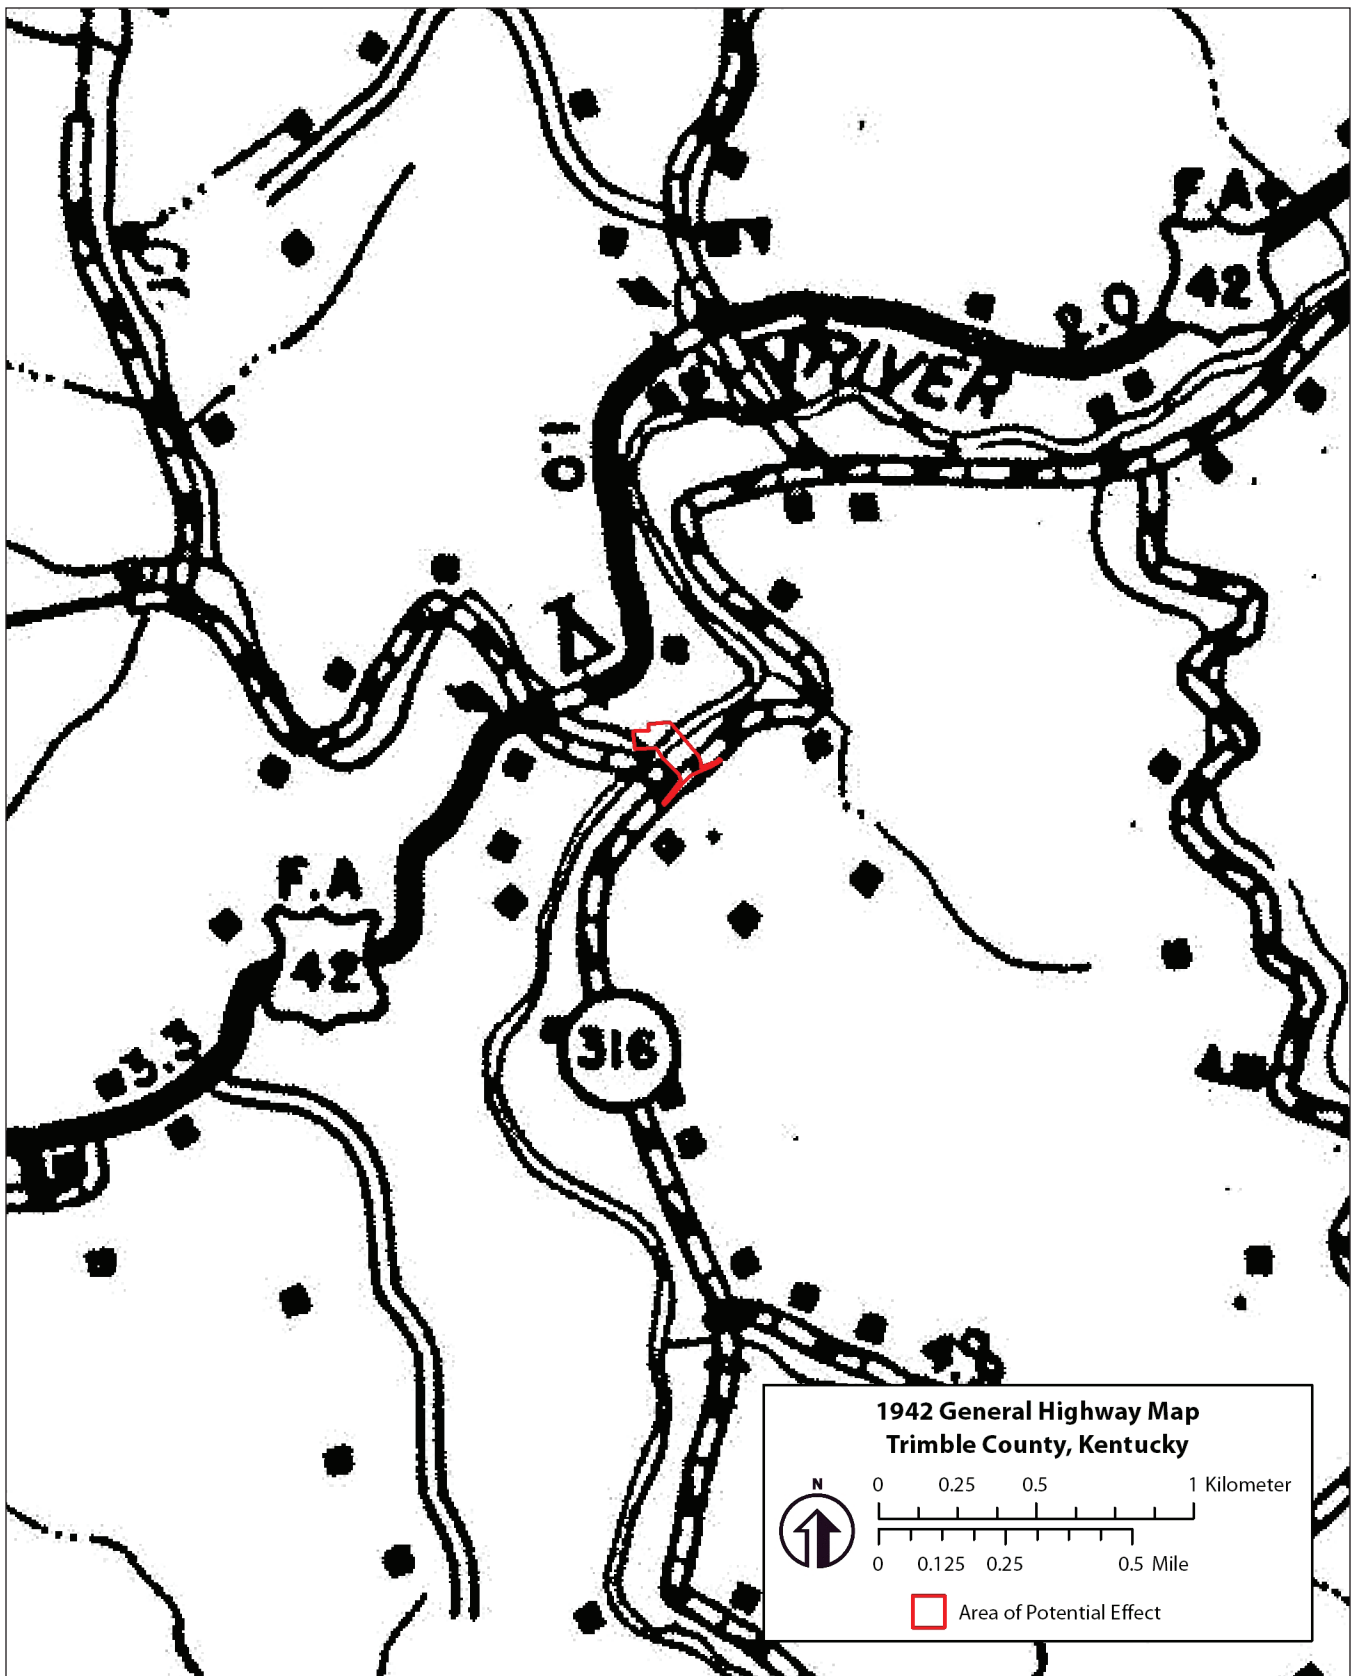
Figure 2.1 Location of proposed bridge replacement designated KYTC Item No. 5-1075, as shown on a 1942 General Highway map of Trimble County, Kentucky.

The three historic maps consulted during this investigation include general highway maps and one USGS topographic quadrangle. County transportation maps from 1942 and 1955 illustrate roads in the general area; however, no other man-made features (e.g. buildings) fall within the APE on these maps (Figure 2.1 and 2.2). Similarly, no man-made features are illustrated within the APE on a 1953 USGS topographic quadrangle (Figure 2.3). These maps do, however, illustrate that the alignment of KY 2871 lying south of the Little Kentucky River was shifted east sometime after 1955.
