AN ARCHAEOLOGICAL SURVEY FOR THE RECONSTRUCTION OF A SECTION OF KY 40 IN MARTIN COUNTY, KENTUCKY (ITEM NO. 12-192.00)

May 26, 2015

Lead Agency: Federal Highway Administration
Kentucky Transportation Cabinet Item Number 12-192.00
Statewide Contract No. PON2 1500000058, Agreement 201487, Letter Agreement No. 17-DBD
OSA Project Registration No.: FY15_8406

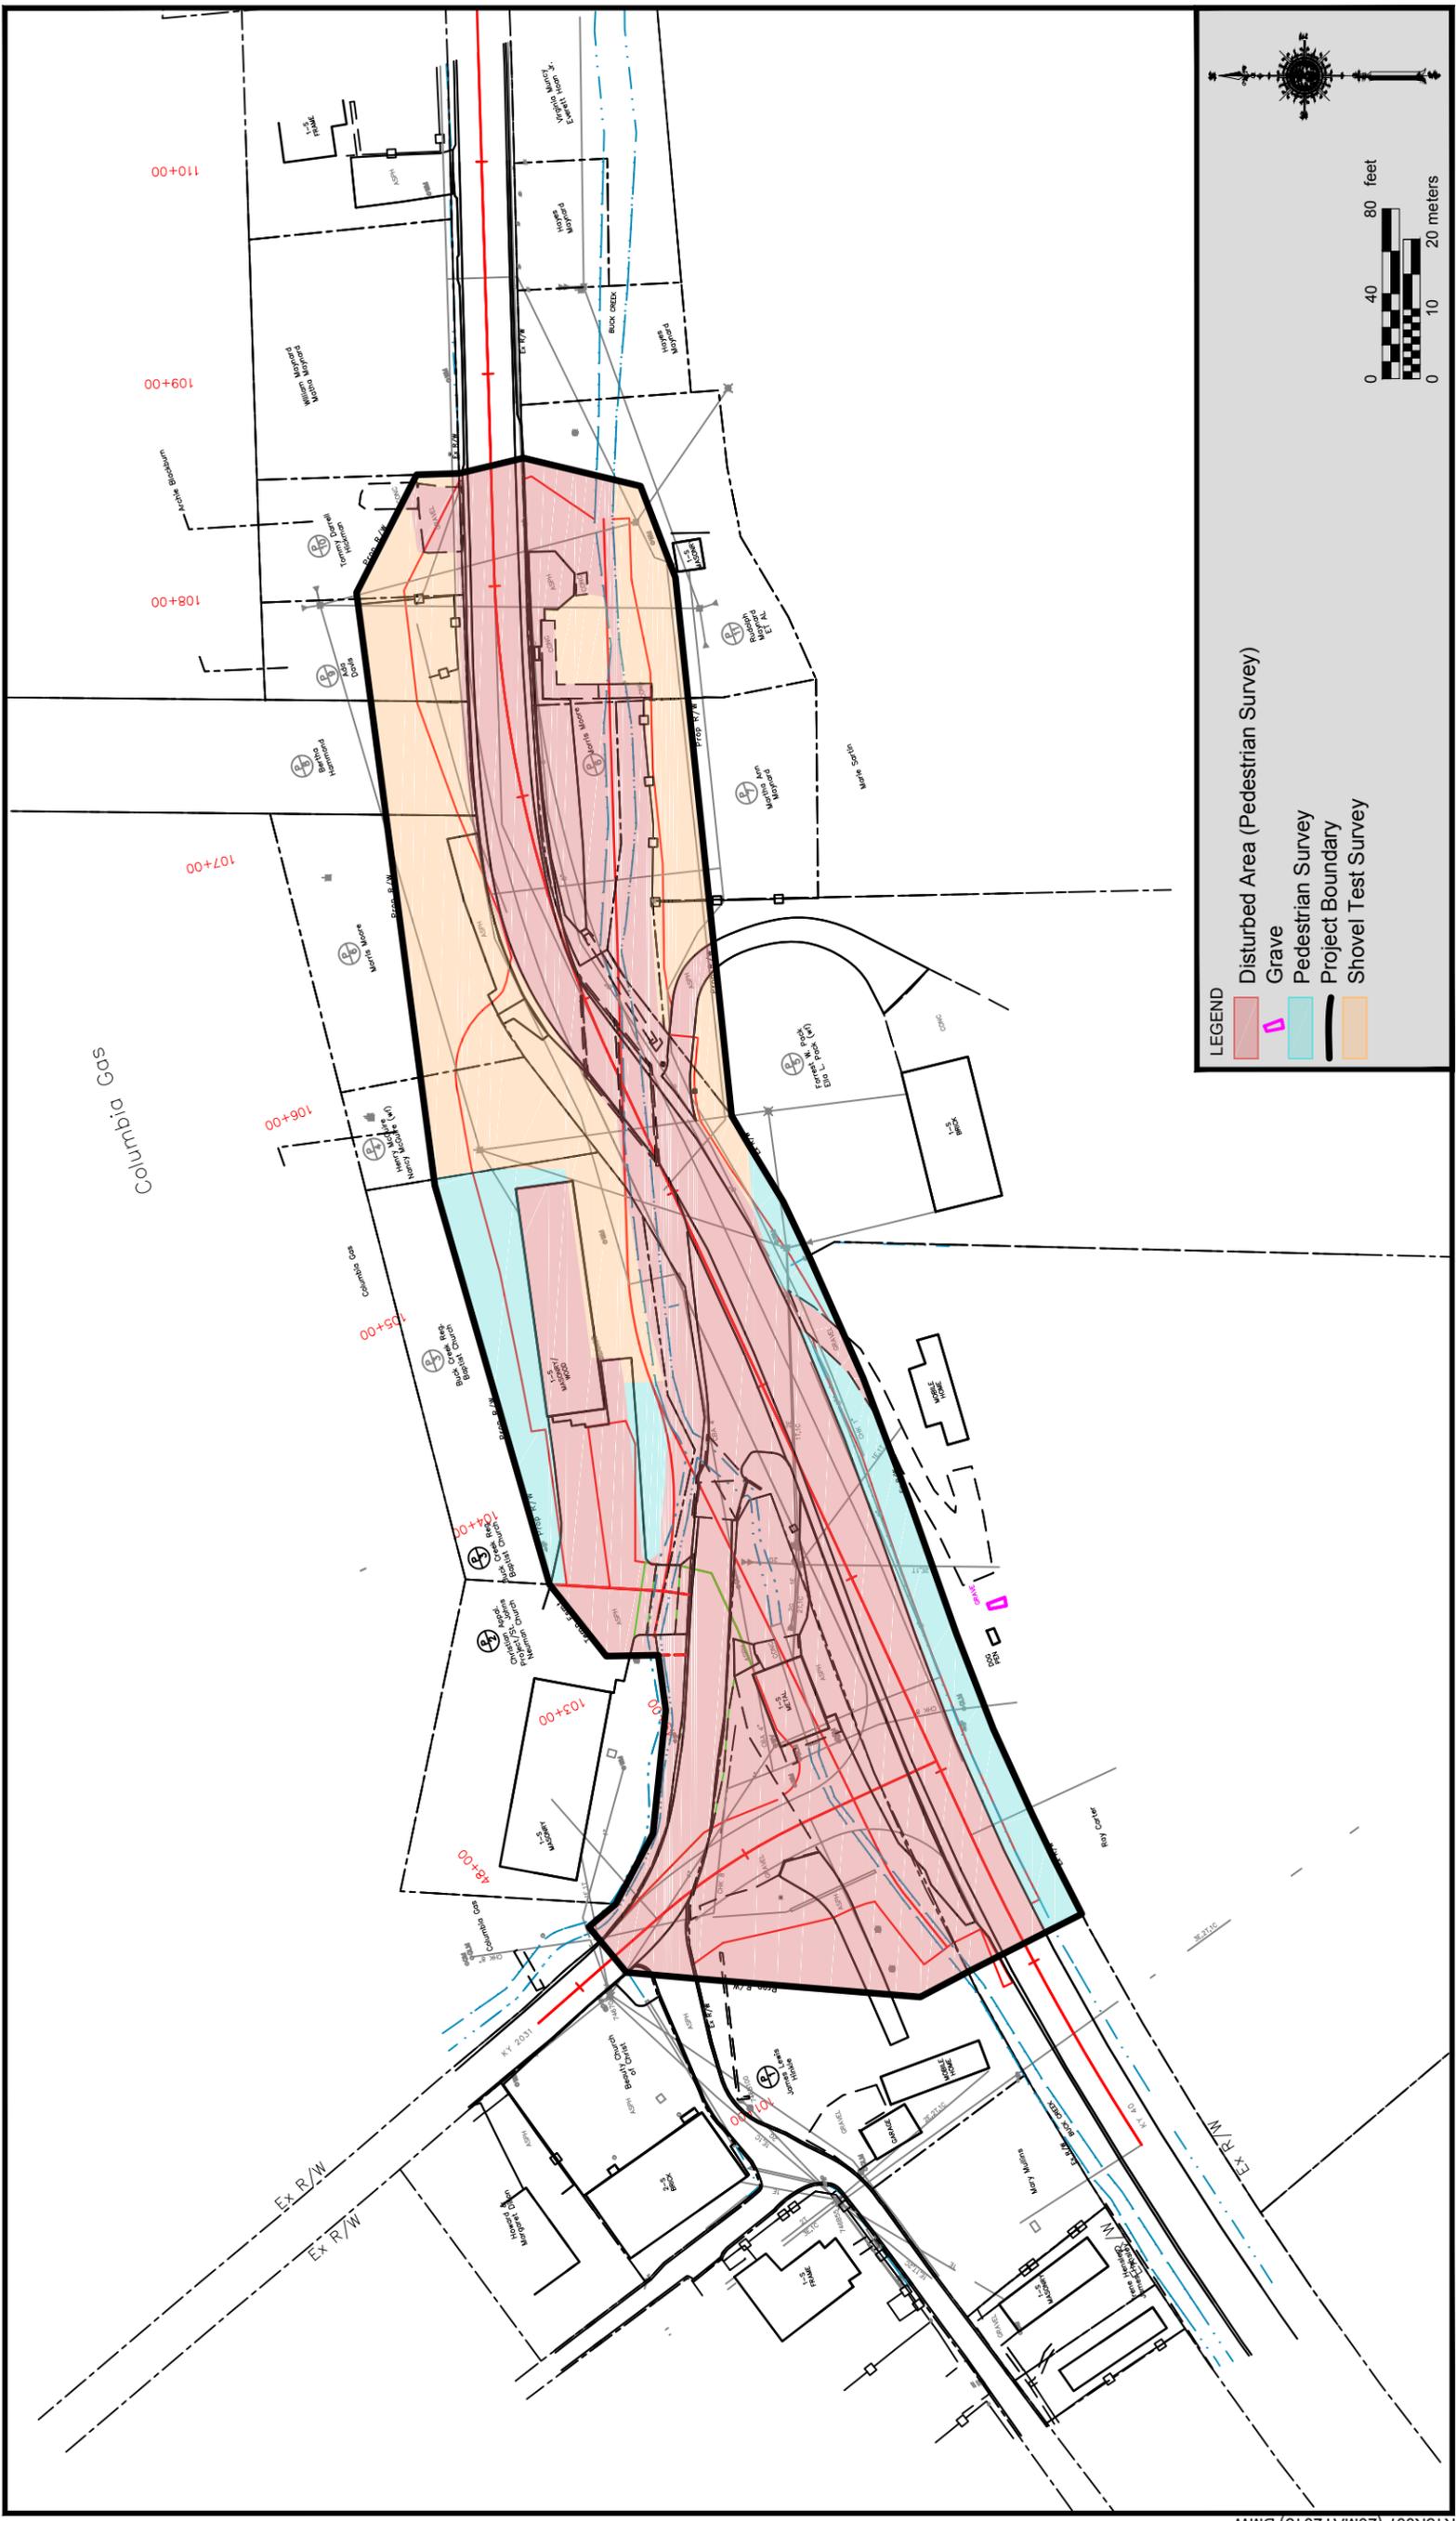
Figure 3. Project area plan map.

More specifically and as shown in Figure 3, the east-west extent of the proposed project begins approximately 75 m (246 ft) west of the existing junction of KY 40 and KY 2031 and extends east along KY 40 for a distance of approximately 150 m (492 ft). The project area also extends north along KY 2031 approximately 75 m (246 ft) from the junction.

The entire project area was subjected to intensive pedestrian survey and shovel testing (see Figure 3). Pedestrian walkover was conducted by walking parallel transects along natural contours. Steep sideslopes were inspected for natural benches and overhangs. Dirt roads and all exposed areas were walked and visually examined for indications of cultural material and features.

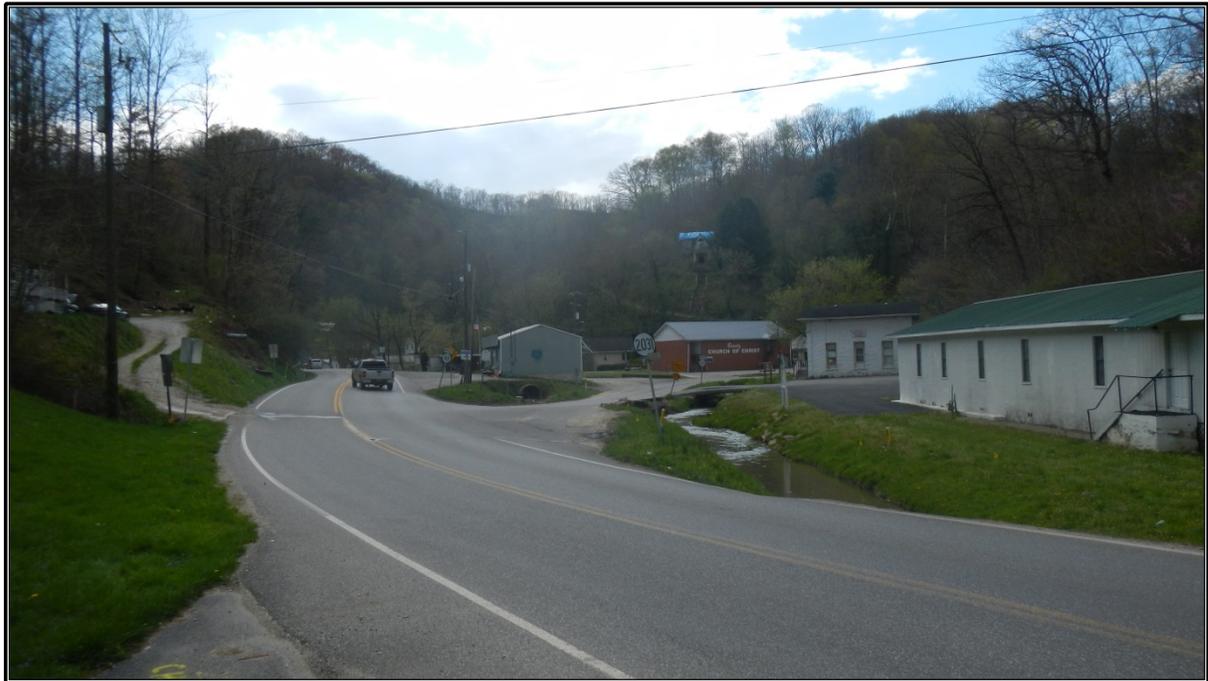
Ground surface visibility within most portions of the project area was obscured by manicured lawns (Figure 4), secondary growth (Figure 5), and leaf litter. Other portions had been disturbed by gas lines, parking lots

Figure 4. General overview showing manicured lawns in and around the junction, facing west.

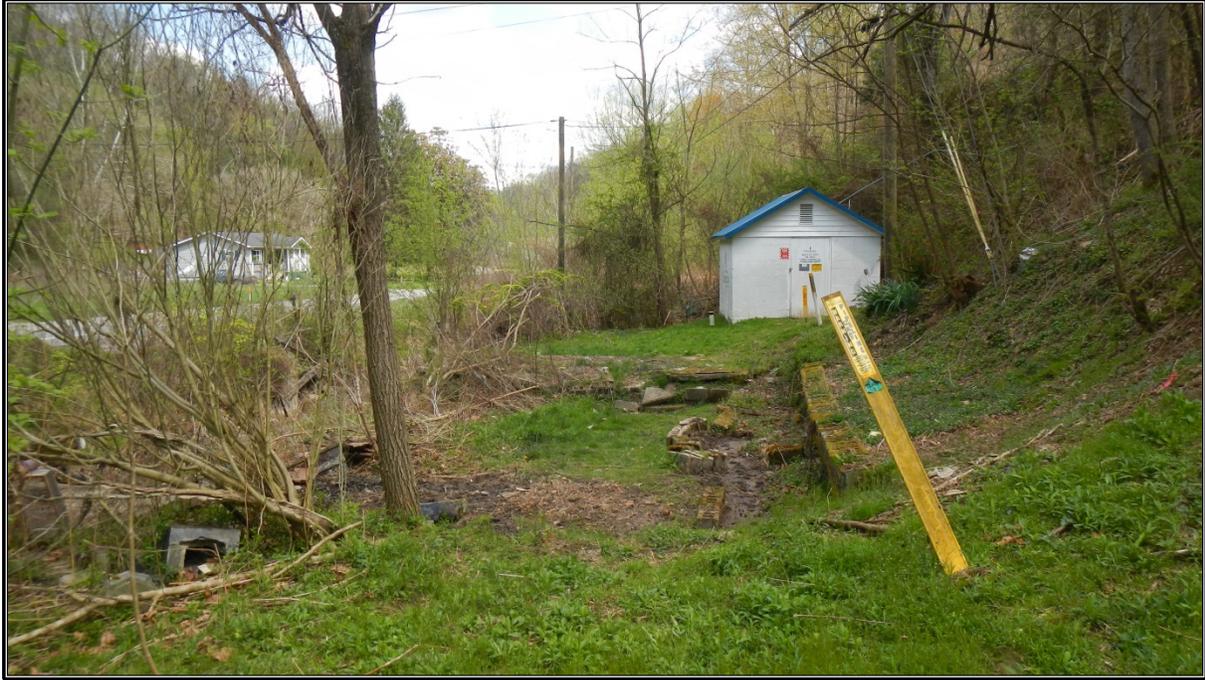
Figure 5. General overview of the project area south of KY 40 showing secondary growth, facing east.

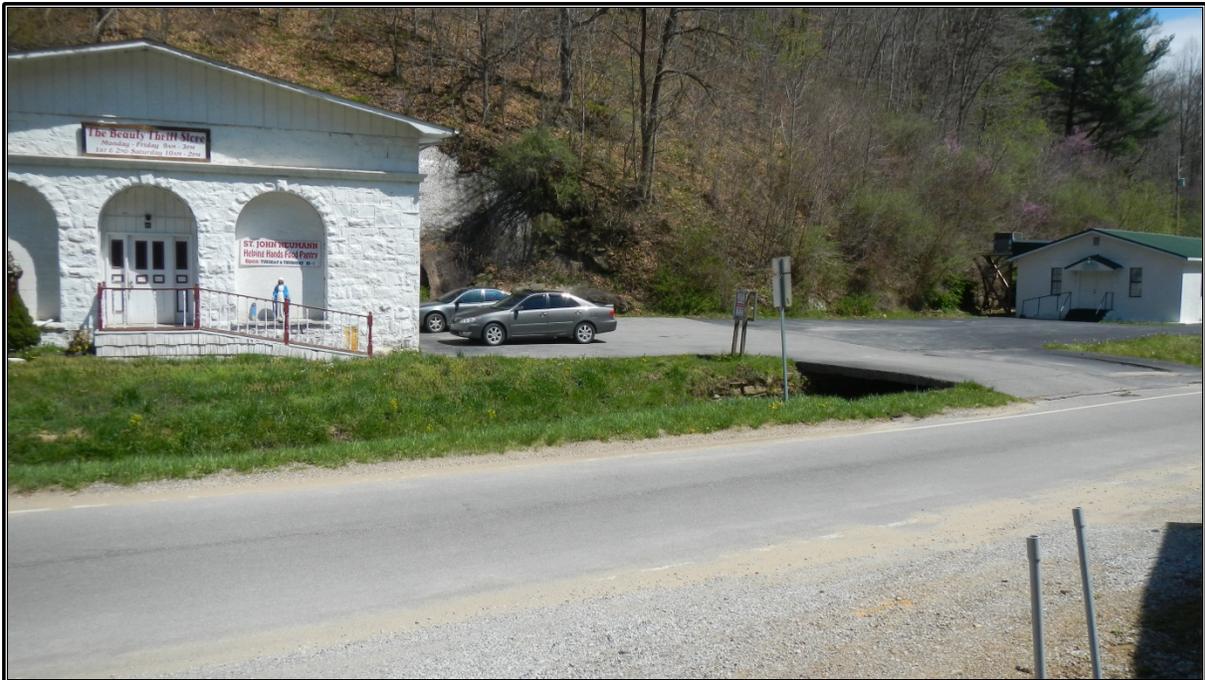
(Figure 6), the construction of buildings (Figures 7 and 8), and in-filling with gravel (Figure 9).

Figure 6. Parking lot associated with a thrift store and church north of KY 40, facing northeast.

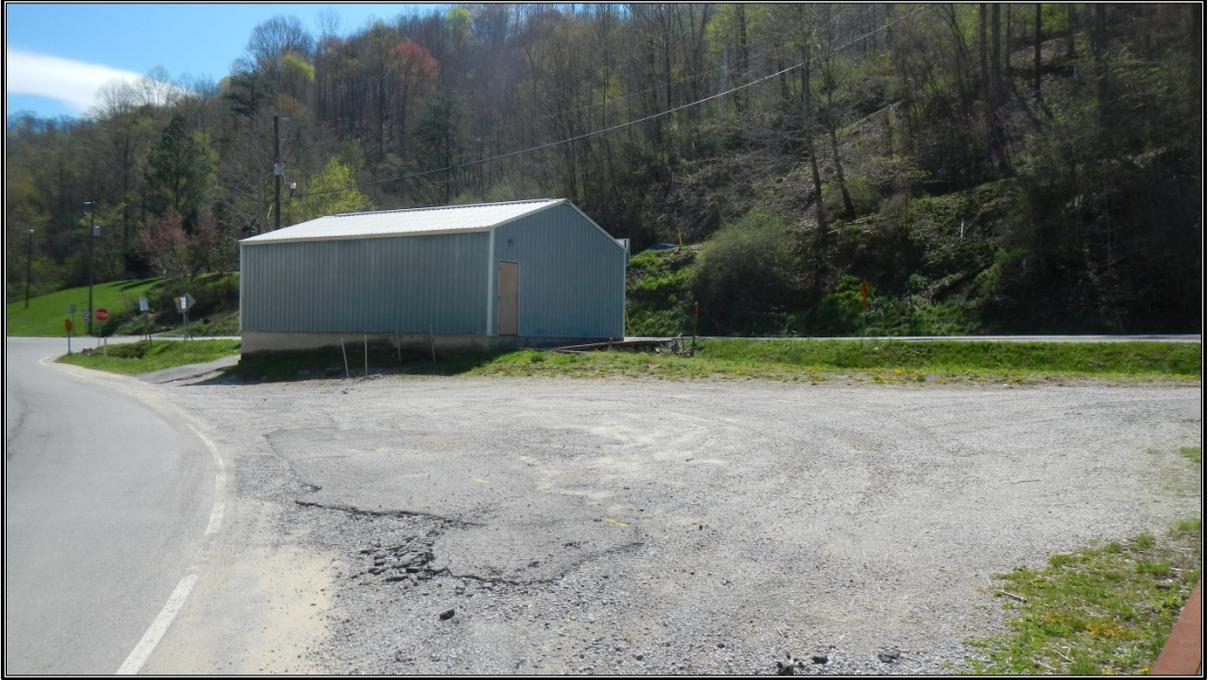
Figure 7. Modern metal building at western end of project area, facing southeast.

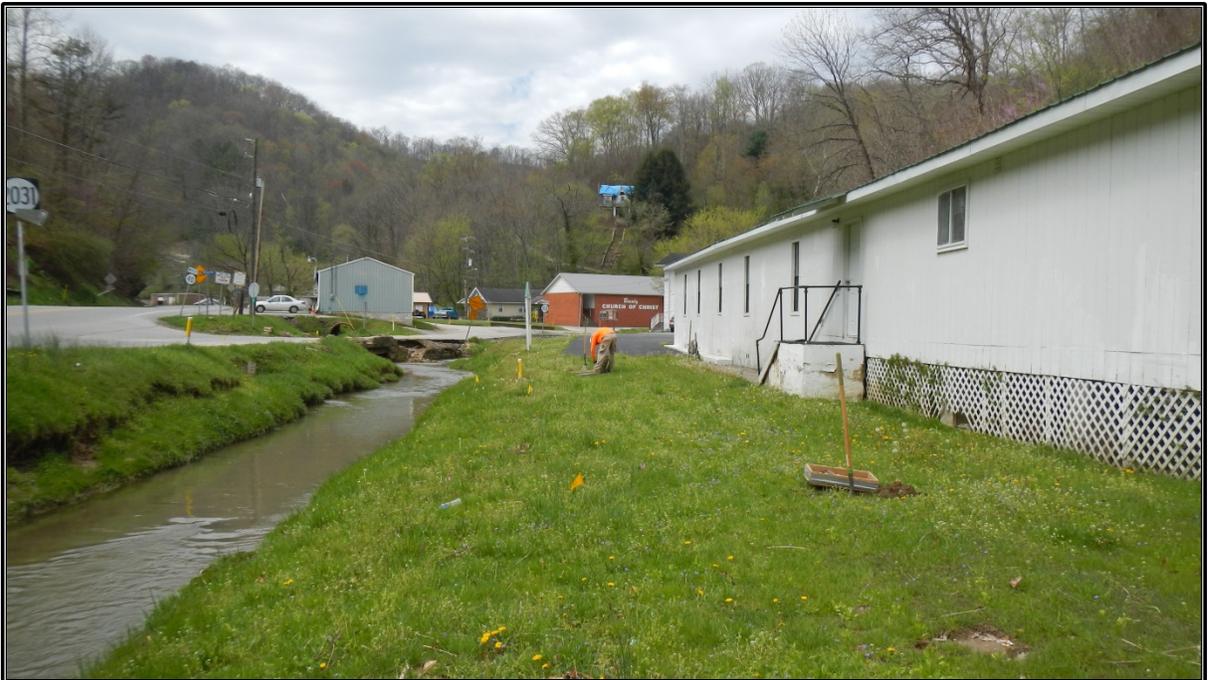
Figure 8. Modern church, facing west.

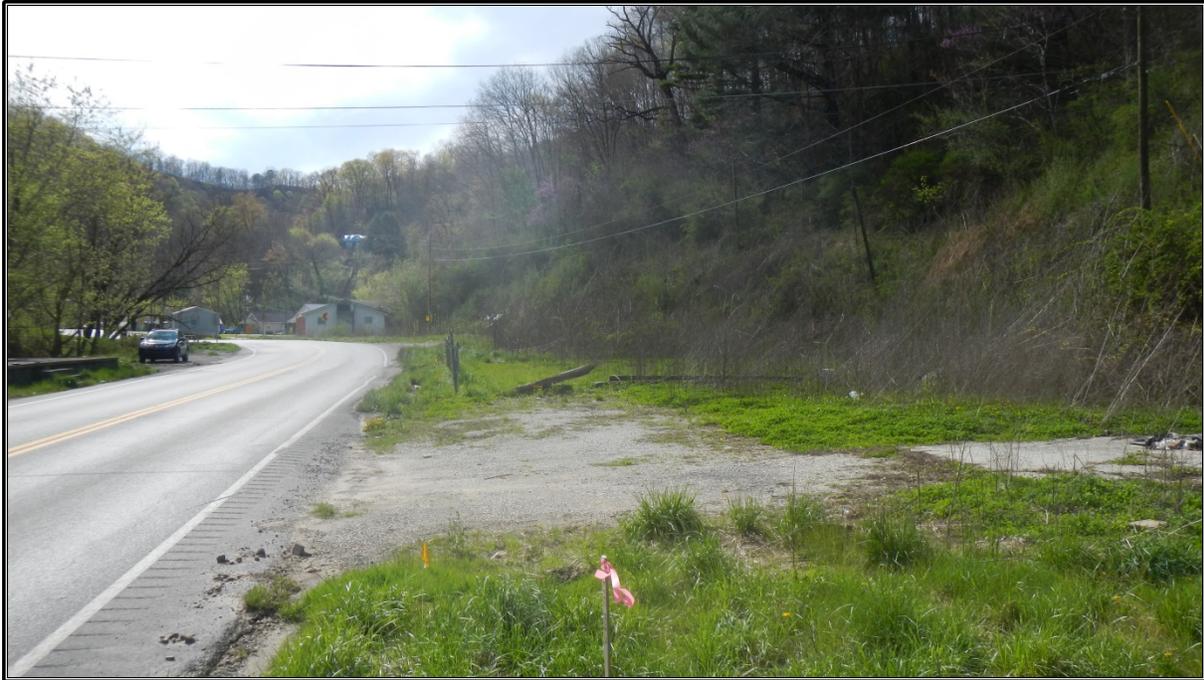
Figure 9. Overview of disturbed portion of project with gravel, facing northwest.

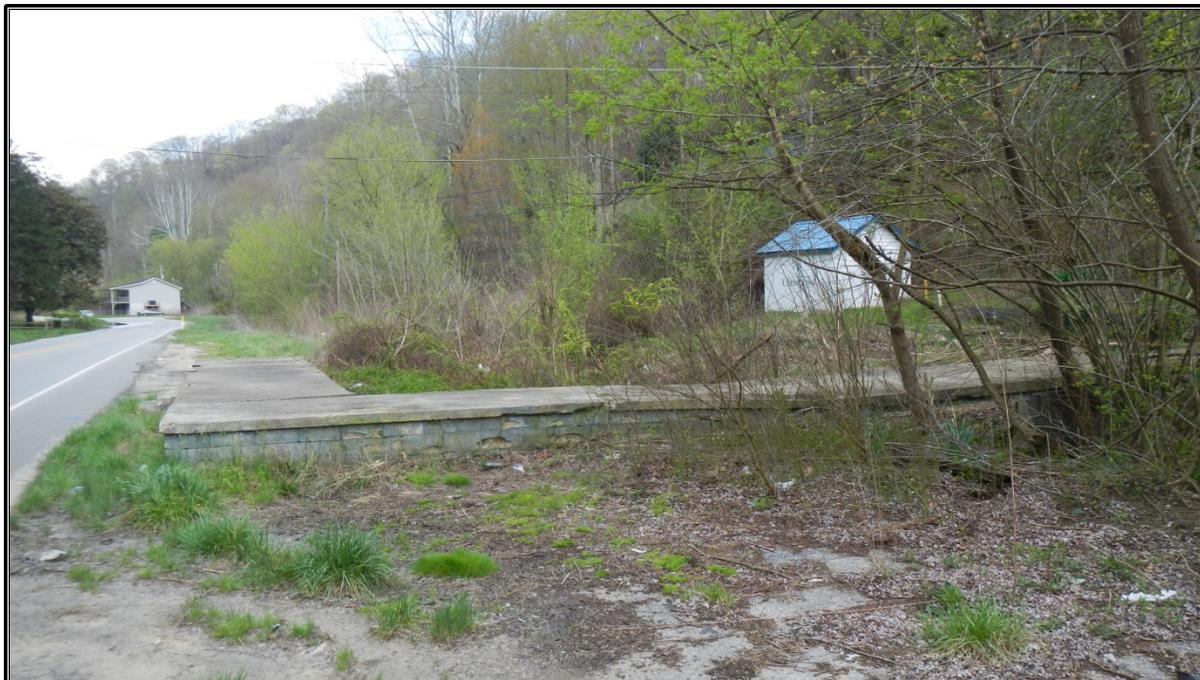
Lastly, numerous locations of former standing structures were present in the project area that had been demolished sometime previous to the fieldwork. This was particularly the case for the vacant lots located north of KY 40 at the east end of the project area. No evidence of the presence of the former structures was identified archaeologically except for cinder and, in one case, a concrete pad. Also at the east end, but south of KY 40, was the remains of a raised cinder block and concrete pad connected to a concrete bridge that spanned Buck Creek. Building debris in the form of roofing shingles and plywood fragments were present in this area, but nothing older than 50 years in age was noted in shovel tests or on the ground surface (Figure 10).

Figure 10. Remains of a raised cinder block and concrete walk-way spanning Buck Creek, facing east.

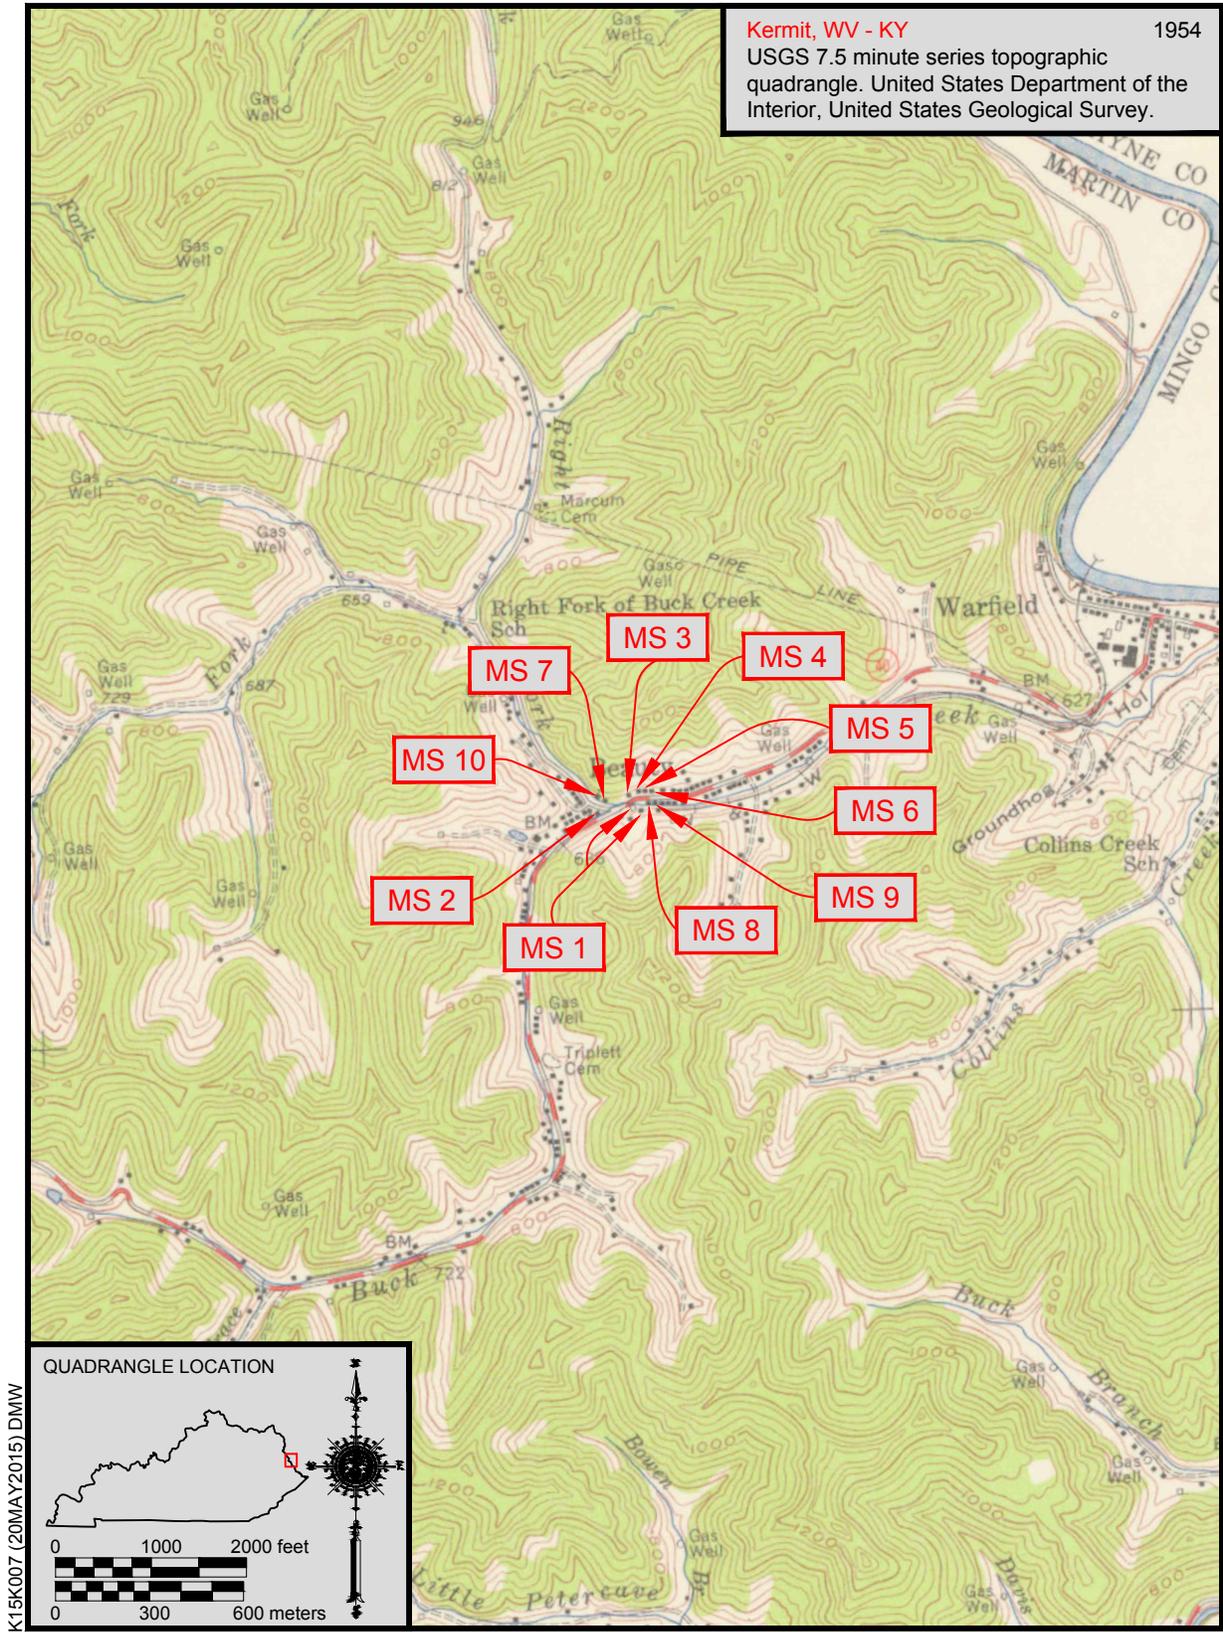
The 1954 Kermit, Kentucky–West Virginia 7.5-minute topographic quadrangle provides some clarification concerning the location of the various structures depicted on the 1952 highway map (Figure 12). Based on the geo-referencing of this map, it appears that approximately nine structures, including a single unoccupied structure south of KY 40, was present within the project area. This unoccupied structure appears to correlate to MS 1. MS 2 is still shown as well on the west end of the project area. In addition to these, seven more structures are evident. MS 3–MS 6 and MS 8–MS 10 are the locations of former structures that have since been demolished. As will be discussed below, MS 7 still exists.

Figure 12. Map structures on historic 7.5' topographic quadrangle.
