Phase I Archaeological Site Detection Survey in Support of a Proposed Bridge Replacement over Simpson Creek on KY 2885 (KYTC Item No. 5-1080)

Spencer County, Kentucky

November 2015

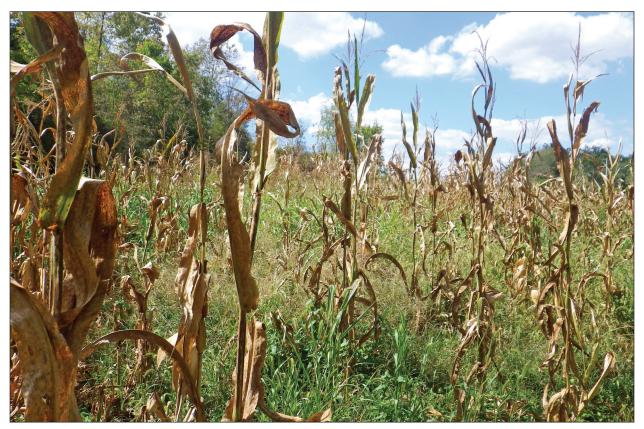
Figure 1.3 General Overview of agricultural field within APE, east side Simpson Creek and north of KY2885, facing south.

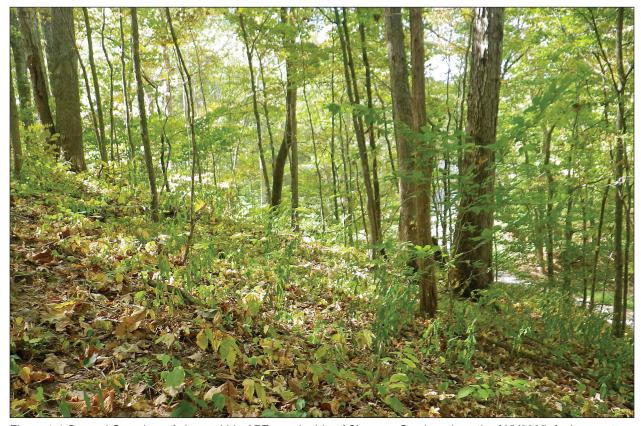
Figure 1.4 General Overview of slope within APE, south side of Simpson Creek and south of KY2885, facing west.

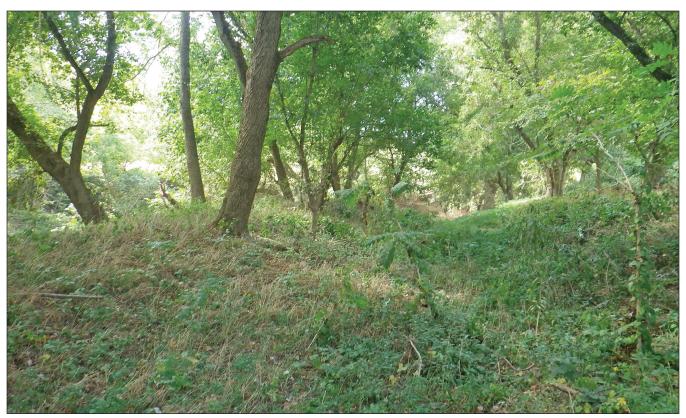
Figure 1.5 General Overview of APE along Simpson Creek, north side of Simpson Creek and west of KY2885, facing west.

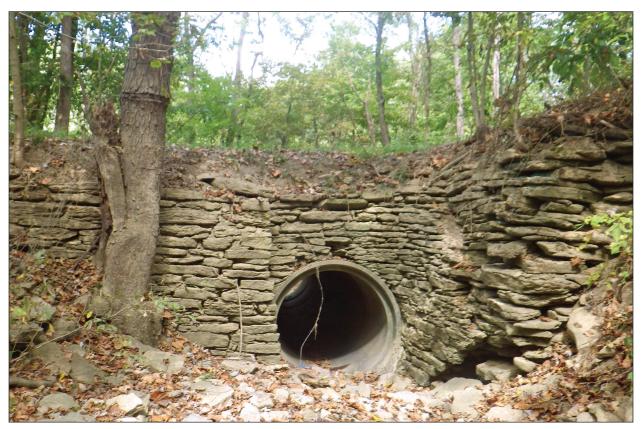
Figure 4.2 Stacked limestone retaining wall and culvert along KY2885, 40 meters west of its intersection with Netherton Lane.
