**Subject: Preconstruction Notification for Nationwide Permit 14 and Request for Individual Water Quality Certification
KY 32 (Brown Ridge Road) Major Widening
Elliott County, Kentucky
KYTC Item No.: 9-8802.00**

Project Purpose: The purpose of this project is to improve horizontal, vertical, and width deficiencies within a portion of KY 32 between approximate mile points 9.2 and 10.2.

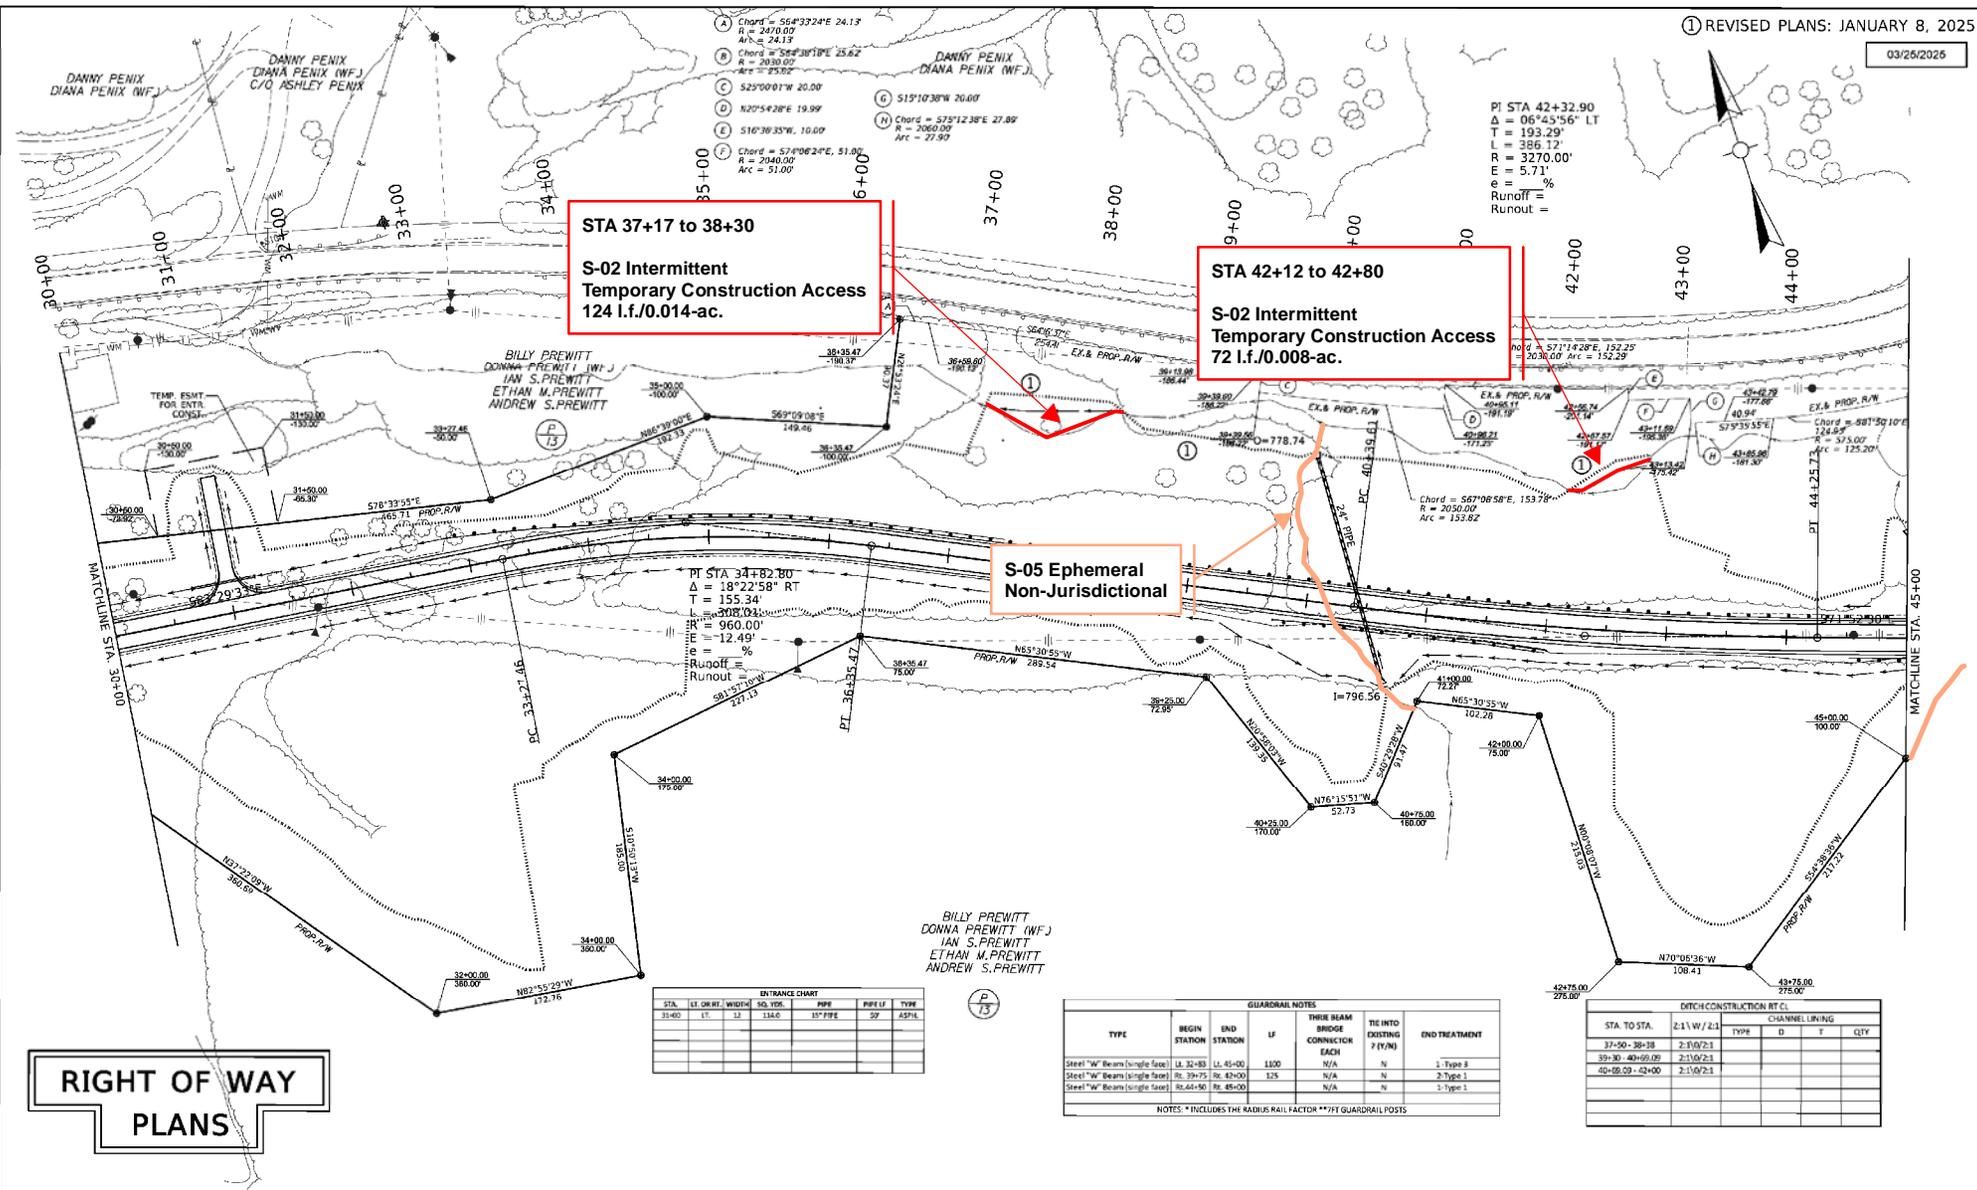
STA 37+17 to 38+30
S-02 Intermittent
Temporary Construction Access
124 l.f./0.014-ac.

STA 42+12 to 42+80
S-02 Intermittent
Temporary Construction Access
72 l.f./0.008-ac.

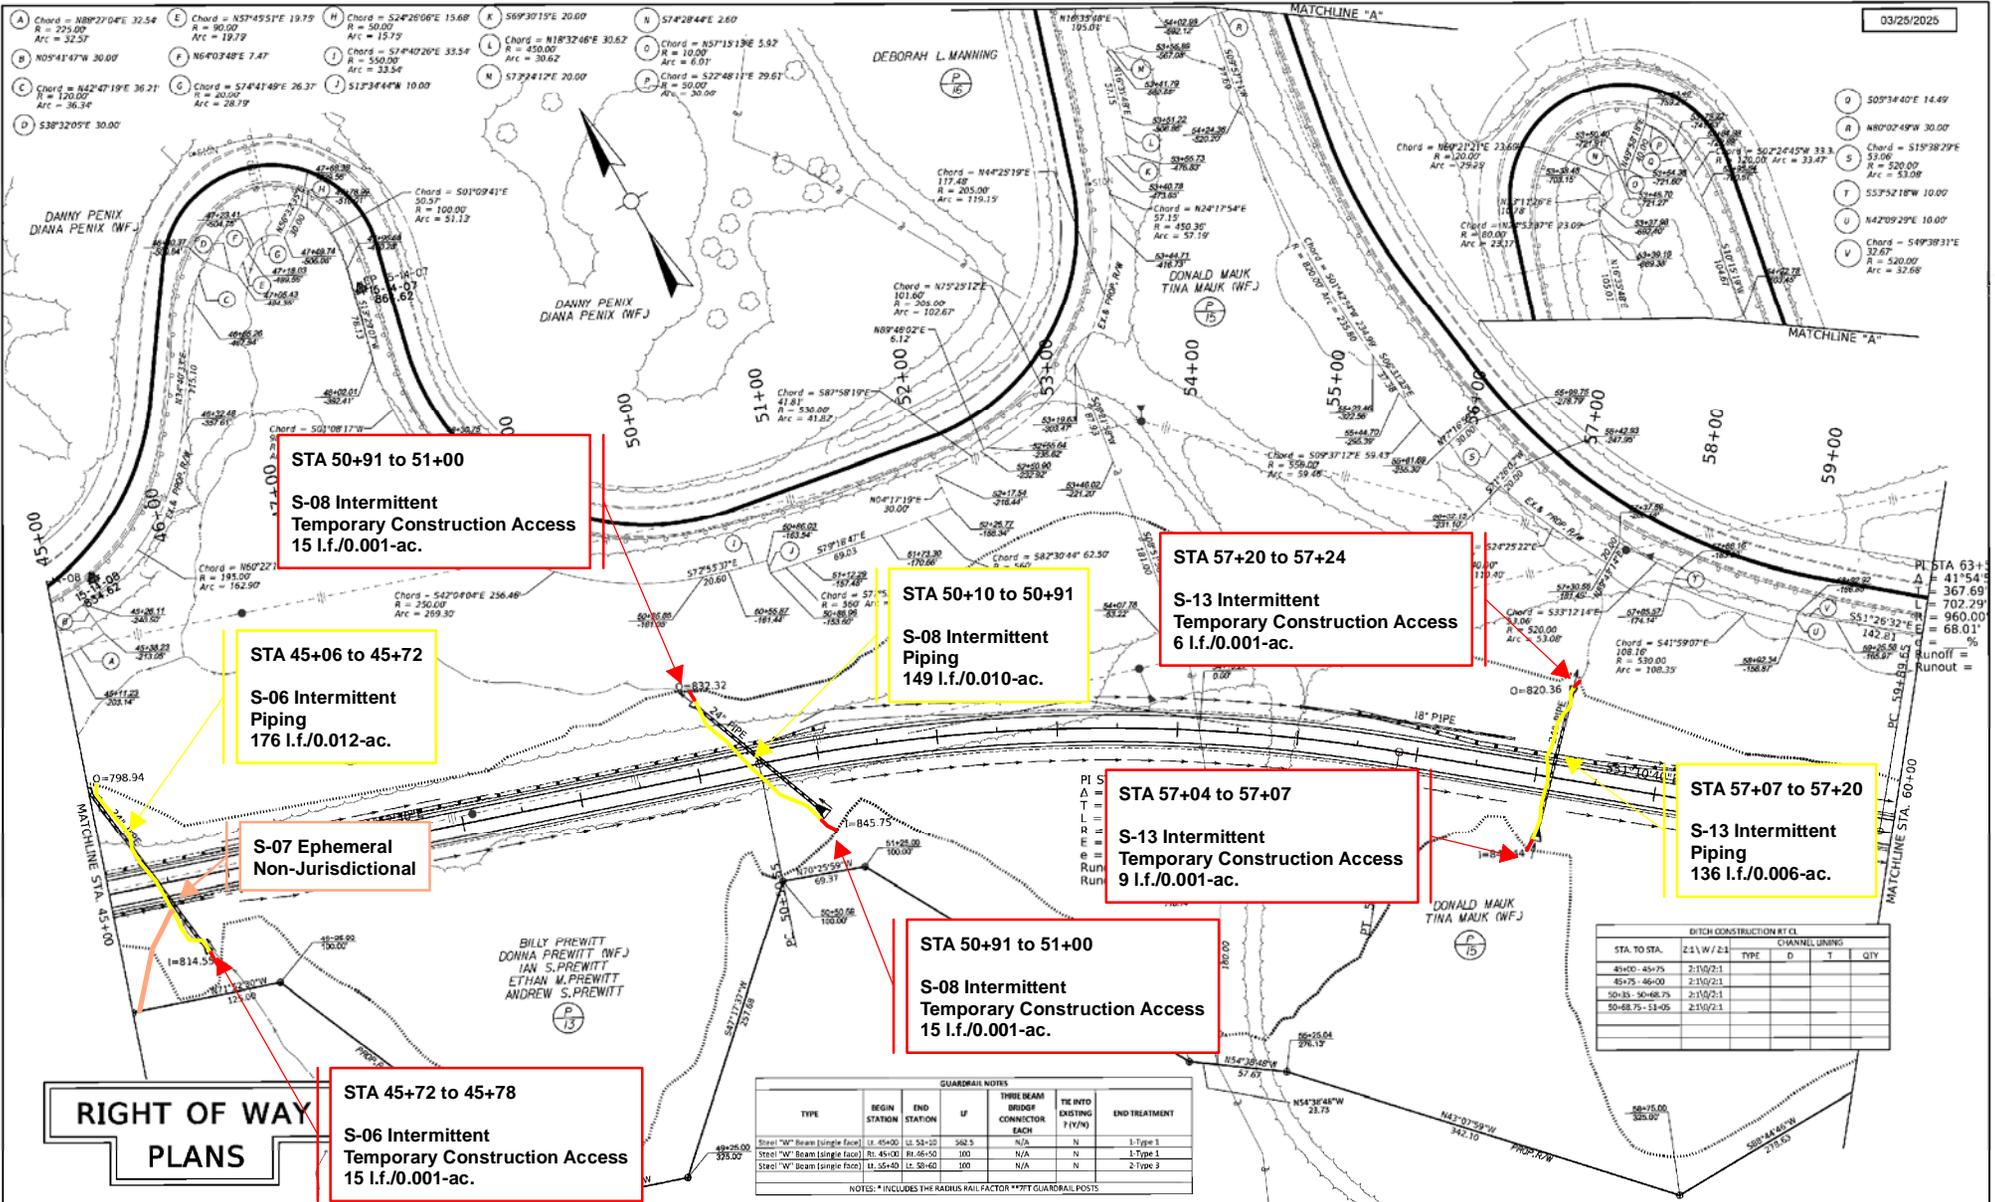
STA 50+91 to 51+00
S-08 Intermittent Temporary Construction Access
15 l.f./0.001-ac.

STA 45+06 to 45+72
S-06 Intermittent Piping
176 l.f./0.012-ac.

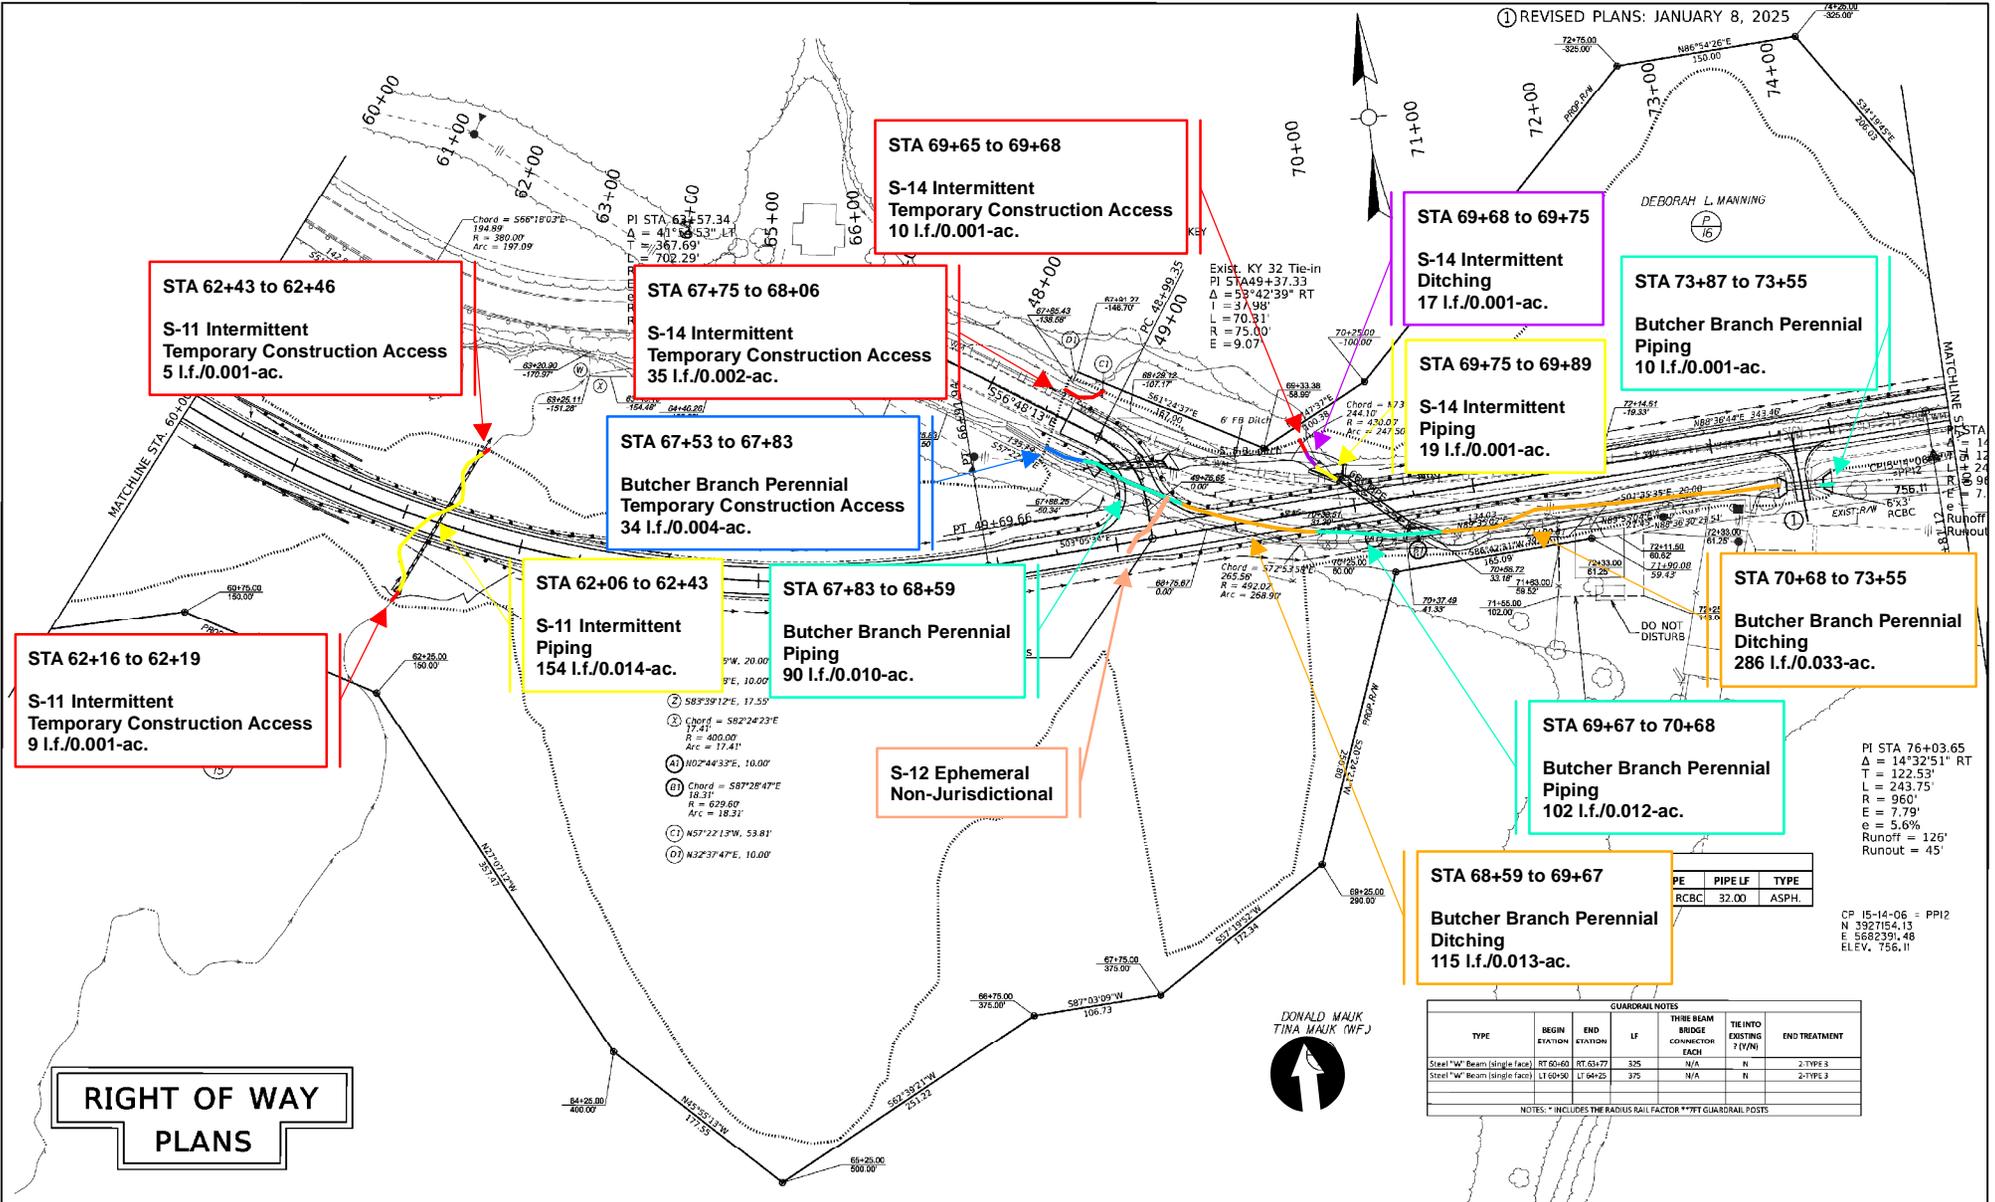
STA 62+43 to 62+46
S-11 Intermittent Temporary Construction Access
5 l.f./0.001-ac.

STA 67+75 to 68+06
S-14 Intermittent Temporary Construction Access
35 l.f./0.002-ac.

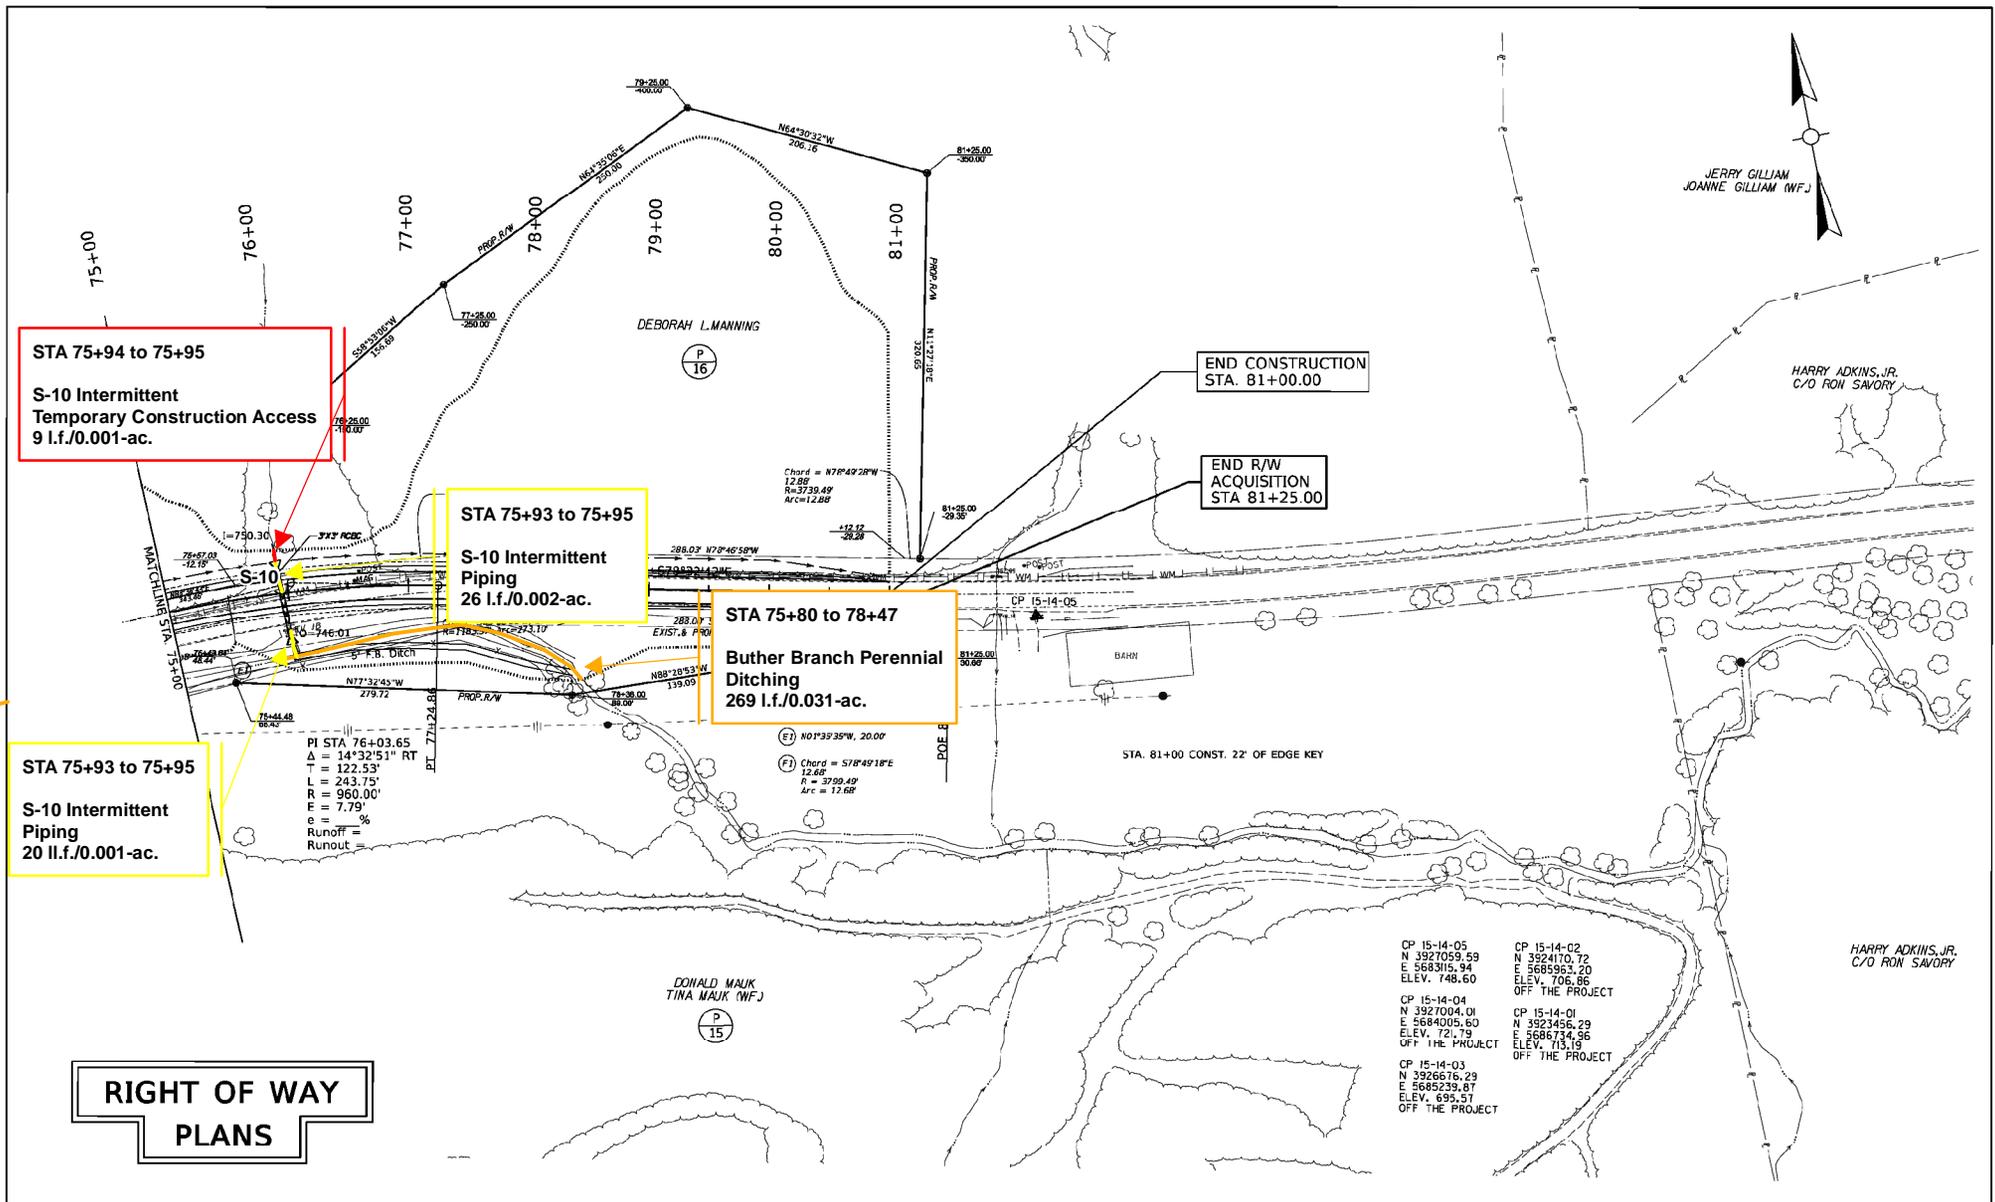
STA 75+94 to 75+95
S-10 Intermittent
Temporary Construction Access
9 l.f./0.001-ac.

STA 75+93 to 75+95
S-10 Intermittent
Piping
26 l.f./0.002-ac.

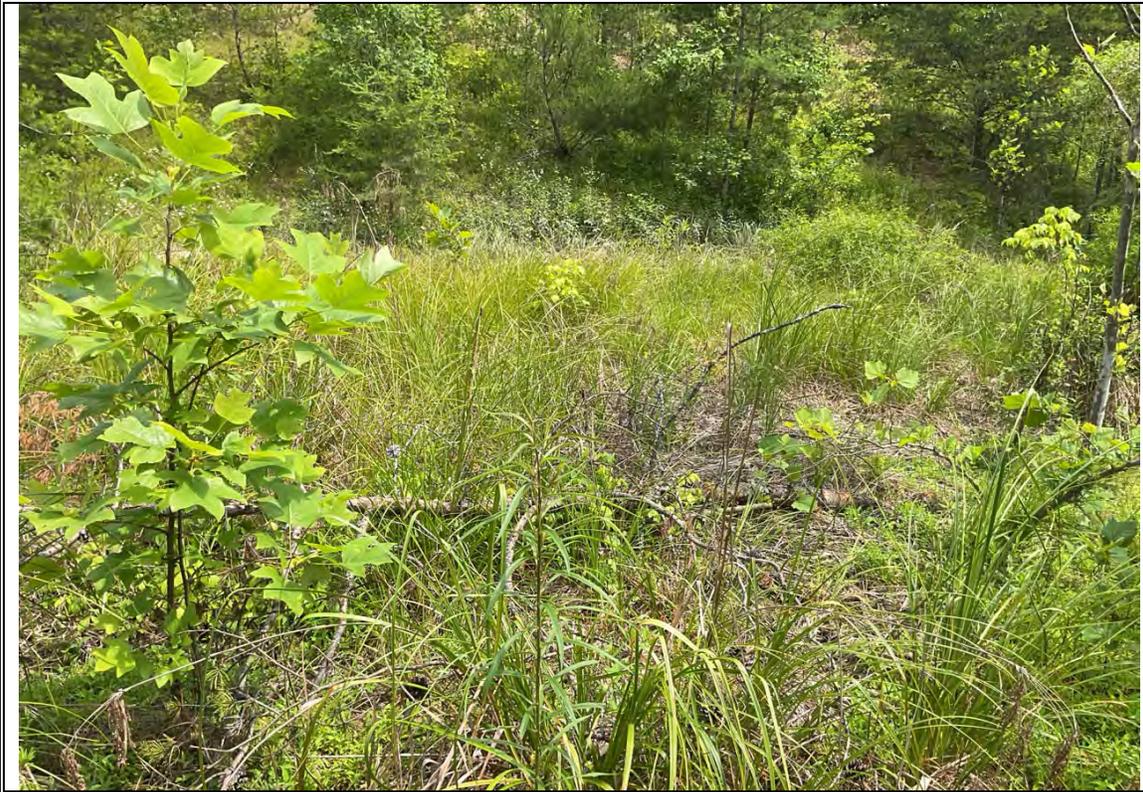
Photograph 1: Wetland 1 (W-1). June 12, 2025. Station 26+41 to 30+00, Sheet No. R3, PEM Wetland.

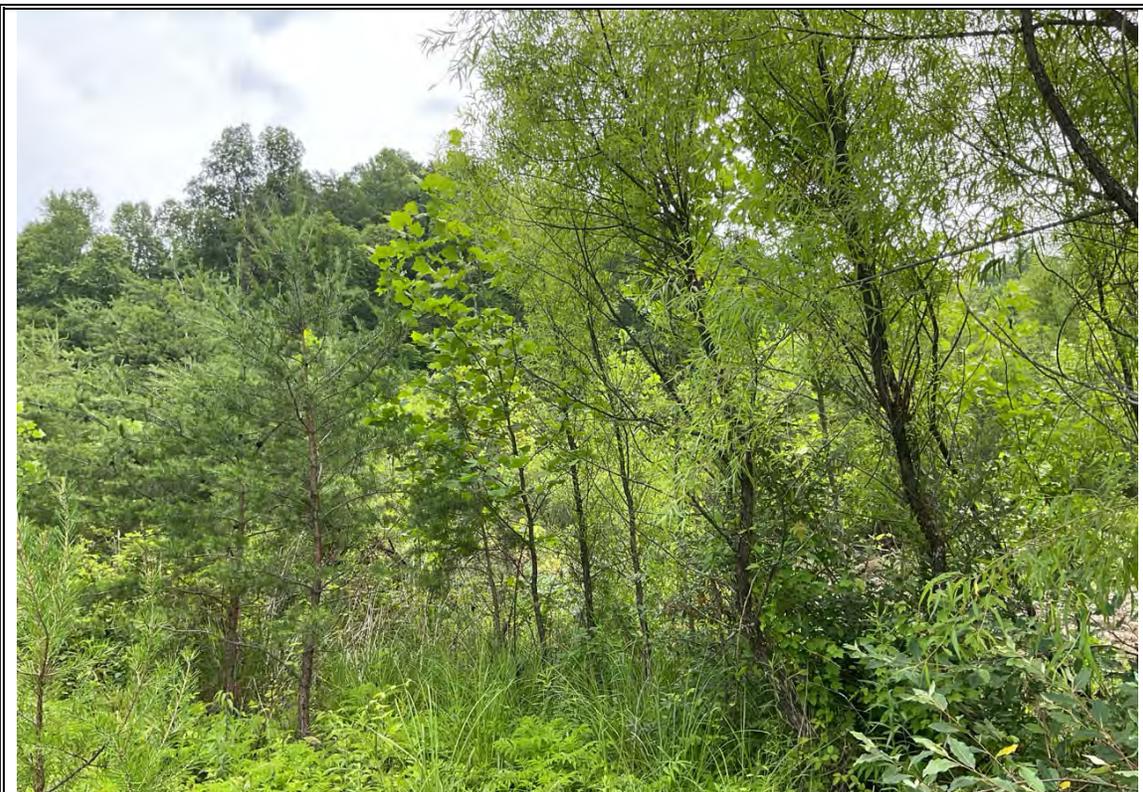
Photograph 2: Wetland 1 (W-1). June 12, 2025. Station 26+49 to 28+63, Sheet No. R3, PSS Wetland.

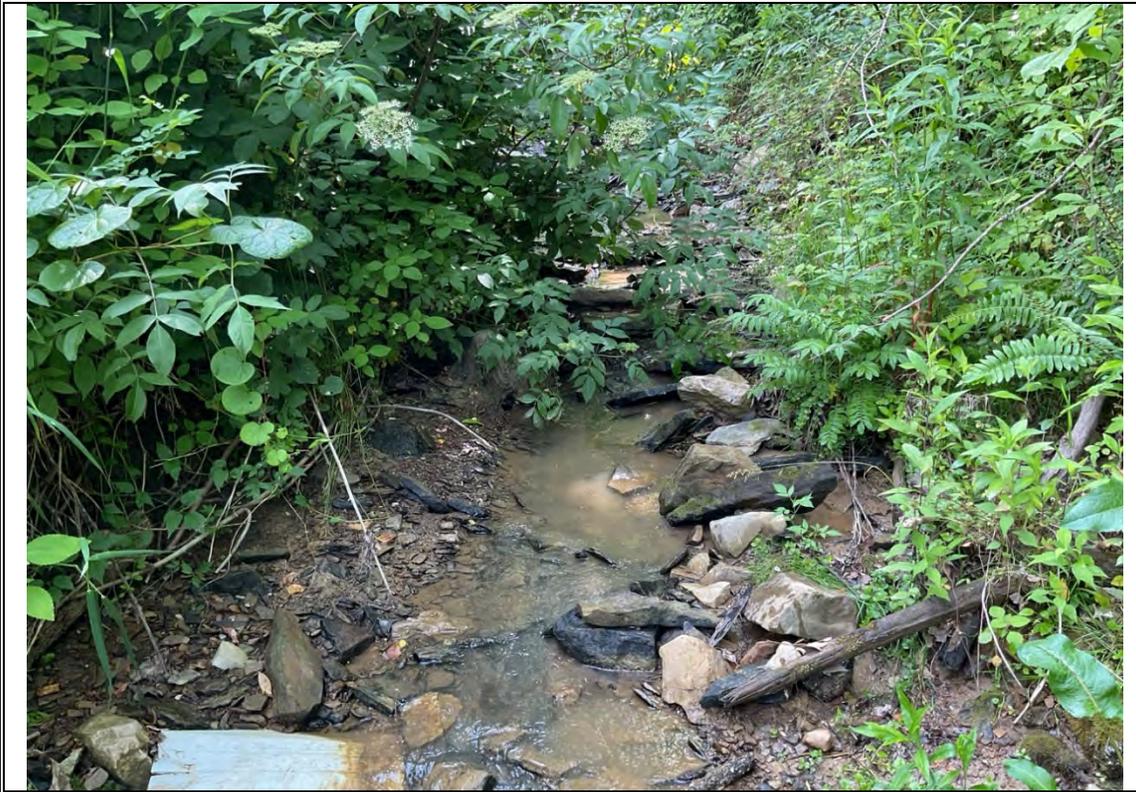
Photograph 3: Stream S-01 (Intermittent). June 12, 2025. Station 21+07 to 23+54, Sheet No. R3, 119 RBP score.

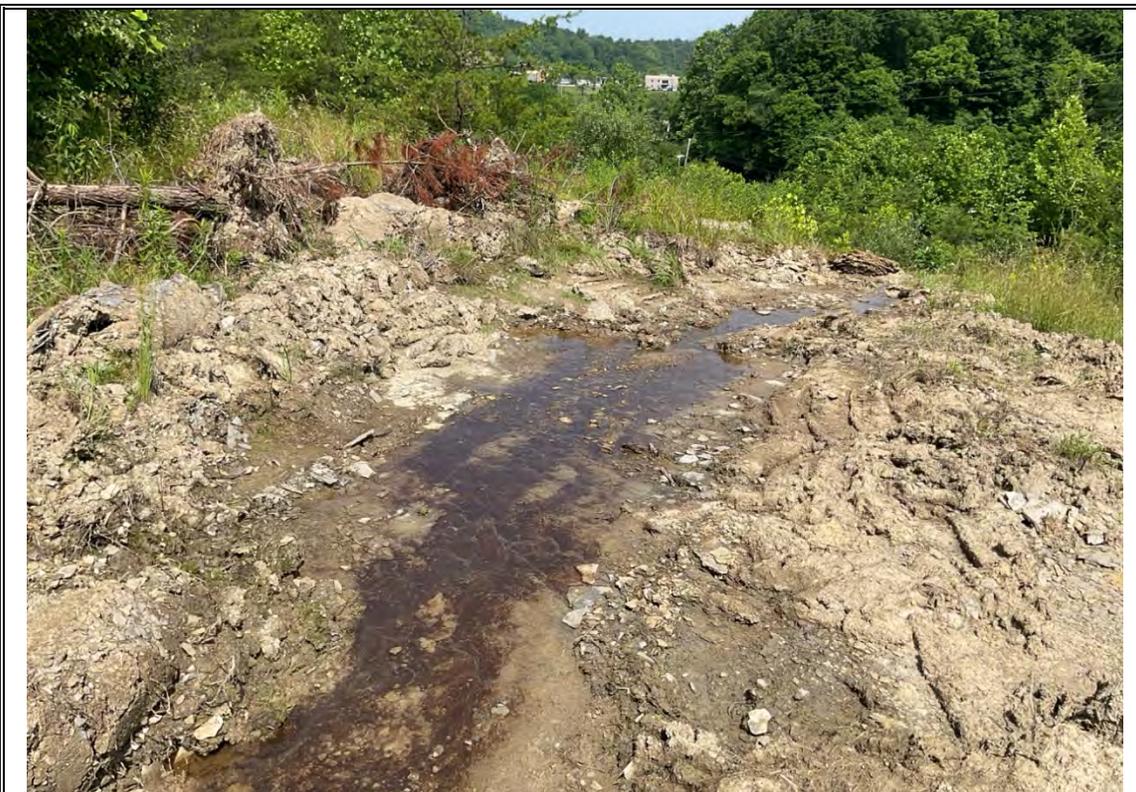
Photograph 4: Stream S-04 (Intermittent). June 12, 2025. Station 27+49 to 28+43, Sheet No. R3, 62 RBP score.

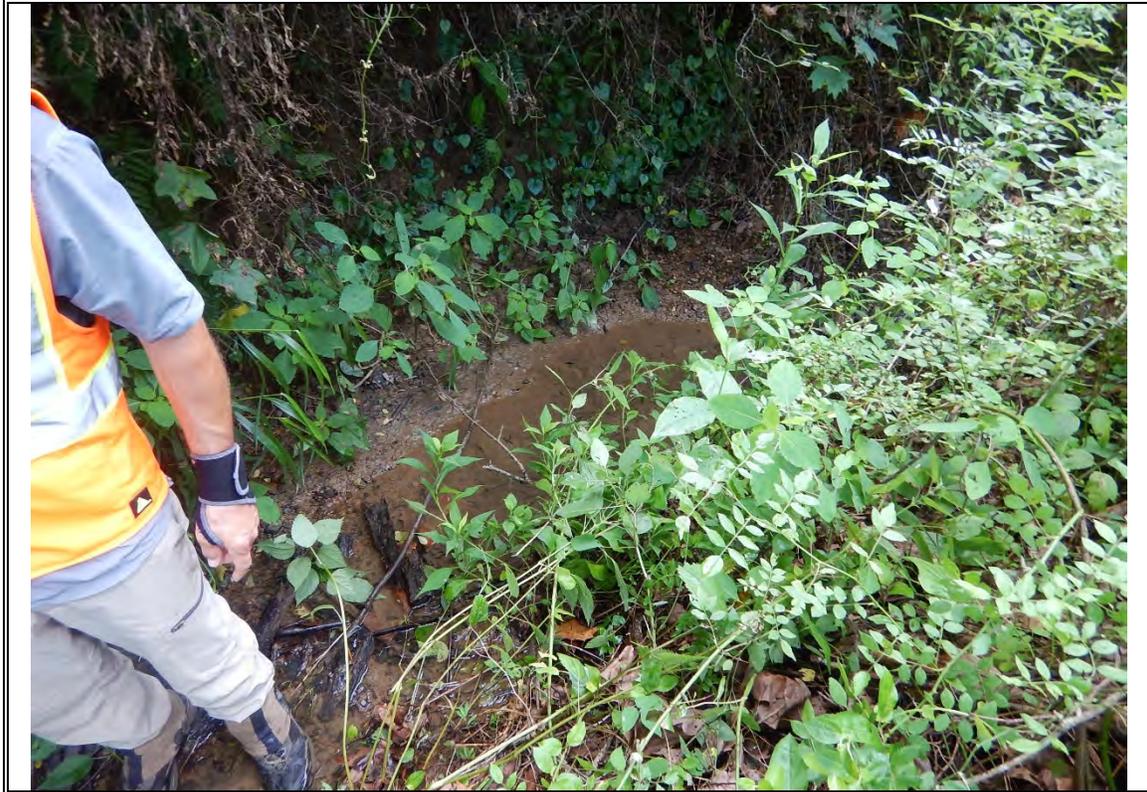
Photograph 5: Stream S-10 (Intermittent). July 3, 2025. Station 75+94 to 75+95, Sheet No. R11, 58 RBP score.

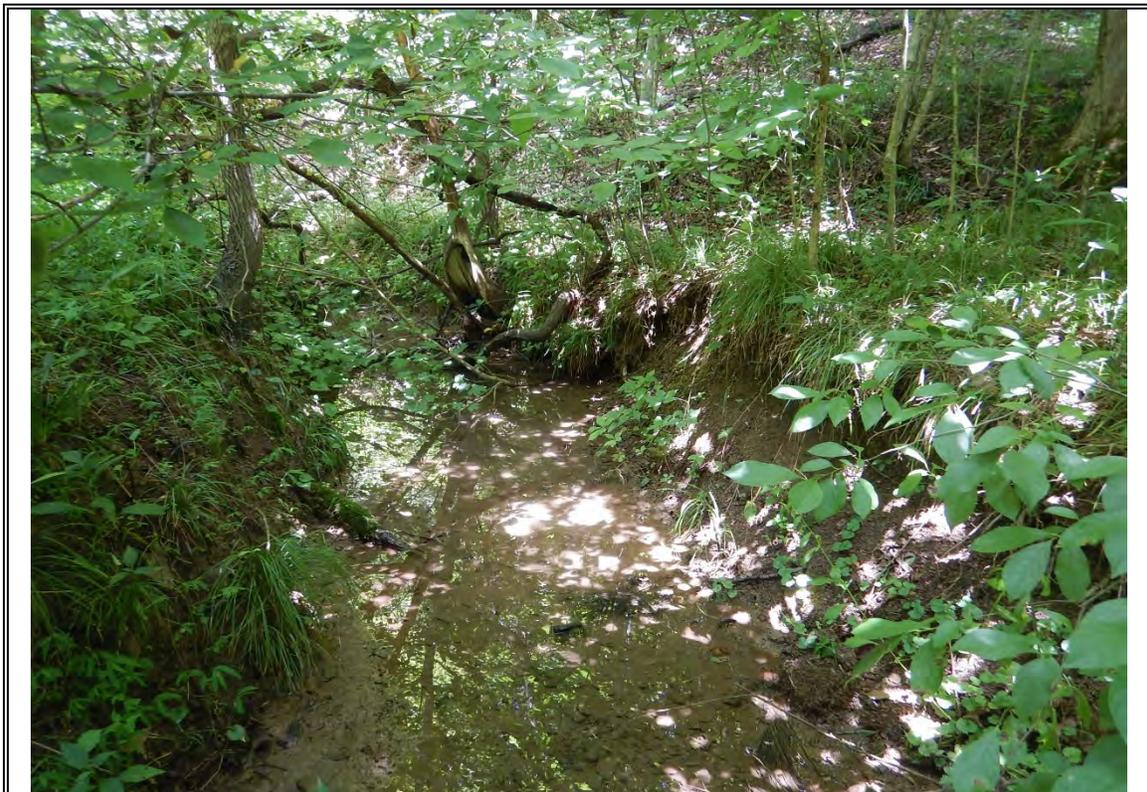
Photograph 6: Stream S-14 (Intermittent). July 3, 2025. Station 67+75 to 69+89, Sheet No. R9, 117 RBP score.

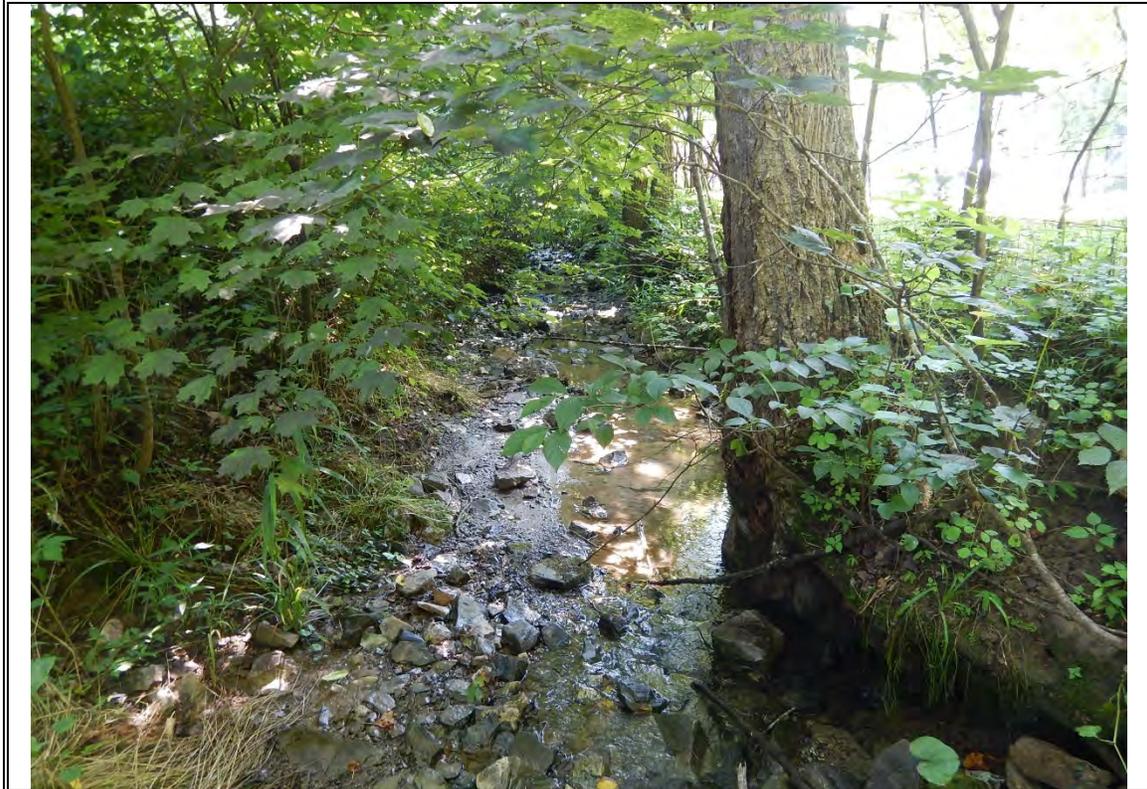
Photograph 7: Butcher Branch (Perennial). July 3, 2025. Station 67+53 to 78+47, Sheet No. R9/R11, 123 RBP score.

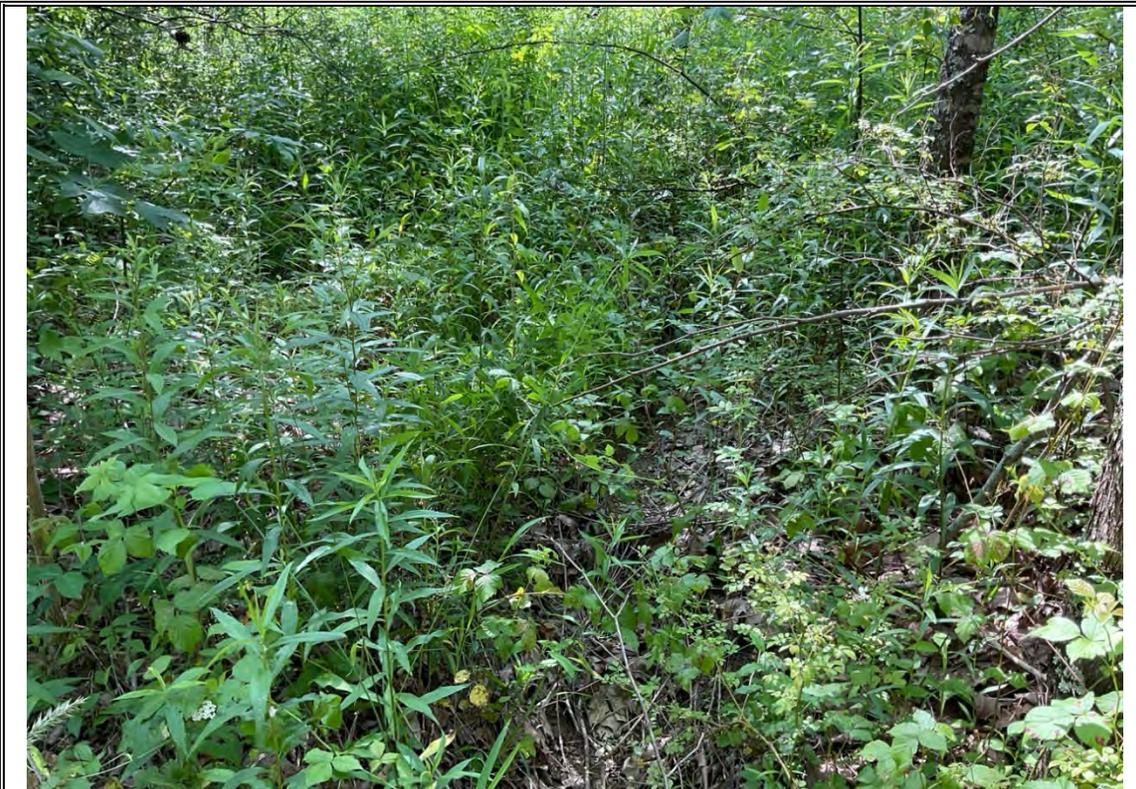
Photograph 4: Stream S-03e (Ephemeral). Stream S-03e does not contribute relatively permanent flow to stream waters and therefore it is not considered to be subject to USACE jurisdiction.

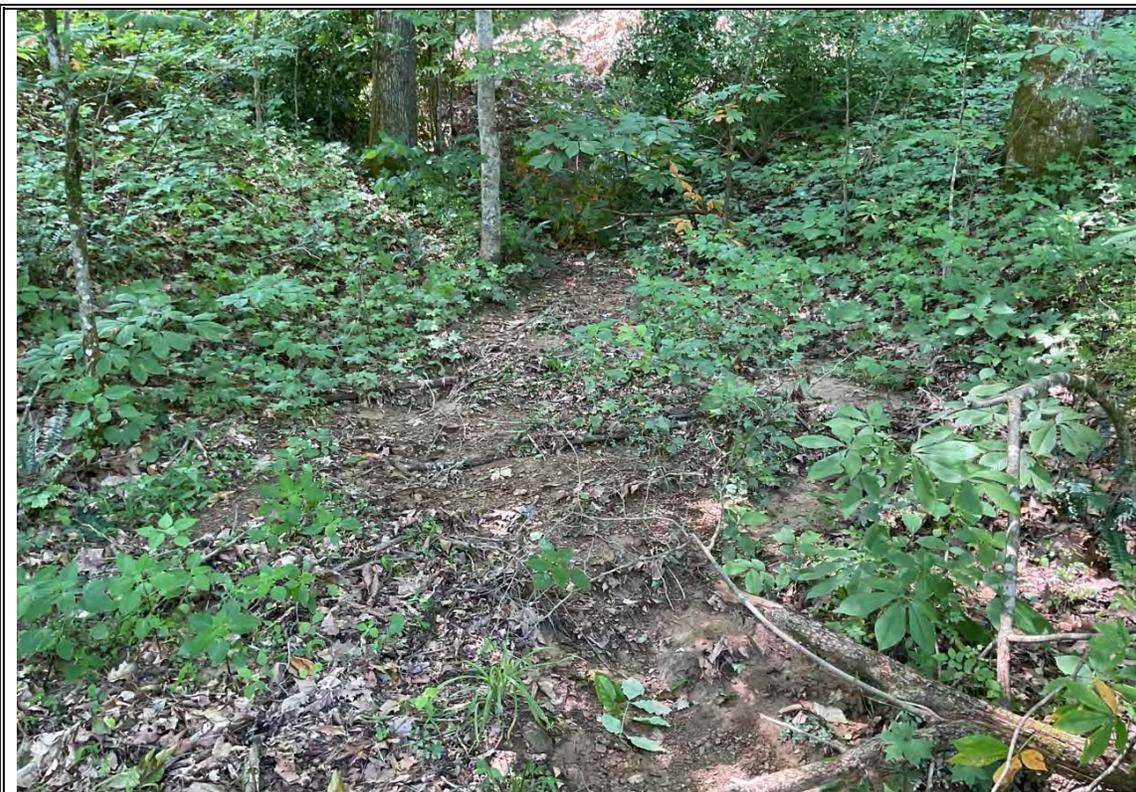
Photograph 6: Stream S-05e (Ephemeral). Stream S-05e does not contribute relatively permanent flow to stream waters and therefore it is not considered to be subject to USACE jurisdiction.

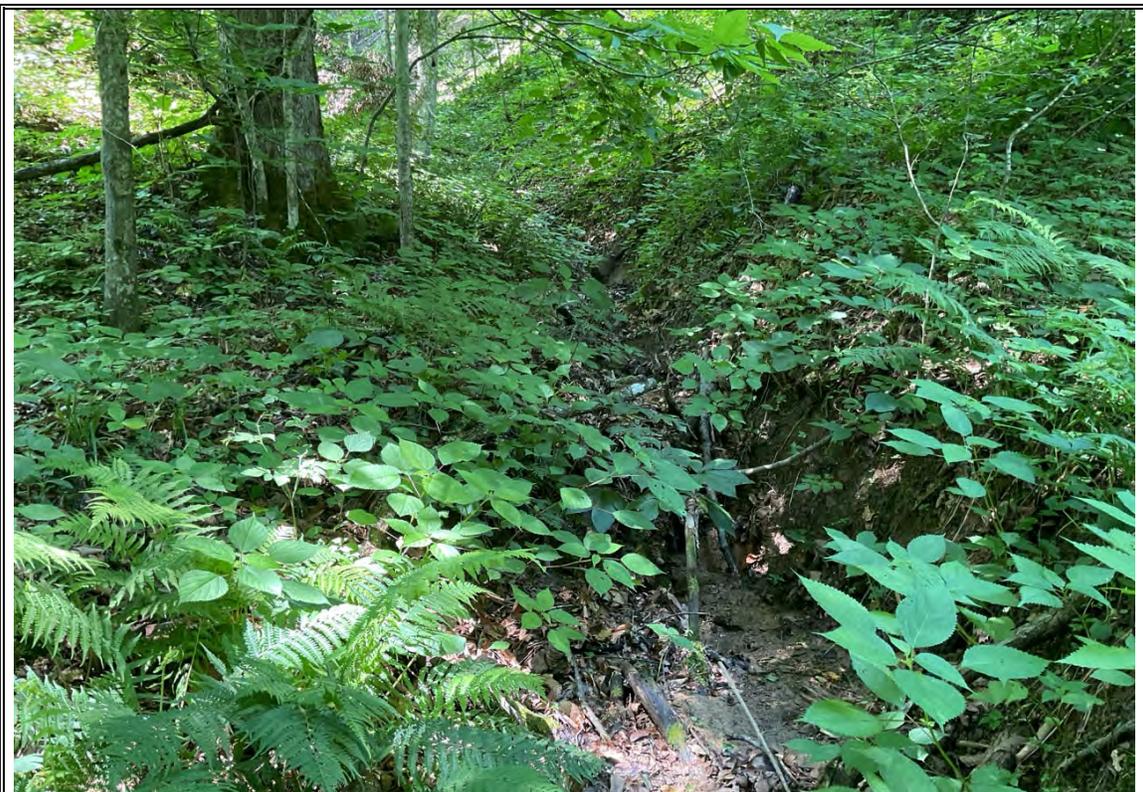
Photograph 8: Stream S-07e (Ephemeral). Stream S-07e does not contribute relatively permanent flow to stream waters and therefore it is not considered to be subject to USACE jurisdiction.

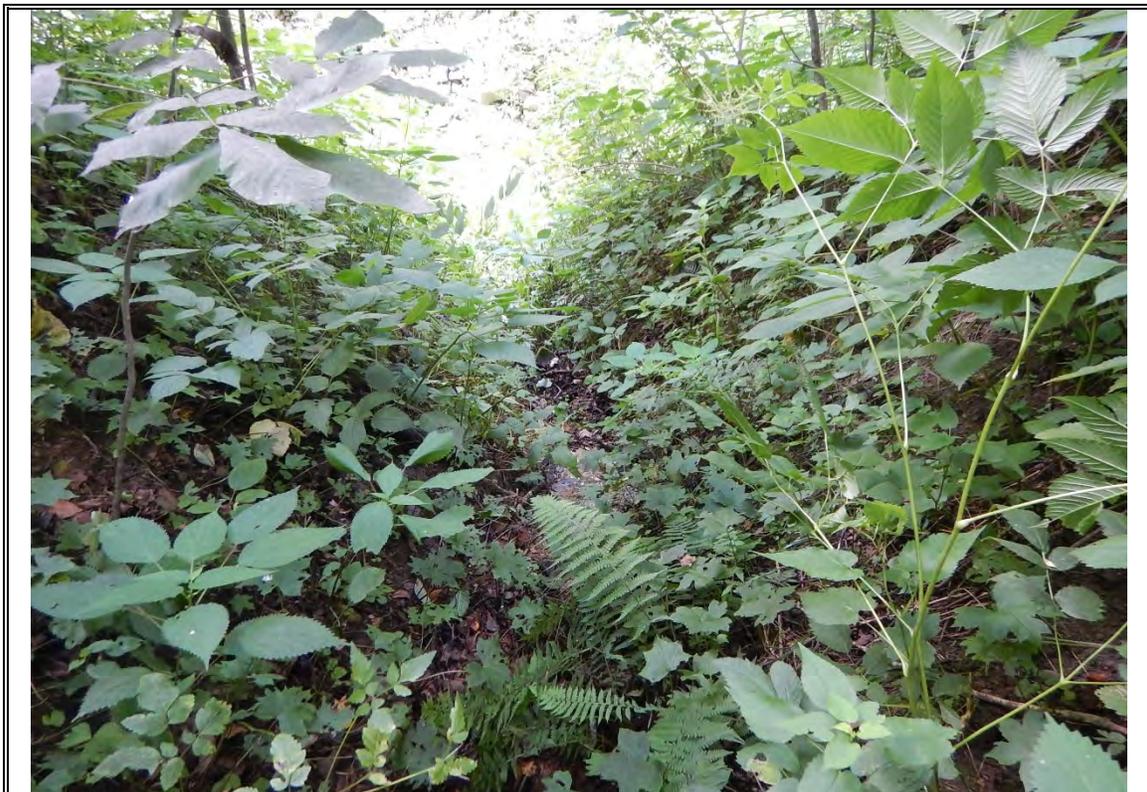
Photograph 12: Stream S-12e (Ephemeral). Stream S-12e does not contribute relatively permanent flow to stream waters and therefore it is not considered to be subject to USACE jurisdiction.
