Section 401/404 Permit Application

**Wendell H. Ford Airport Access Road
Perry County, Kentucky
KYTC Item No. 10-80100**

**Prepared for:
Kentucky Transportation Cabinet
Division of Environmental Analysis
and District 10**

**Prepared by:
Palmer Engineering**

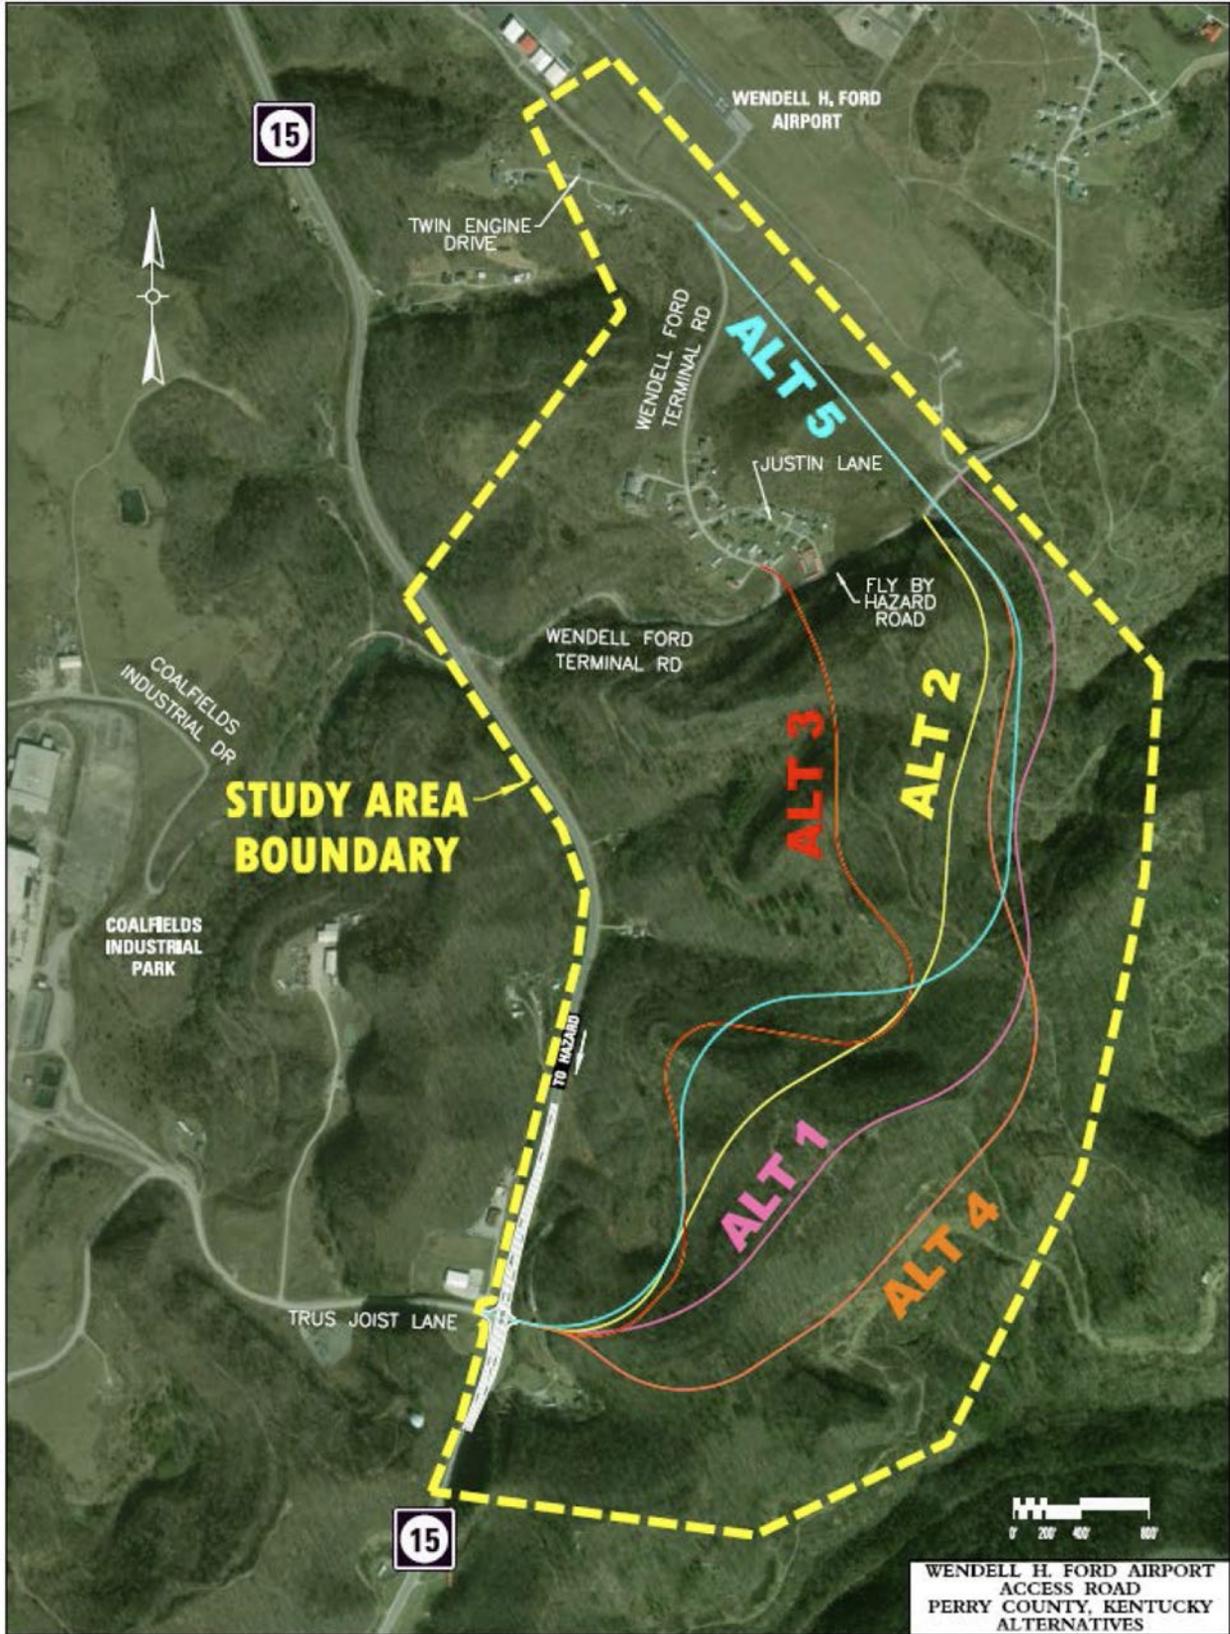
Figure 1: Study Area and Potential Alternatives.

Alternative 5 was developed using a design speed of 40 mph with a maximum grade of 5%. From the Trus Joist Lane intersection it traverses north easterly across an undeveloped forested mountainside. The alignment lies to the north of a residential development near the intersection with Fly By Hazard Road, and ties-in with Terminal Road just south of the airport taxiway and east of Twin Engine Road (Figure 1).

The Wendell H. Ford Airport Access Road Scoping Study, Perry County, Kentucky (November 2018) evaluated five alternatives and a no-build to provide a new connection between KY 15 and the airport. The five alternatives (Figure 1) were distinguished by color: green (ALT 1), yellow (ALT 2), red (ALT 3), orange (ALT 4), and blue (ALT 5). All build alternatives addressed the geometric deficiencies along the access road, using a 35-40 mph design speed, with a maximum 10% grade, and 11-foot lanes with 4-foot shoulders. Alternatives 1, 2, and 3 all terminate at Fly By Hazard Road near a subdivision development along Terminal Road. Alternative 4 intersects with Fly By Hazard Road further to the east and continues northward to tie-in with Terminal Road just west of the airport, avoiding the subdivision. Alternatives 1 and 2 were dismissed due to their similarities with other alternatives. Alternative 5 was later developed with maximum 5% grades and a 40 mph design speed. Its alignment crosses between Alternatives 3 and 4 and is coincidental with Alternative 4 between Fly By Hazard Road and its terminus with Terminal Road near the airport. The scoping study recommended that Alternative 5 be advanced for further study and preliminary engineering as the Preferred Alternative.

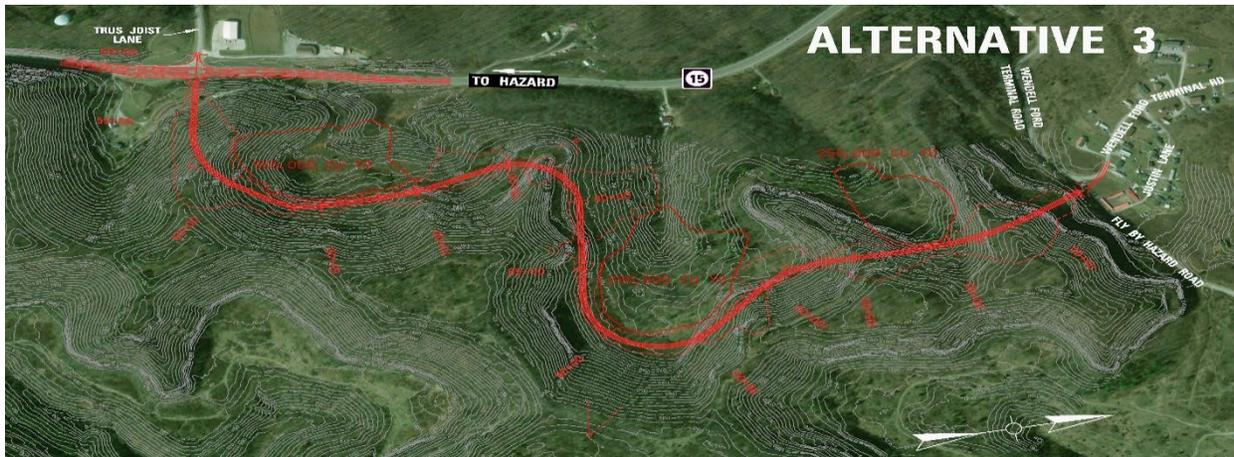
Figure 2: Alternative 3.

Alternative 3 is 1.22 miles long and was developed using a 35 mph design speed (Figure 2). It has maximum grades of 10% for 820 feet of the alignment. It would require more than 1.7 million cubic yards of excavation and generate more than 1.4 million cubic yards of excess material. Three excess material sites would be required, which would result in additional environmental impacts to WOTUS and forested habitat. By terminating at the Terminal Road and Fly By Hazard Road intersection, traffic would continue to pass through the residential development south of the airport. Though no relocations in the neighborhood are required, the continued routing of traffic through this area does not meet the objective of “avoiding impacts to existing housing developments” as suitably as other alternatives.

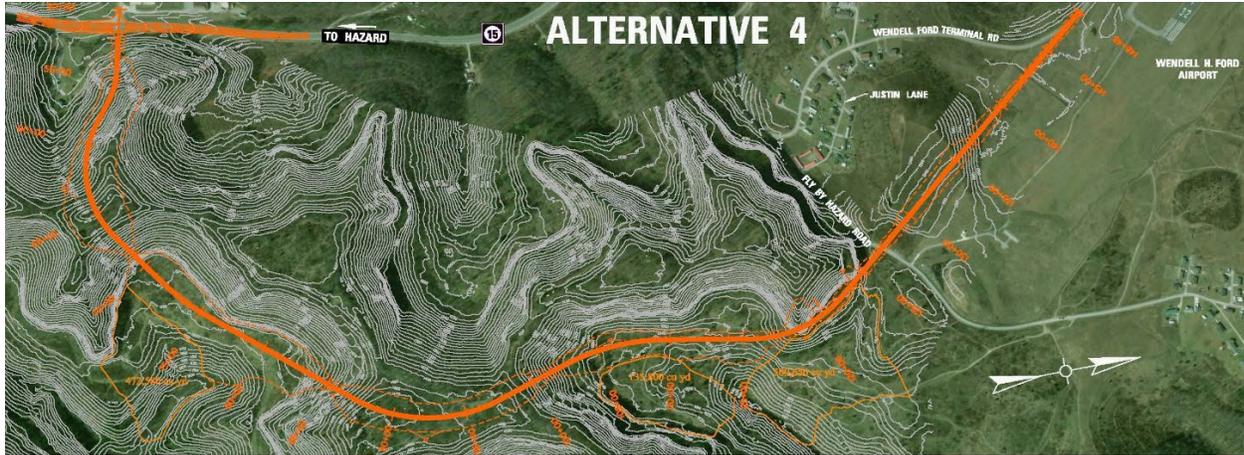
Figure 3: Alternative 4.

Alternative 4 is 1.85 miles long and was also developed using a 35 mph design speed (Figure 3). It has a series of 10% grades stretching across the first mile of the alignment nearest KY 15. The alignment lies to the north of the residential development near the Fly By Hazard Road intersection and ties-in with Terminal Road just south of the airport taxiway and east of Twin Engine Road. Construction would require more than 2.1 million cubic yards of excavation and generate over 1.1 million cubic yards of excess material. Three excess material sites would be required, which would result in additional environmental impacts to streams and forested habitat, and mitigation costs to construct this alternative.

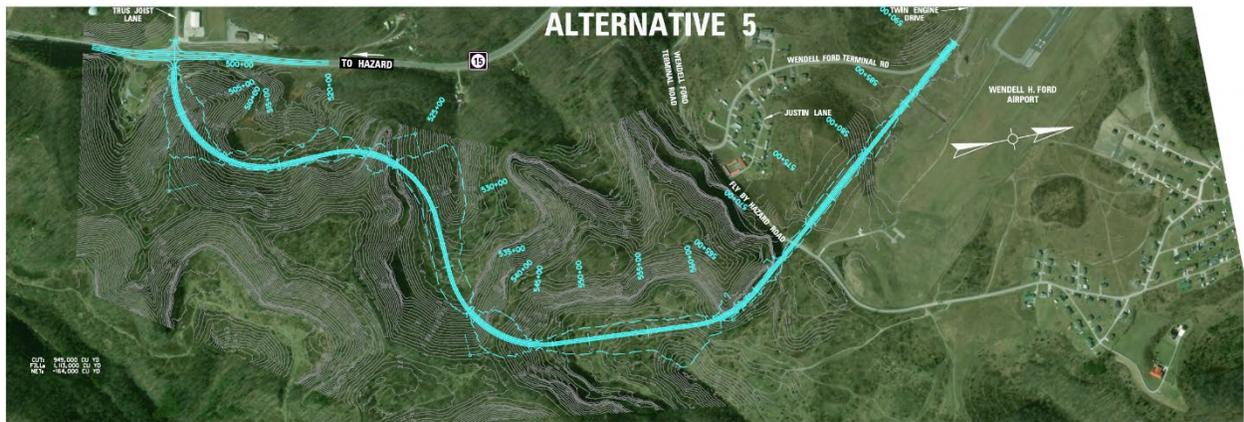
Figure 4: Alternative 5.

Alternative 5 is 1.74 miles long and was developed using a design speed of 40 mph with a maximum grade of 5% (Figure 4). Like Alternative 4, the alignment lies to the north of the residential development near the Fly By Hazard intersection, and ties-in with Terminal Road just south of the airport taxiway and east of Twin Engine Road. Earthwork is much more balanced than the other alternatives. Construction would require approximately 1 million cubic yards of excavation and 1.1 million cubic yards of fill. Given the uncertainty of accurately predicting swell, this alternative is considered balanced.

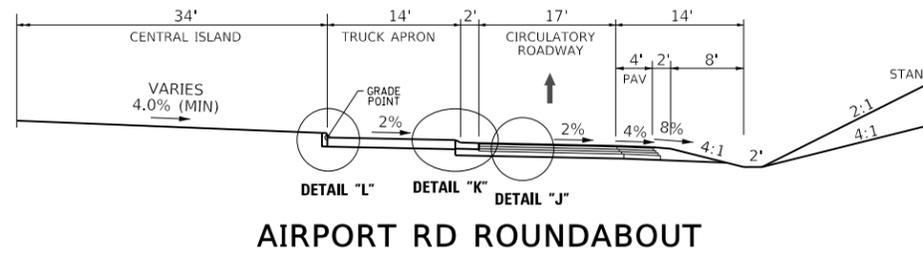
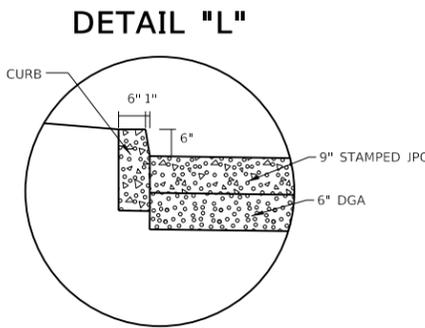
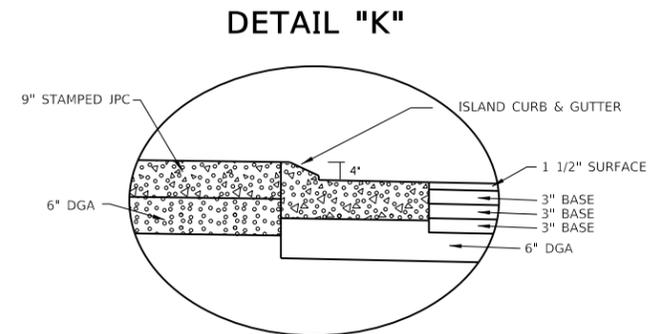
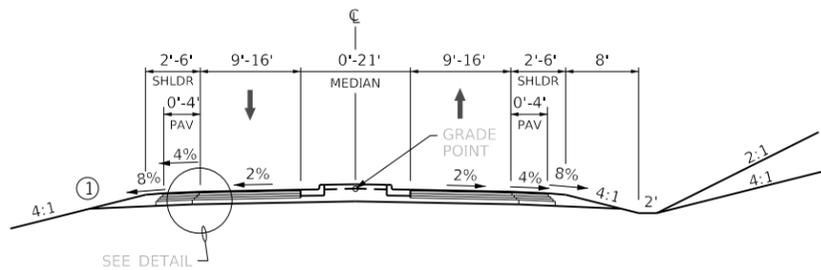
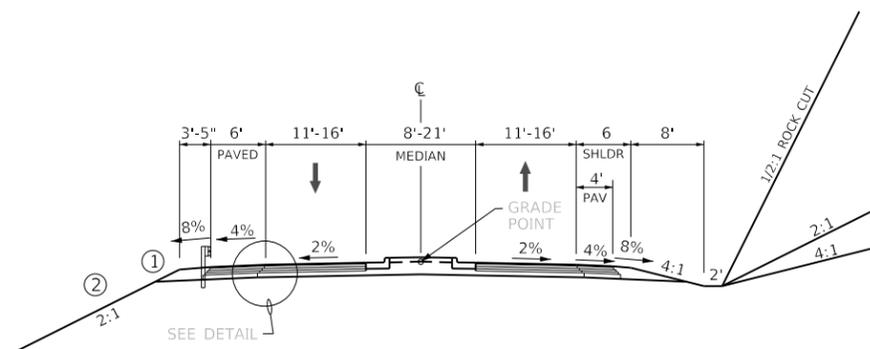
- ① SEE CROSS SECTIONS FOR SLOPES OUTSIDE THE LIMITS OF THE SHOULDERS.
- ④ TREAT CEMENT STABILIZED ROADWAY WITH 2.0 LBS/ SQ YD. OF ASPHALT CURING SEAL AND 5.0 LBS/ SQ YD. OF SAND FOR BLOTTER.

- ① ASPHALT SEAL FOR SHOULDERS FROM OUTSIDE EDGE OF PAVEMENT TO A POINT 2 FEET DOWN THE DITCH OR FILL SLOPE.
- ② SEE CROSS SECTIONS FOR SLOPES OUTSIDE THE LIMITS OF THE SHOULDERS.

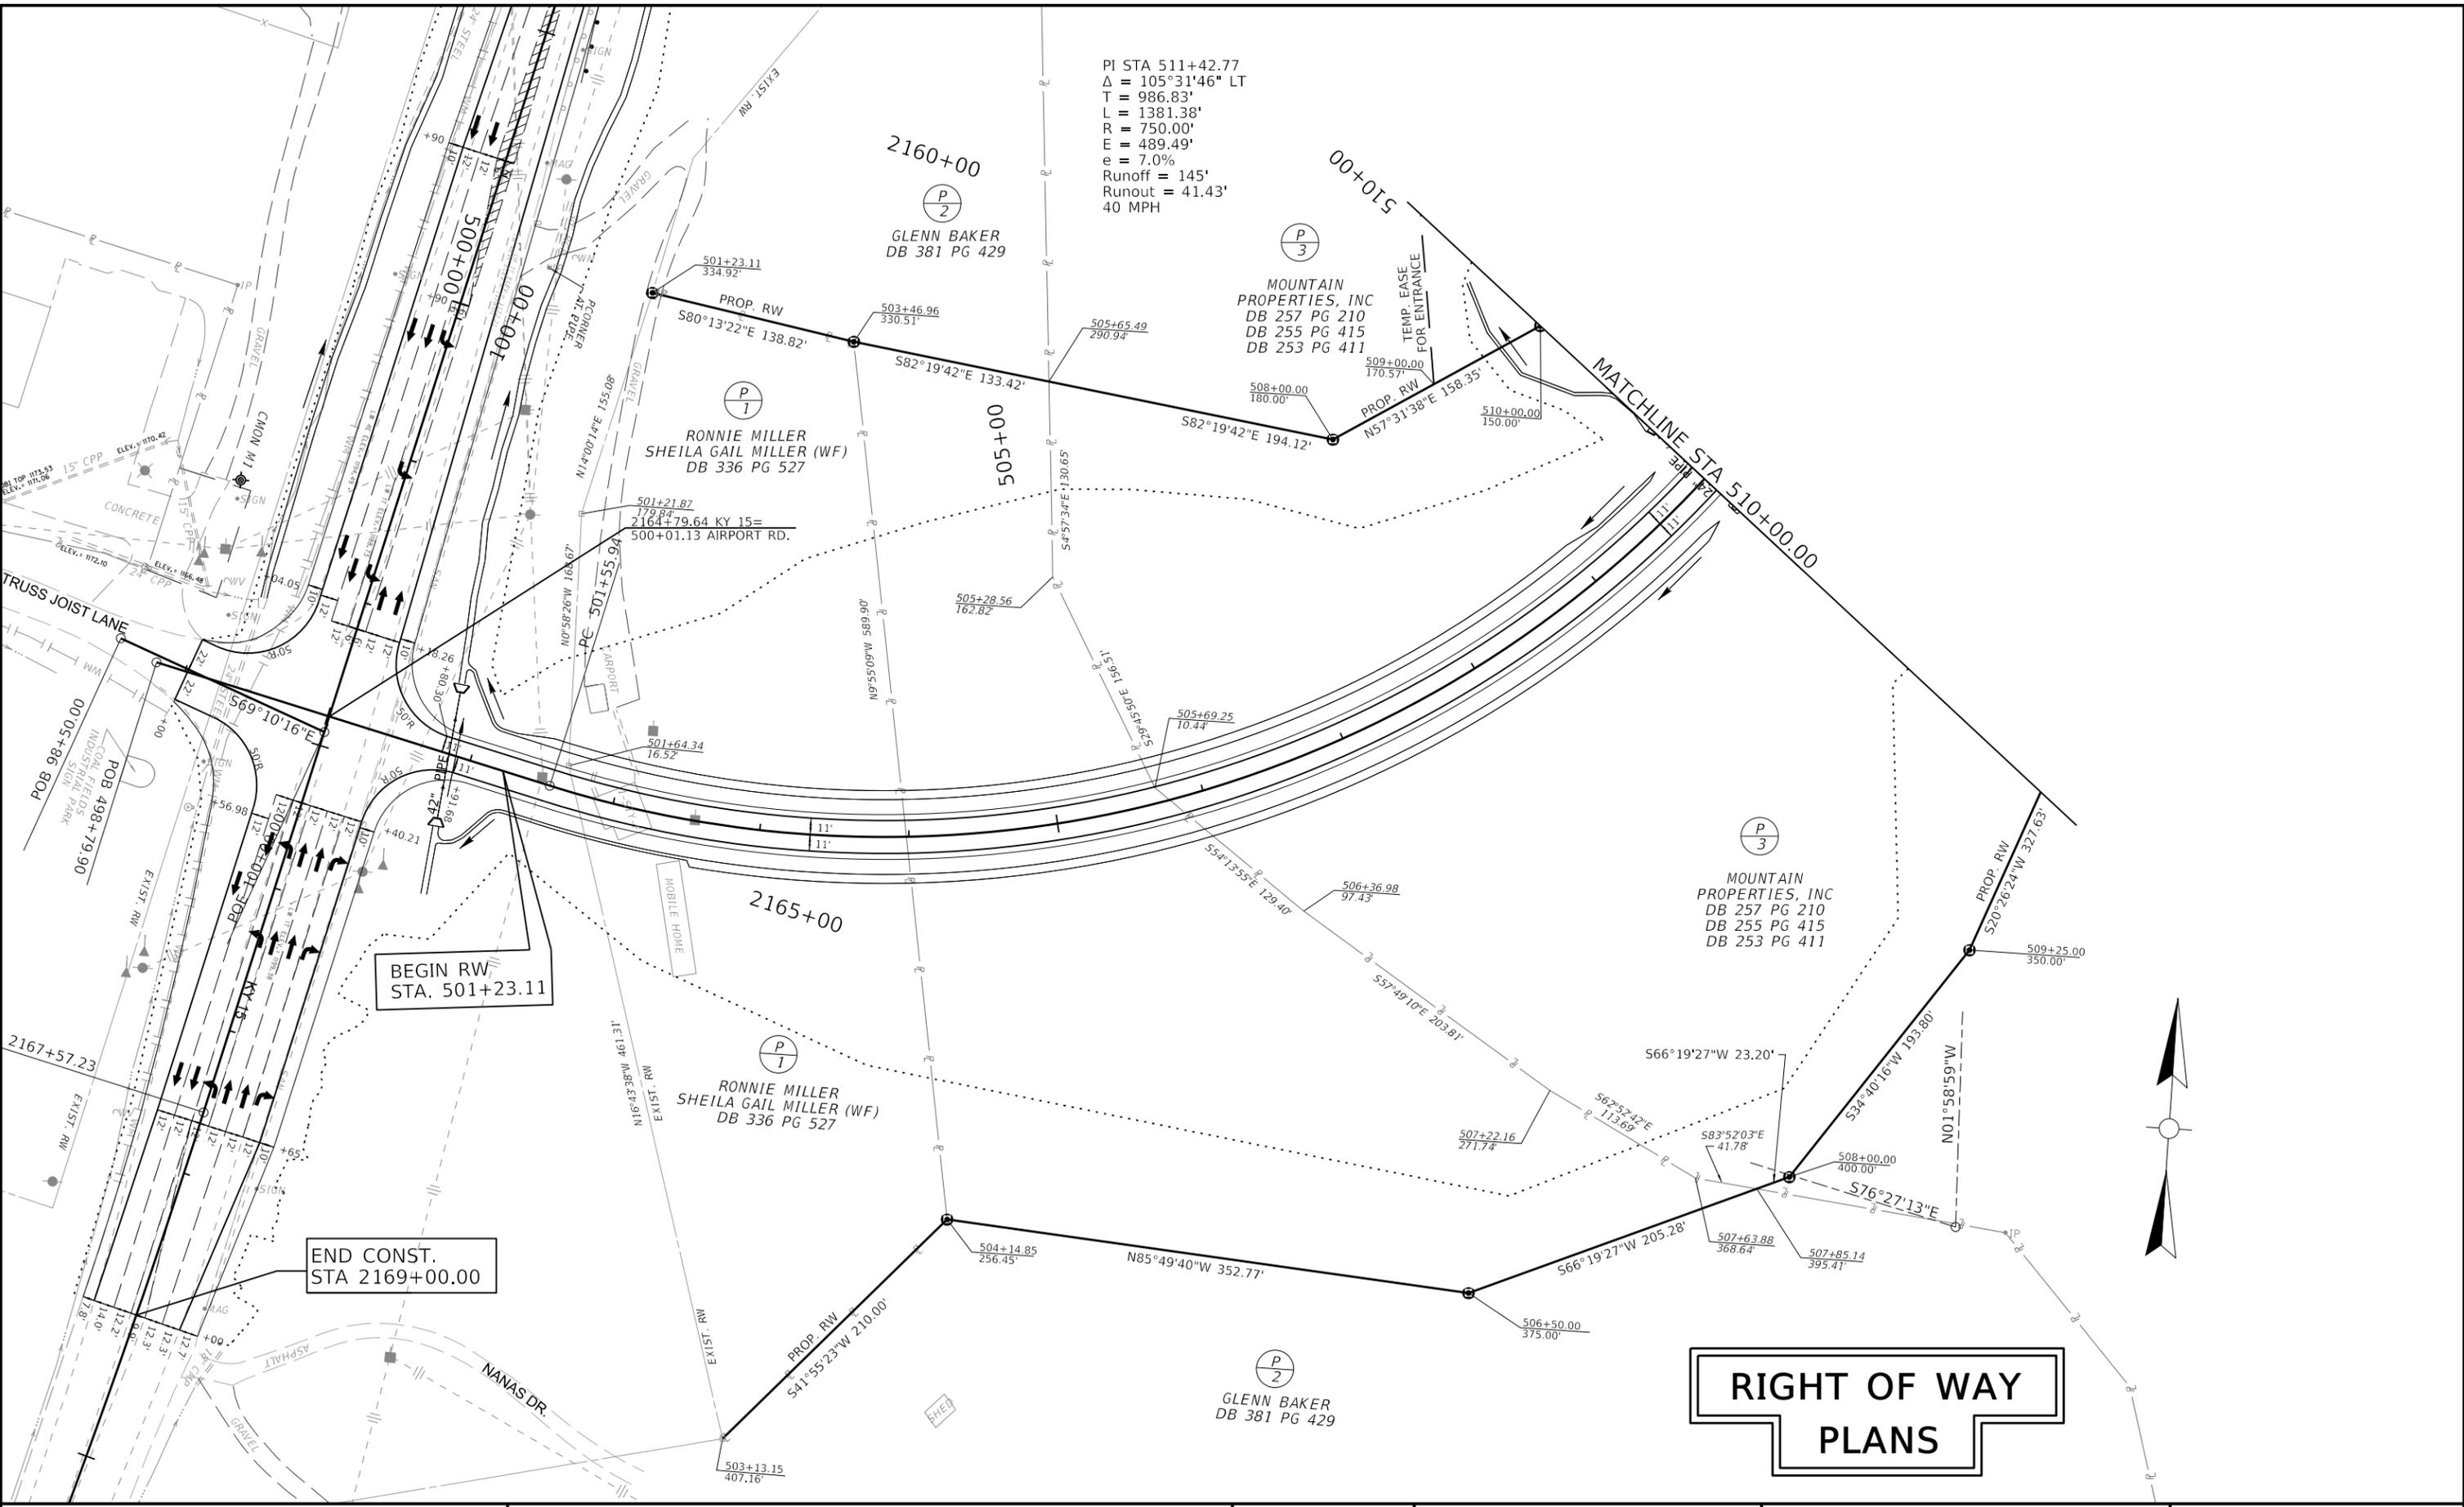
ITEM NO. 10-80100.00 COUNTY OF PERRY
 SHEET NO. R4

PI STA 511+42.77
 $\Delta = 105^\circ 31' 46''$ LT
 $T = 986.83'$
 $L = 1381.38'$
 $R = 750.00'$
 $E = 489.49'$
 $e = 7.0\%$
 Runoff = 145'
 Runout = 41.43'
 40 MPH

STA 498+79.90 TO STA 510+00
