Broadway Street Bridge over Kentucky River

Nov. 16, 2023

Bridge Conversion Feasibility Study
Broadway Street (KY 3506) over Kentucky River
Franklin County, KY

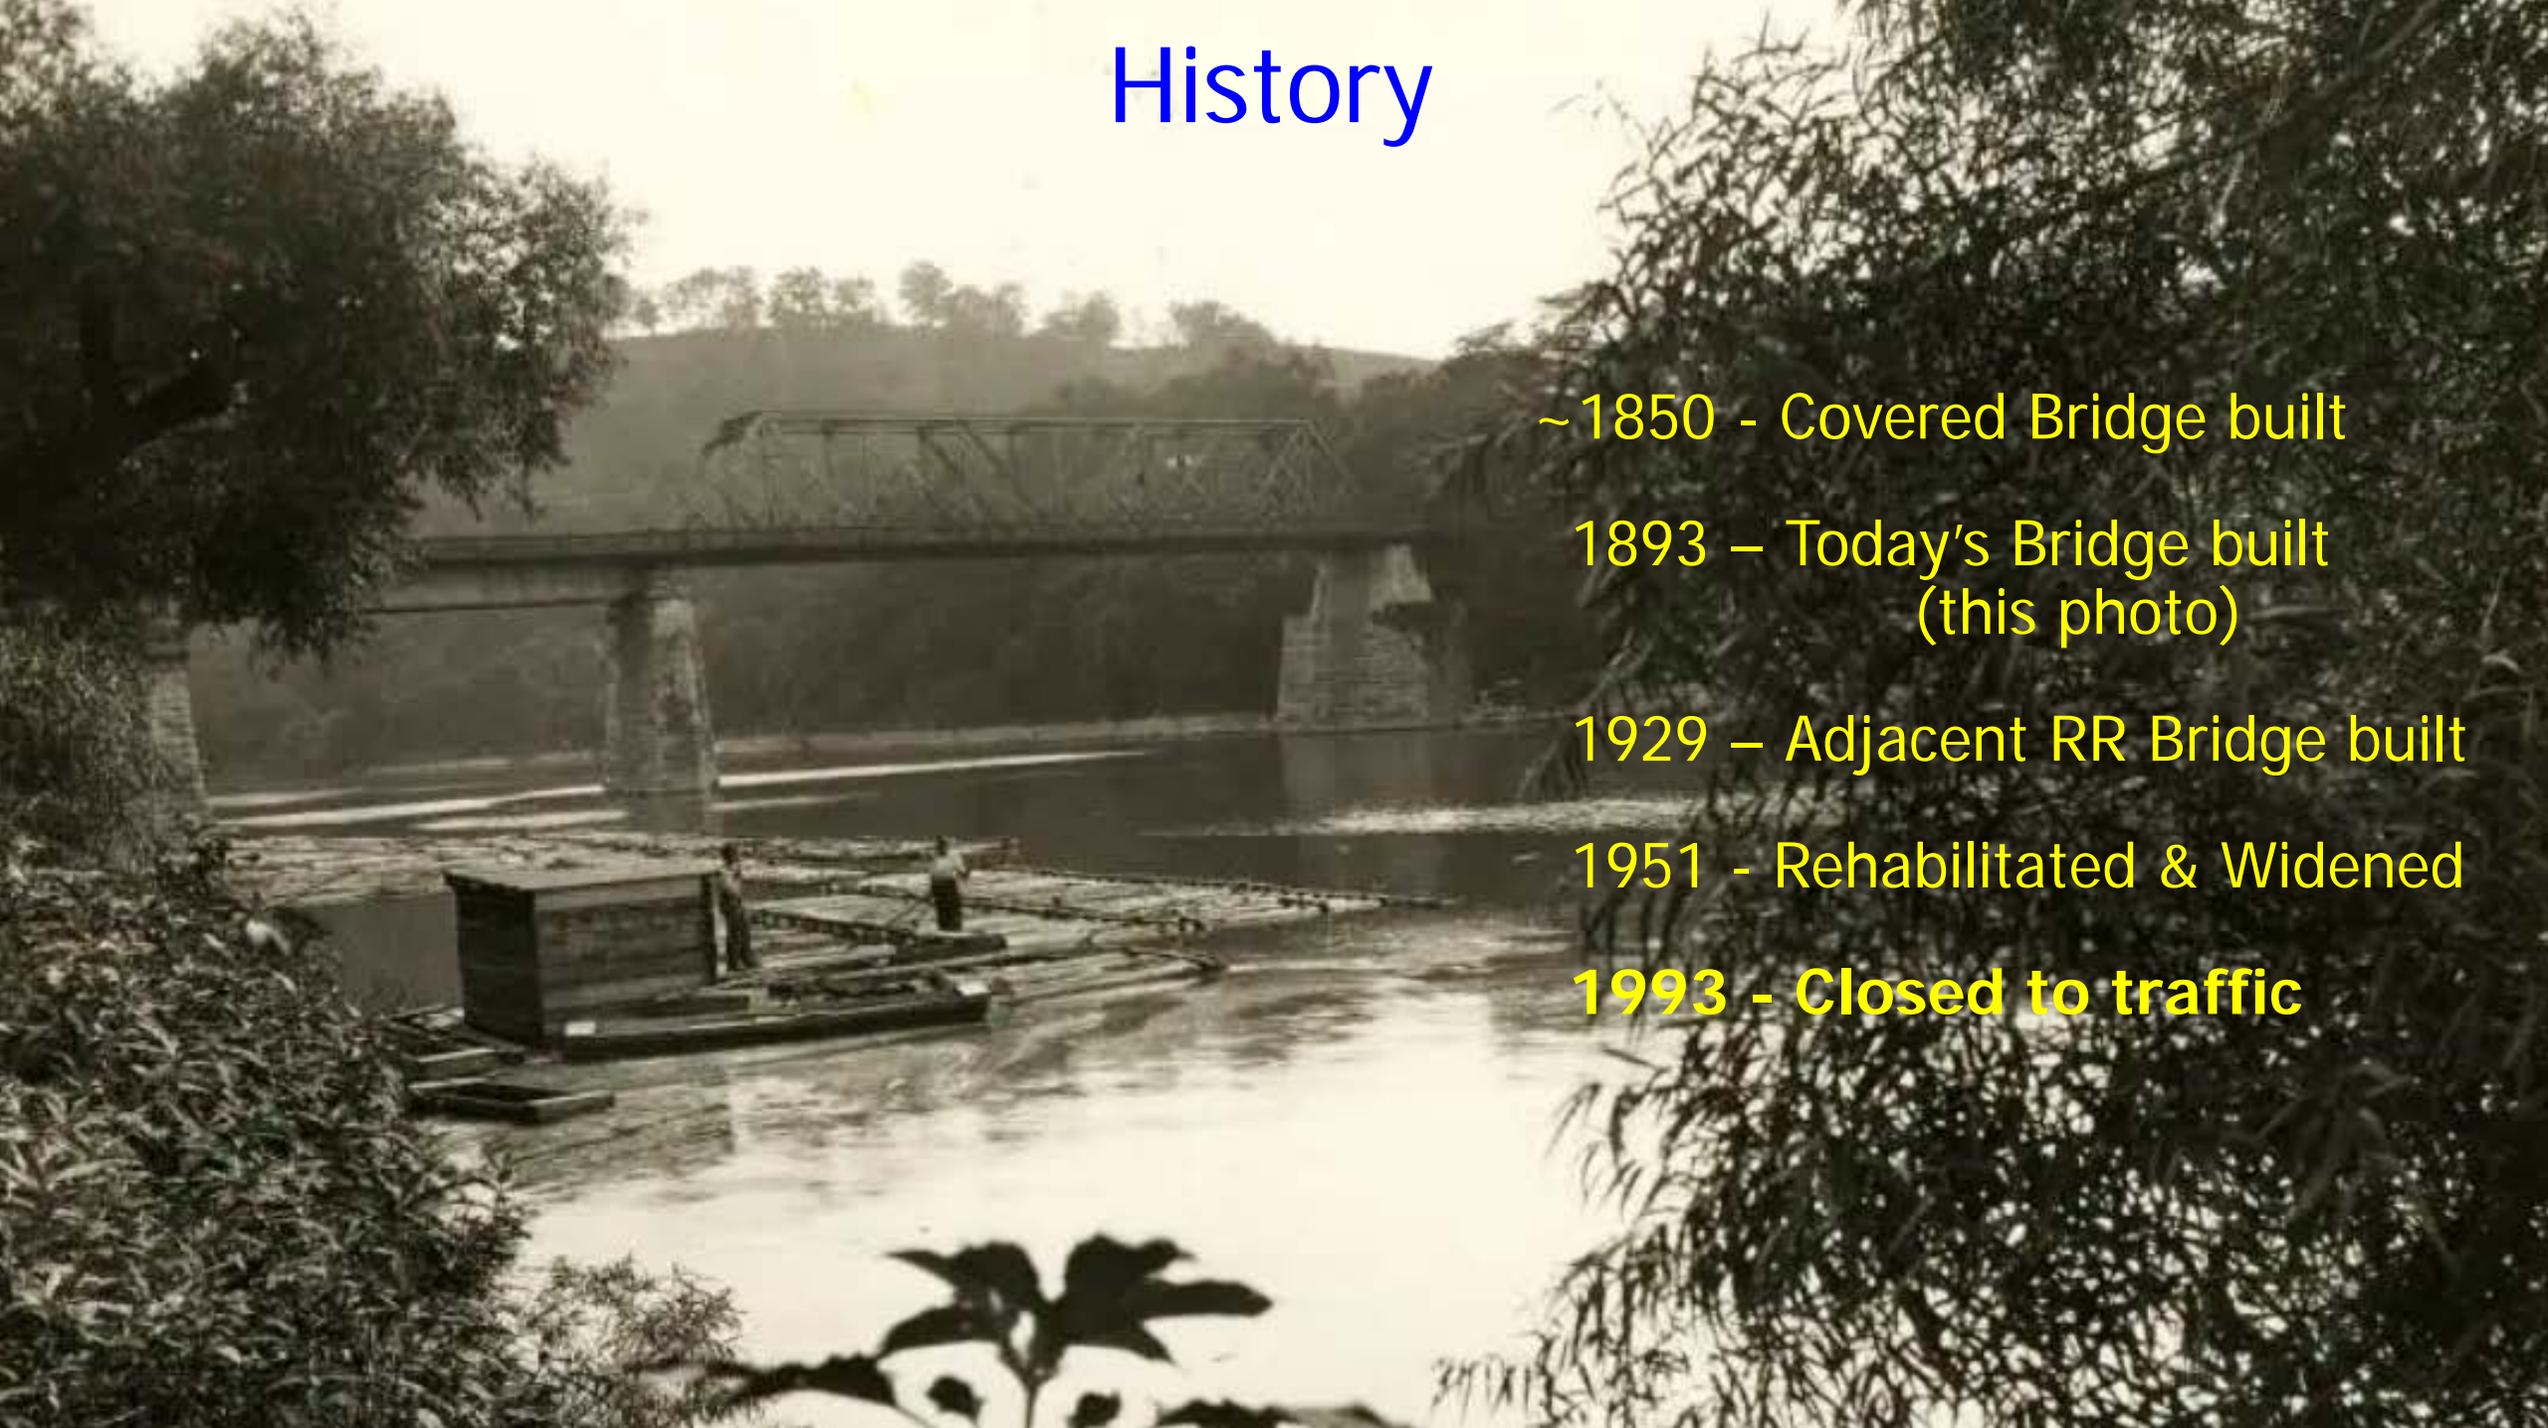
1893 - Today's Bridge built
(this photo)

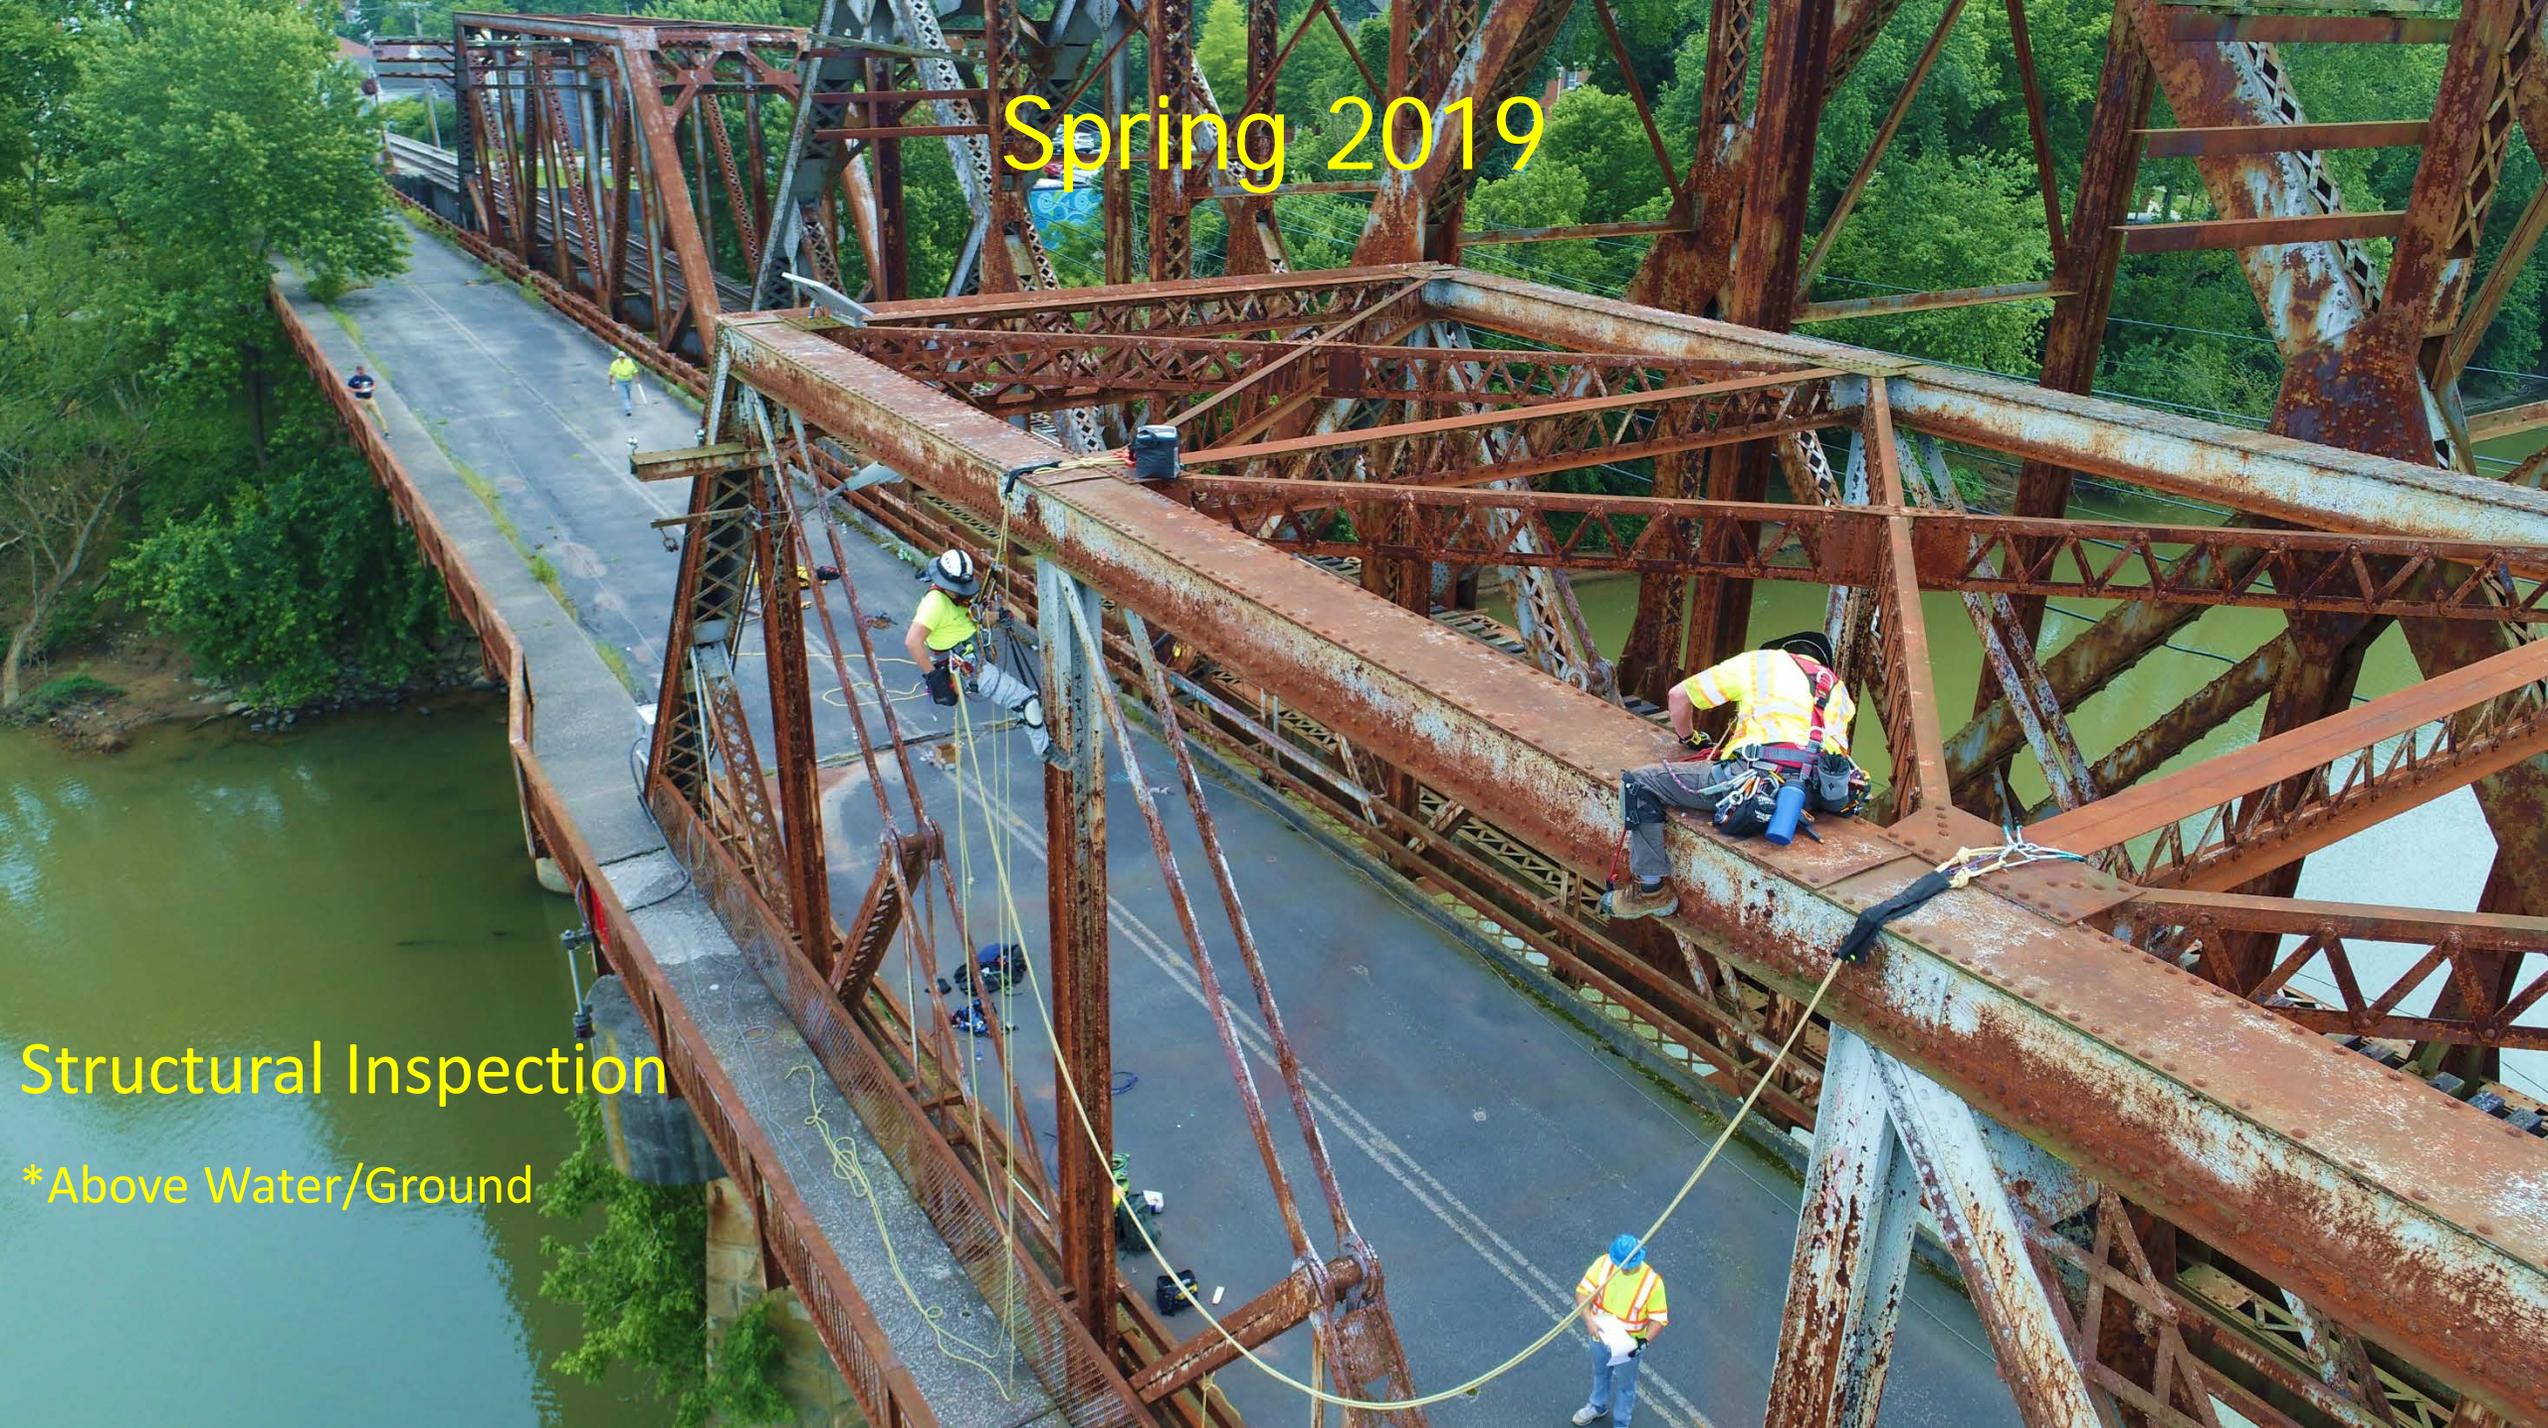
Spring 2019

Structural Inspection

*Above Water/Ground

Bridge Rating of 1 out of 9 -

Imminent Failure

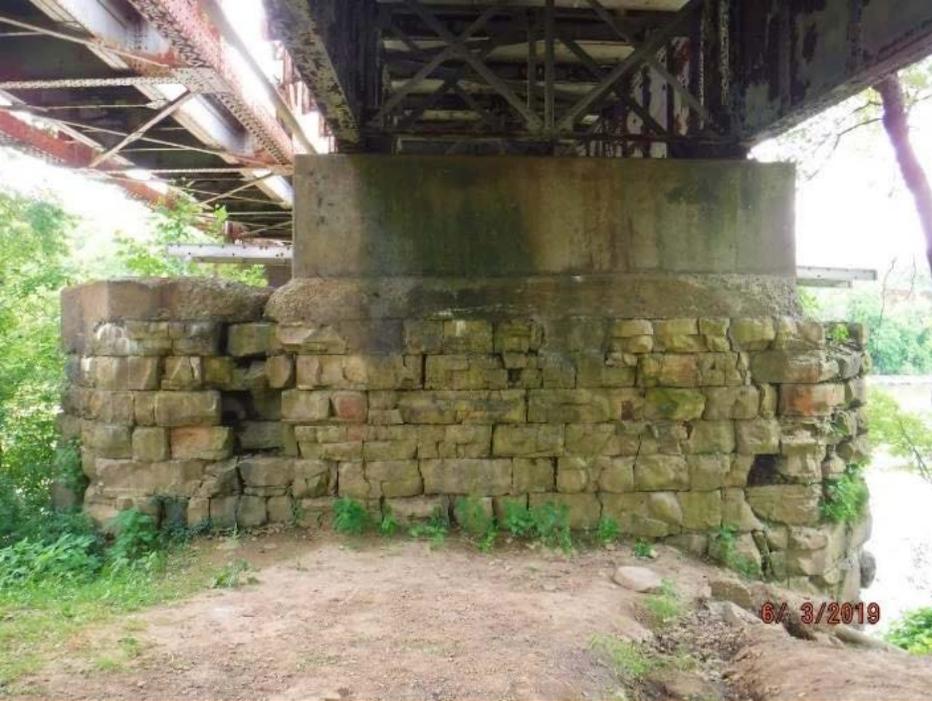
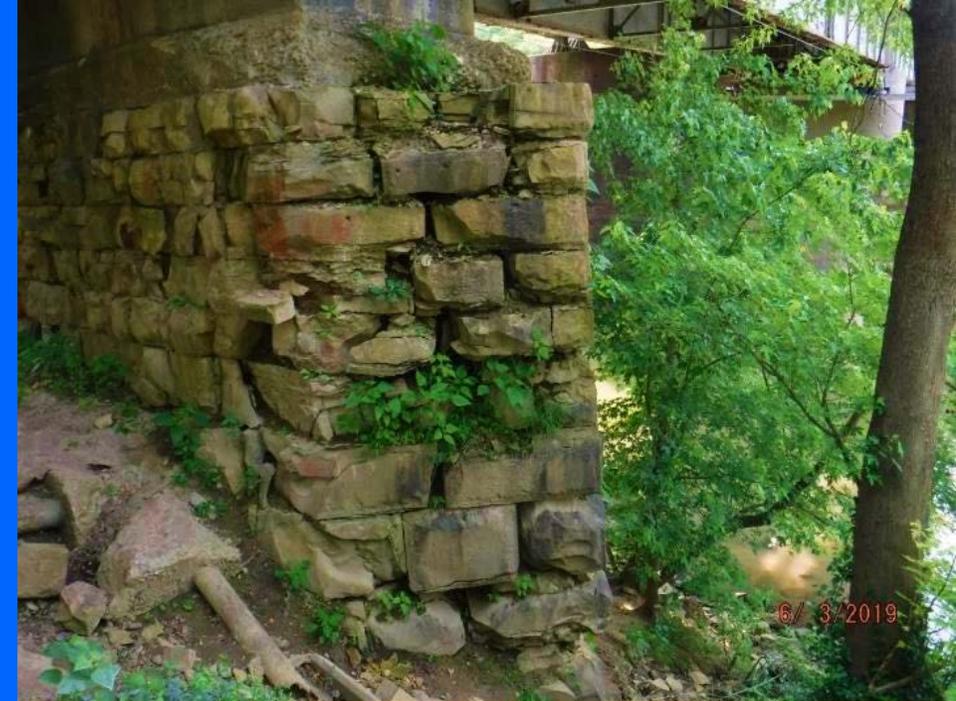
Pier 3 -
Serious Condition

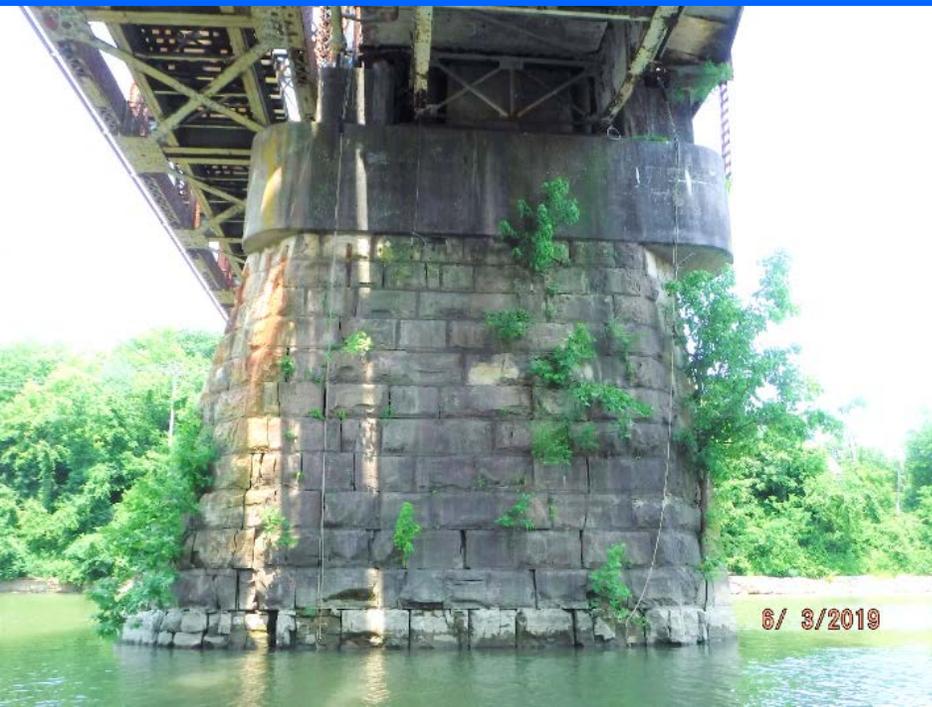
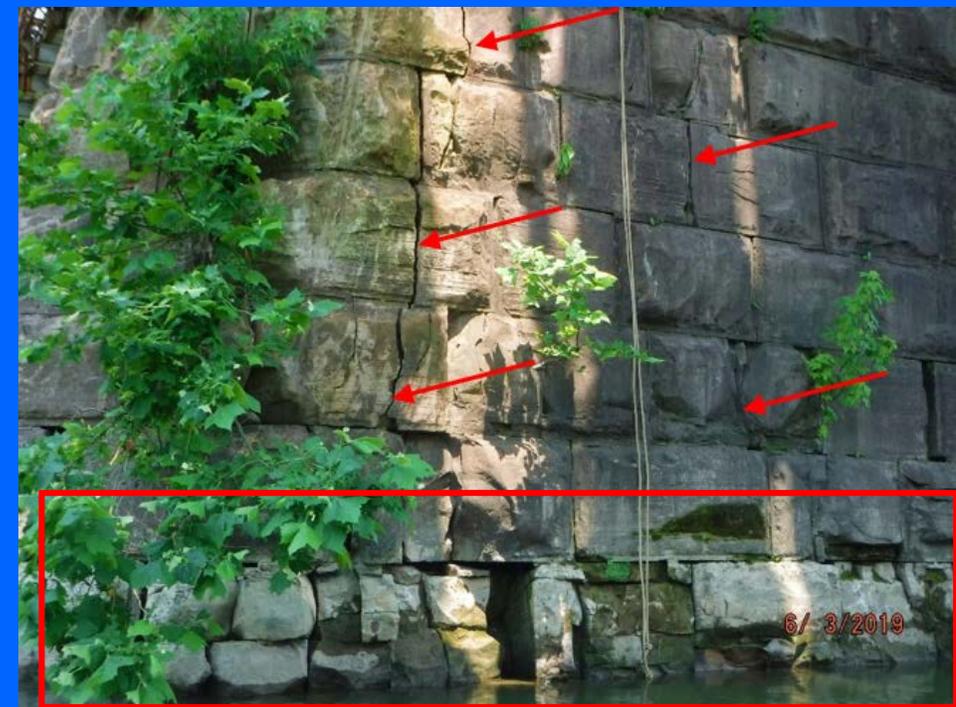
Pier 5 -
Serious Condition

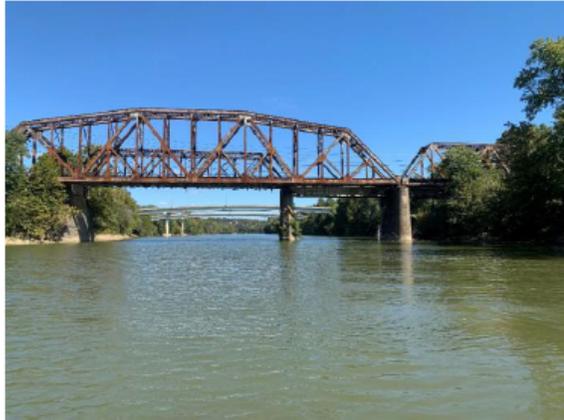
Underwater Bridge Inspection Report

Structure No.: 037B00066N
Crossing: Kentucky River
Route: Old Broadway Pedestrian Bridge
County: Franklin
District: 5
State: Kentucky

Underwater Inspection (River Piers 4, 5, and 6)

Pier 5 - needs Substantial
Rehabilitation

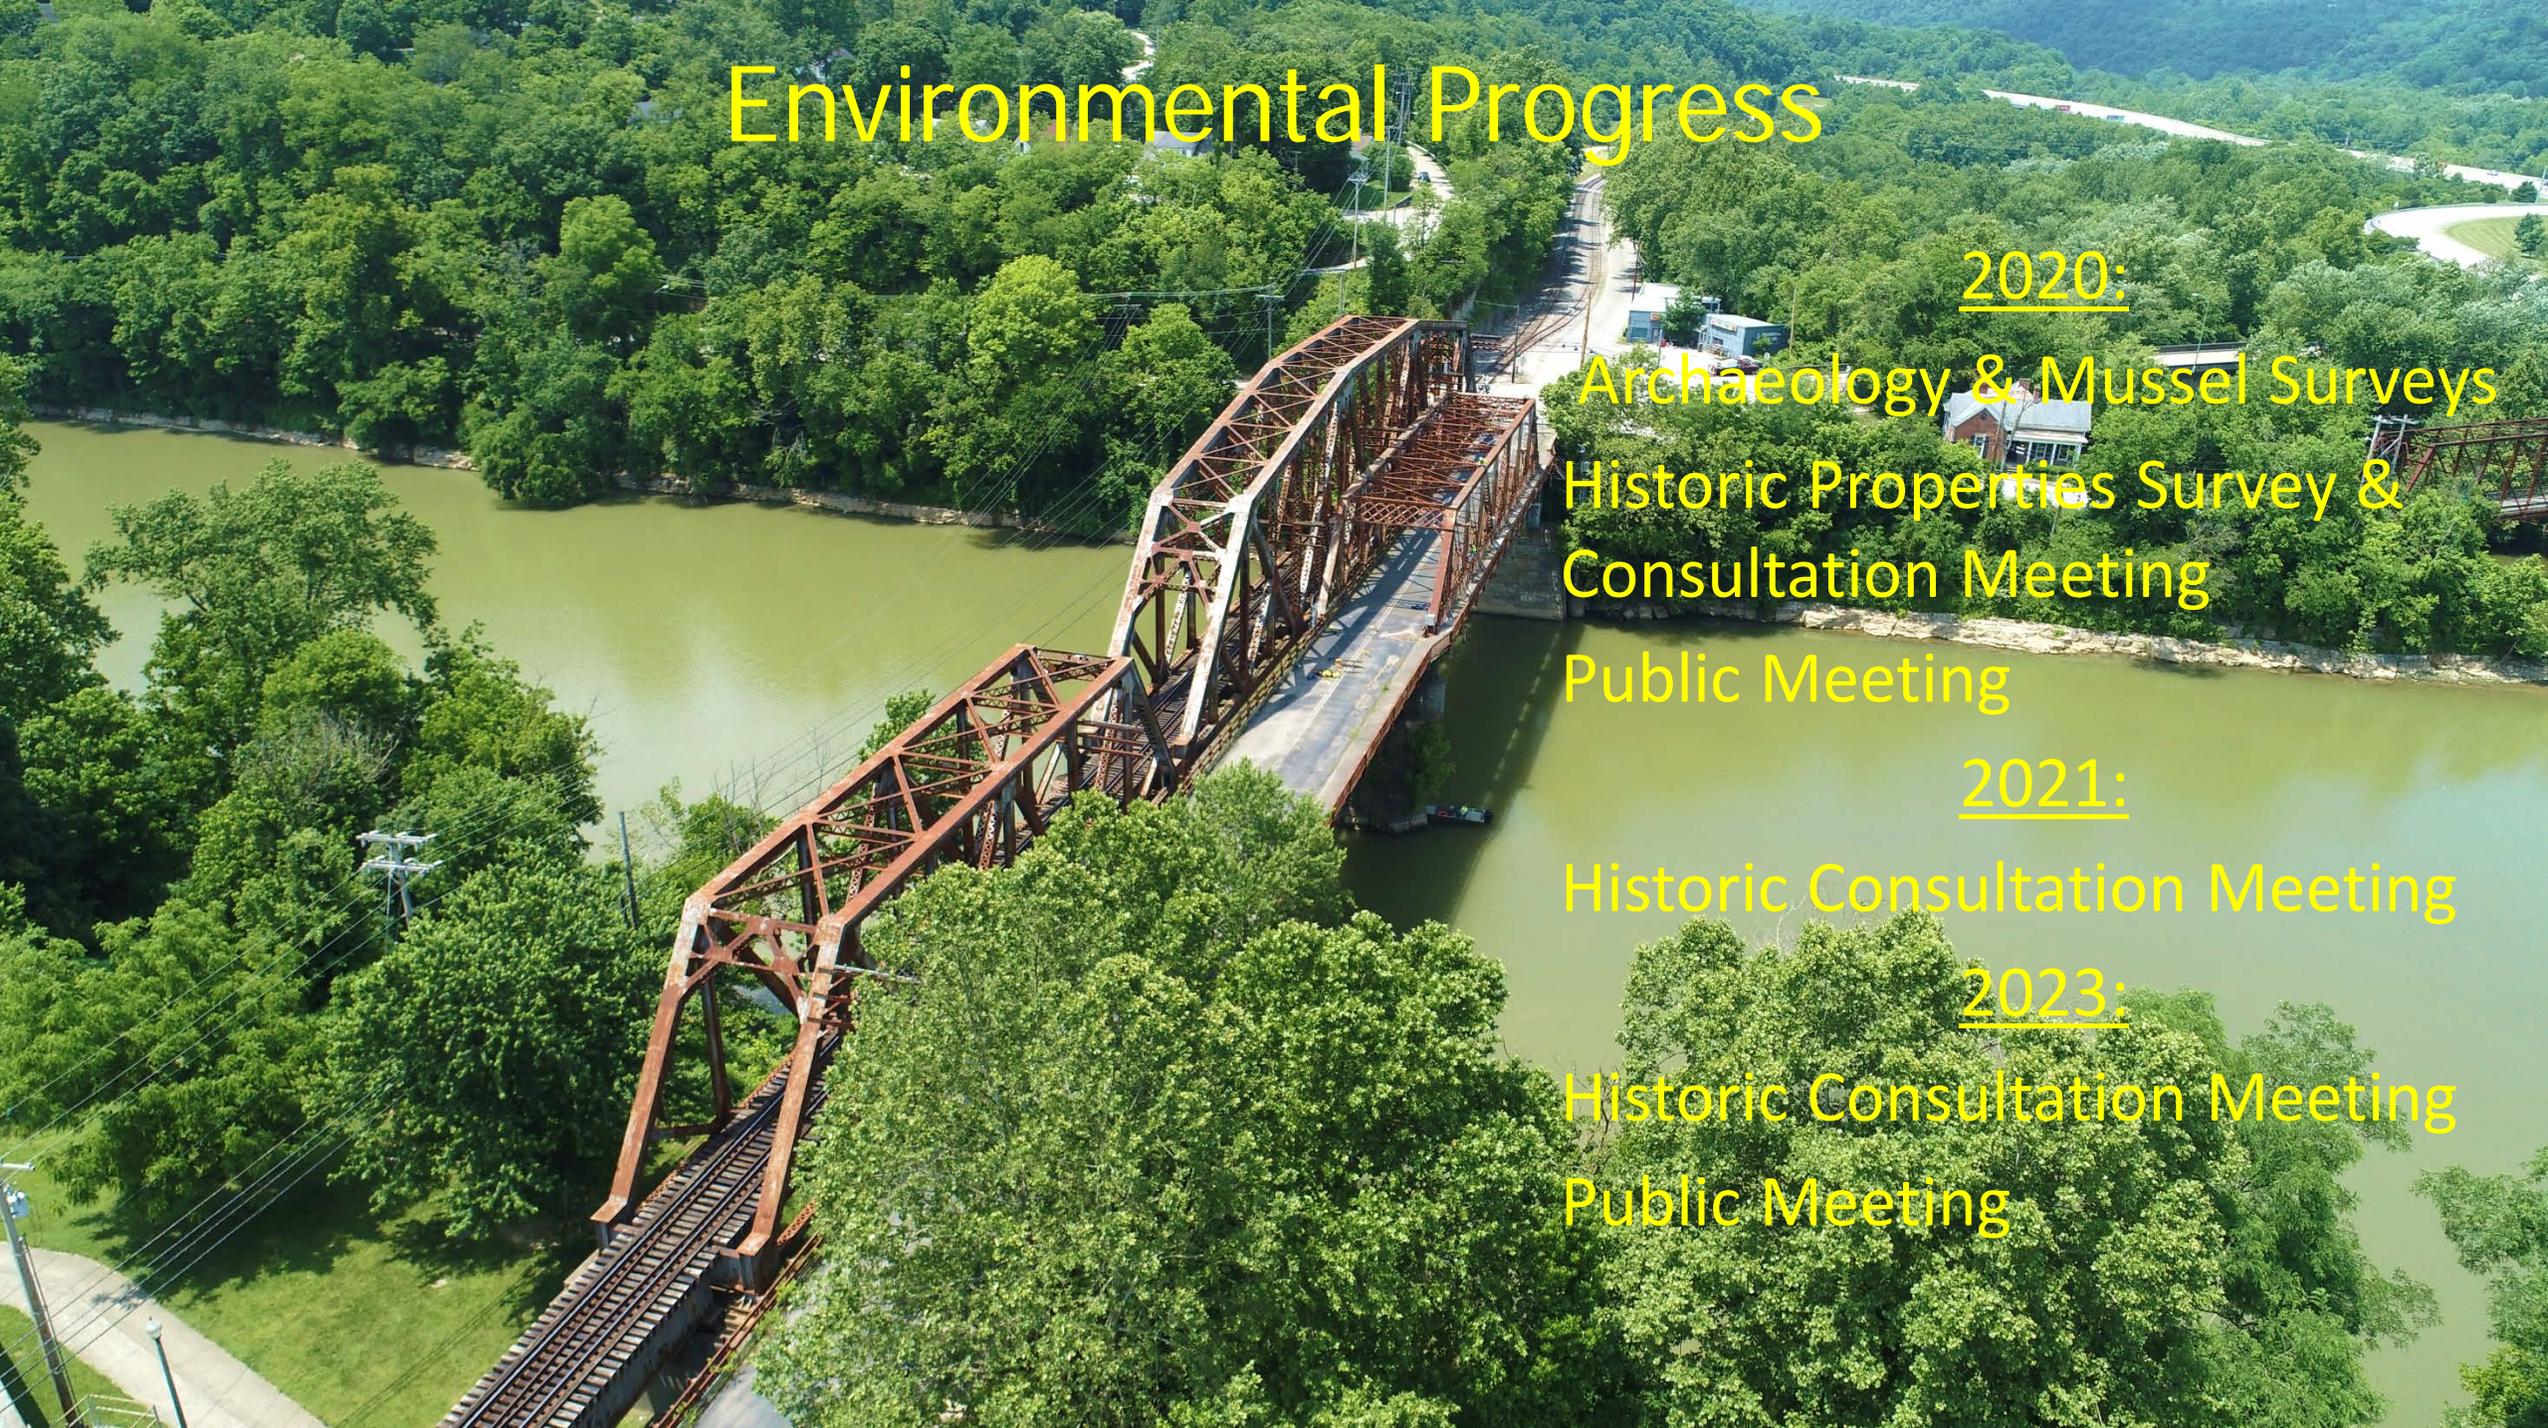
An aerial photograph of a large, multi-span steel truss bridge crossing a wide river. The bridge is made of reddish-brown metal and has a road deck on top. The surrounding area is lush with green trees and vegetation. In the background, a road and some buildings are visible on the right bank. The sky is clear and blue.

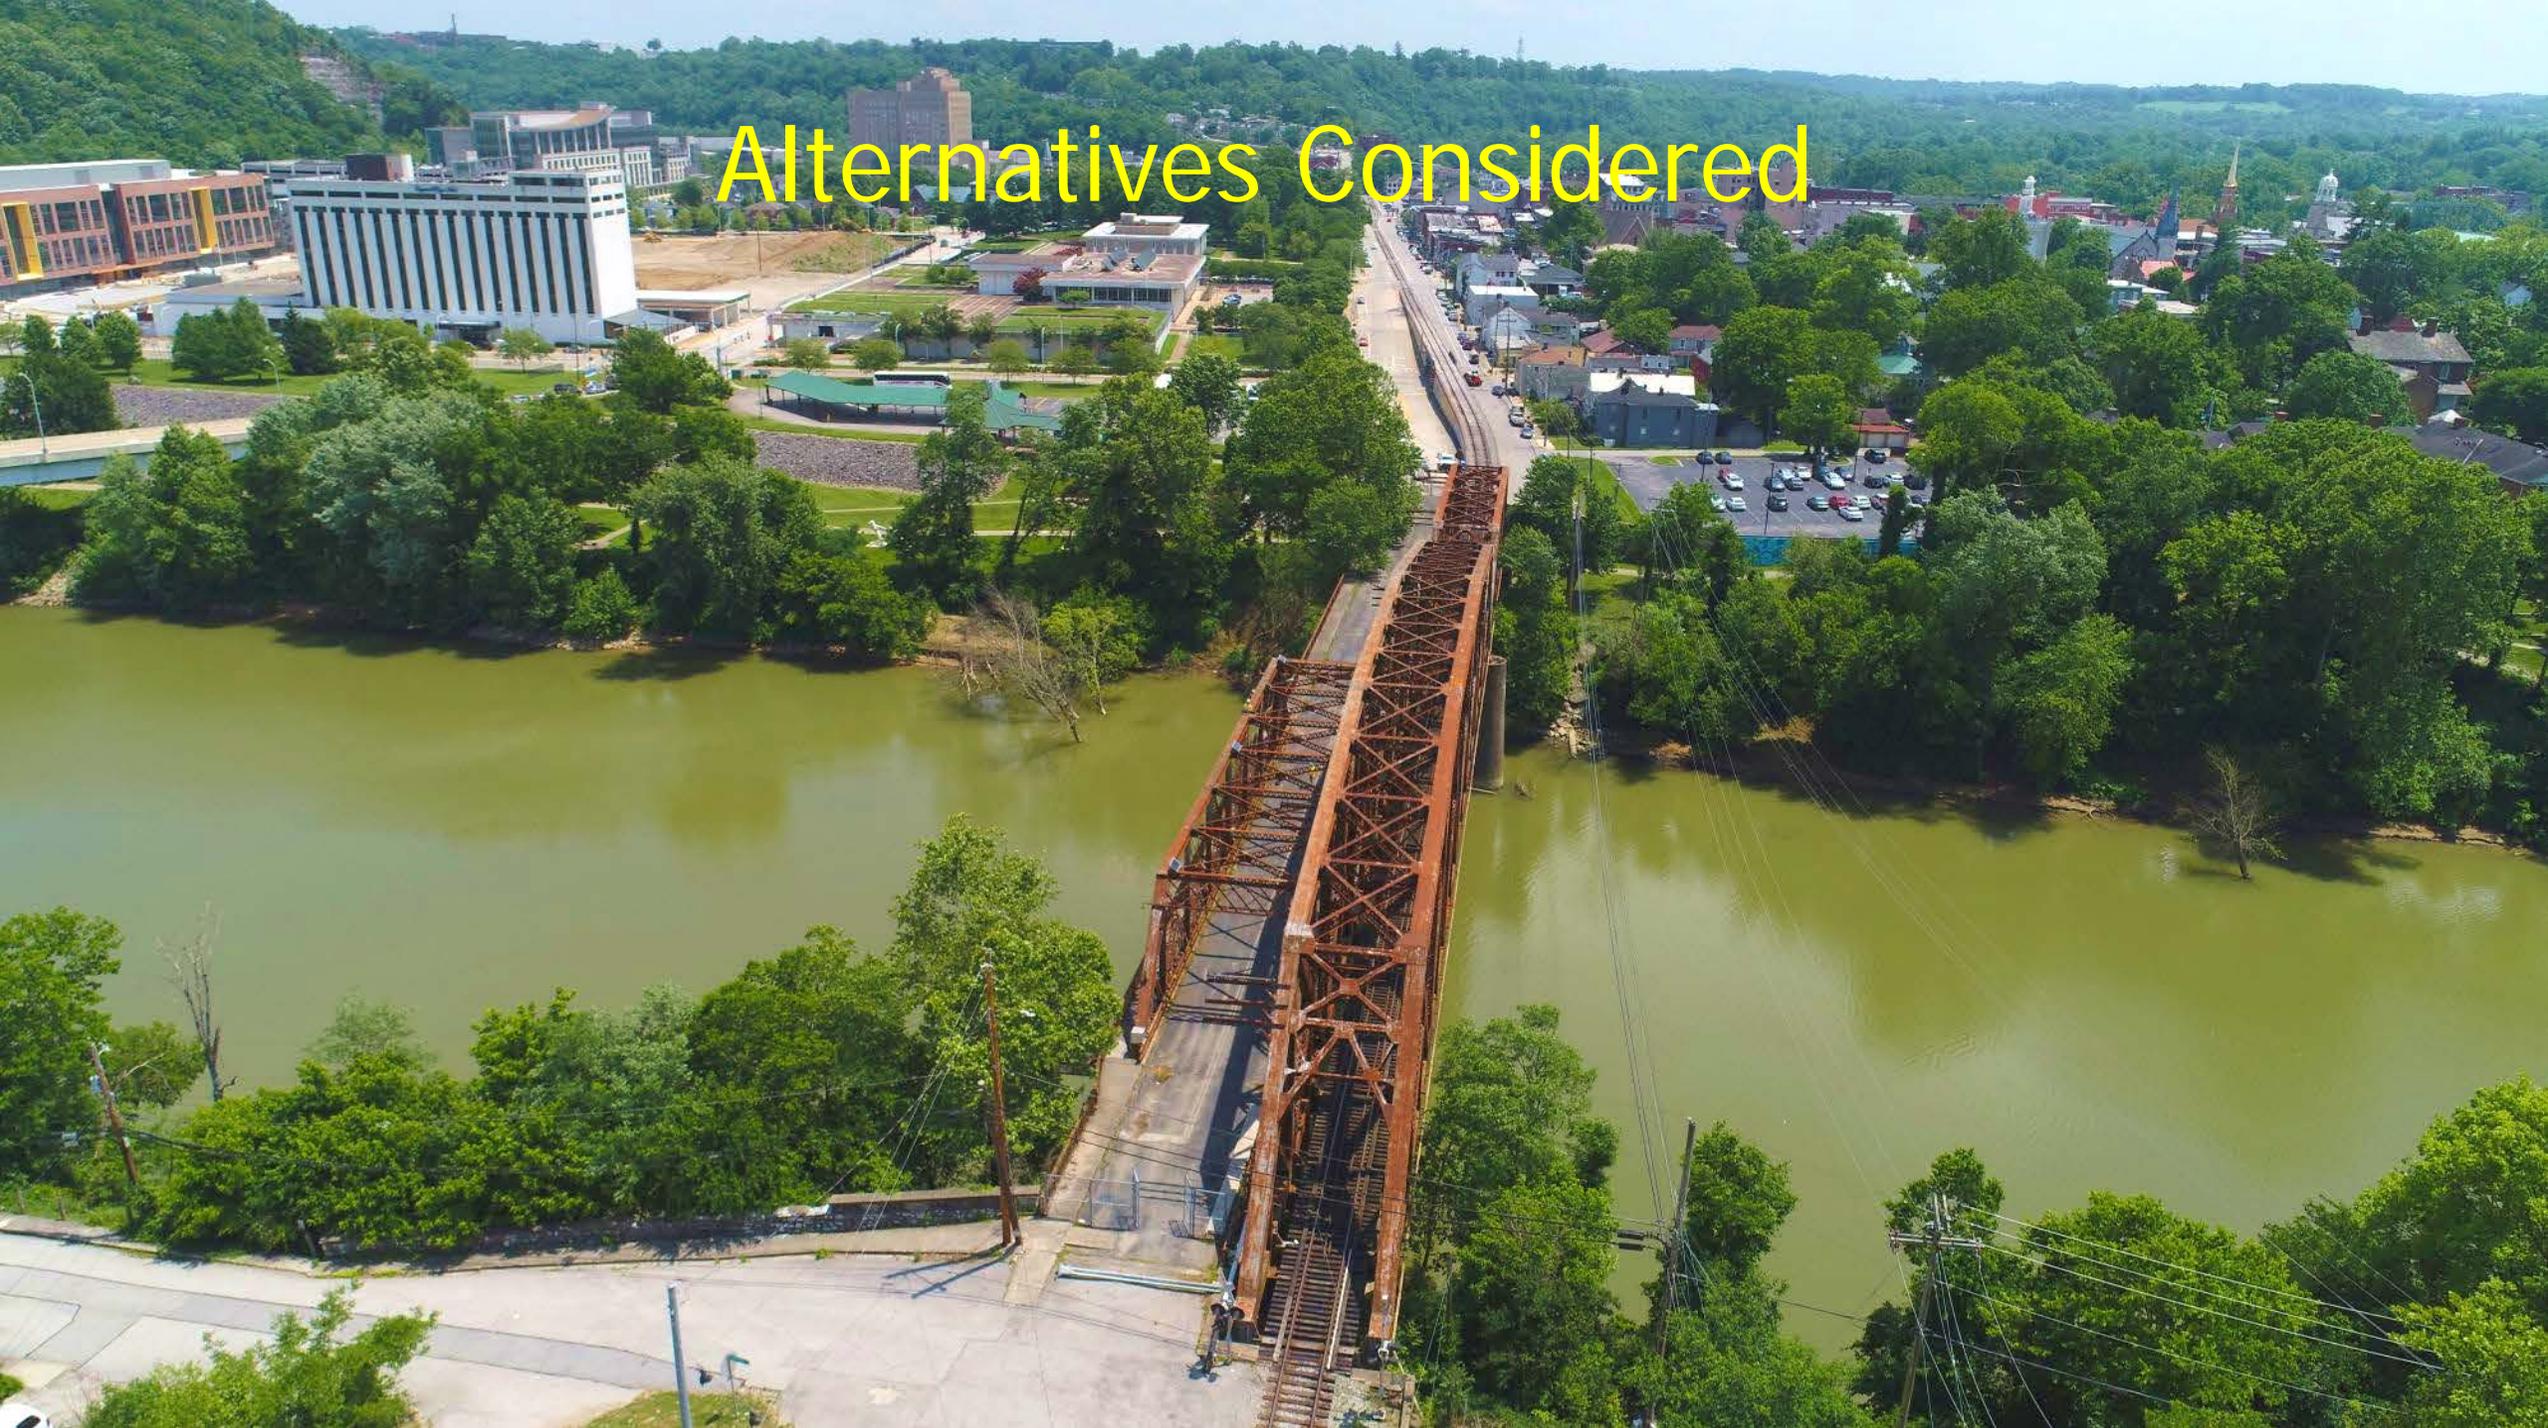
Alternative #1: Demolition

Remove former highway bridge

Historic:	Adverse Effect
Cost:	Lowest
Structural:	No Concerns

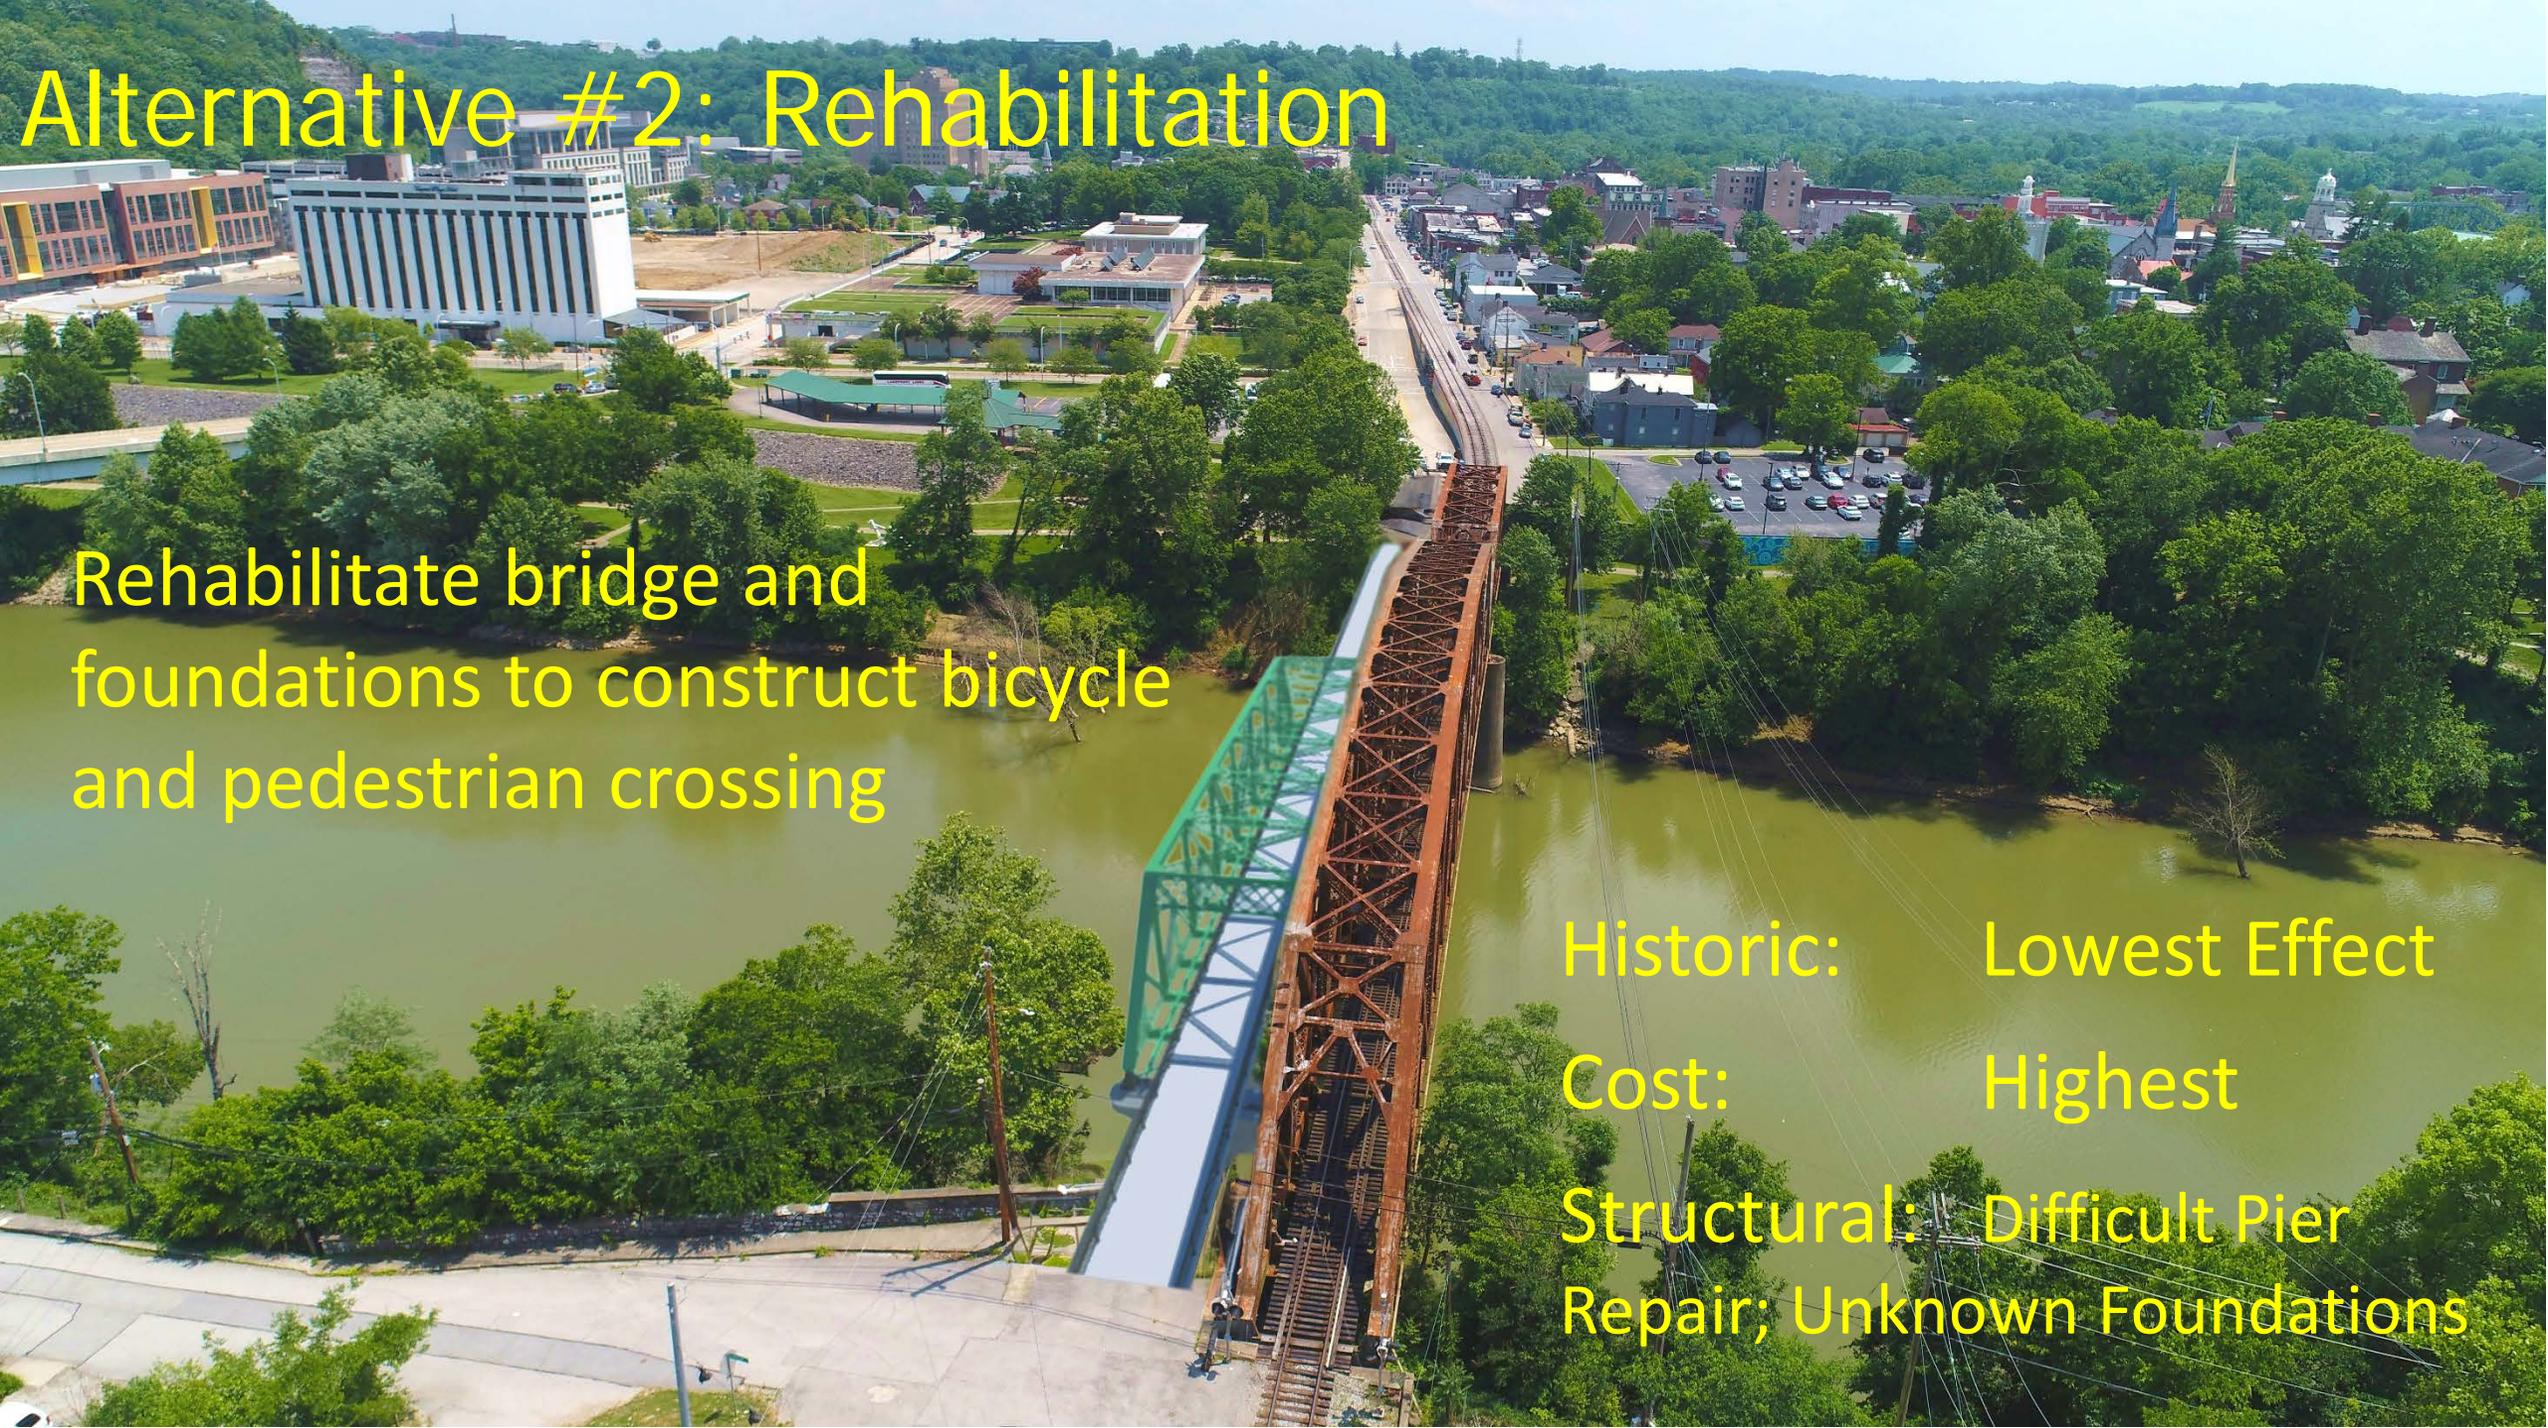
Alternative #2: Rehabilitation

Rehabilitate bridge and foundations to construct bicycle and pedestrian crossing

Historic: Lowest Effect
Cost: Highest
Structural: Difficult Pier Repair; Unknown Foundations
