Broadway Street Bridge over Kentucky River

Nov. 16, 2023

Bridge Conversion Feasibility Study
Broadway Street (KY 3506) over Kentucky River
Franklin County, KY

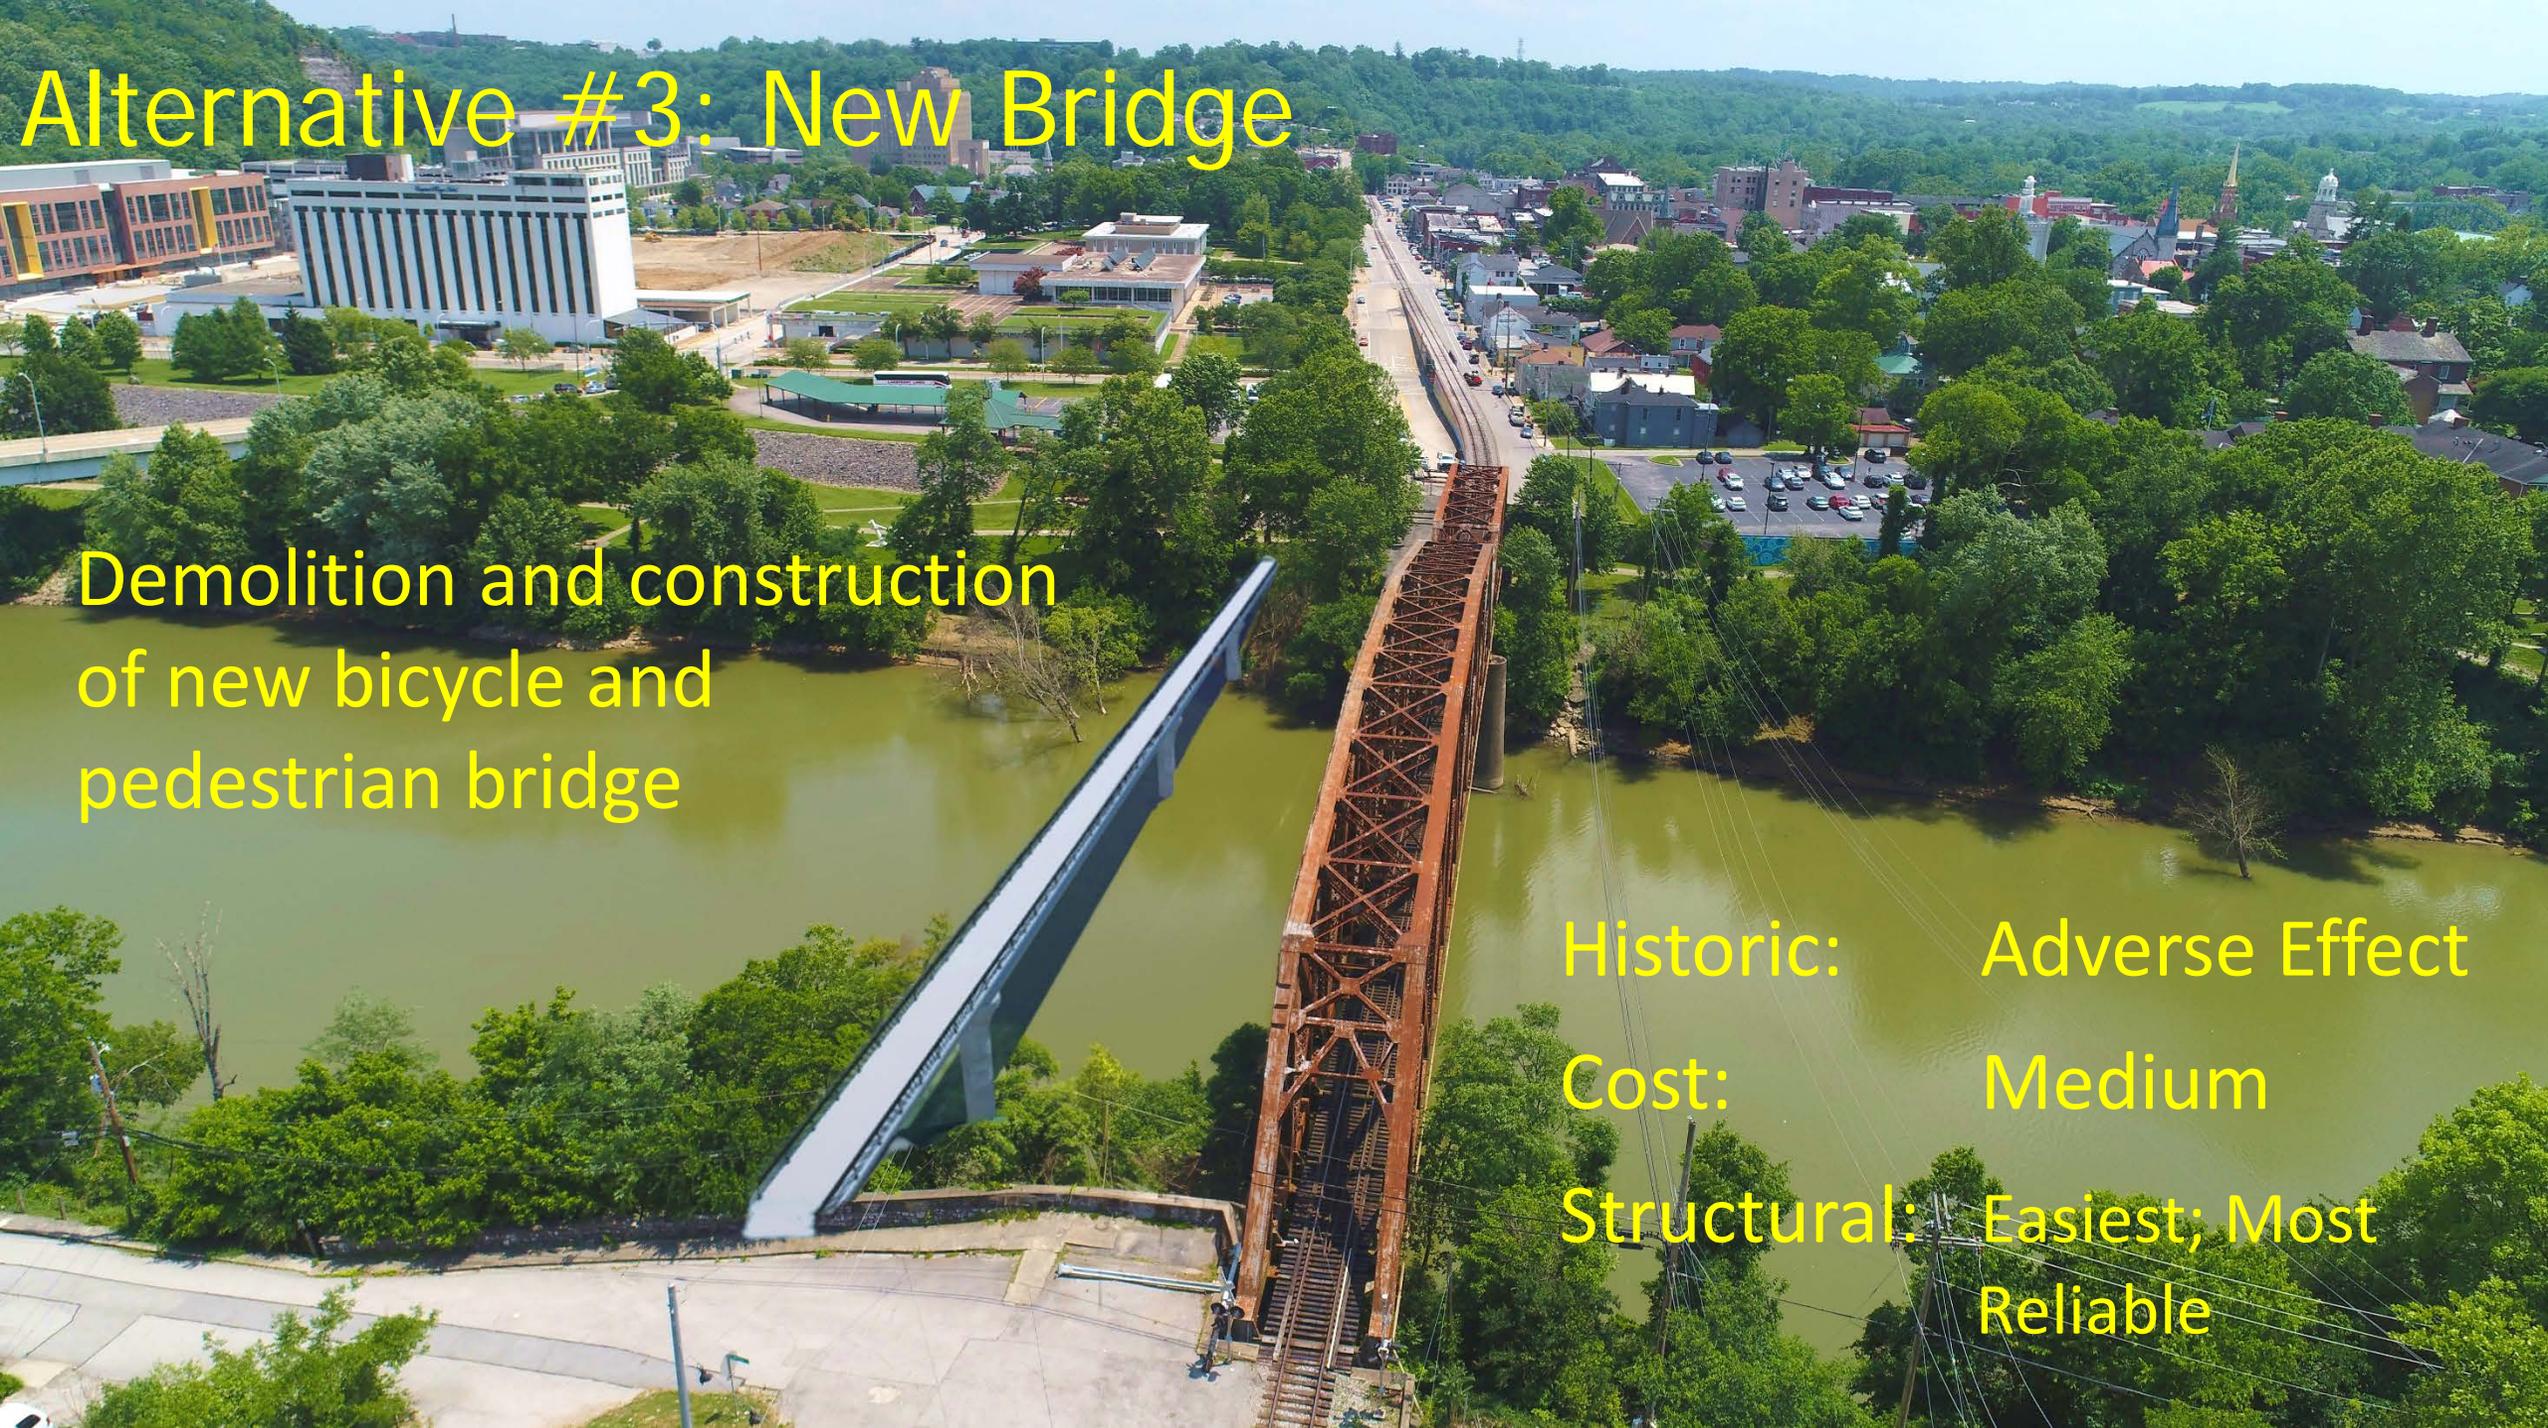
Alternative #3: New Bridge

Demolition and construction of new bicycle and pedestrian bridge

Historic:	Adverse Effect
Cost:	Medium
Structural:	Easiest; Most Reliable

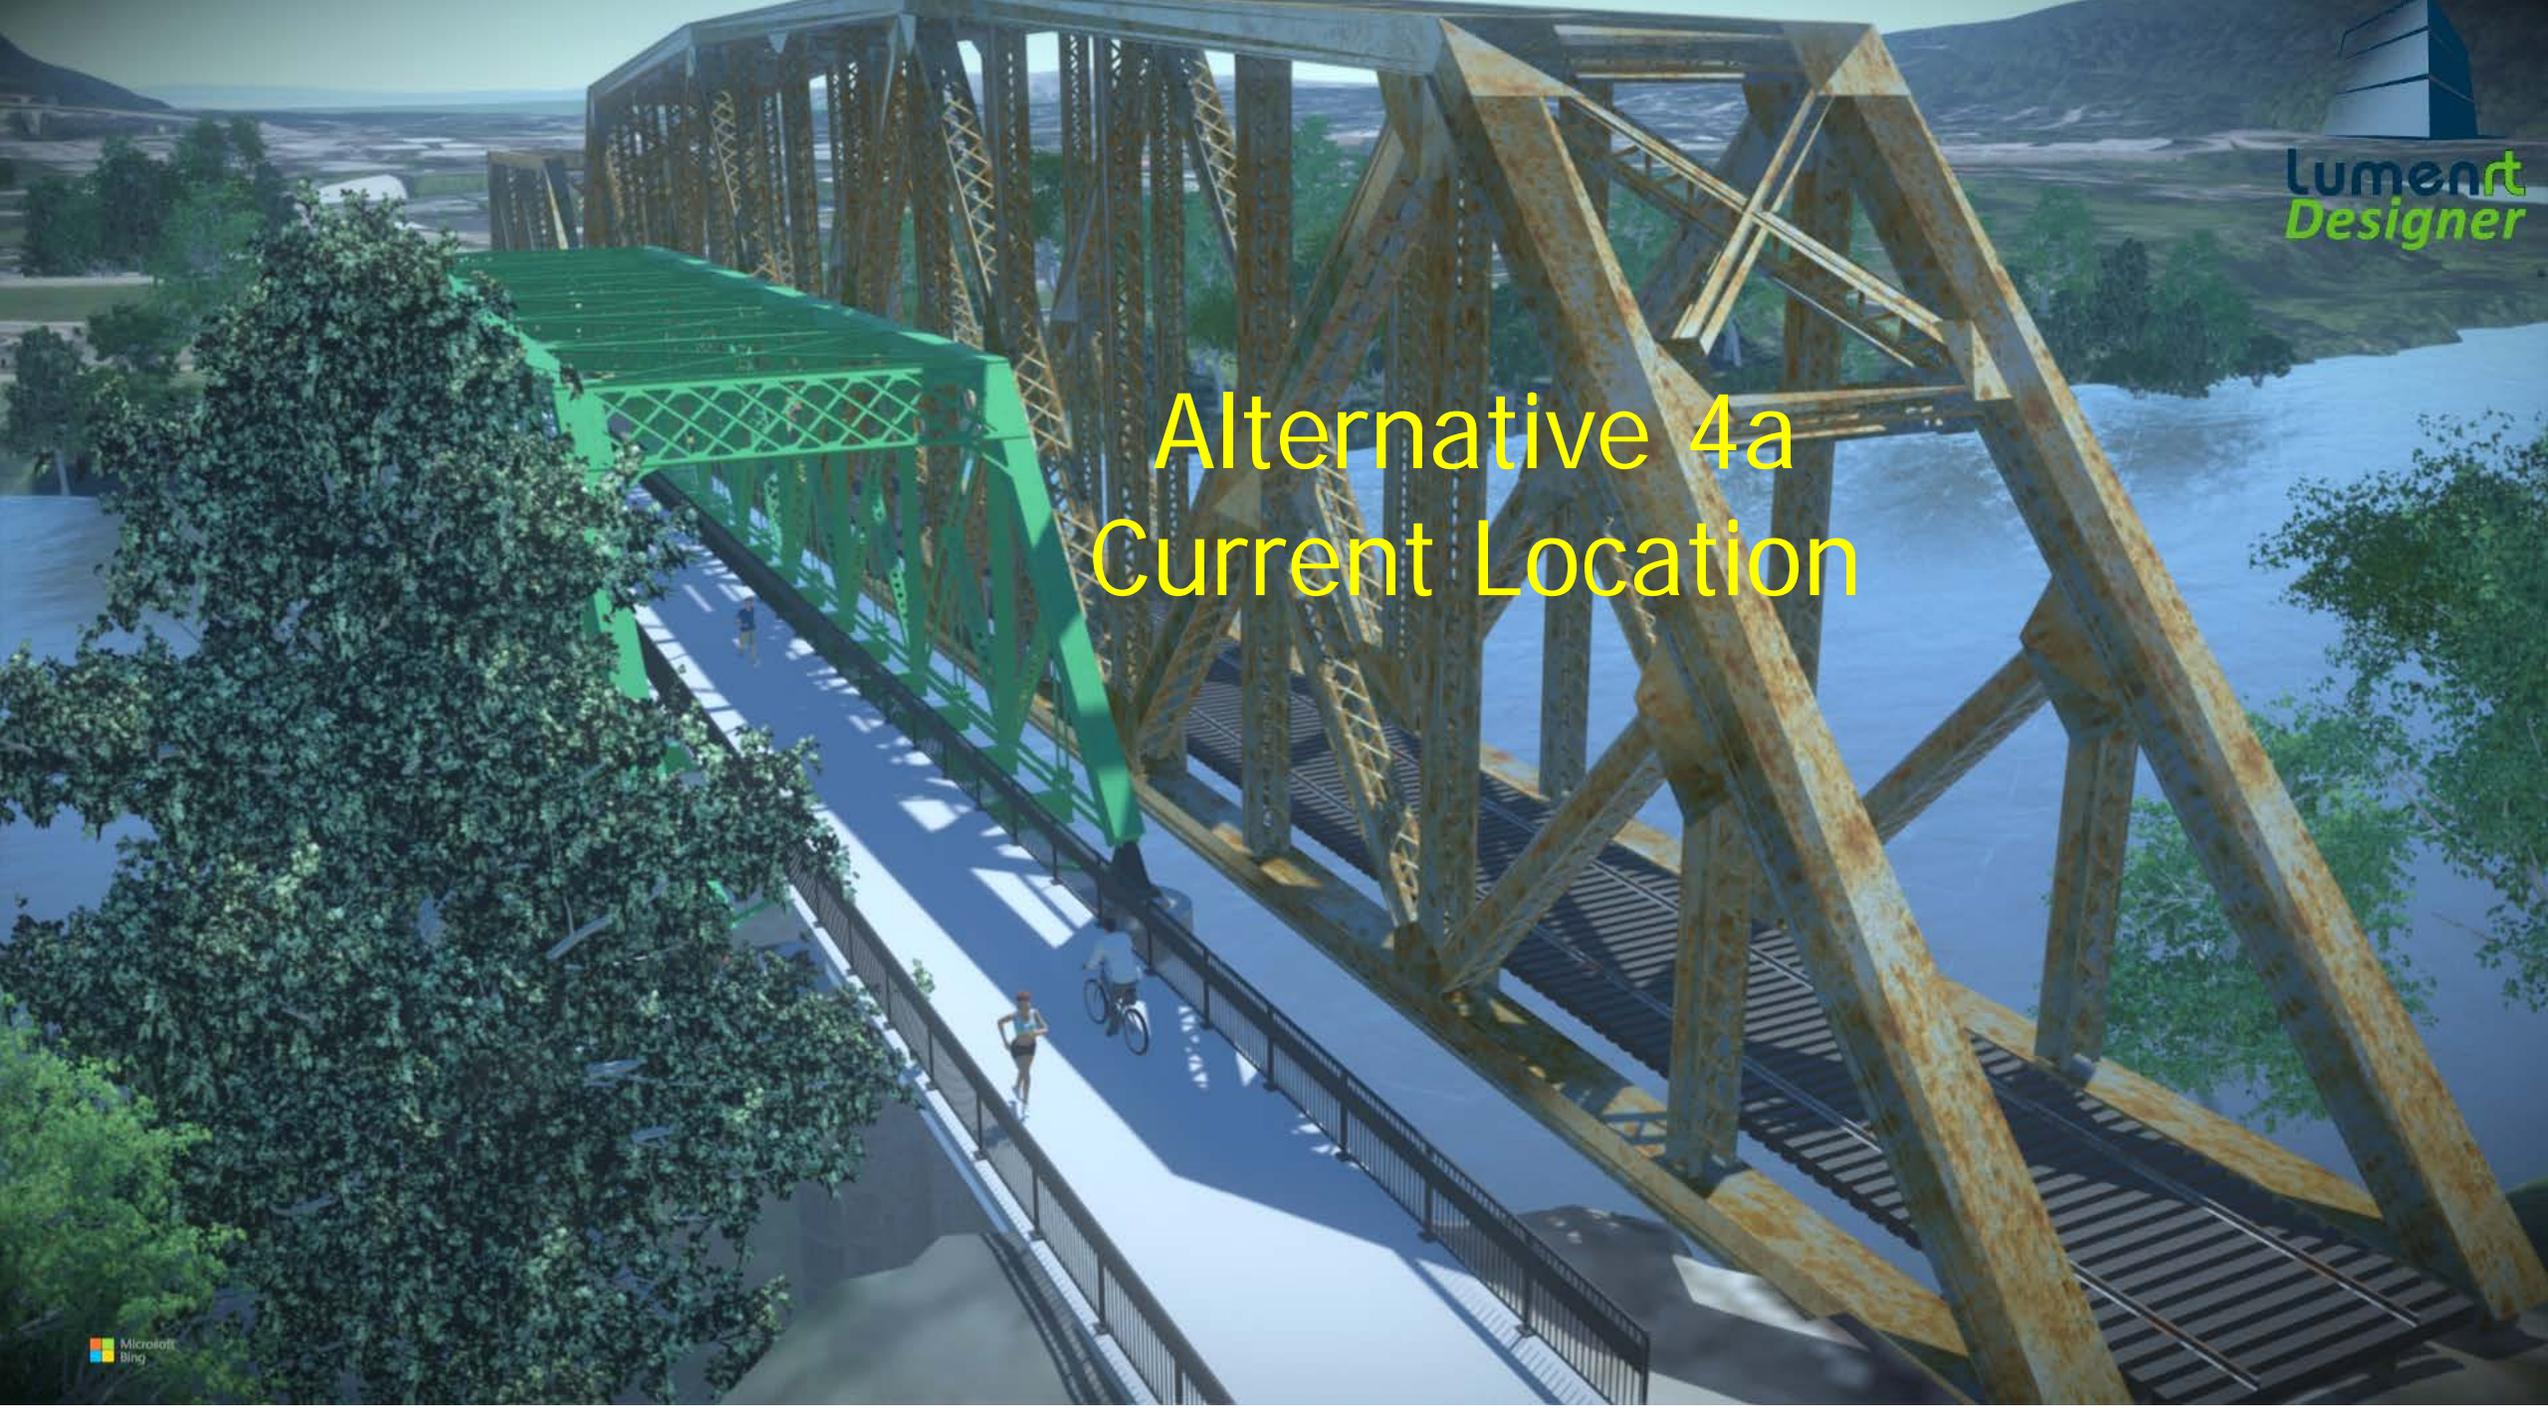
Current Location

Slower & More Costly
Construction

Interference with Existing
Foundations

Users Close to RR Bridge &
Train Traffic

Alternative 4a Current Location

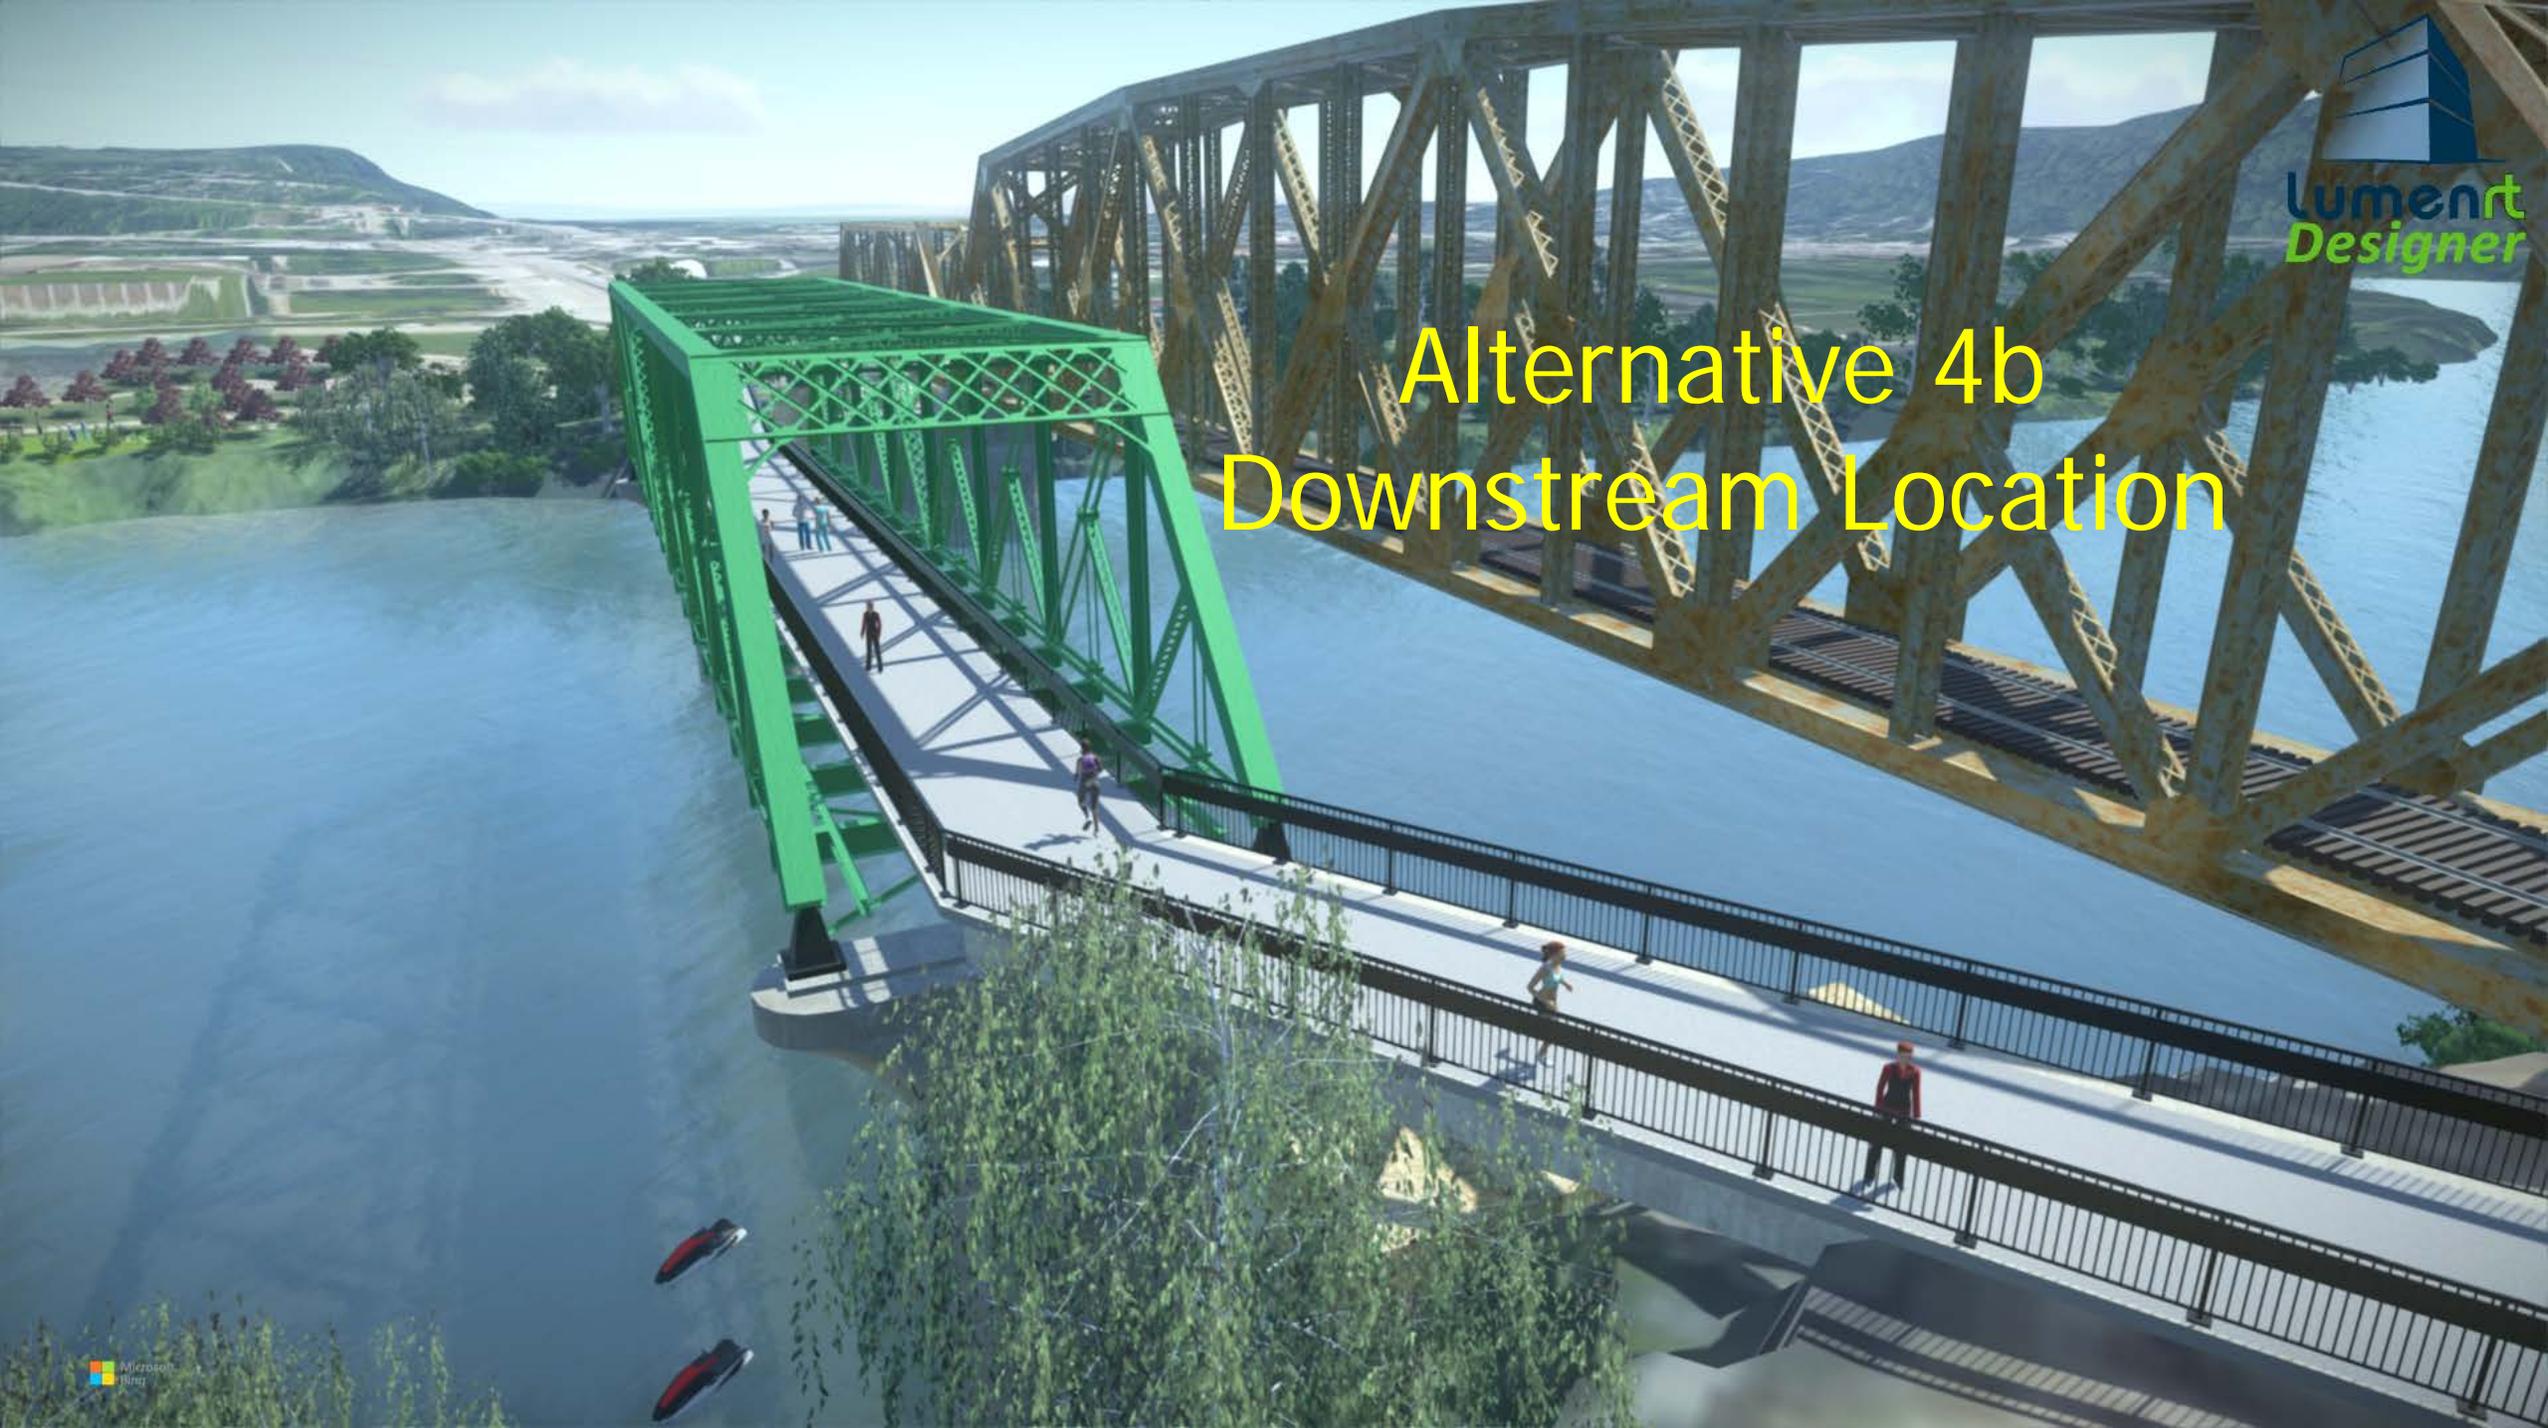
Downstream
Location

Faster & Less Costly Construction

No Interference with Existing
Foundations

Users Farther away from Train
Traffic

Alternative 4b Downstream Location
