Bridge Conversion Feasibility Study Broadway Street (KY 3506) over Kentucky River Franklin County, KY

August 2019

FEASIBILITY STUDY

BROADWAY BRIDGE OVER KENTUCKY RIVER

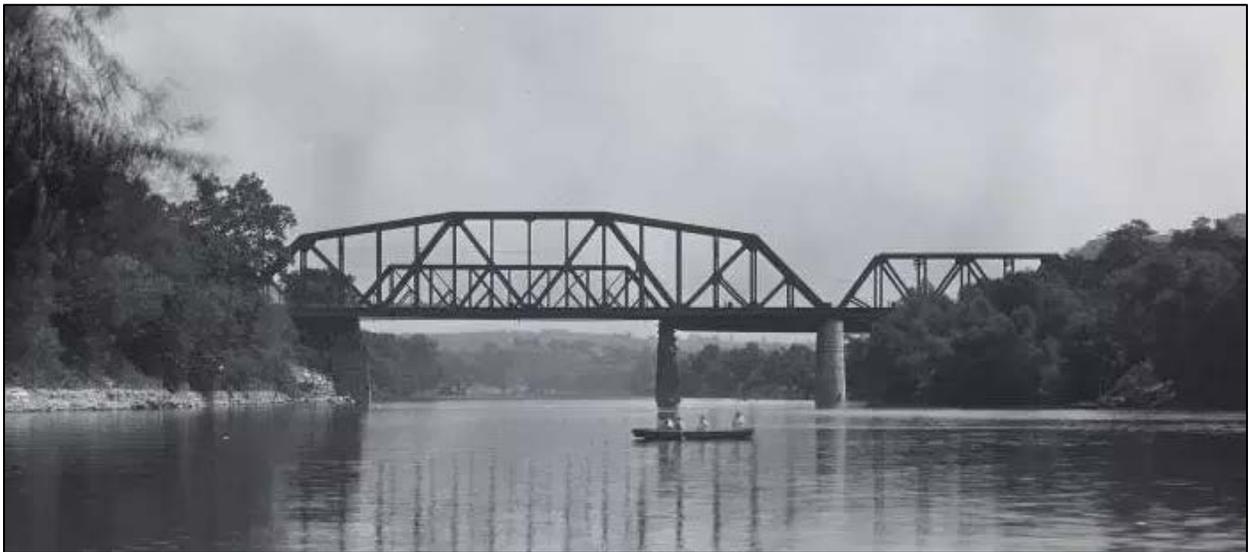
Figure 1: Railroad Bridge and Broadway Bridge, circa 1930 by Cusick Studio

Construction of an iron Fink truss in 1868 restored the link across the Kentucky River. Around 1910, a new pin-connected Baltimore Petit truss, the current Broadway Street Bridge, replaced the Fink truss bridge. From the beginning, the bridges over the Kentucky River carried railroad traffic. In 1929, the American Bridge Company constructed a railroad truss bridge running parallel and adjacent to the Broadway Bridge (Figure 1).

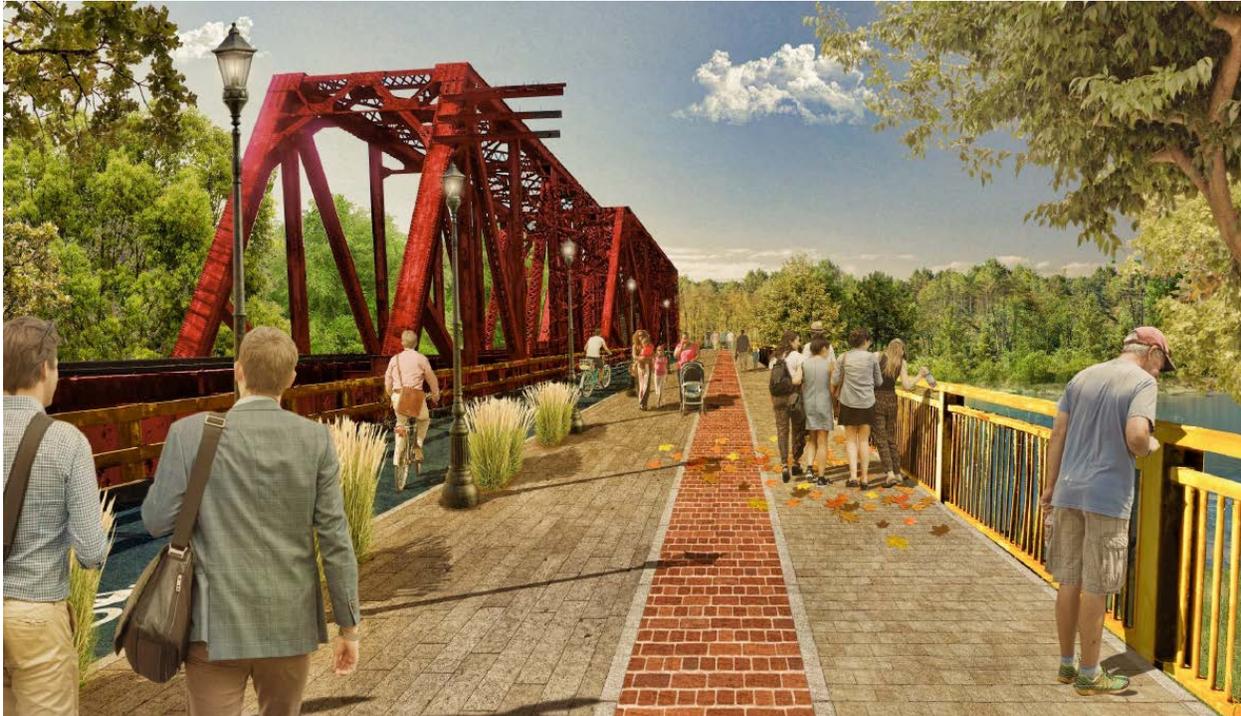
Figure 2: Broadway Bridge shown in Frankfort Downtown Master Plan

recommendation to improve the system is, “Foremost is renovation and reuse of the Broadway Bridge into a pedestrian/bike facility.” Figure 2 from Frankfort’s Downtown Master Plan shows one idea of how the Broadway Bridge might look if rehabilitated.

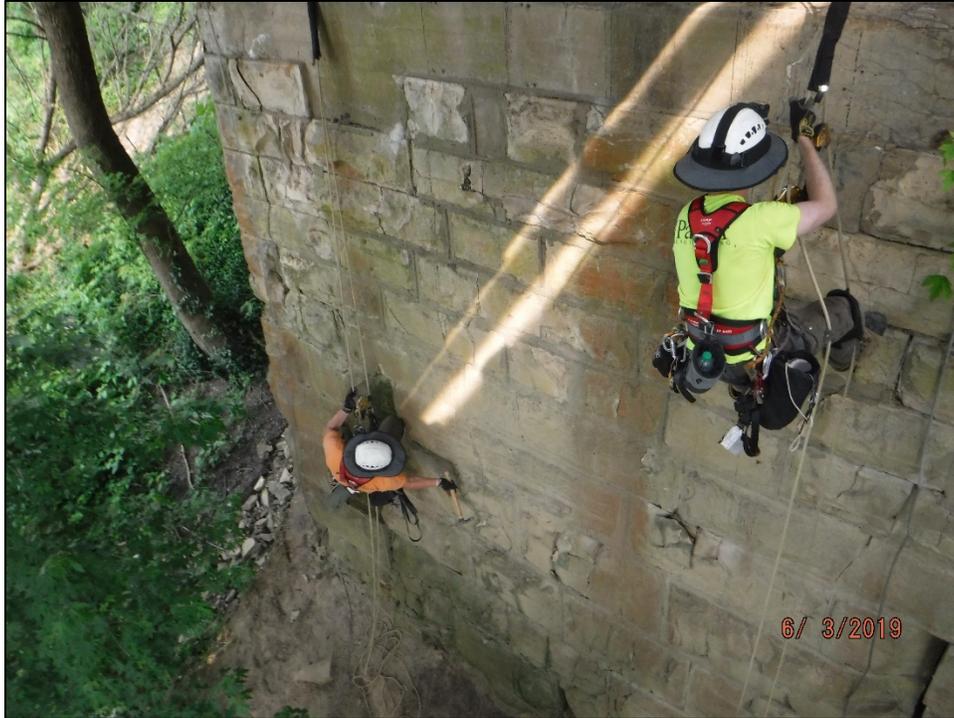
Figure 3: Inspection of pier using rope access in accordance with SPRAT

Broadway Bridge is in a deteriorated condition and has no recent inspection so its structural capacity is unknown. Normally, a snooper-truck on the bridge’s deck provides access for inspectors to be within arm’s length of the structural members. Due to uncertain structural capacity, this method was not feasible. Instead, Palmer used rope climbing techniques in accordance with SPRAT (Society of Professional Rope Access Technicians), ladders, a boat, and rigging below deck to gain close access.

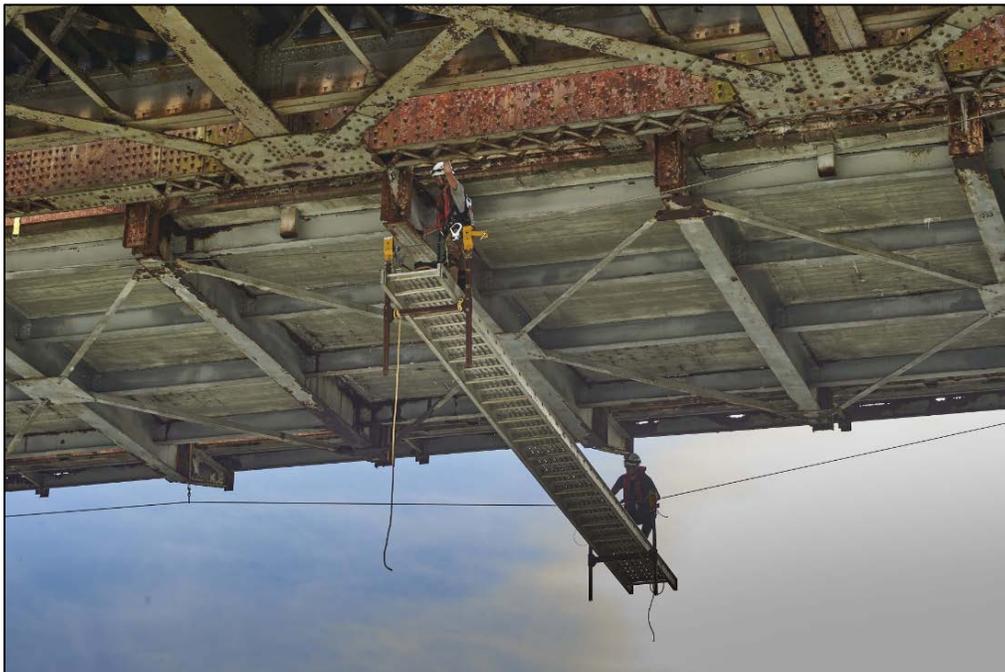
Figure 4: Below-deck inspection of truss from a pickboard

A pickboard is a movable scaffolding supported by cable rigging. It provided below-deck inspection of the truss and twin girder approach spans as seen in Figure 4.

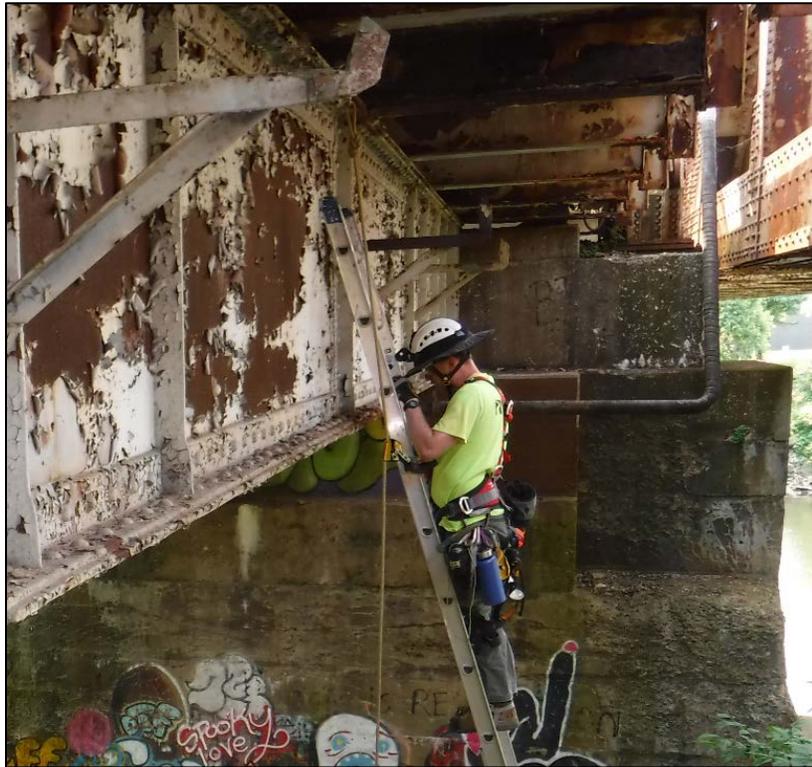
Figure 5: Girder inspection from extension ladder

Inspectors used extension ladders from the ground when inspecting the twin girder superstructures of Spans 1, 2, and 6 and for sounding substructure where practical (Figure 5).

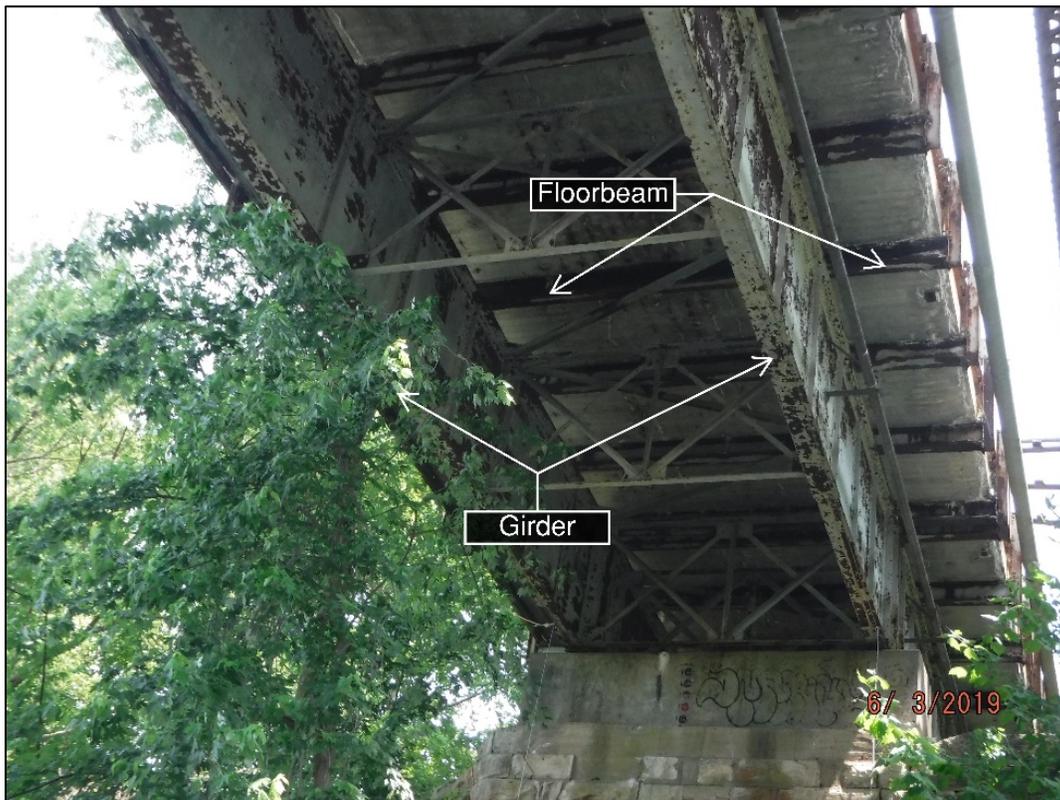
Figure 6: Approach spans member types

The approach spans consist of twin steel girders spanned by floorbeams, with a reinforced concrete deck. These members were modeled and load rated in LARS Bridge.

Field measurements were used for determining dimensions of bottom flange plates, angles, and web plates, whereas dimensions noted in repair plans from 1950 were used for top flange plate, lateral bracing, and floorbeam member sizes. Although the Broadway Street Bridge was constructed circa 1910, material properties for steel bridges constructed prior to 1905, based on the AASHTO (American Association of State Highway and Transportation Officials) Manual for Bridge Evaluation, was conservatively used in the analyses.

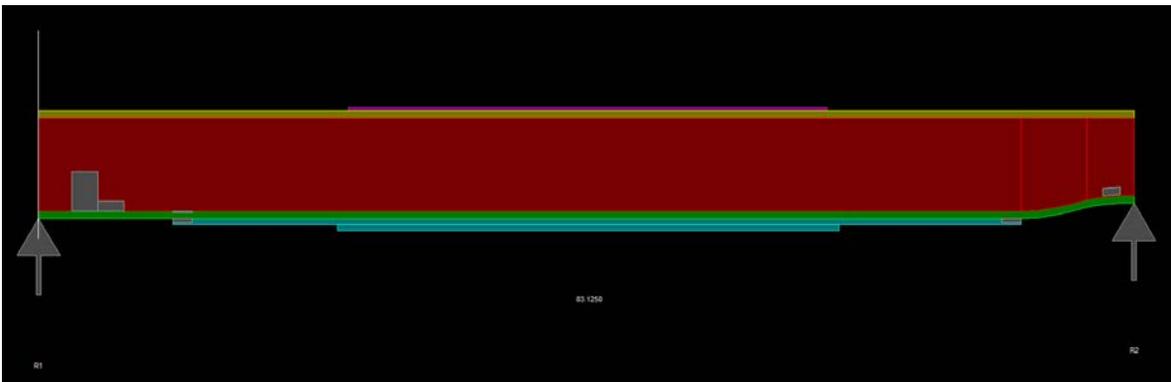
Figure 7: Span 4 Steel Girder modeled in LARS Bridge

Load demands were found using continuous beam theory for prismatic sections, and distribution factors for girders and floorbeams were calculated using a tributary width for interior members and simply-supported beam distribution for exterior members. The beam's self-weight was scaled up by a factor of 1.1 to account for splice plates that were not included in the structural model due to deterioration, heavy pack rust, connecting elements, and pipes running along the upstream side of the girders. Lateral bracing loads were averaged and applied as a distributed load along the length of the girders. Section loss was input based on field notes and observations, and only the worst case of deterioration of the two girders within a span was modeled.

The twin girders on the approach spans were found to have sufficient capacity to support a full-width (23.25 ft.) 8" thick cast-in-place concrete deck and full pedestrian loading despite some deterioration (top flange cover plates at floorbeams). Span six controlled the load rating for all girders for both pedestrian loading and H10 truck loading, but had rating factors quite a bit larger than the 1.0 minimum required.

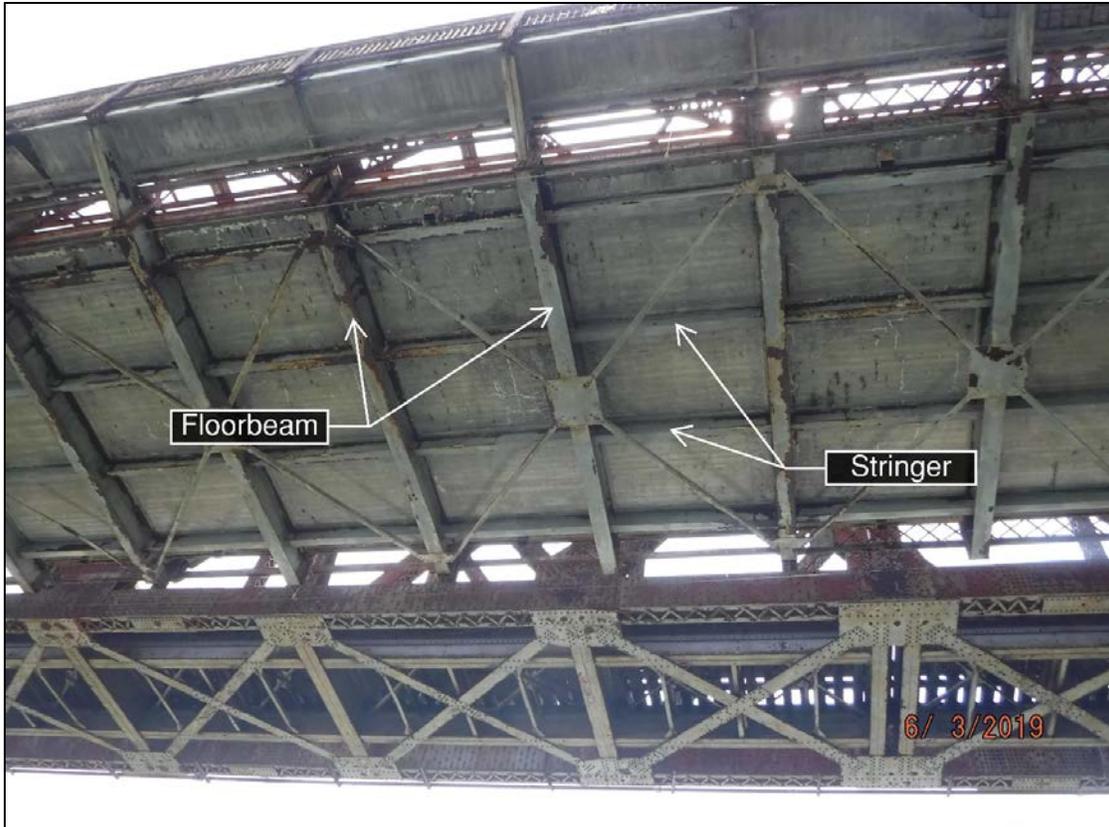
Figure 8: Truss member types below deck

The floorbeams and stringers on the truss span were modeled in LARS Bridge with the same procedure as described above for the approach span's floorbeams and stringers.

Floorbeam

Stringer

On the truss span, the five floorbeams located under deck joints are also deficient, and were found to have a rating factor of 0.50 for the H10 truck and would need to be replaced. The other floorbeams in the truss span rated at greater than 1.0 for pedestrian loading and H10 loading.

The stringers in the truss span that are adjacent to any deficient floorbeams will also require replacement. The exterior stringers are also in a deteriorated state, and will need to be removed or replaced, depending on the width of the pedestrian path selected.

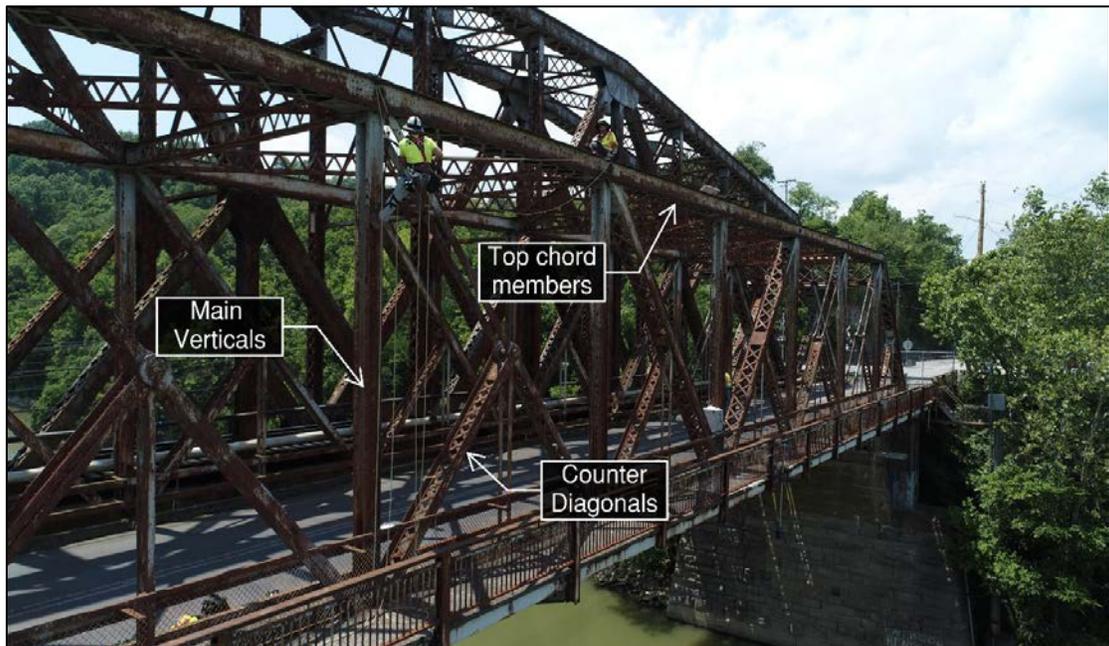
Figure 9: Truss member types above deck

SAP2000 was used to model the truss itself as a two-dimensional elastic structure.

Main Verticals

Top chord members

Upper chord members have section loss at splice plate locations. The sufficiency of these members depends on the width and type of pedestrian path selected. For a full-width pedestrian path (23.25 ft. available between truss lines), with an 8" cast-in-place concrete deck, these members have a rating factor of 0.90, and will need to be repaired. However, if a narrower pedestrian path is selected, or one with a wearing surface of a lighter material than concrete (such as wood), these members may not require replacement. In the case of a 12-ft wide pedestrian path with 8" cast-in-place deck, these members are able to support pedestrian and H10 loading in their current condition.

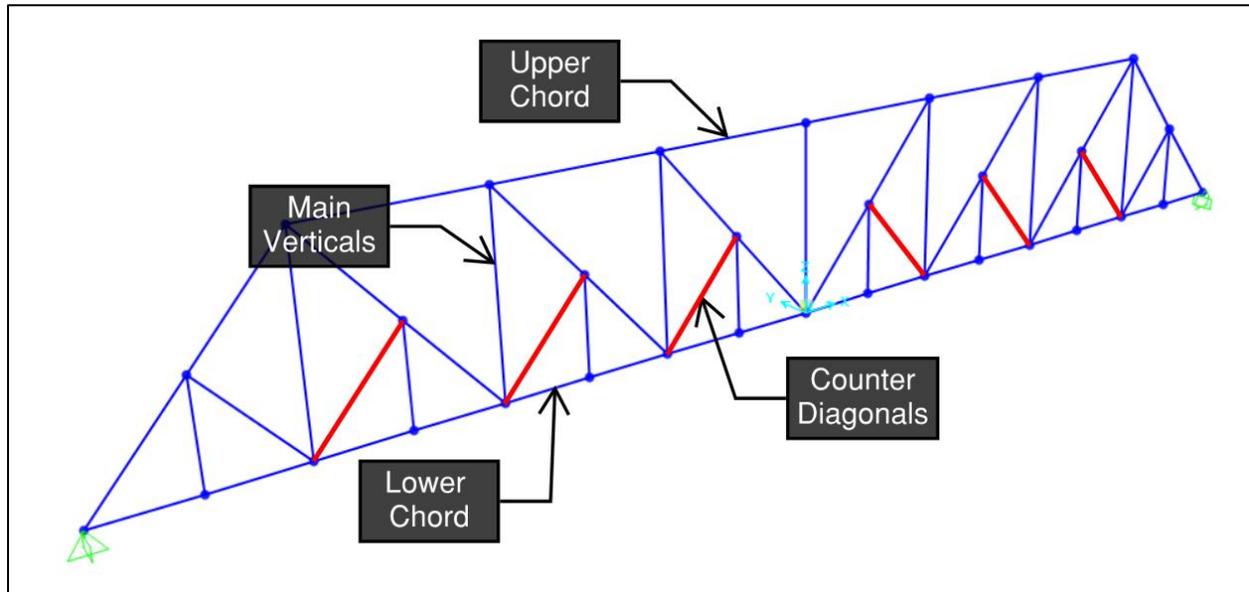
Figure 10: Truss Span modeled in SAP2000

Only one trussline was analyzed, using section properties of the more deteriorated of the two. Simply-supported floorbeams between the trusslines allow for quick determination of nodal loads to each of the two truss lines for any patch, strip or off-center loadings.

The connections between truss members are pin connections, which transfer no moment between members. This is a simplification since, in reality, connections often have enough stiffness to transfer some moment between members, but this load transfer is typically very small and pin connections are accurate for most truss bridges. This assessment uses conventional truss design and behavior with axial-only members and all loads applied to nodes.

Gross cross sectional area for each member were used in the truss model to determine maximum member demands. Broadway Bridge's truss configuration is statically determinant so member stiffness does not affect the distribution of loads in the member. In contrast to determining truss member loads, section loss directly affects member capacity. Each member capacity accounts for any deterioration measured during the inspection.

The truss analyses led to several conclusions. First, the counter-diagonals present in the middle of each bay were determined to be a major component of truss stability. They have severe section loss, especially at the bottom connection, and are inadequate to carry any live load and, therefore, need to be repaired or replaced.

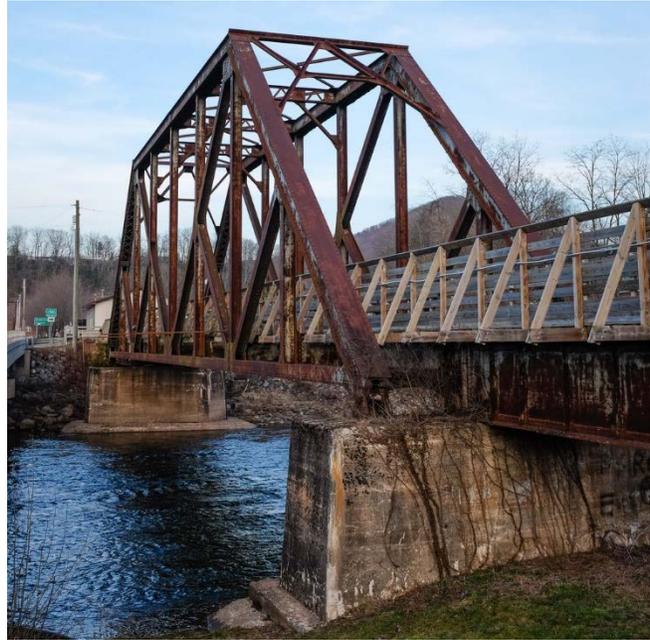
Figure 11: Wooden Pathway on Parsons, WV bridge

Additionally, a 10 ft.-wide wooden path is also an option. This boardwalk-style path has the lowest initial cost, but would require regular maintenance and replacements. It also would probably be pedestrian and bicycle only and might not be able to carry the lightweight service truck that the concrete path can. Other bridges converted into pedestrian use such as Frankfort's Benson Creek Bridge, just to the north of the Broadway Bridge, and the Parsons, WV bridge in Figure 11 are examples of wooden paths.
