Ecological Baseline Study *of*

KYTC Item I-115, I-115.1, I-118

US 60 from 0.5 miles west of KY 310 to east of Kevil
Ballard and McCracken Counties, Kentucky

Third Rock Consultants, LLC
2526 Regency Road, Ste 180, Lexington, Kentucky 40503

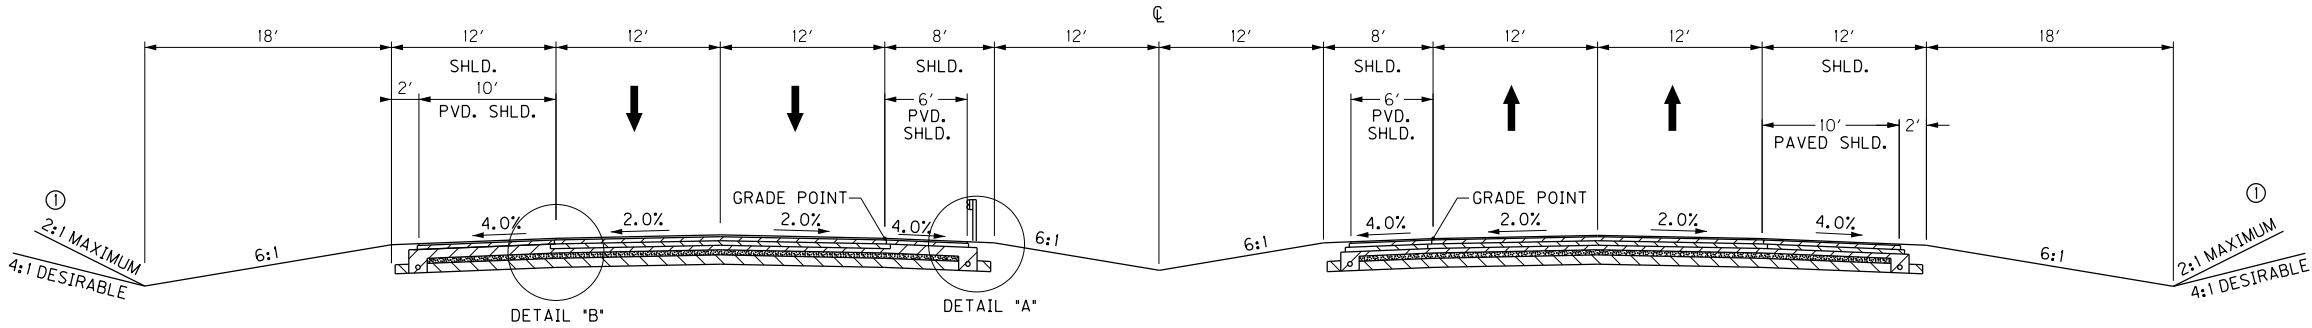
RURAL (NORMAL) SECTION
TEMPLATE USED ON ALIGNMENT SECTIONS:
1-A, 1-B
2-A, 2B
3

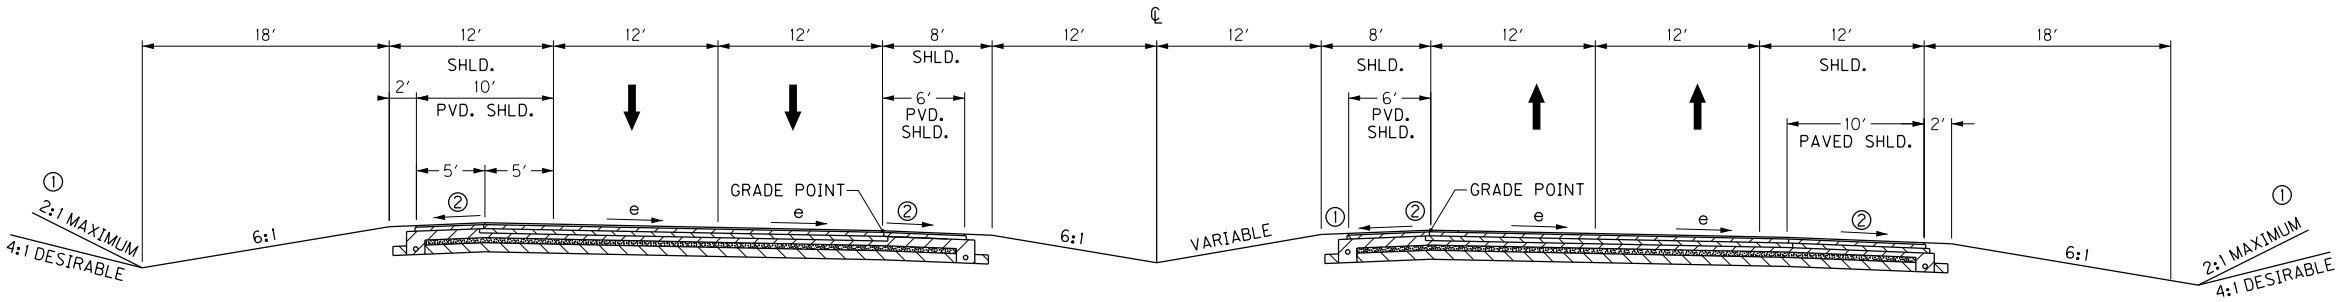
RURAL (SUPERELEVATED) SECTION
TEMPLATE USED ON ALIGNMENT SECTIONS:
1-A, 1-B
2-A, 2-B
3

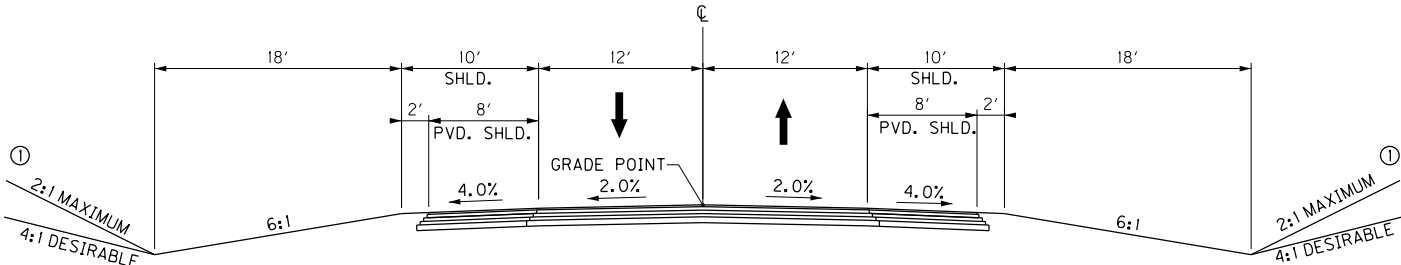
SUPER 2 - RURAL (NORMAL) SECTION
TEMPLATE USED ON ALIGNMENT SECTIONS:
1-A, 1-B
2-A, 2-B
3

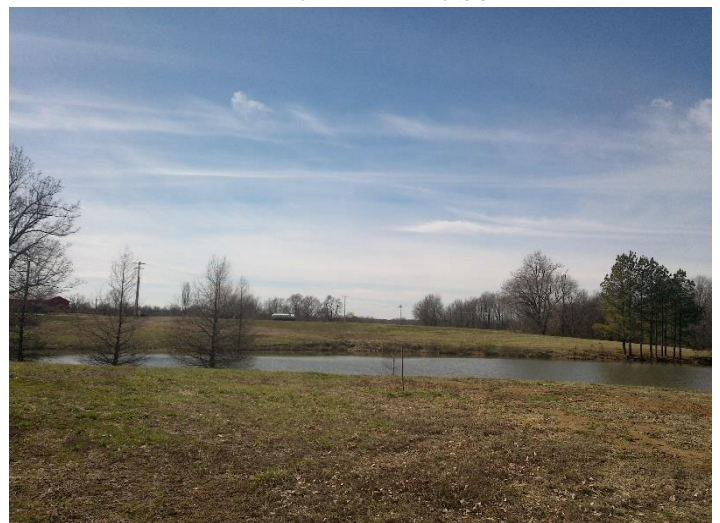
Pond I, No Wetland Fringe.jpg

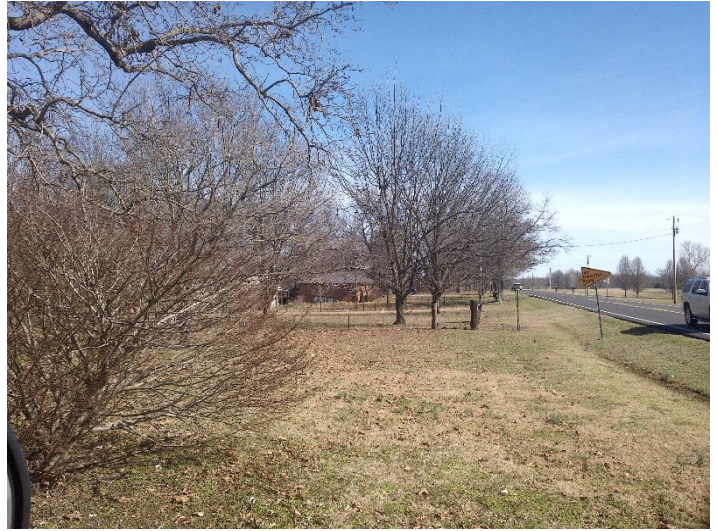
Roadside Ornamentals - No Bat Habitat.jpg

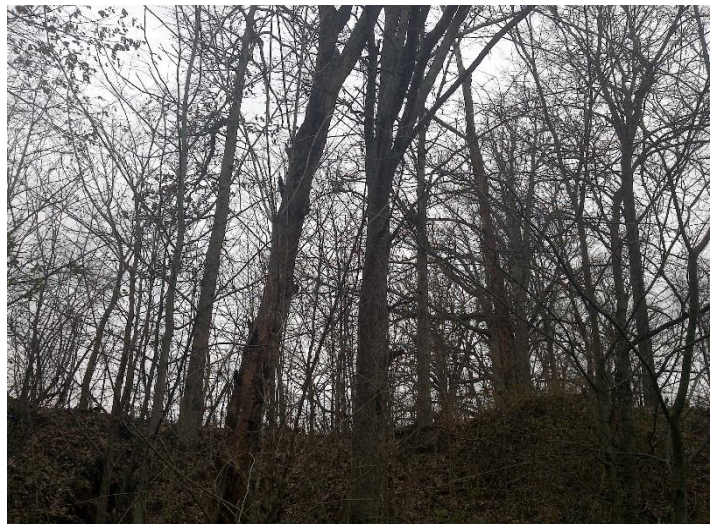
Snags of Maternity Size.jpg
