Streamlining Section 7 Review

2019 ACEC-KY/FHWA/KYTC Partnering Conference
September 4, 2019

Bridging Kentucky Goals

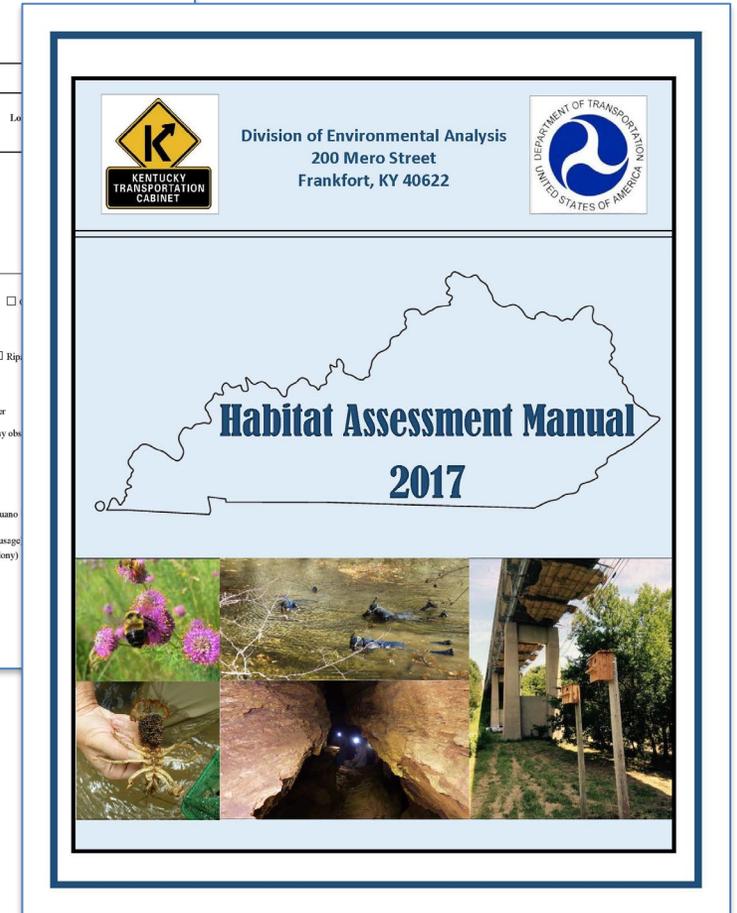
BATS IN BRIDGES DATASHEET

- KYTC Habitat Assessment Manual
- Bats in Bridges Datasheet
- Site reconnaissance
- Water quality screening
- Visual screening

Bridge Type: (check one)

Bat indicators: (check all that apply) Visual Smell Sound Staining Guano

Use intensity: (check one) Minor (scattered guano/staining - few bats or temporary usage) Major (guano piles/staining obvious - semipermanent colony)

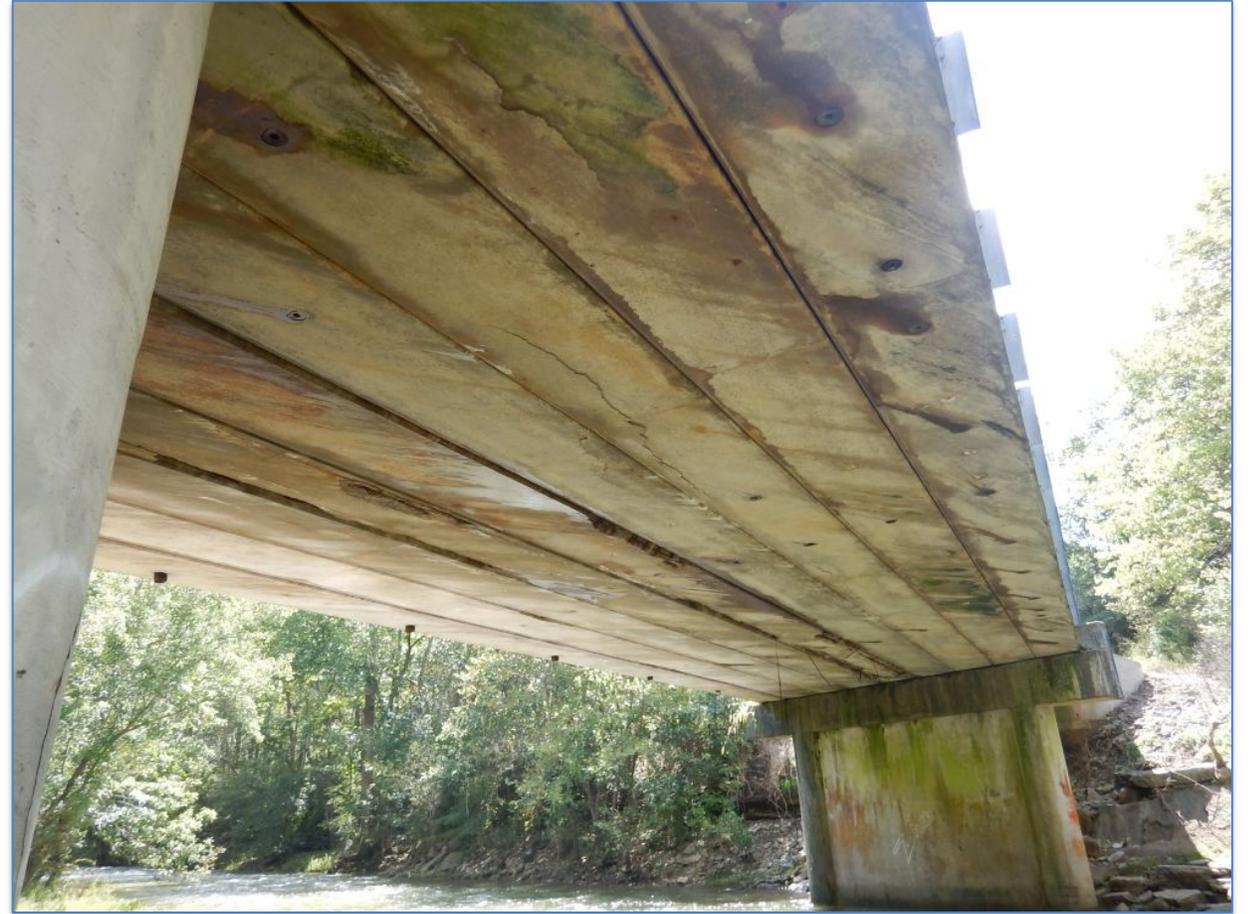
Jessamine County Bridge

- Box beam bridge built in 1983
- Tensioning rod failure and beam separation observed
- Superstructure replacement
- Project letting and construction proposed for fall 2019

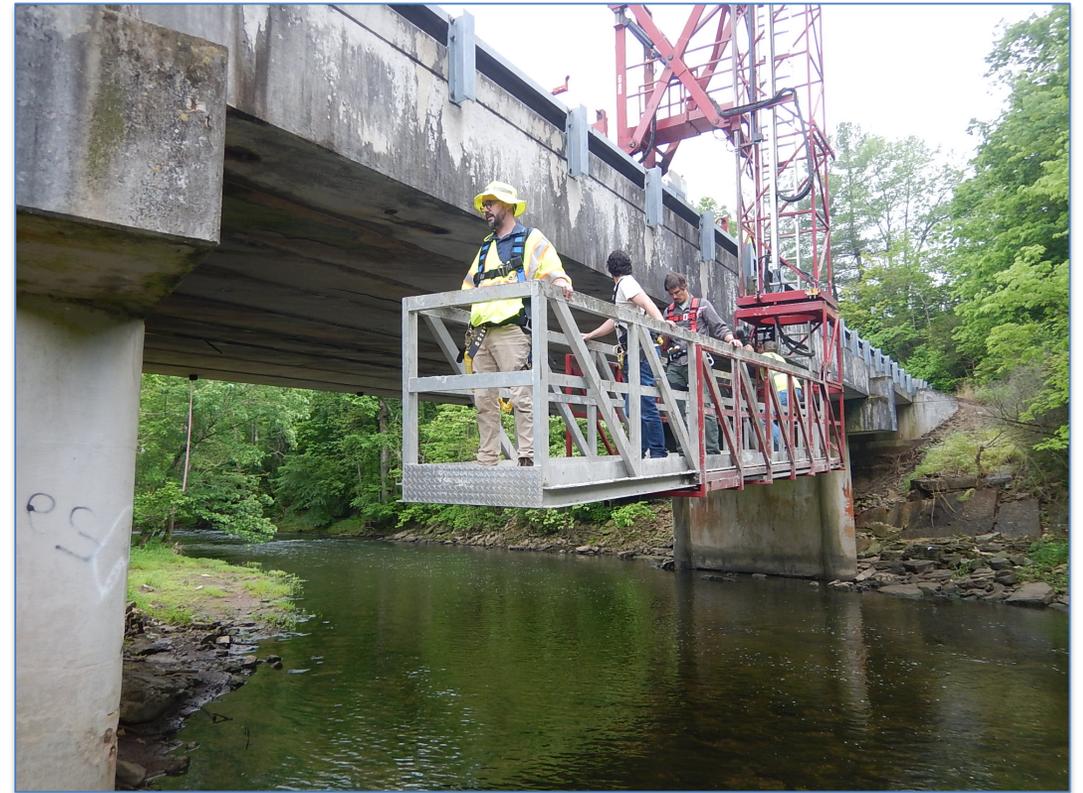
Jessamine County Bridge

- Bat signs and individuals identified
- No habitat for plants and mussels
- USFWS confirms known gray bat maternity colony
- One of few remaining maternity colonies in Bluegrass Region
- USFWS estimates 4,000 bats during maternity season

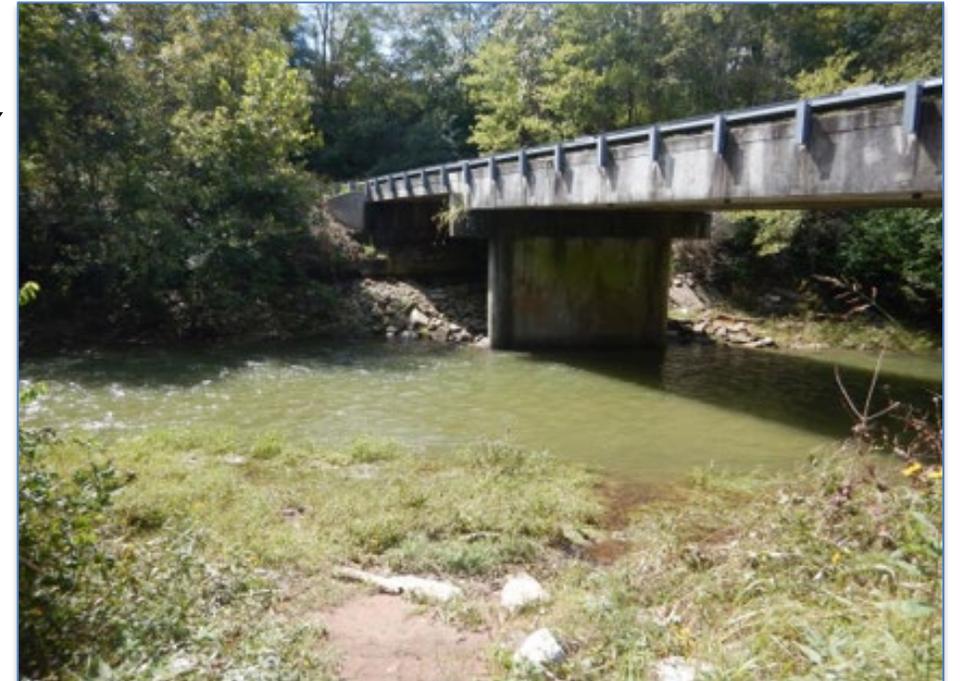
Coordination and Reporting Timeline

- 3 / 2019 - Roosting locations mapped
- 4 / 2019 - Meet with USFWS & Bridging KY
- 4 / 2019 - Meet with project engineer
- 5 / 2019 - Platform inspection of bridge
- 6 / 2019 - First draft BA submitted
- 7 / 2019 - Final draft BA submitted
- 8 / 2019 - Final Section 7 approval

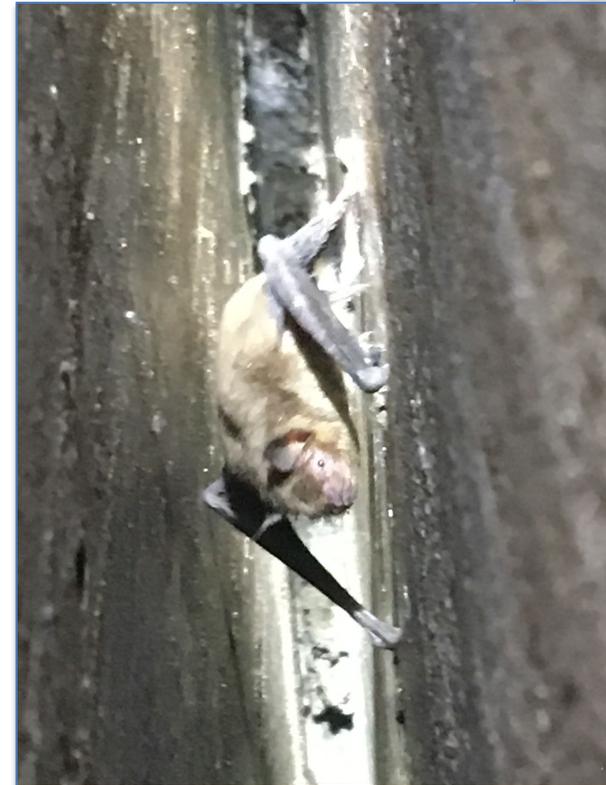
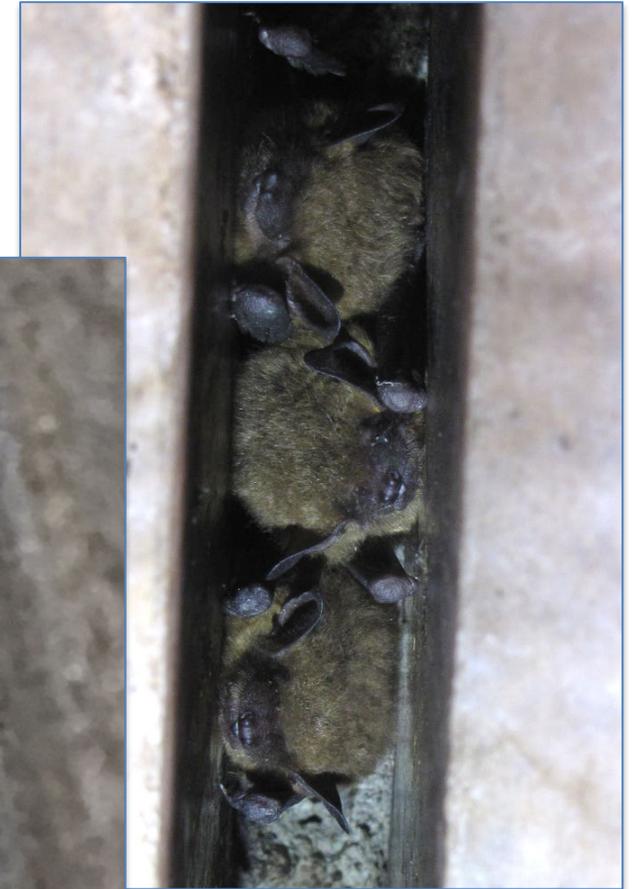
Avoidance and Minimization Measures

- Construction timeframe limited to November 15 to March 31
- Typical erosion and sediment control measures
- Preconstruction platform bridge inspection
- Post-construction monitoring
- **BUILD A BAT BRIDGE** for recolonization of gray bats

Building a Bat Bridge

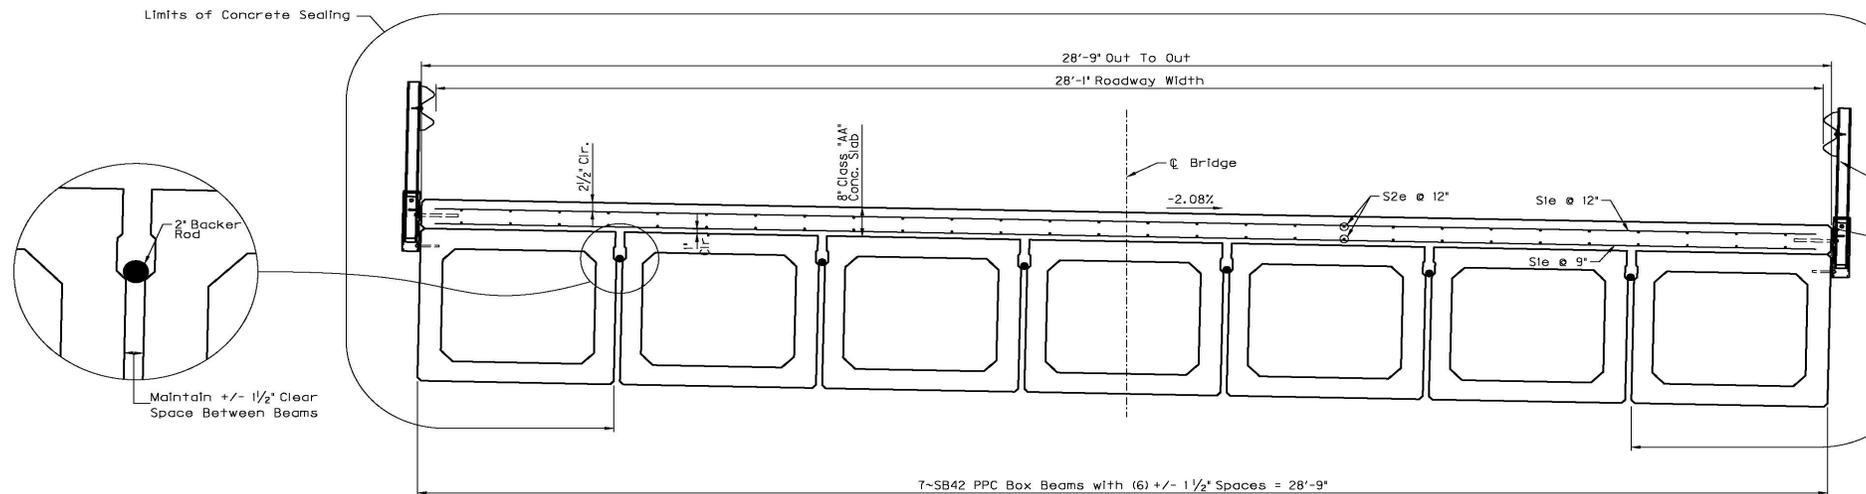
TYP. SECTION (SPANS 1 & 3)

- Box beam gap spacing of 1.5"
- Net increase of linear roosting area from 572' to 762'
- Joint depths range from 9" to 34"
- Roosting volume increase from 133 ft³ to 218 ft³
- Stable and protected bat habitat for 30-year lifespan bridge design

Design Parameters
