Quality Matters

Vol. VIII Issue 1—Spring 2018

from the Quality Assurance Branch (QAB) of Highway Design

Pass-through over Turtle Creek

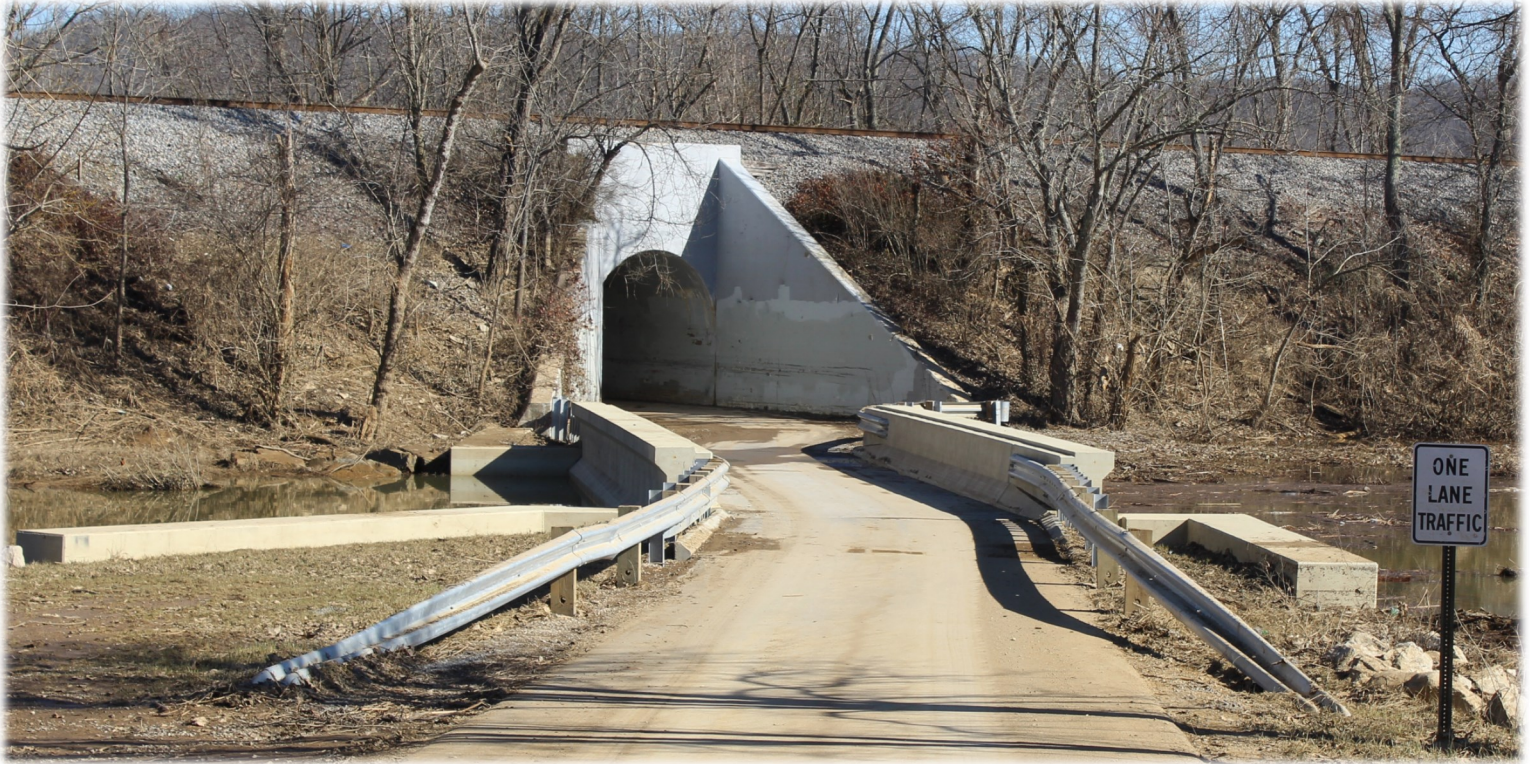
Roadway alignment constraints, water elevation, loose soil and underground obstructions typically aren't the conditions you hope for when beginning a bridge replacement project, but that's what a one-lane bridge over Turtle Creek in Bracken County presented to designers and District 6 construction staff. Challenging conditions can lead to innovative solutions, though, and that's just what happened in this situation.

Designers then considered the pass-through concept using precast concrete beams. Differing from a conventional design in which the deck sits on top of the concrete beam, Turtle Creek's bridge deck is supported on the lower flange of the beam – a design that drove up the unit cost sub-

stantially for each beam. However, the unusual design required only two beams instead of the normal three, making it non-redundant and best used for narrow bridges.

The bridge deck was poured and tied into the beams using rebar. The lateral stiffness of the beams was increased even more by pouring the barrier wall against the beams and tying it to both the beams and the deck. As a result of the bracing requirements, the deck required hand, rather than machine, finishing.

To contain and support the abutments and wing walls, designers drove interconnected, steel sheet piles into the 30 feet of soil that sat on top of bedrock. After the crew drove the sheet piling, affixed a concrete pile cap, and placed an anchor wall and wing walls, the substructure became a solid platform for the concrete beams, and a new bridge was well on its way.

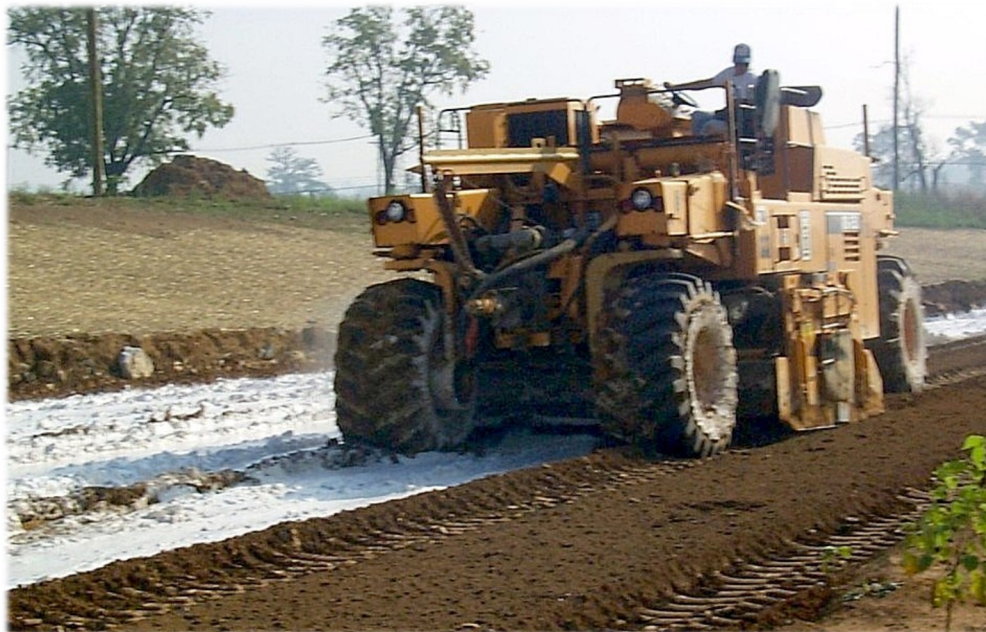
While the ability to reduce costs is a major incentive for using chemically treated subgrades, the increased longevity of the asphalt or concrete pavement is an even bigger incentive. Base failures are indicative of a weak subgrade. When first compacted, clay soils have a high bearing strength. However, when exposed to water, the soil absorbs moisture and forms a soft layer in the subgrade, which leads to a reduction in soil density and bearing strength.

Chemically treated subgrades are not weakened by exposure to water. A soft layer will occur under the treated subgrade as well, but when located deeper, it is impacted less by traffic stresses, which makes the soft layer less consequential. One consideration to be aware of is that chemically stabi-
