Turkeyfoot Road (KY 1303) Scoping Study

Barnwood Dr. (MP 5.085)
to
I-275 (MP 5.797)

December 13, 2017

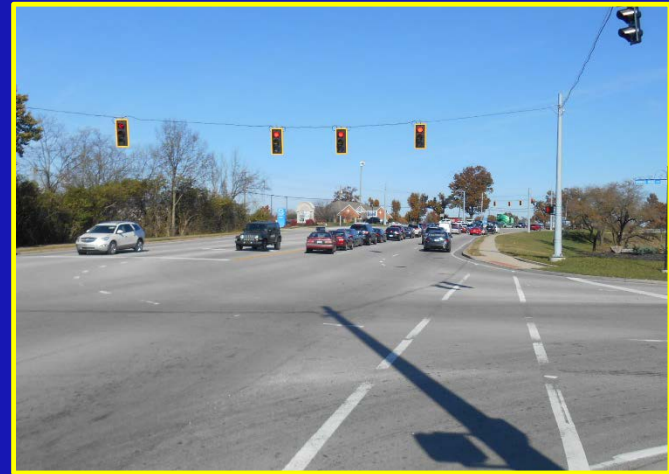
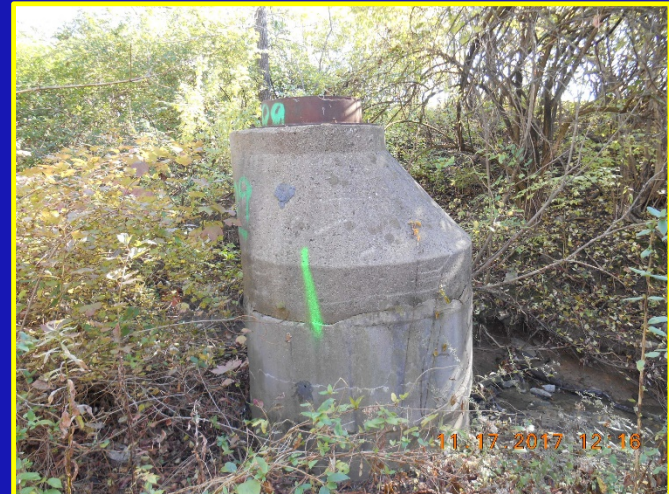
Existing Roadway Conditions

- Lane, Shoulder, and Median Configuration
- Turning Movements
- Origin – Destination Movements
- Access Points
- Accommodations for Bicycles and Pedestrians
- Geometry not meeting current standards

TURKEYFOOT RD (KY 1303)
TRAFFIC AND ROADWAY CHARACTERISTICS
DECEMBER 13th, 2017

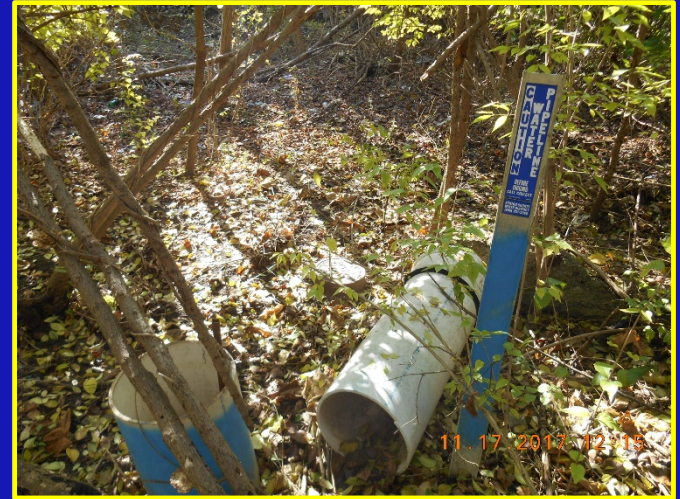
Existing Utilities

- Water
- Natural Gas
- Overhead Utilities
- Underground Electric
- Communications – Fiber, TV, Telephone
- Storm Sewer
- Sanitary Sewer
- Right of Way / Property

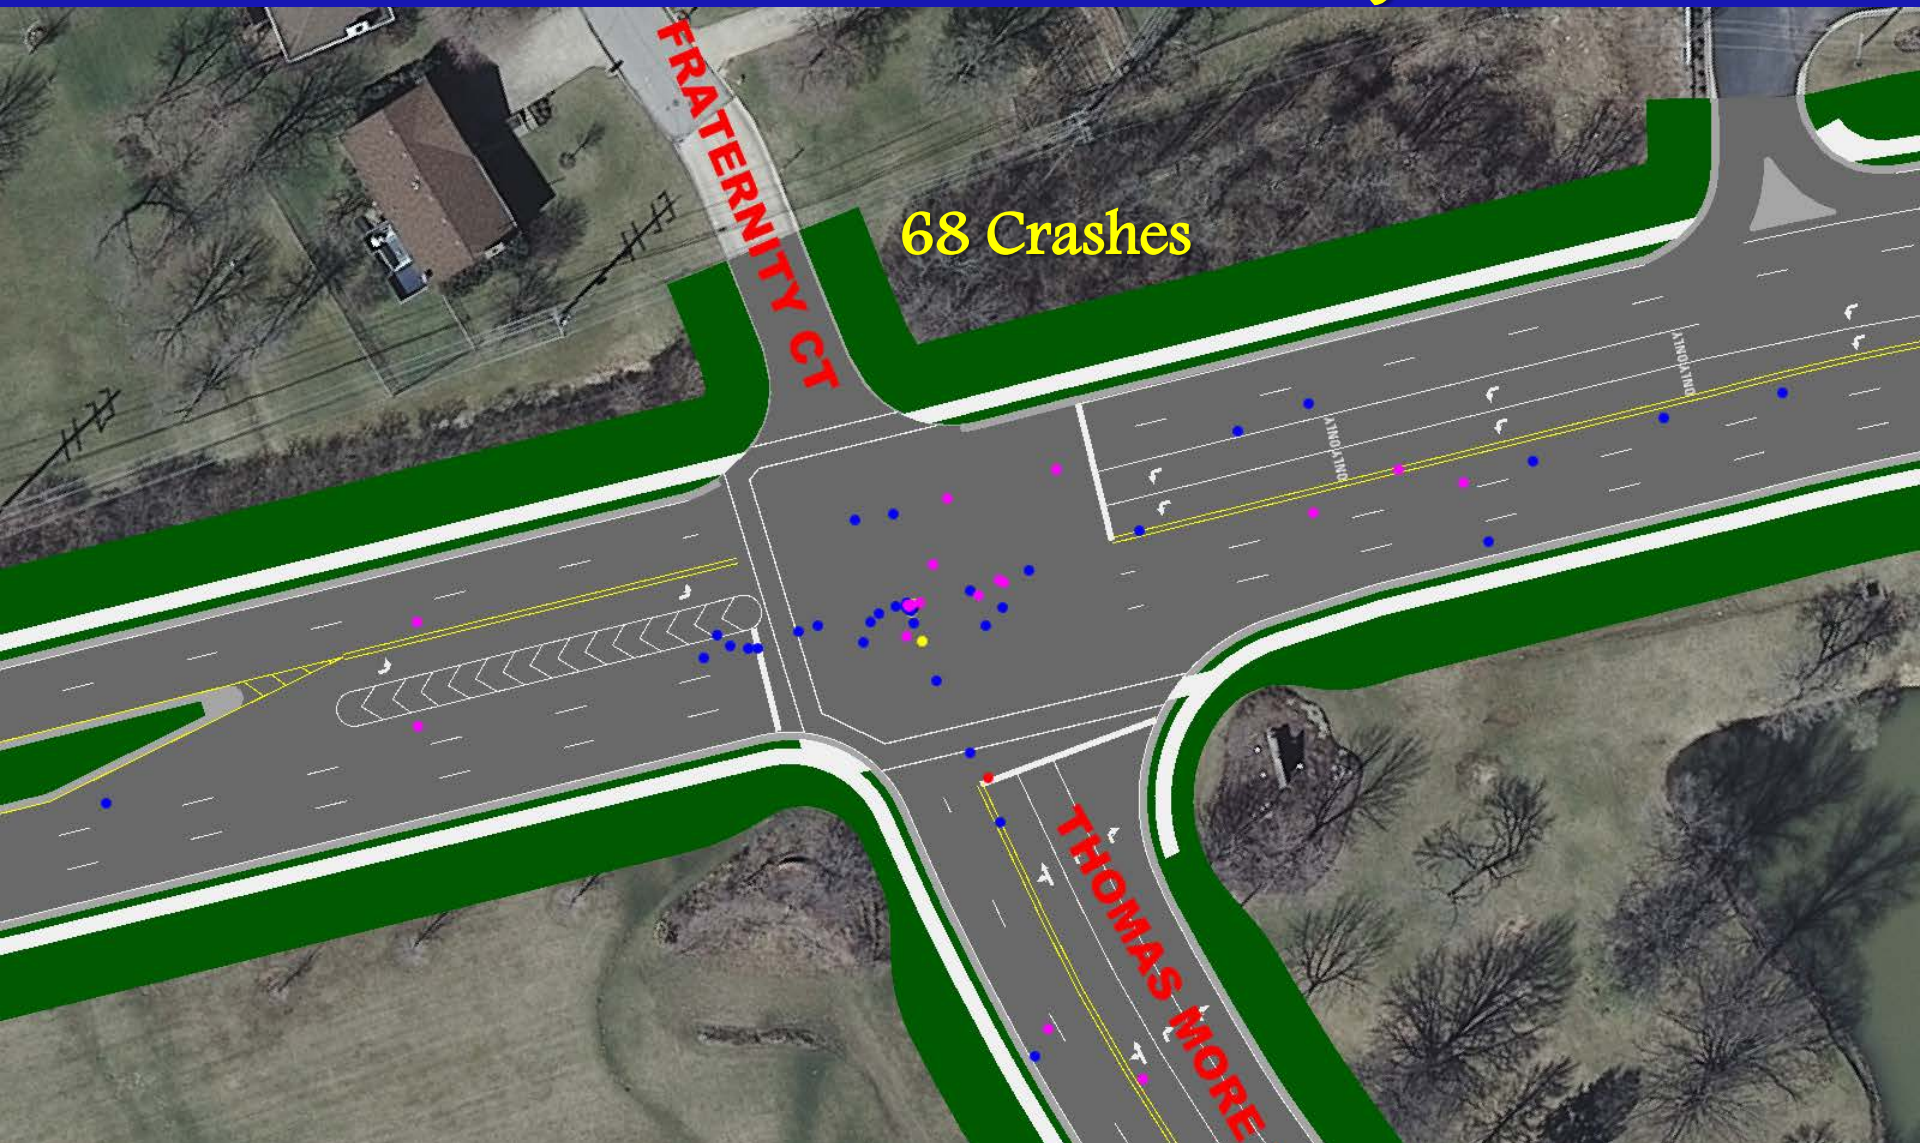
Thomas More Parkway

Crash Histories

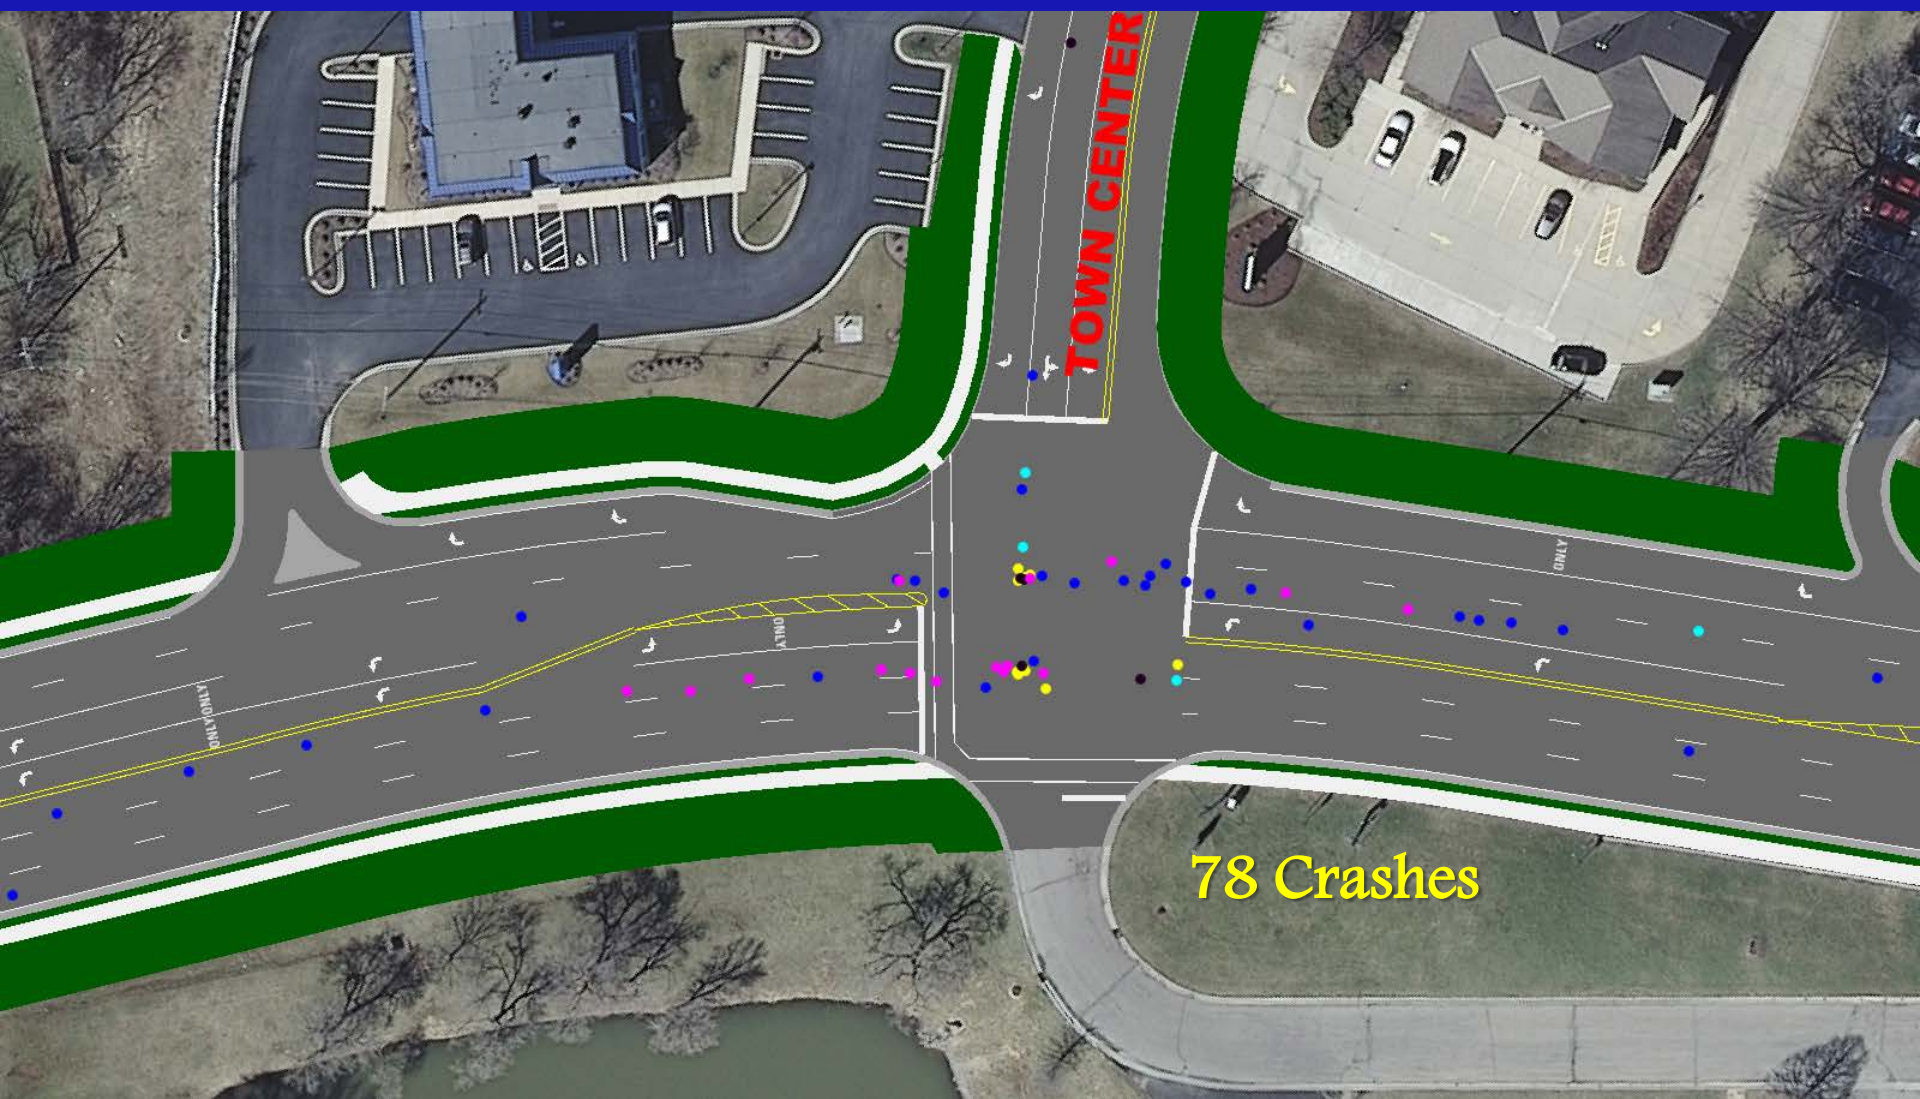
Town Center Blvd

Crash Histories

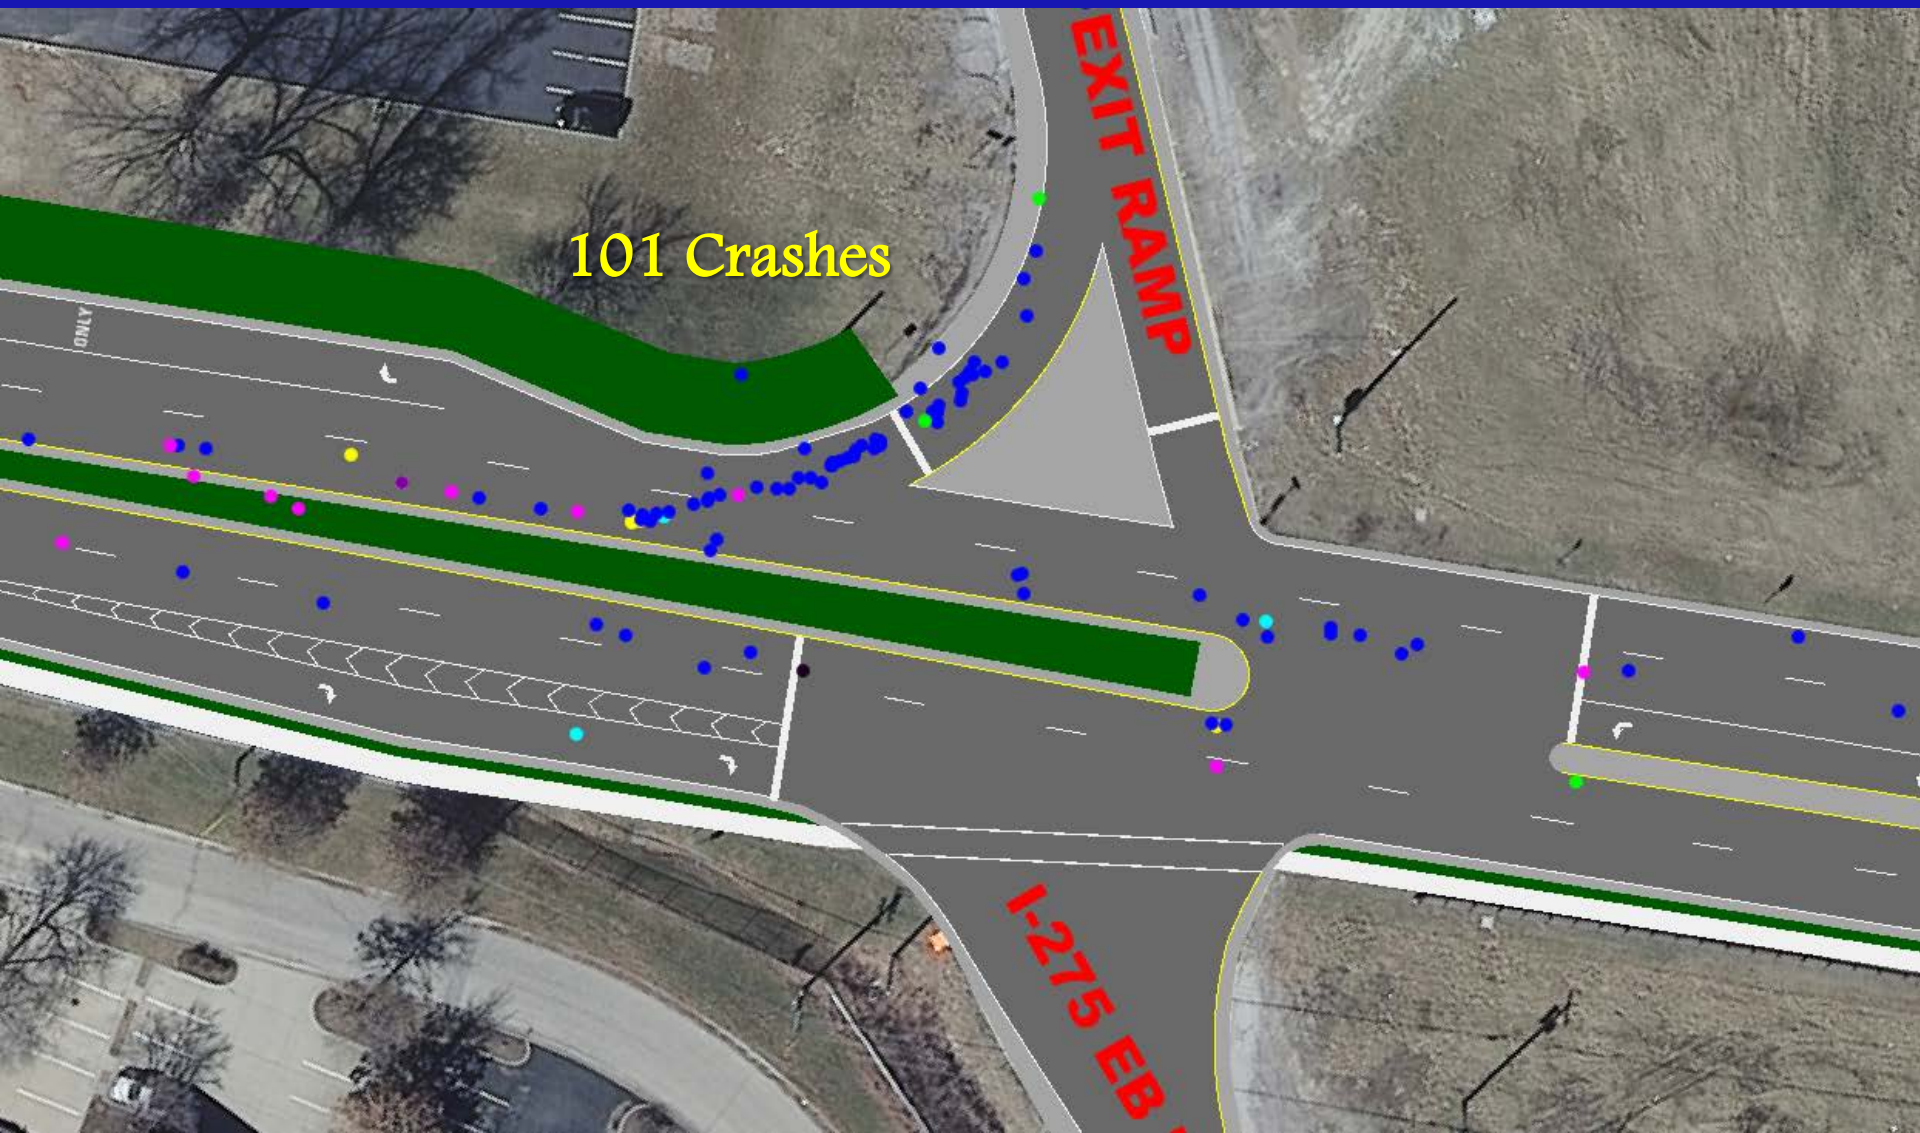
I-275 EB Off-Ramp

Crash Histories

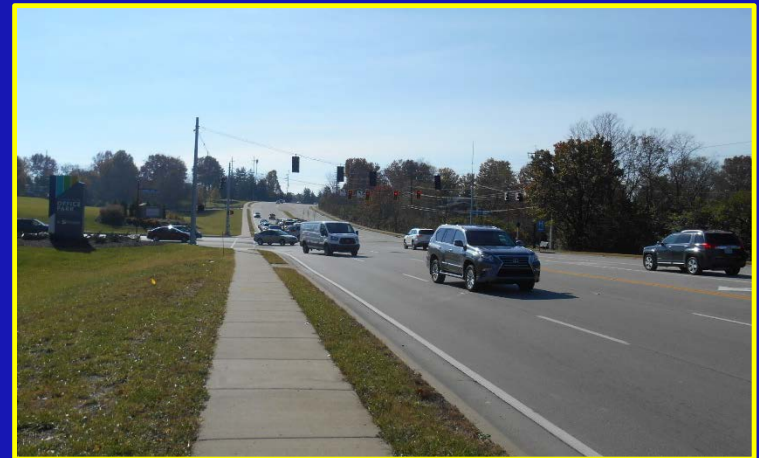
Traffic Analyses

- Traffic Counts – *video count methodology*
 - *24 Hour Count – October 3, 2017*
 - *Identification of critical traffic weaving operations*
- Calibrated with field run travel times
- Operational Characteristics
 - *Travel Times*
 - *Queue Lengths (back-ups)*
 - *Delay / Level of Service*
