**APPENDIX B:
ENVIRONMENTAL
OVERVIEW**

**Environmental Overview (EO) –
US 68 Corridor Study, Jessamine
and Mercer Counties, Kentucky**

KYTC Item No. 7-80251.00

Stantec Consulting Services, Inc.
Lexington, KY

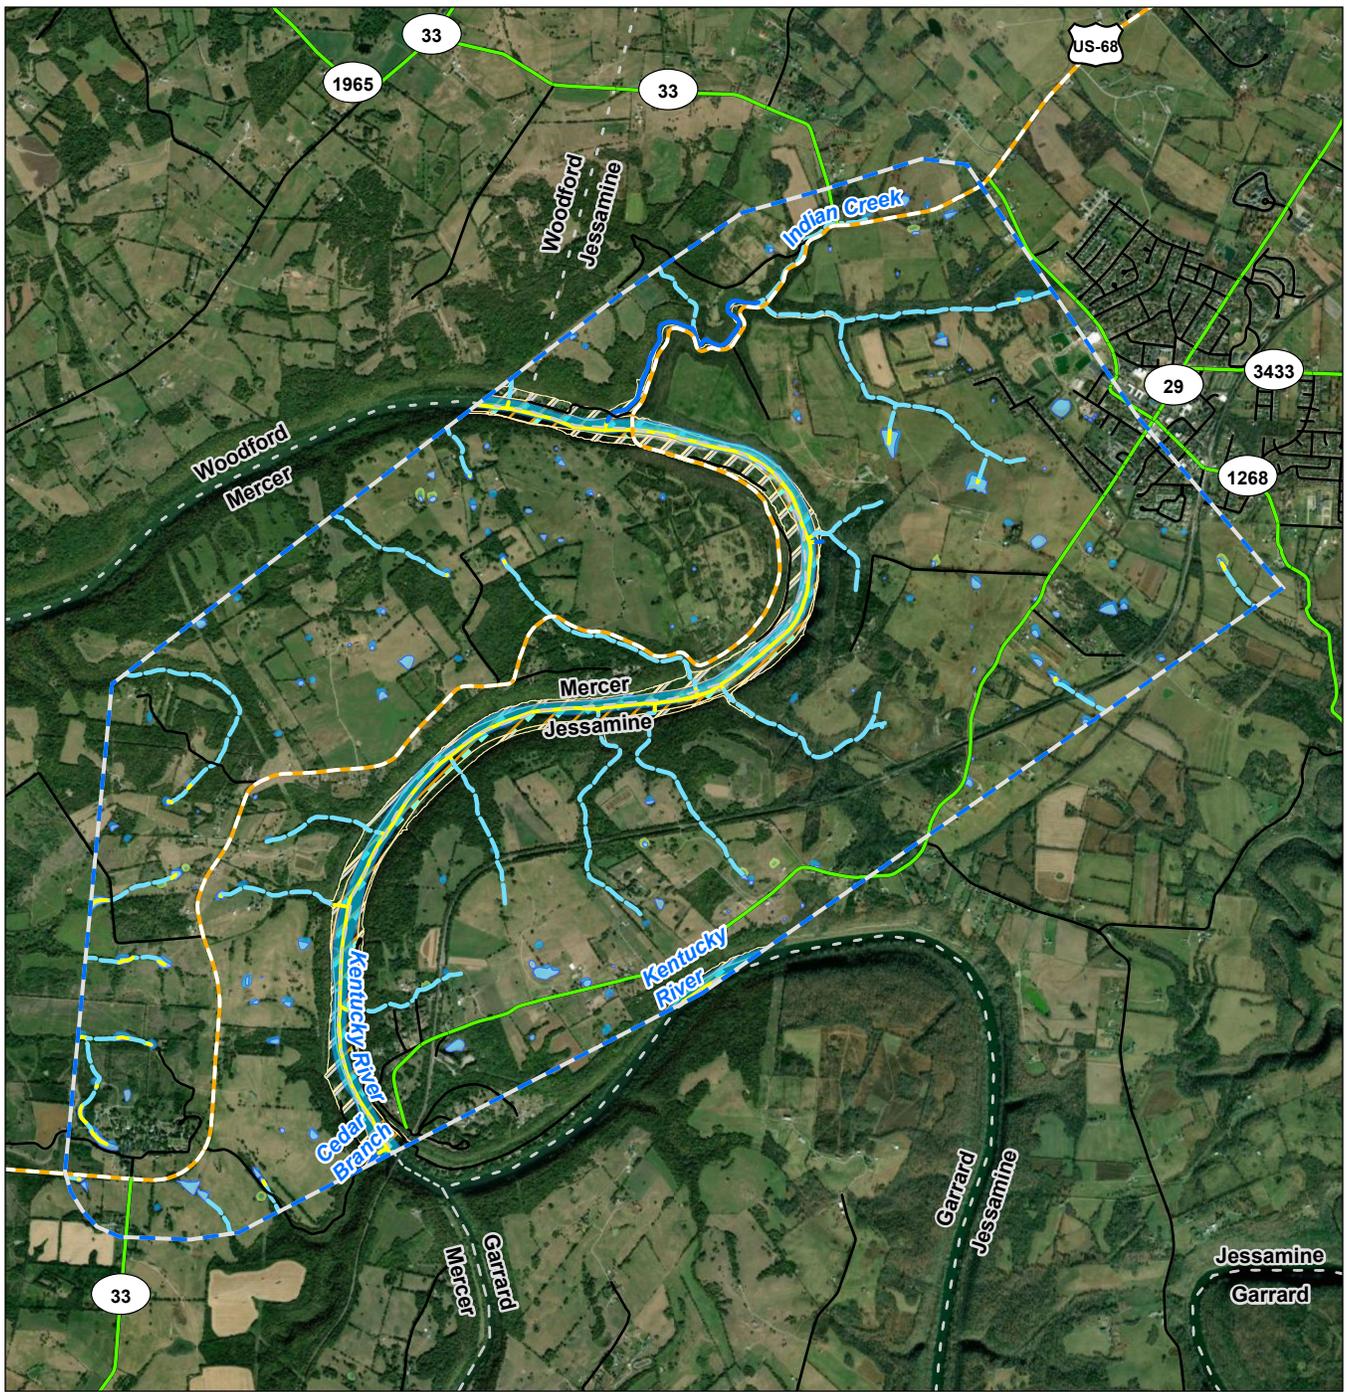
FEMA Special Flood Hazard Areas

- Project Overview Map (**Figure 1**)
- Water resources (**Figures 2 & 3**):
 - FEMA National Flood Hazard Layer (NFHL) Data
 - USGS National Hydrography Dataset (NHD) Streams & Waterbodies

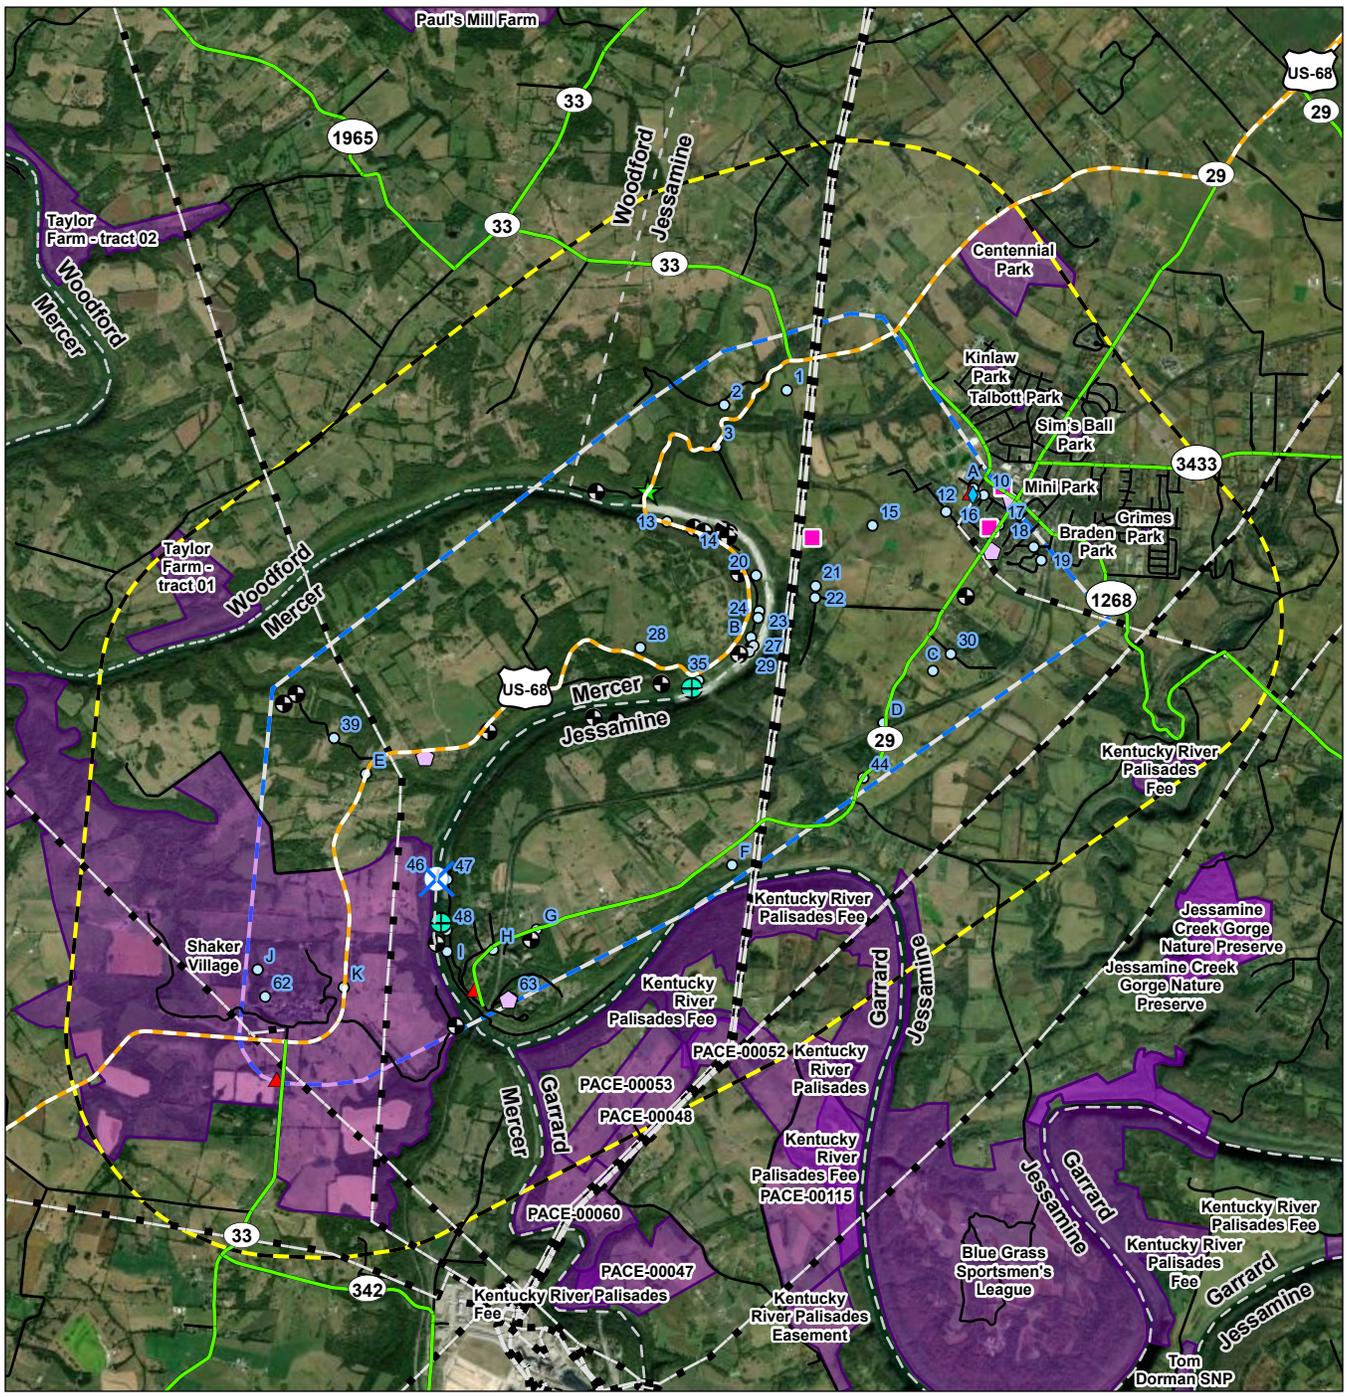
- Legend**
- Study Area
 - 1-Mile Buffer
 - US Highway
 - Interstate*
 - State Route
 - Local Road
 - Railroad
 - Educational Facility
 - ★ Boone Tunnel
 - ⊕ Boat Ramp
 - ⊗ KY River L&D #7 / Mother Ann Lee Hydroelectric Station
 - ⬠ Water Treatment Plant
 - ▲ Fire Department
 - Protected Area
 - Well
 - ⊕ Church
 - EDR Site
 - Electric Transmission Line

Potential hazardous materials concerns exist throughout the Study Area. For additional information on specific hazardous materials concerns in and around the surrounding Study Area, please reference the full EDR report (provided separately). (Figure 7, Attachment 6)

and the Palisade Adventures boat ramp are located within the Study Area. Dix River Trail is also noted from the KDFWR High Bridge boat ramp upstream to the headwaters of the Dix River. (Figure 7 and Attachment 7)

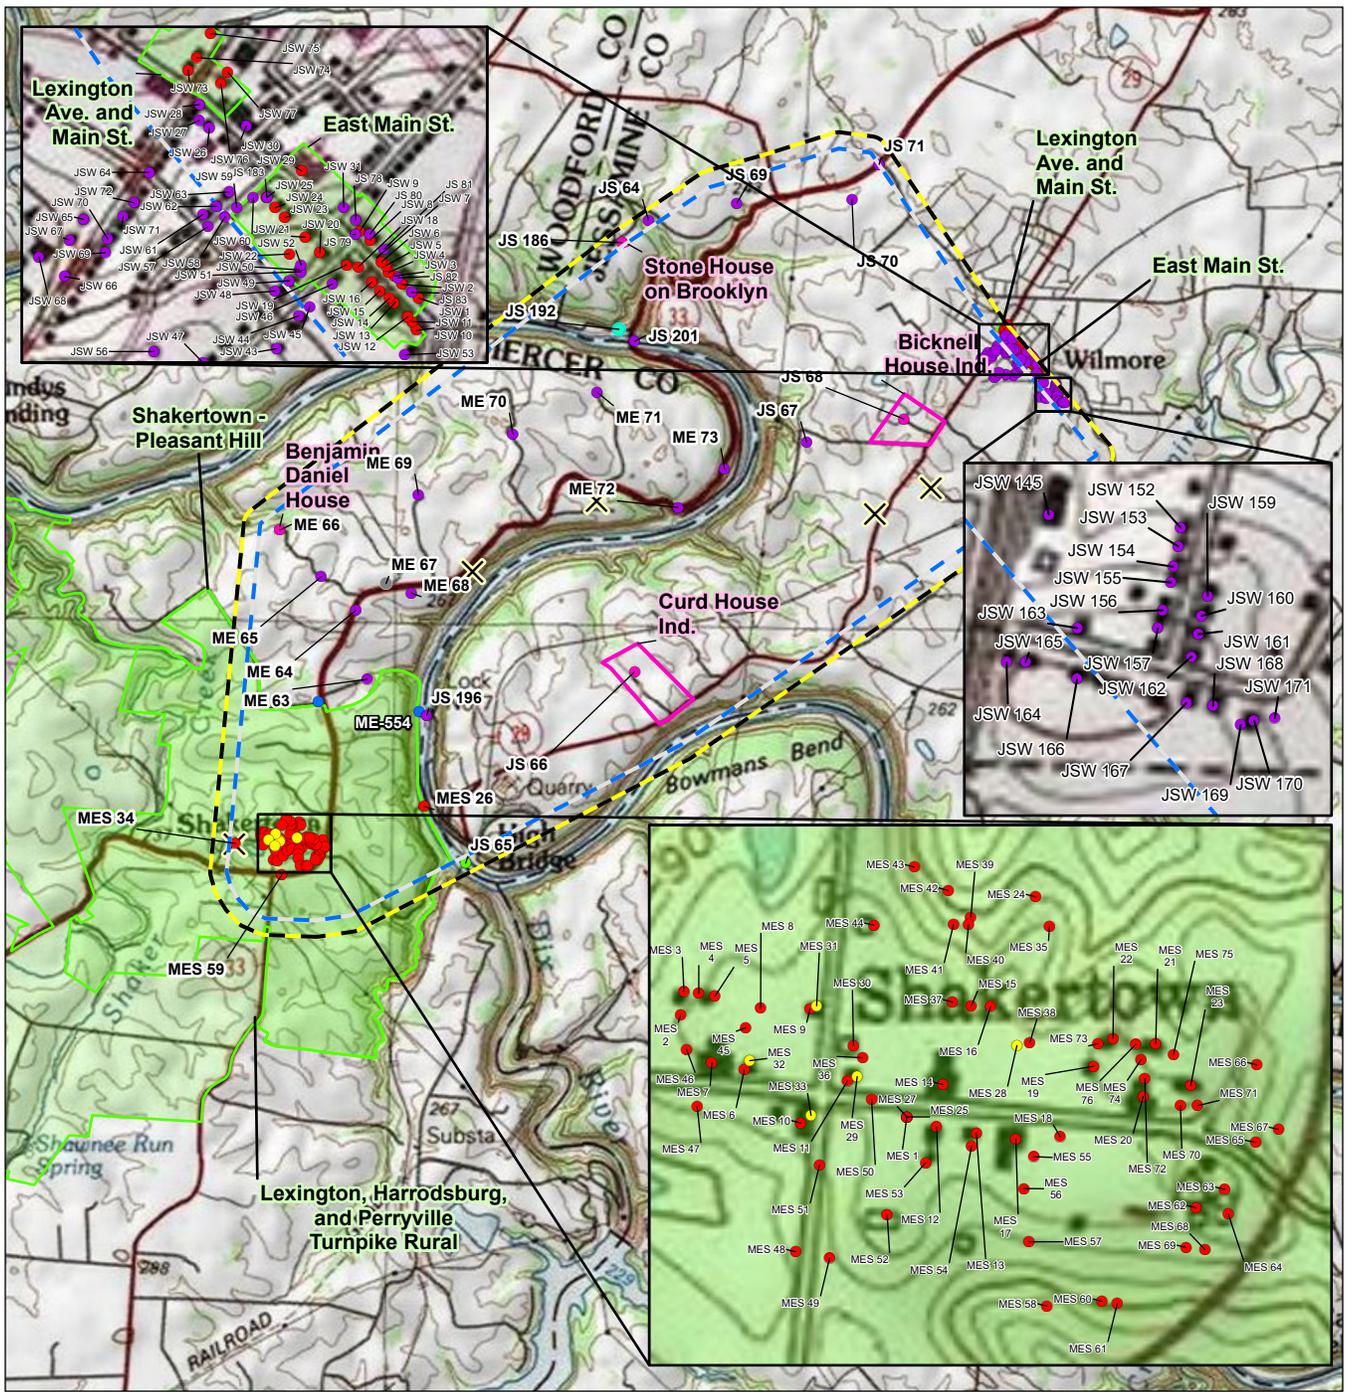
- Legend**
- Study Area
 - 500-Foot Buffer
 - Cemetery
 - NRHP Listed Property
 - NRHP Listed Historic District
 - Preliminary Resources
- Status**
- Demolished
 - Determined Eligible
 - N/R District Contrl. Site
 - National Register
 - Retired Number
 - Undetermined

Based upon these initial results and a knowledge of the area, Stantec recommends a reconnaissance historic architectural survey, regardless of funding source. This survey work will be required if the project is determined to be a federal undertaking, per Section 106 of the National Historic Preservation Act of 1966. (Figure 9)

Cemeteries: Five cemeteries were identified by KHC within the Study Area and are shown in Figure 9. Additionally, the Kentucky Historical Society's (KHS) cemeteries database notes numerous cemeteries within Mercer and Jessamine Counties; however, many KHS cemetery locations referenced family farm names or were generally incomplete so addresses were unable to be confirmed. Additional research or field verification is recommended, but based on preliminary review of the KHS list additional cemeteries within the Study Area may include Jewell Cemetery (226 Gillespie Lane), Guerrant Cemetery (825 High Bridge Pike), Lillard/Nooe Cemetery (Brooklyn Hill US 68 S or 9620 Harrodsburg Road), Champion Family Cemetery (Cornishville, KY 40330), and general areas of interest within the Study Area may include near High Bridge and Brooklyn Hill. (Figure 7, Figure 9)

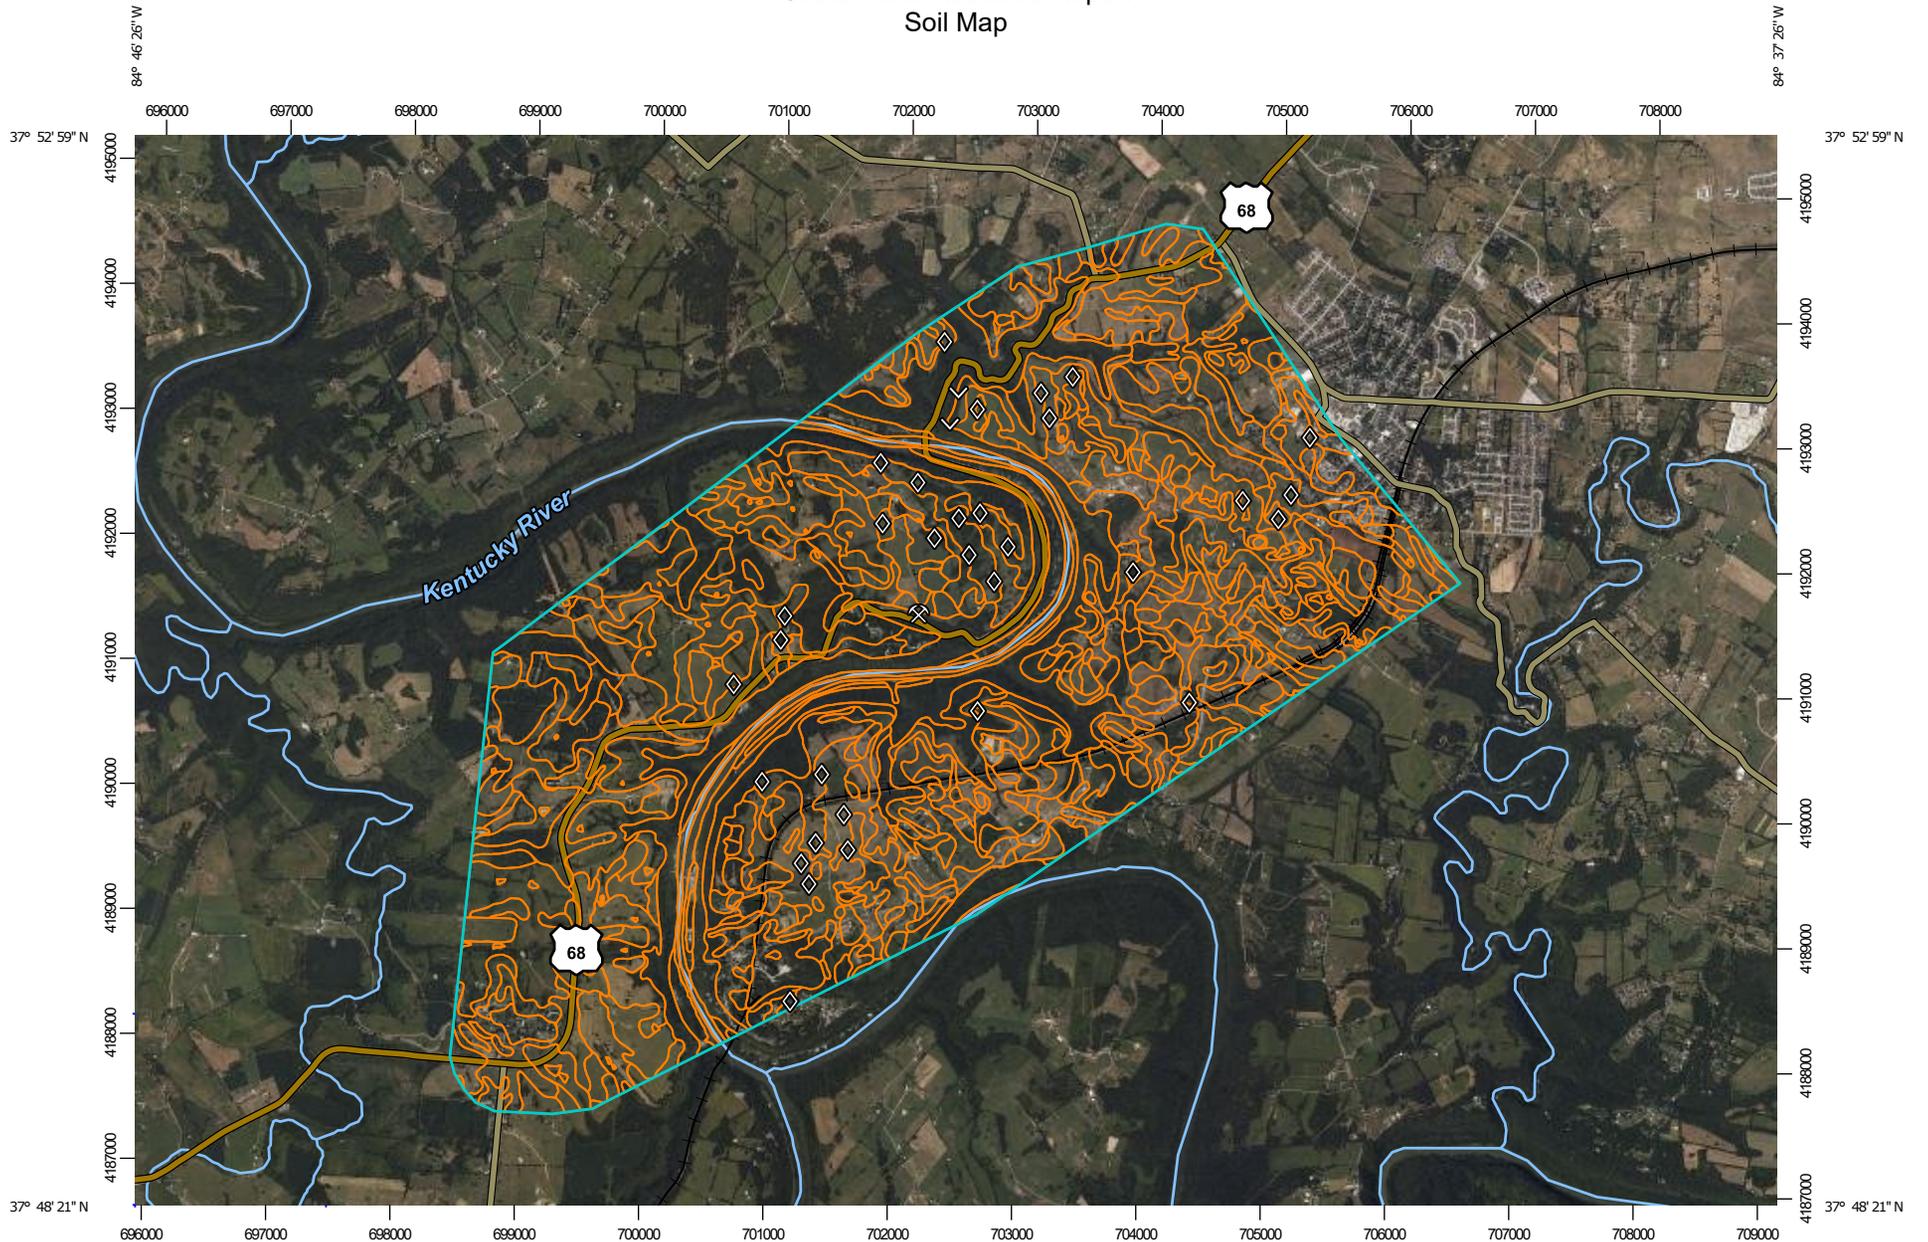
Custom Soil Resource Report Soil Map

The soil map section includes the soil map for the defined area of interest, a list of soil map units on the map and extent of each map unit, and cartographic symbols displayed on the map. Also presented are various metadata about data used to produce the map, and a description of each soil map unit.
