RE: Cultural Historic Overview Study of KY 168 (Blackburn Avenue/Wheatley Road) and Its Vicinity Between US 60 (13th Street) and Hoods Creek Pike in Boyd County, Kentucky
CRA Project No.: K230160
Contract Publication Series: 23-165

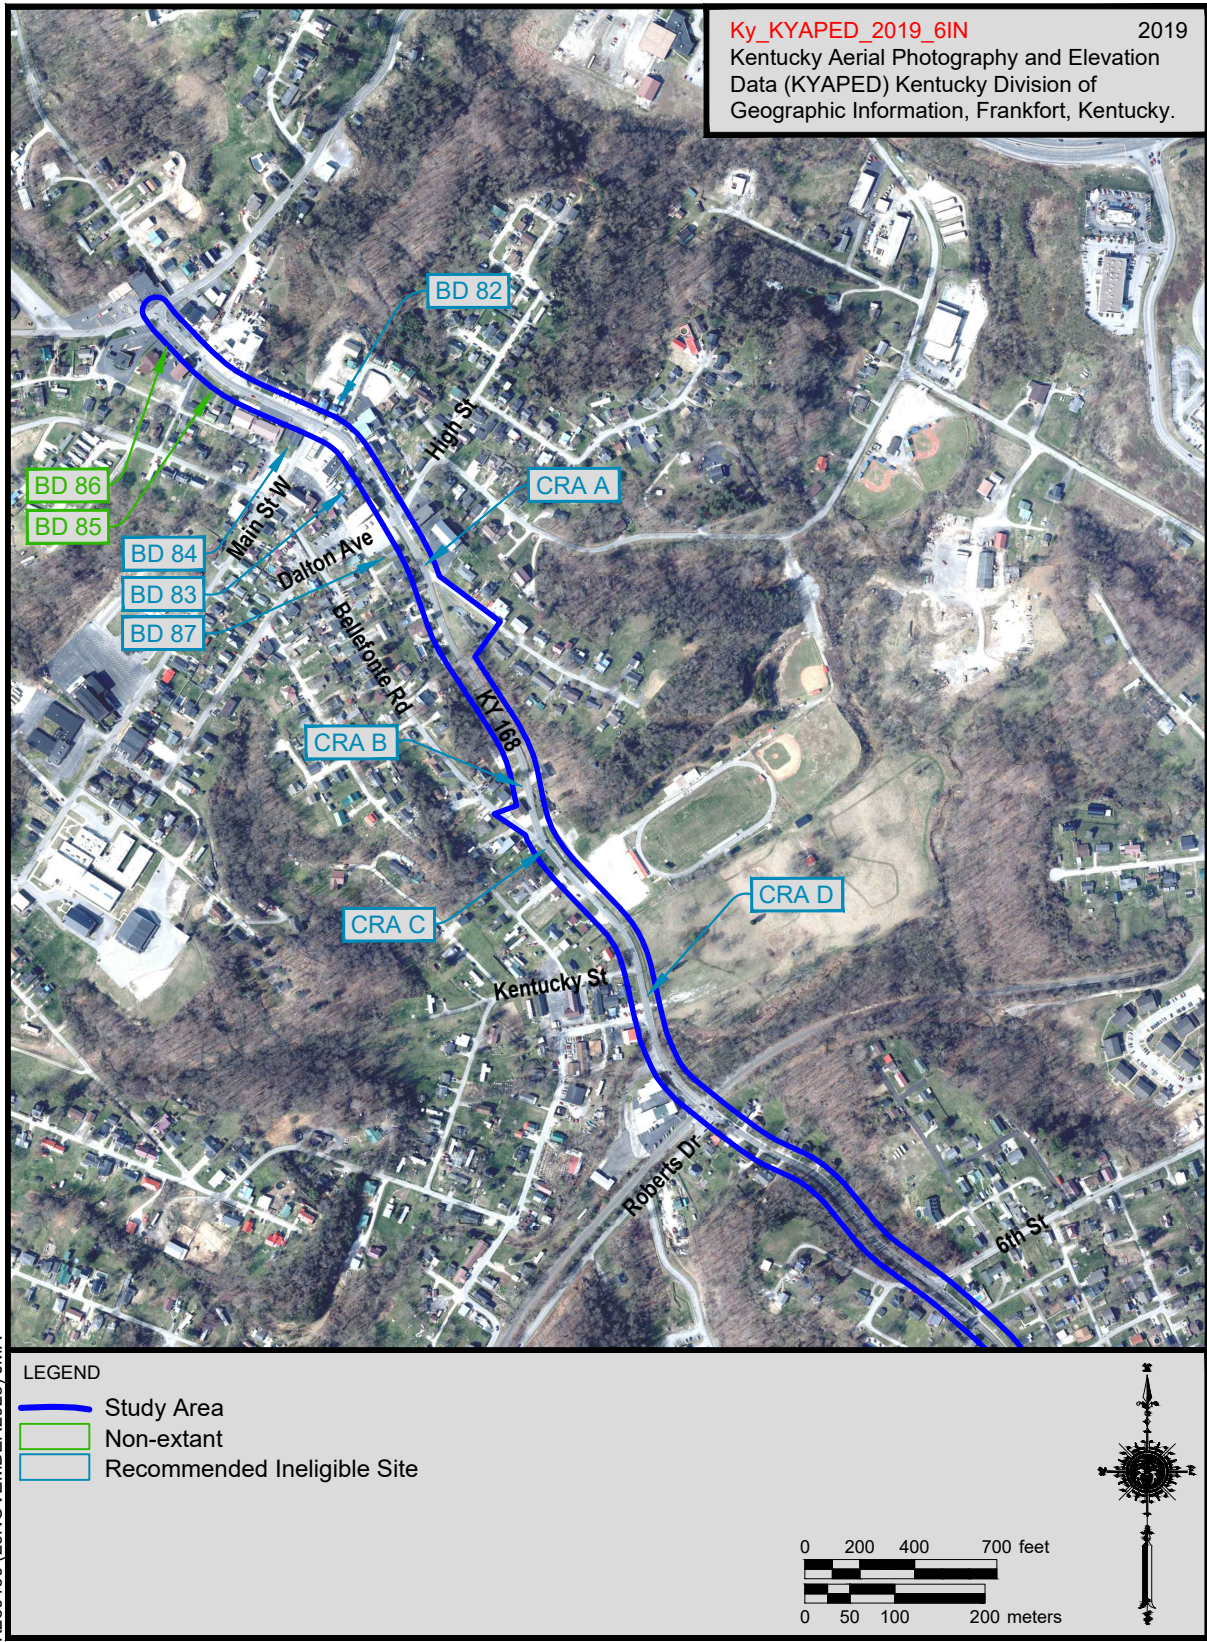
Figure 2a. Aerial depicting the study area and locations of cultural historic resources.

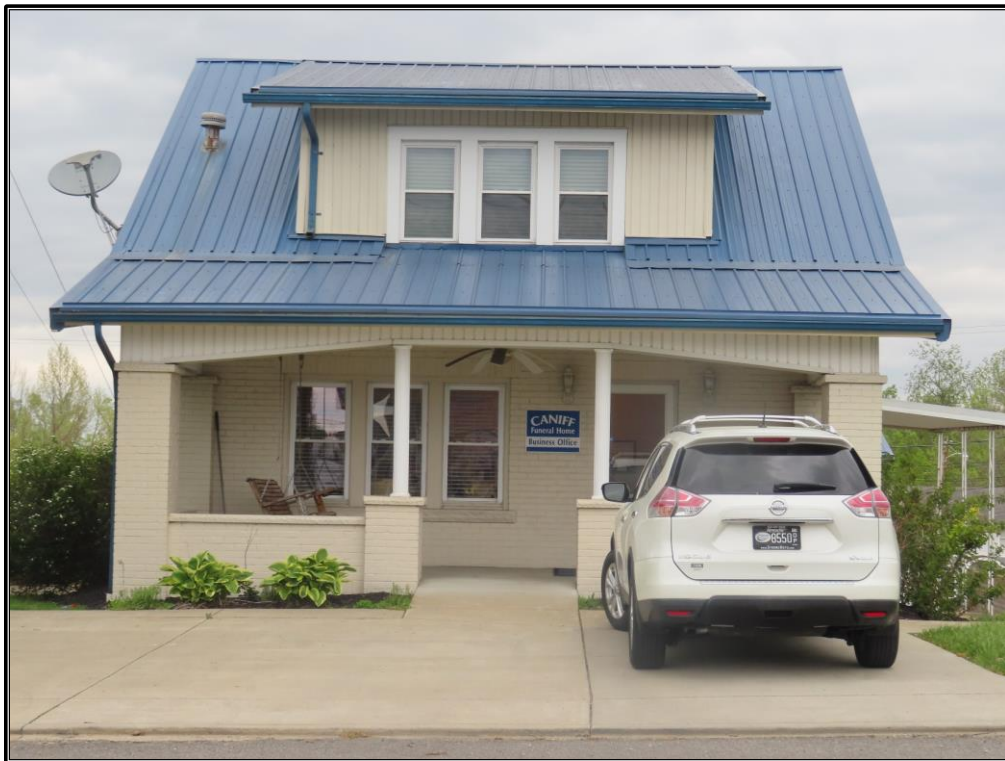
Figure A-12. BD 82: Façade of the converted residence, looking north-northeast.

Site/Survey #	Resource Name/Function	Address/Location	NRHP Status	Condition	Figures
BD 82	House	600 Wheatley Road/Westwood	Undetermined per KHC database; Not eligible based on CRA windshield survey	Good; lacks significance and integrity as a common residential type with enclosed rear porch and replacement materials	A-12 and A-13
BD 83	House	515 Wheatley Road/Westwood	Undetermined per KHC database; Not eligible based on CRA windshield survey	Good; lacks significance and integrity as a common residential type with enclosed rear porch and replacement materials	A-14-A-17
BD 84	Garage	SW Corner Intersection of Main Street and Wheatley Road Intersection/Westwood	Undetermined per KHC database; Not eligible based on CRA windshield survey	Fair; lacks significance an integrity as a common commercial building type with replacement garage doors	A-18
BD 85	House	South Side Wheatley Road, East of Intersection with Hoods Creek Pike/Westwood	Undetermined per KHC database	Non-extant per CRA windshield survey	N/A

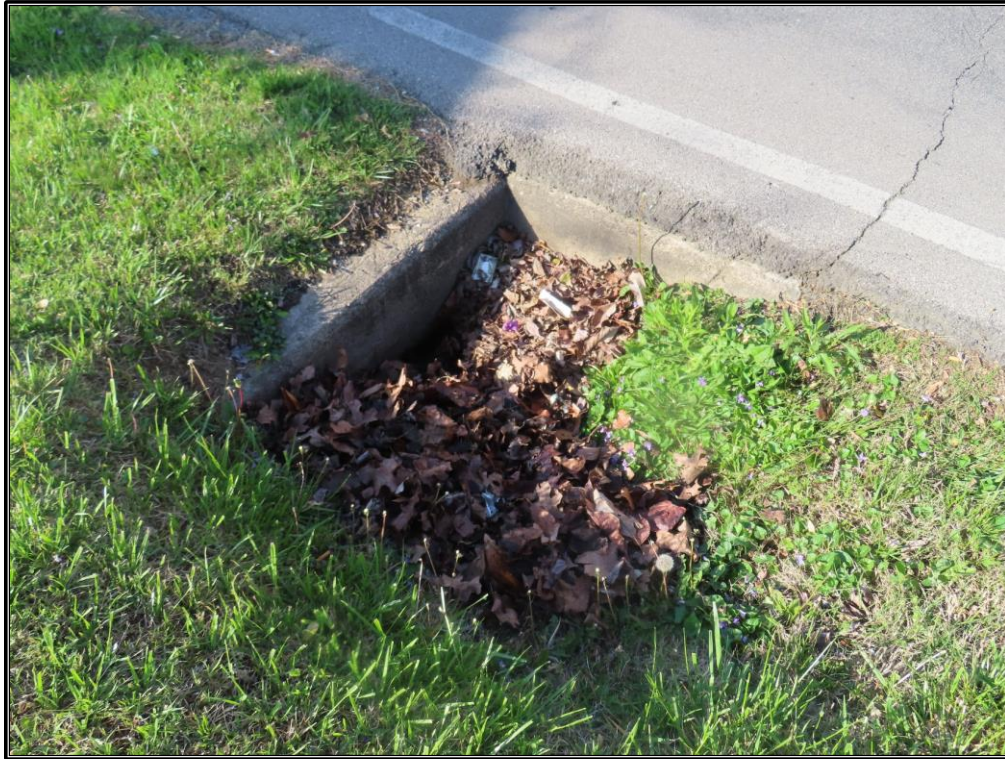
Figure A-21. CRA A: Pipe culvert at KY 168/Woodland Avenue intersection, looking south-southwest.

CRA identified four concrete pipe culverts along KY 168 during the windshield survey (CRA A–CRA D) (see Table 1). They are concentrated to the northwest of Little Hood Creek. The culverts are positioned below grade in concrete basins covered by metal grates, or they exhibit concrete headwalls or concrete headwalls and wing walls. Photographs were taken of CRA A–CRA C only, as they are representative of the four culverts identified during the survey (Figures A-21–A-23). Deposited sediment partially blocks the openings to the pipes associated with CRA A and CRA C. The culverts are in good condition, though CRA C exhibits some weathering on its eastern headwall. CRA recommends that the four culverts (CRA A–CRA D) do not appear to be potentially significant and are not eligible for listing in the NRHP. The culverts are common examples of their type without a noteworthy method of construction. Such examples are common throughout Boyd County and Kentucky. There is no record in the KYTC’s archives of a historical road project for the section of KY 168 within the study area (KYTC n.d.). Based on their form and materials, the culverts were most likely constructed between circa 1925 and 1950. The period in which Westwood was developed supports this approximate construction date range (Westwood Real Estate and Development Company [WREDC] 1953). An exhaustive survey effort would be required to confirm if there are additional culverts in the study area that were not identified during the windshield survey.

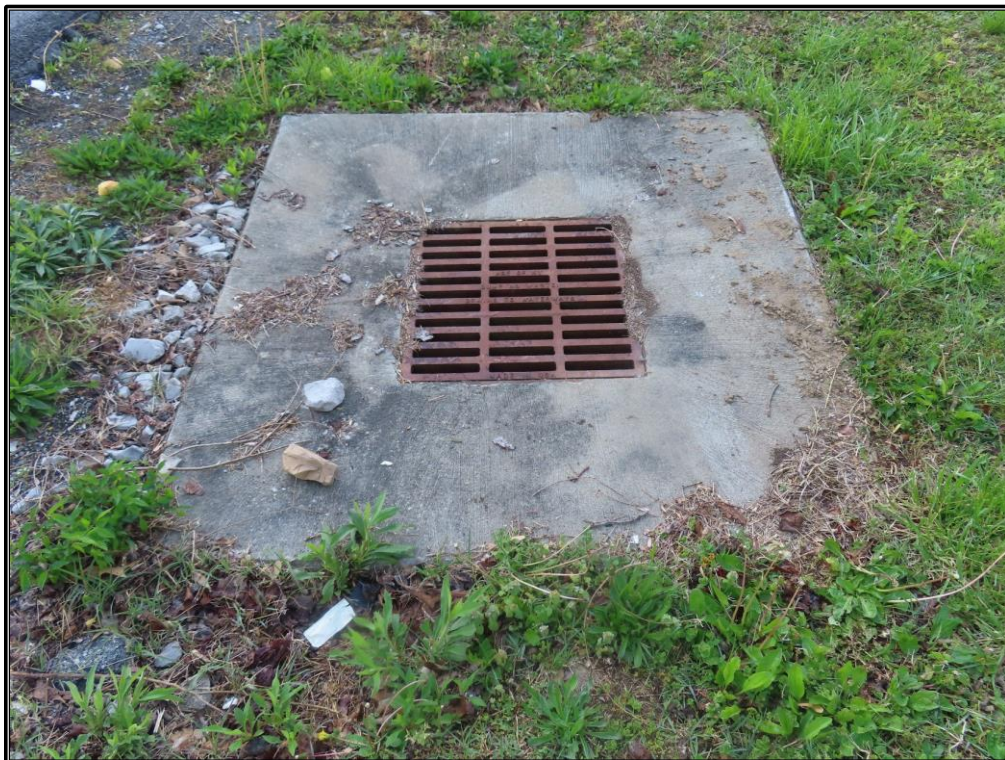
Figure A-22. CRA B: Pipe culvert in concrete basin north-northwest of KY 168/Bellefonte Road intersection, looking south-southeast.

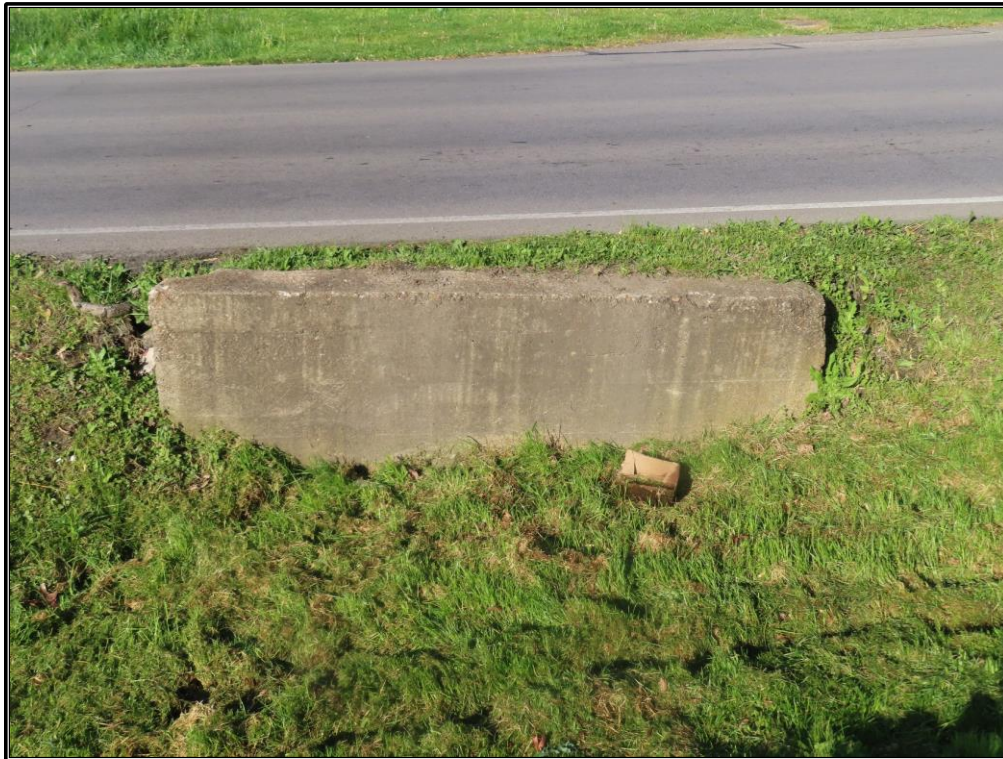
Figure A-23. CRA C: Pipe culvert's northeast headwall, looking west-southwest.

BD 86	Store	Southeast Corner of Wheatley Road and Hoods Creek Pike Intersection/Westwood	Undetermined per KHC database	Non-extant per CRA windshield survey	N/A
BD 87	Fred Fossin House	429 Wheatley Road/Westwood	Undetermined per KHC database; Not eligible based on CRA windshield survey	Good; lacks significance and integrity as a common residential type with replacement materials	A-19 and A-20
CRA A	Concrete pipe culvert	KY 168 and Woodland Avenue Intersection (38.482784°, -82.670266°)	Not eligible based on CRA windshield survey	Good; lacks significance as a common culvert type	A-21
CRA B	Concrete pipe culvert	KY 168, approximately 160 ft north-northwest of intersection with Bellefonte Road (38.480531°, -82.669123°)	Not eligible based on CRA windshield survey	Good; lacks significance as a common culvert type	A-22
CRA C	Concrete pipe culvert	KY 168 and Bellefonte Road Intersection (38.479925°, -82.668838°)	Not eligible based on CRA windshield survey	Good; lacks significance as a common culvert type	A-23

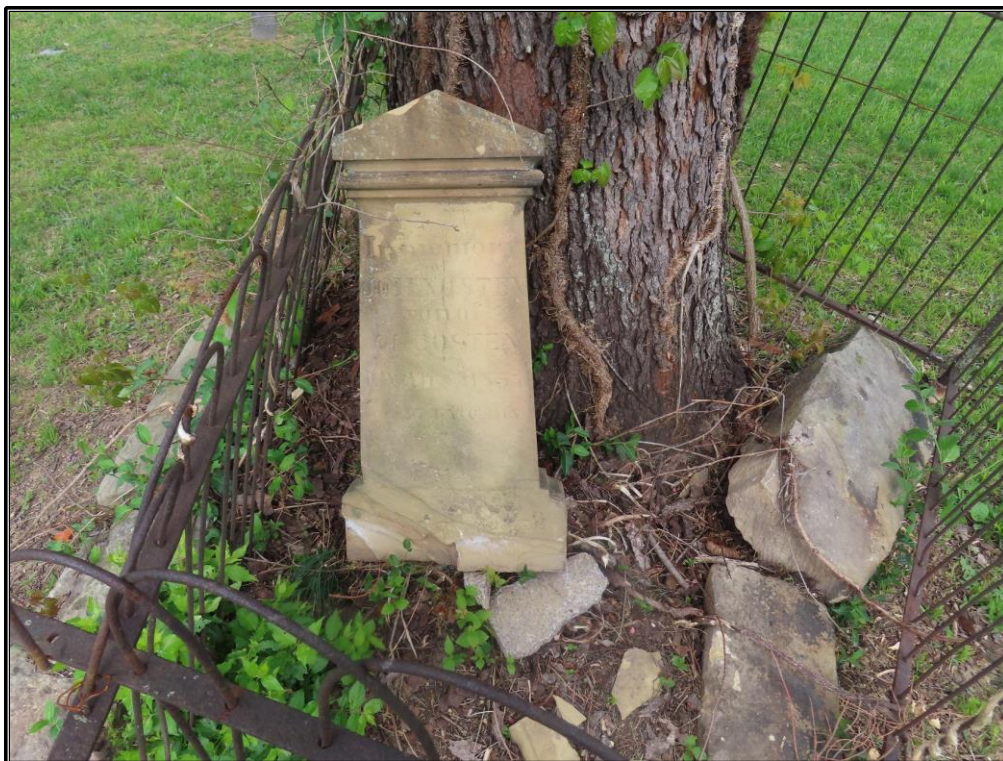
Figure A-28. Cemetery 1: Detail of burial marker.

Site/Survey #	Resource Name/Function	Address/Location	NRHP Status	Condition	Figures
Cemetery 1	Pollard Cemetery	NE Corner Blackburn Avenue and Dixon Street Intersection (38.471817°, -82.661730°)	Undetermined based on CRA windshield survey	Fair; some burial markers have settled, are broken, or are badly weathered	A-24-A-32

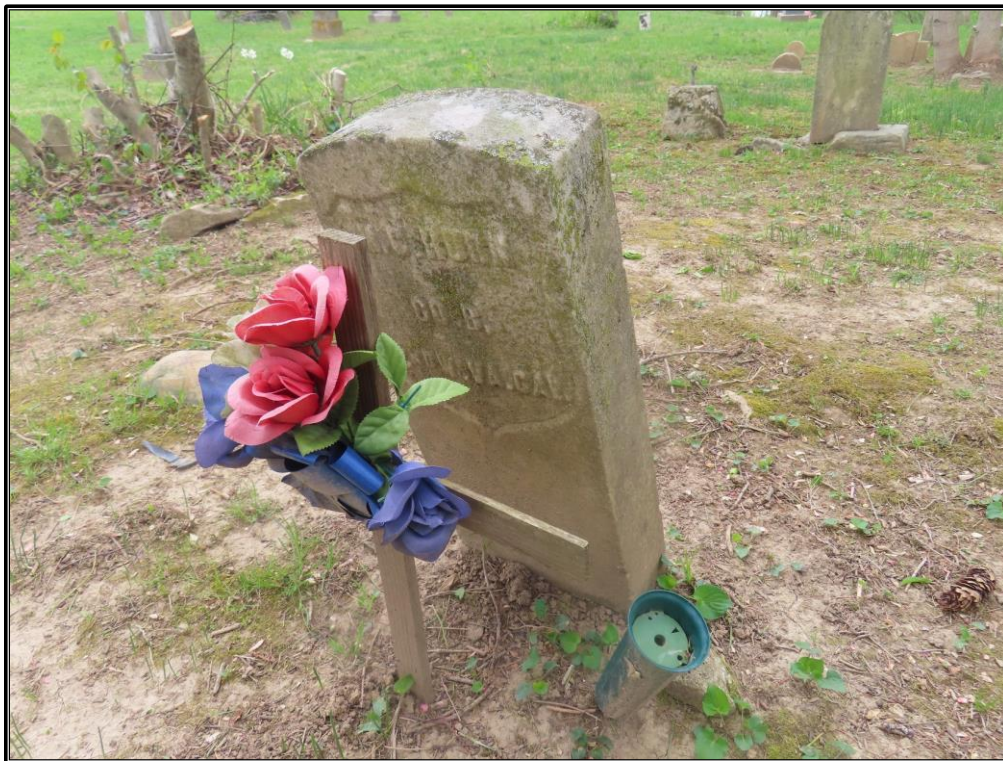
Figure A-29. Cemetery 1: Detail of burial marker.

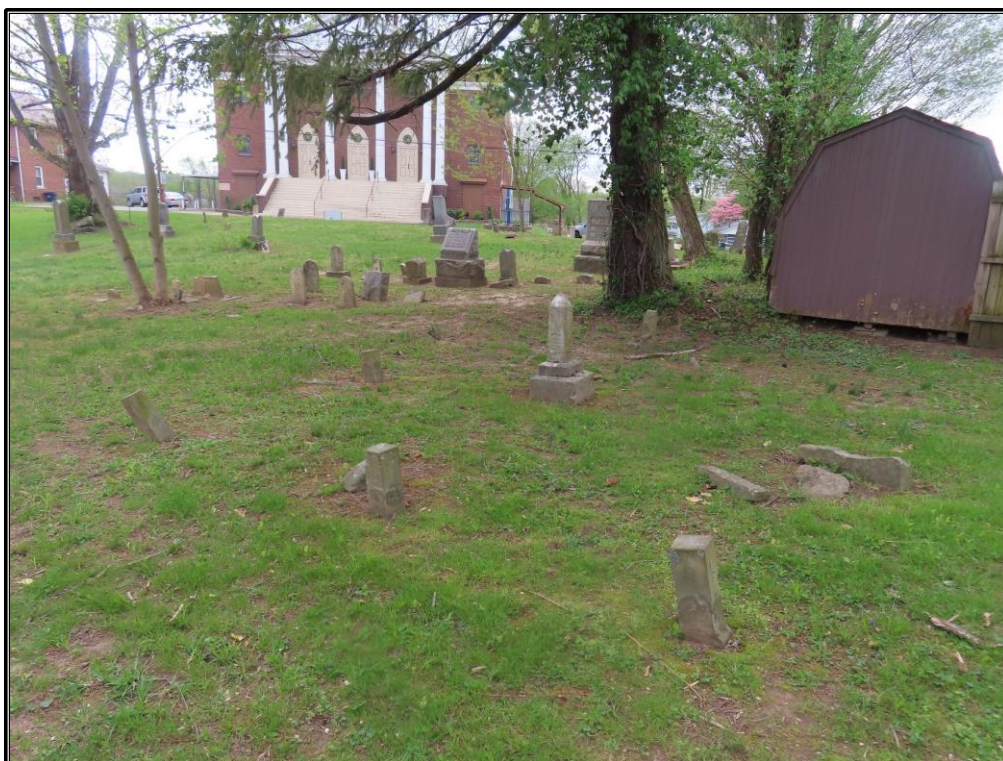
Figure A-30. Cemetery 1: Detail of burial markers with lot markers.

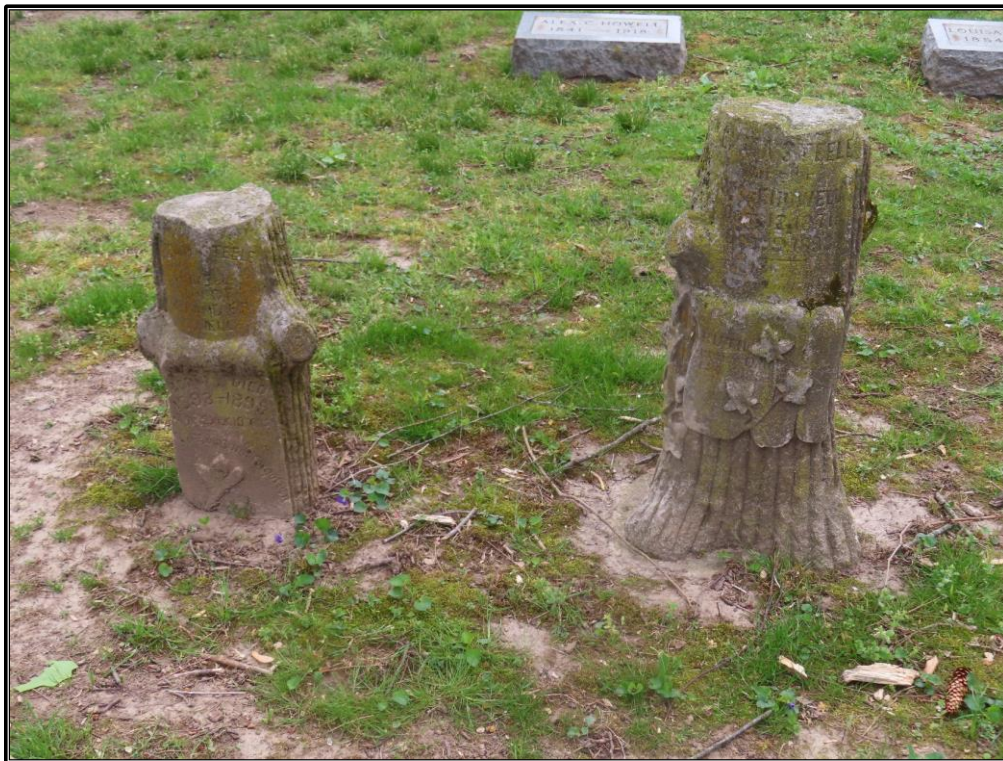
Figure A-31. Cemetery 1: Detail of burial markers.

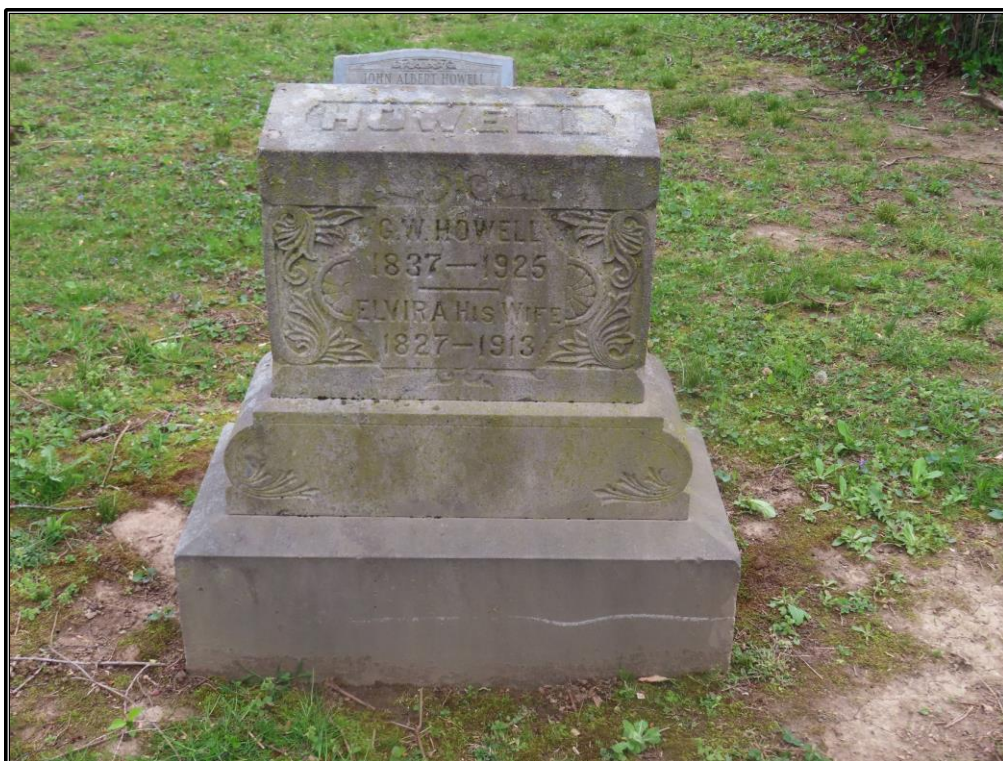
Figure A-32. Cemetery 1: Detail of burial marker.

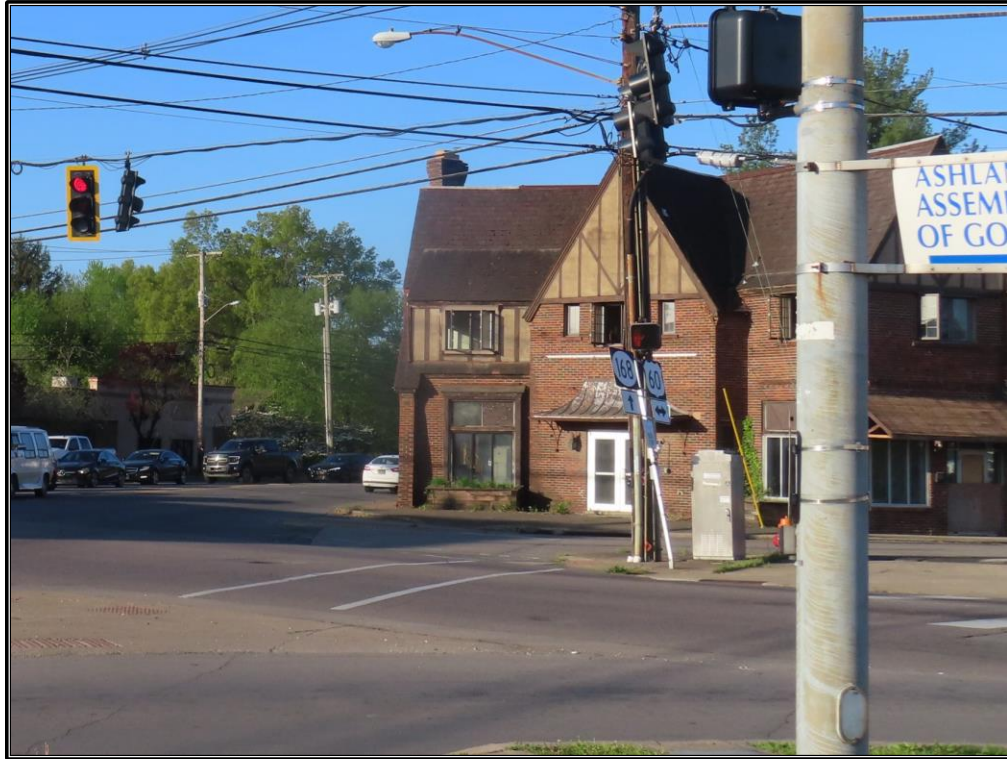
CRA 1, a Tudor Revival-style commercial building appearing vacant at the time of the windshield survey, was identified in the field as a potentially significant resource (see Table 3). CRA 1 is located at the southwest corner of the intersection of Algonquin Avenue and US 60, at the southeastern terminus of the study area (Figures A-33–A-37). The two-story building displays an irregular plan, an exterior of bricks and faux half-timbering, and multiple intersecting, gable roofs. At the time of its depiction on a 1927 Sanborn fire insurance map, the building contained four stores (Sanborn Map Company [SMC] 1927:39). Despite alterations to fenestration and the presence of certain replacement materials, CRA 1 may be potentially significant under Criterion A and/or C; however, CRA 1 requires additional research and a closer examination of significance and integrity for a comprehensive evaluation of its eligibility for listing in the NRHP.

Figure A-33. CRA 1: Overview of the building from the intersection of KY 168 and US 60, looking southwest.

Site/Survey #	Resource Name/Function	Address/Location	NRHP Status	Condition	Figures
CRA 1	Tudor Revival-style commercial building	SW Corner Algonquin Avenue and US 60 Intersection (38.465279°, -82.659433°)	Potentially significant based on CRA windshield survey	Fair; displays some loss of integrity of design and materials	A-33-A-37

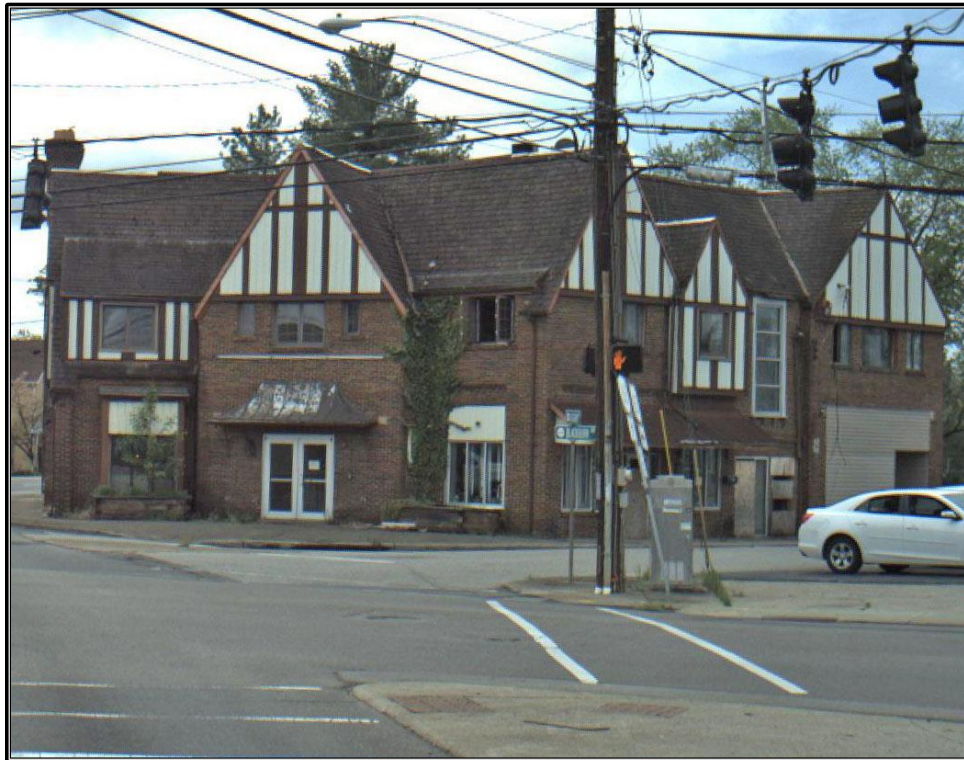
Figure A-34. CRA 1: April 26, 2022 view of the façade and northwest elevations of the building, looking west-southwest; from KYTC's Roadway Photo Viewer.

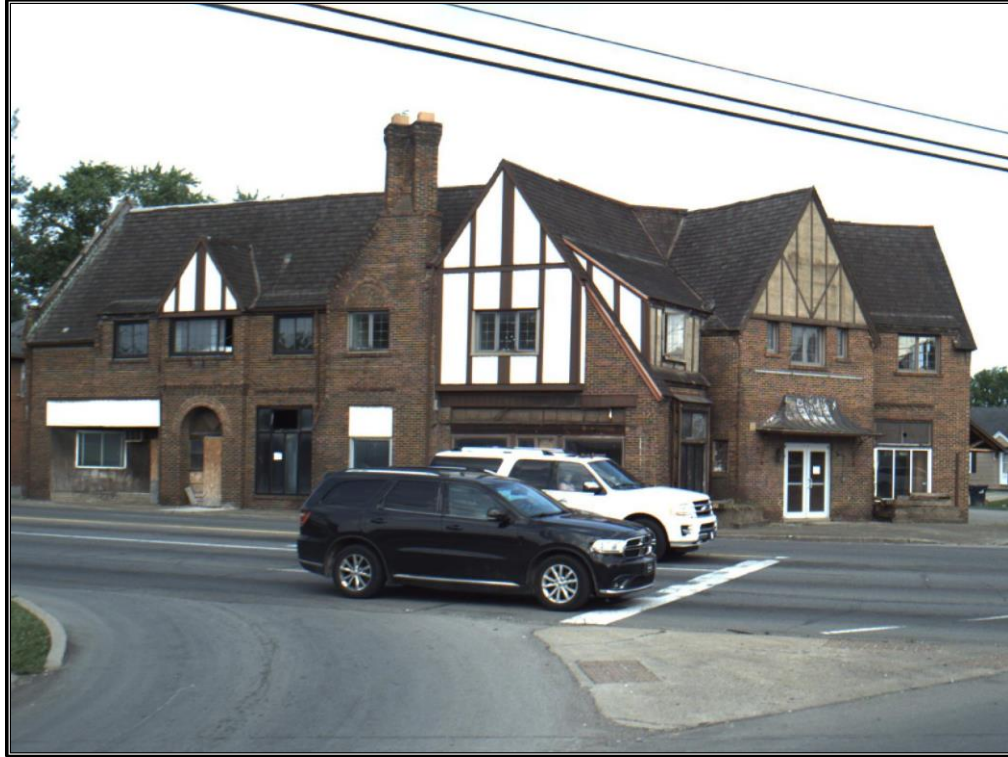
Figure A-35. CRA 1: April 10, 2023 view of the southeast and façade elevations of the building, looking northwest; from KYTC's Roadway Photo Viewer.

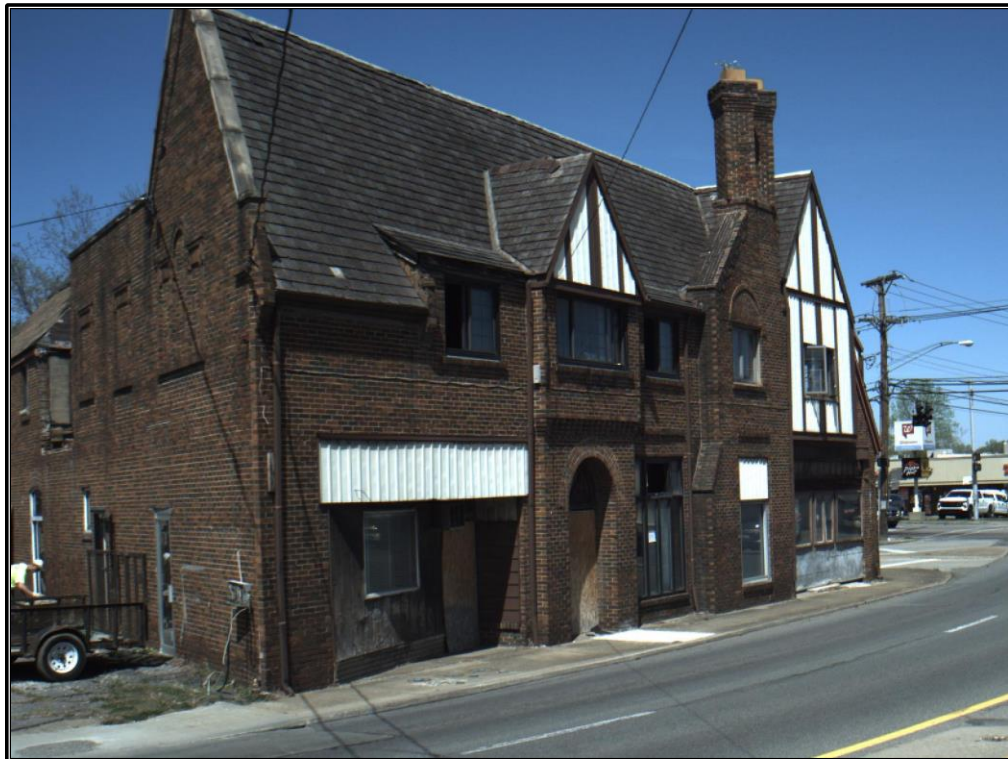
Figure A-36. CRA 1: April 10, 2023 view of the southeast elevation of the building, looking north; from KYTC's Roadway Photo Viewer.

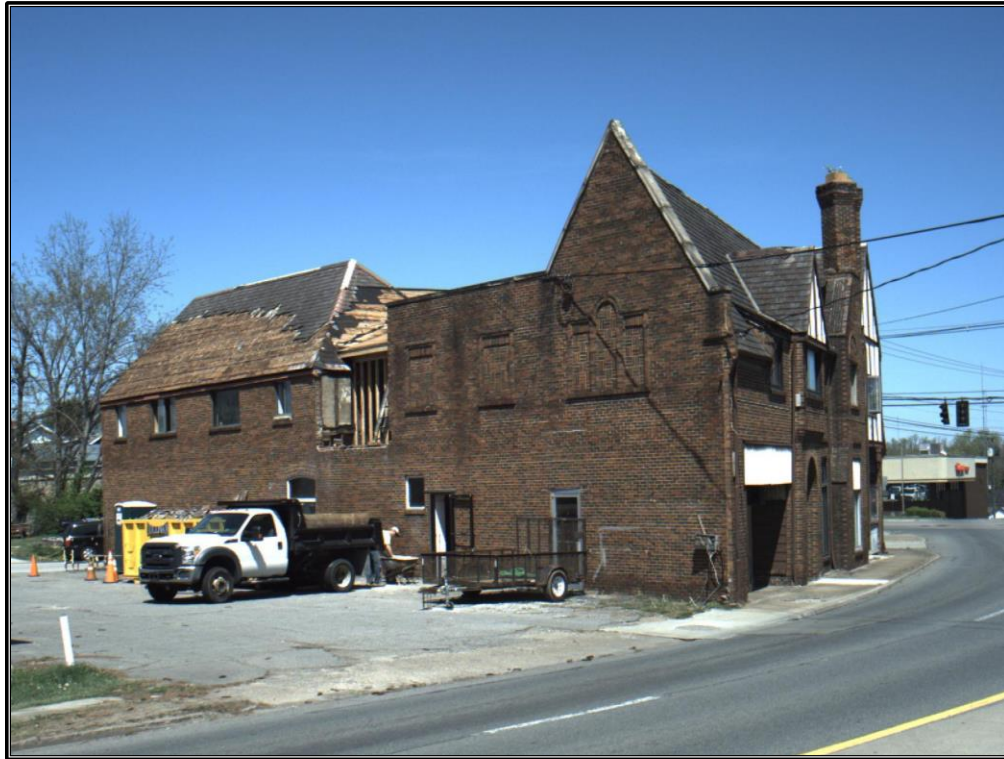
Figure A-37. CRA 1: April 10, 2023 view of the southwest (rear) elevation of the building, looking north-northeast; from KYTC's Roadway Photo Viewer.
