MEMORANDUM

SUBJECT: Nicholas County
FD04 091 0032 009-013P
Safety Improvements Along KY-32
From Lake Rd. (MP 9.5) to Scrubgrass Creek (MP 12.5)
Item # 09-8812.00
Mars # 1528401P
Geotechnical Overview Report

1.0 Project Description

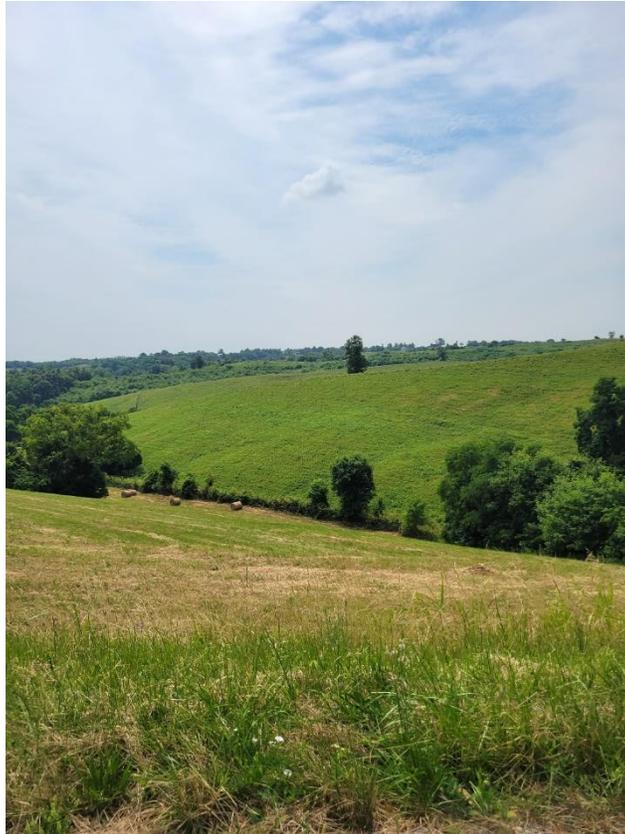
Figure 2: Typical topography of the Outer Bluegrass region on KY-32

The project study area is located within the Outer Bluegrass Physiographic Region. The topography throughout most of the project site is characterized by rolling hills and moderate local relief, leading to the Licking River Valley at the eastern portion of the study area. Typical vertical

relief is on the magnitude of 100 feet, gradually lowering in elevation west to east from approximately 940' AMSL in Carlisle to approximately 600' AMSL in the Scrubgrass Creek tributary to the Licking River. The eastern portion of the alignment crosses several small streams and runs alongside Scrubgrass Creek.

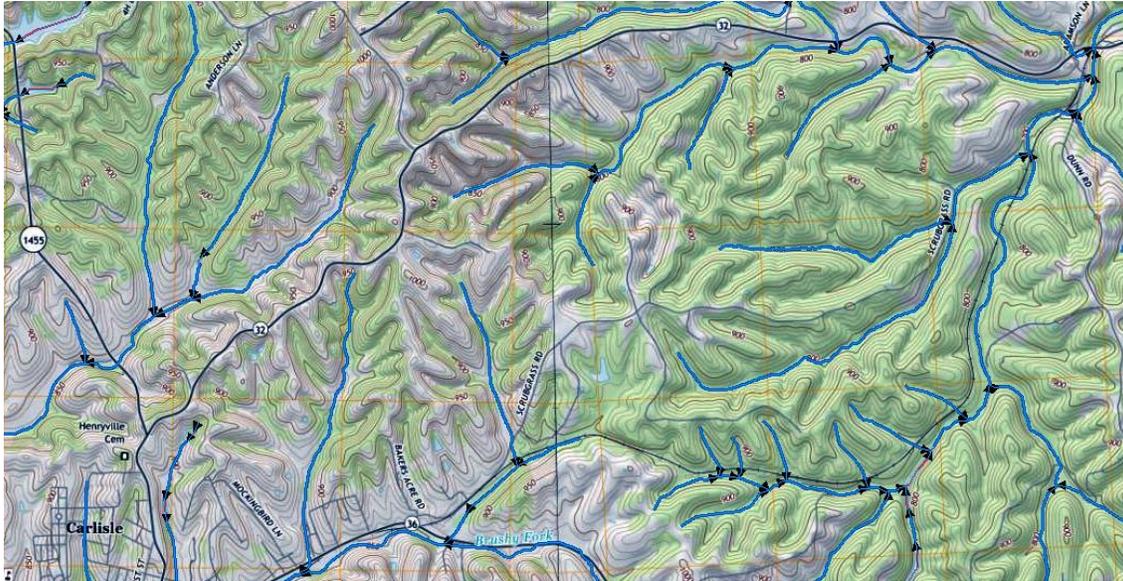
Figure 3: Streams are blue lines and flow paths indicated with black arrows.

The flow regime flows in four distinct watersheds, such that the project can be divided into quadrants. The current roadway serves as the north-south divide as it runs along the ridgetops. The east-west divide lies near mile marker 12 (near the intersection with 1658), where the elevation is the highest in the studied section. In the western side of the east-west divide, surface water flows to the south and then west on both sides of the current roadway – eventually converging outside of the project area west of Carlisle into Brushy Fork. To the east of the east-west divide, surface flow is generally towards KY 32 and to the west towards Scrubgrass Creek, which then

enters the Licking River just northeast outside of the project area. In the eastern portion of the project, the road crosses tributaries to Scrubgrass Creek then runs alongside Scrubgrass Creek at the eastern end.

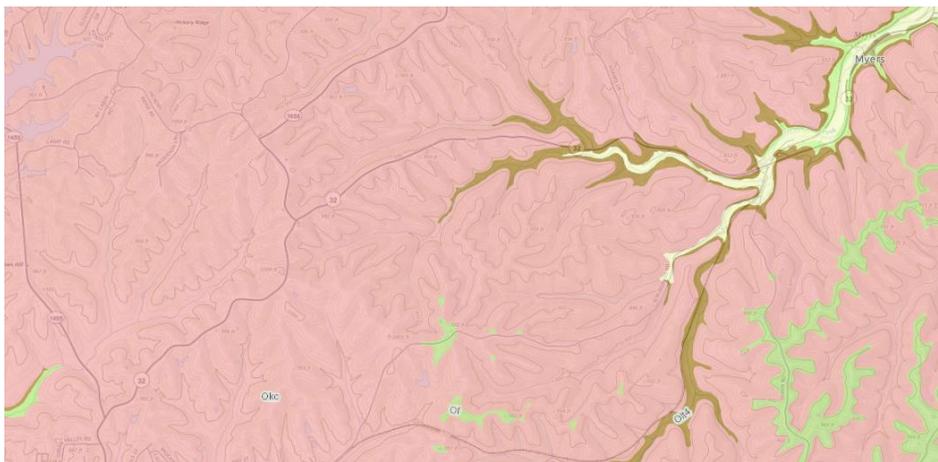
Figure 4: Geologic map of project area

The study corridor begins in the eastern portion of the Carlisle Quadrangle (GQ #1450) and ends in the western portion of the Moorfield Quadrangle (GQ #1510). Geologic mapping indicates almost the entire project area to be underlain by Upper and Middle Ordovician aged bedrock. In descending order, they are the Kope and Clays Ferry Formations (Okc), undivided, and the Nicholas Bed of the Tanglewood Limestone Member of the Lexington Limestone (Oltn). A small portion, and easternmost part, of the alignment encounters alluvium (Qal).

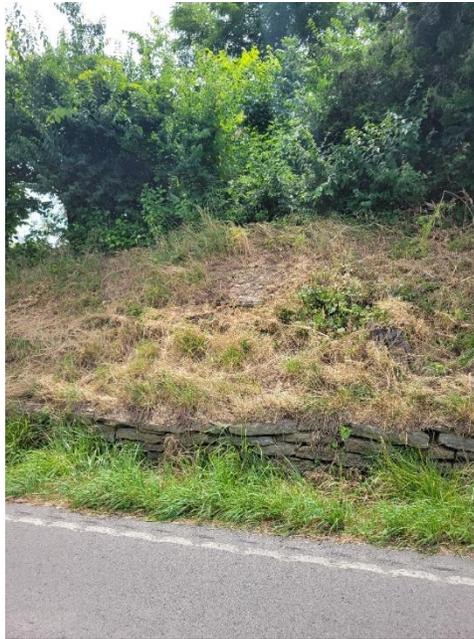
Figure 5: Exposed wall of Kope Formation near mile marker 12.3 on KY-32.

The Kope and Clays Ferry Formations (Okc) is the upper most rock formation in the study corridor. The formation consists of interbedded limestone, shale, and siltstone. Limestone composes about 50% of the formation, varies from micro-grained to coarse-grained in beds 1 inch to 3 feet thick. Clastic to bioclastic. Varying areas of cross-bedding, shale interbedding, and fossils. Shale composes about 40% of the formation, limy, uneven bedding from 1 inch to 4 feet thick, mostly 4 to 6 inches thick as interbeds. When exposed to the elements it typically exhibits a very low resistance to weathering. Siltstone composes about 10% of the formation, micrograined, limy, in even beds 1 to 12 inches thick.

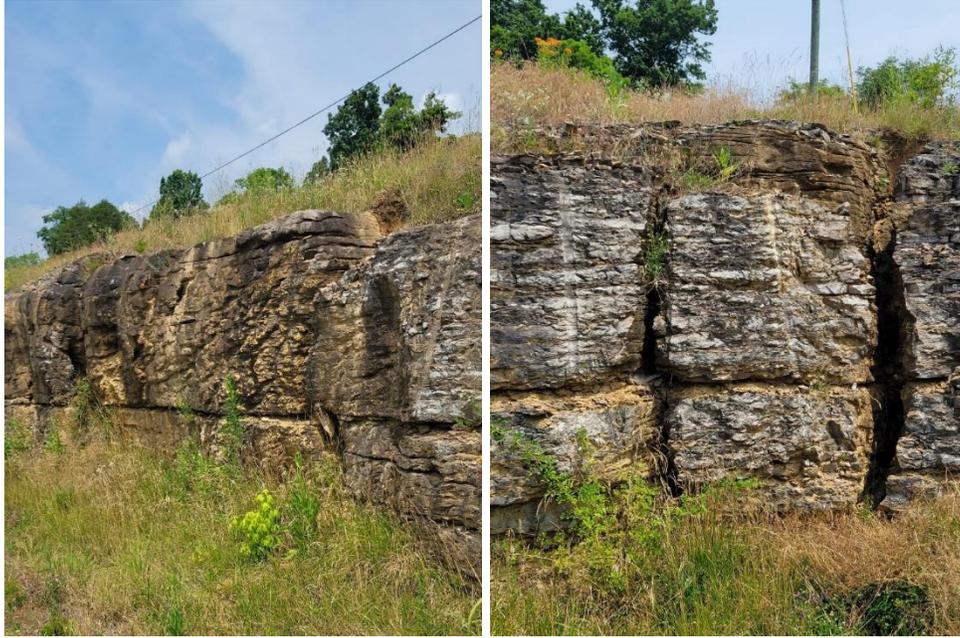
Figures 6 & 7: Exposed Nicholas Bed of the Tanglewood Member of the Lexington Limestone with eroded shale bed and fracturing near mile marker 14.8 on KY-32.

Beneath the Kope and Clays Ferry Formations lies the Tanglewood Member (Oln) of the Lexington Limestone. The Tanglewood Limestone is fine- to very coarse-grained, thin to thick beds, commonly cross-bedded.

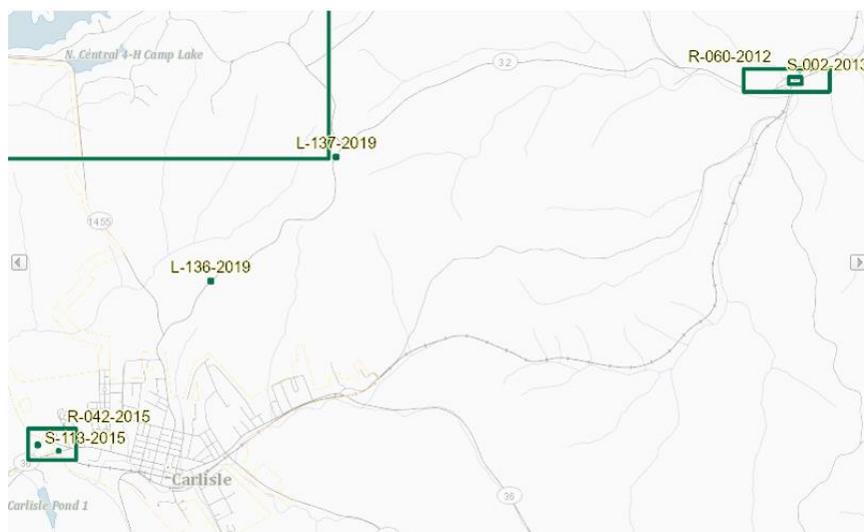
Figure 8: Locations of area projects

Drilling logs from two (2) 2020 reports, L-136-2019 and L137 -2019, on landslides along this segment of KY 32 reported depths to auger refusal from approximately 7 to 18' and rock encountered as limestone or shale, weathered or not specified.

A 2015 report, S-113-2015, for a bridge in Carlisle at the westernmost portion of this project reported depths to refusal between 0.1' to 13.2'. Rock cores obtained from this project revealed fossiliferous limestone with some shale laminations and partings, lightly weathered at the top. Recovery was from 94-100% and KY RQD values were from 26-82%.

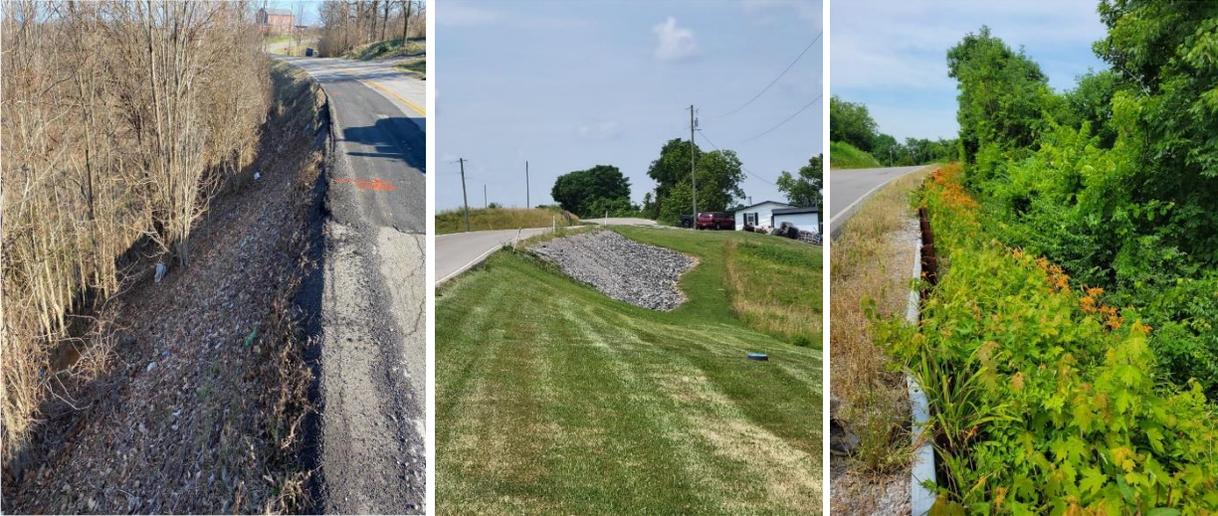
Figure 9: Scarp at mile point 10.0

Figure 10: Slope infill near mile marker 13 on KY-32.

Figure 11: Rail correction with lagging near mile marker 11.2 on KY-32.

Several landslides were noted during the field visit and have had corrective measures applied. In 2019, two landslides affected 200' and 185' of roadway at mile points 10.0 and 11.1. Details can be seen in reports L-136-2019 and L-137-2019. The driving force behind these instabilities can be attributed to groundwater movement, poor rock mass quality, over steepened slopes, and poor construction processes.

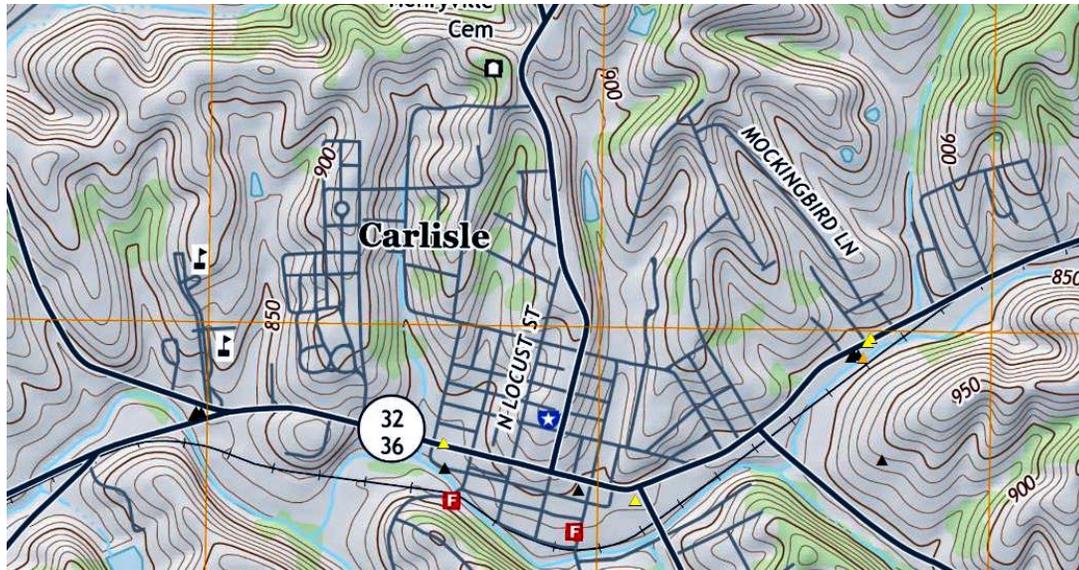
Figure 12: Spring and water wells in Carlisle, KY.

Water wells, both active and plugged, are in the vicinity of Carlisle near the beginning of the studied section. Their locations are noted in Figure 12. Springs may also be present within the study area and their locations would need to be noted and inventoried. If any springs or wells are encountered in the right-of-way, special construction will be required to close the wells. Spring boxes and/or granular material may be required in the vicinity of springs.

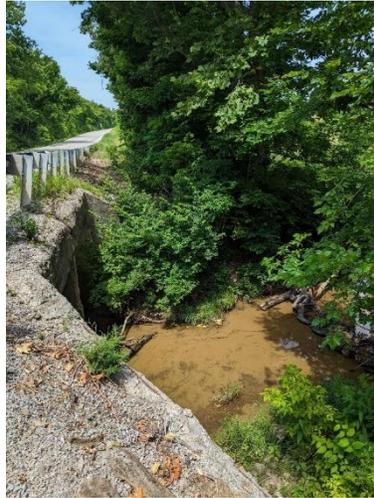
Figure 13: Culvert with exposed bedrock near mile marker 14 on KY-32.

At this time, it is unknown as to whether the proposed roadway would require new and/or widened substructure elements. It can be anticipated that most of the bridges within the project study area are likely supported by rock bearing foundation systems. Culverts along the proposed alignments may be replaced or widened. The culverts within the study area are likely supported by either non-yielding or yielding foundation systems depending upon the location along the proposed alignment. A detailed geotechnical investigation will be required to determine the foundation support systems.

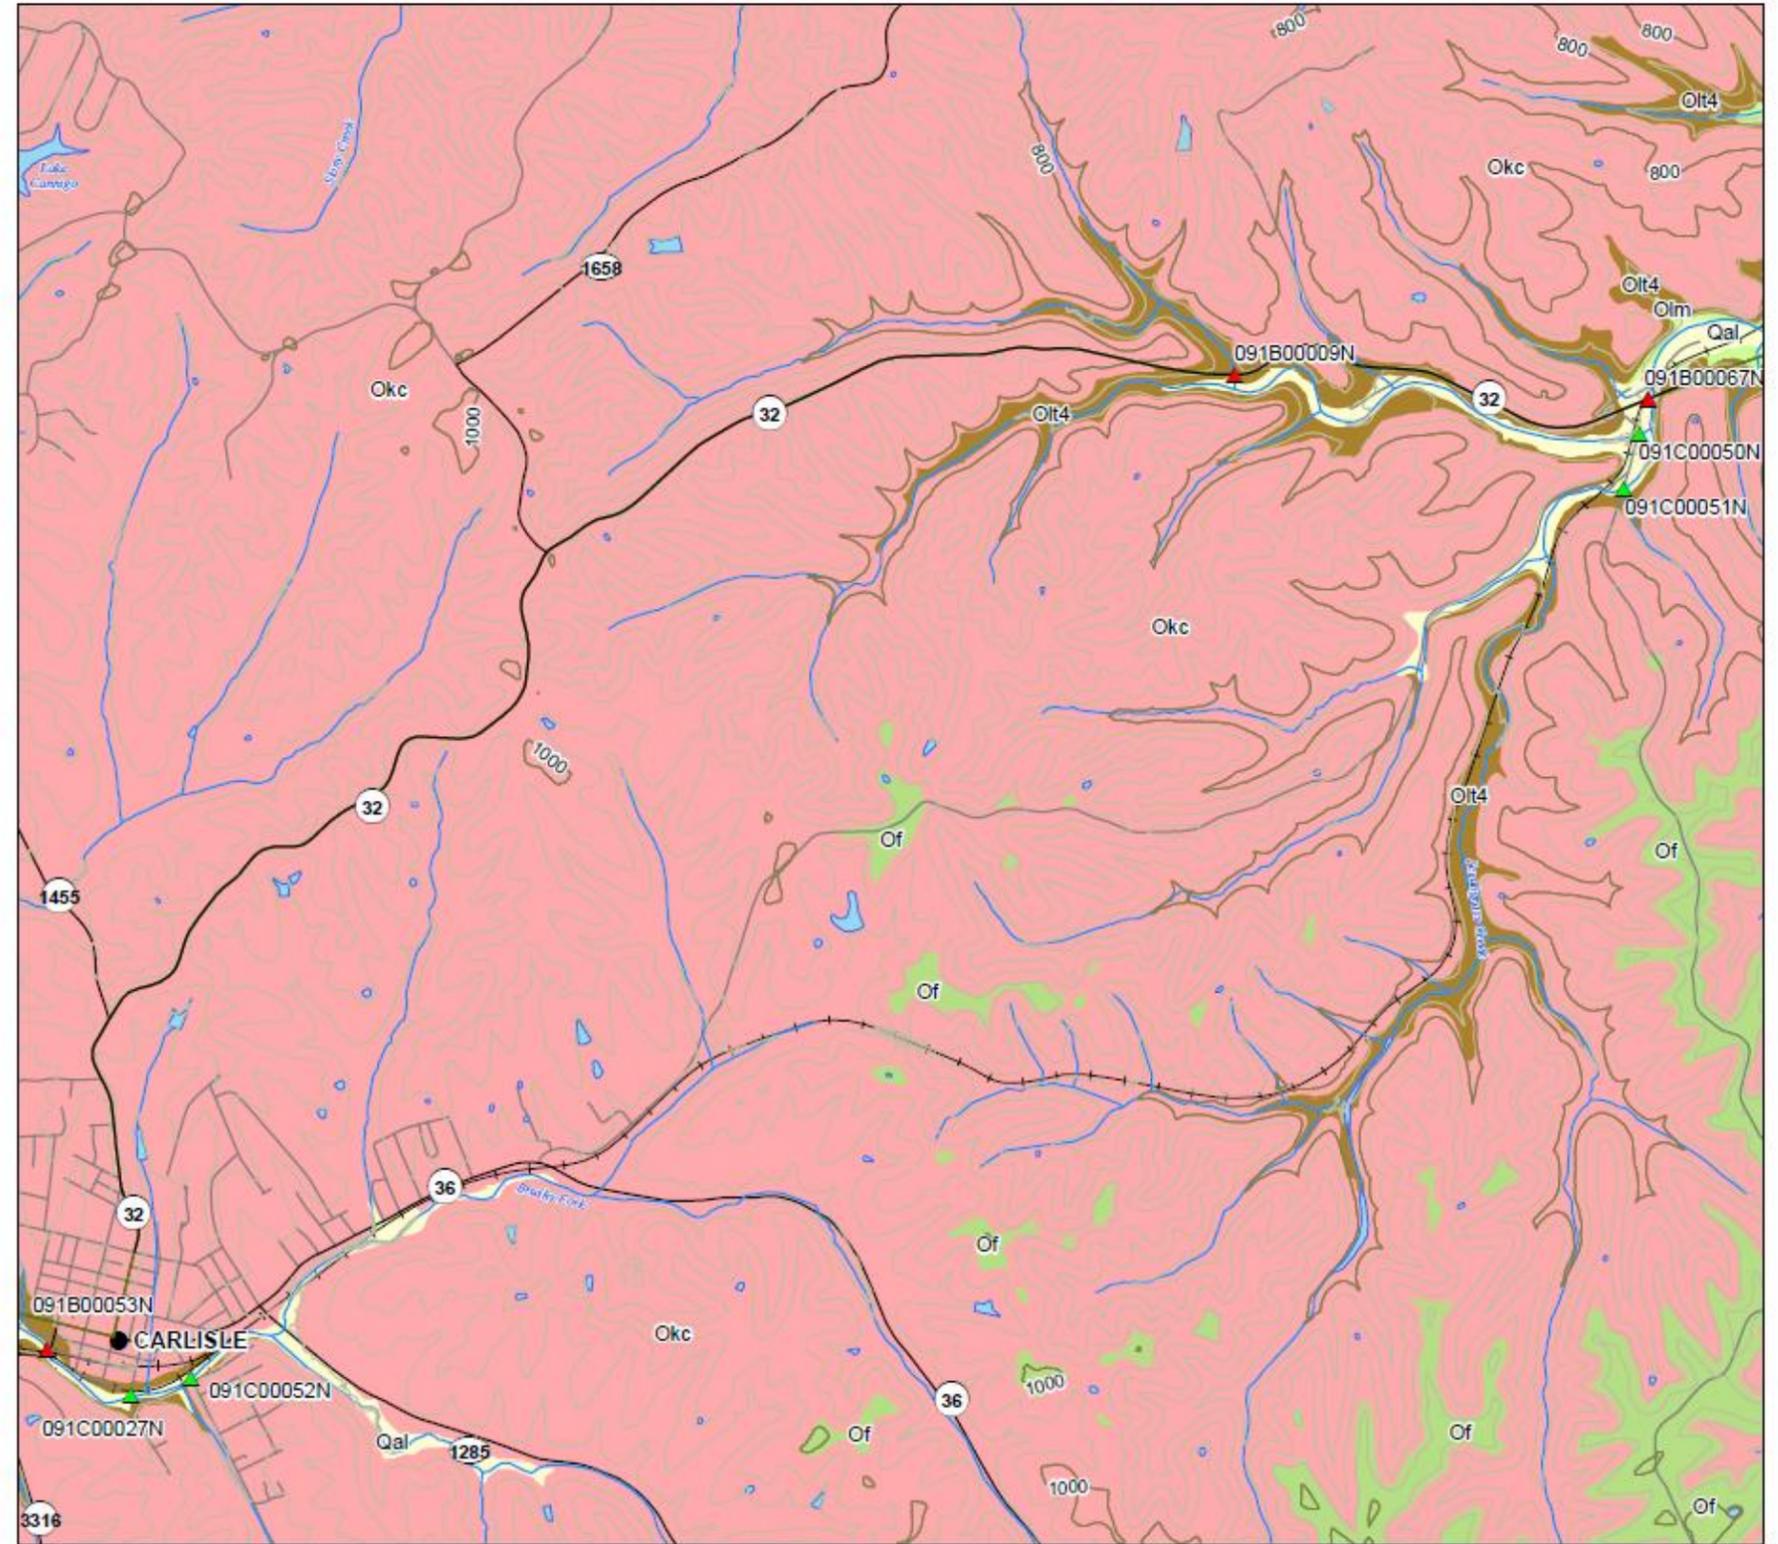
Nicholas Planning Study - Geologic Map

- State Roads
 - Local Roads
 - + + Active Railroad
 - Rivers and Streams
 - Waterbodies
 - Project Location
- Bridges**
- ▲ City/County Maintained
 - ▲ State Maintained
- Geologic Formations**
- Qal Alluvium
 - Of Fairview Formation
 - Okc Kope and Clays Ferry Formations
 - Olm Millersburg Member
 - Olt4 Tanglewood Limestone Member No. 4 (upper tongue)

According to geologic mapping (GQ#1450 & 1510) (Appendix B) structural contours, drawn on tops of the Lexington Limestone and Fairview Formation, the underlying bedrock is dipping west-southwest. No faults or other significant structural features are noted in the study area.

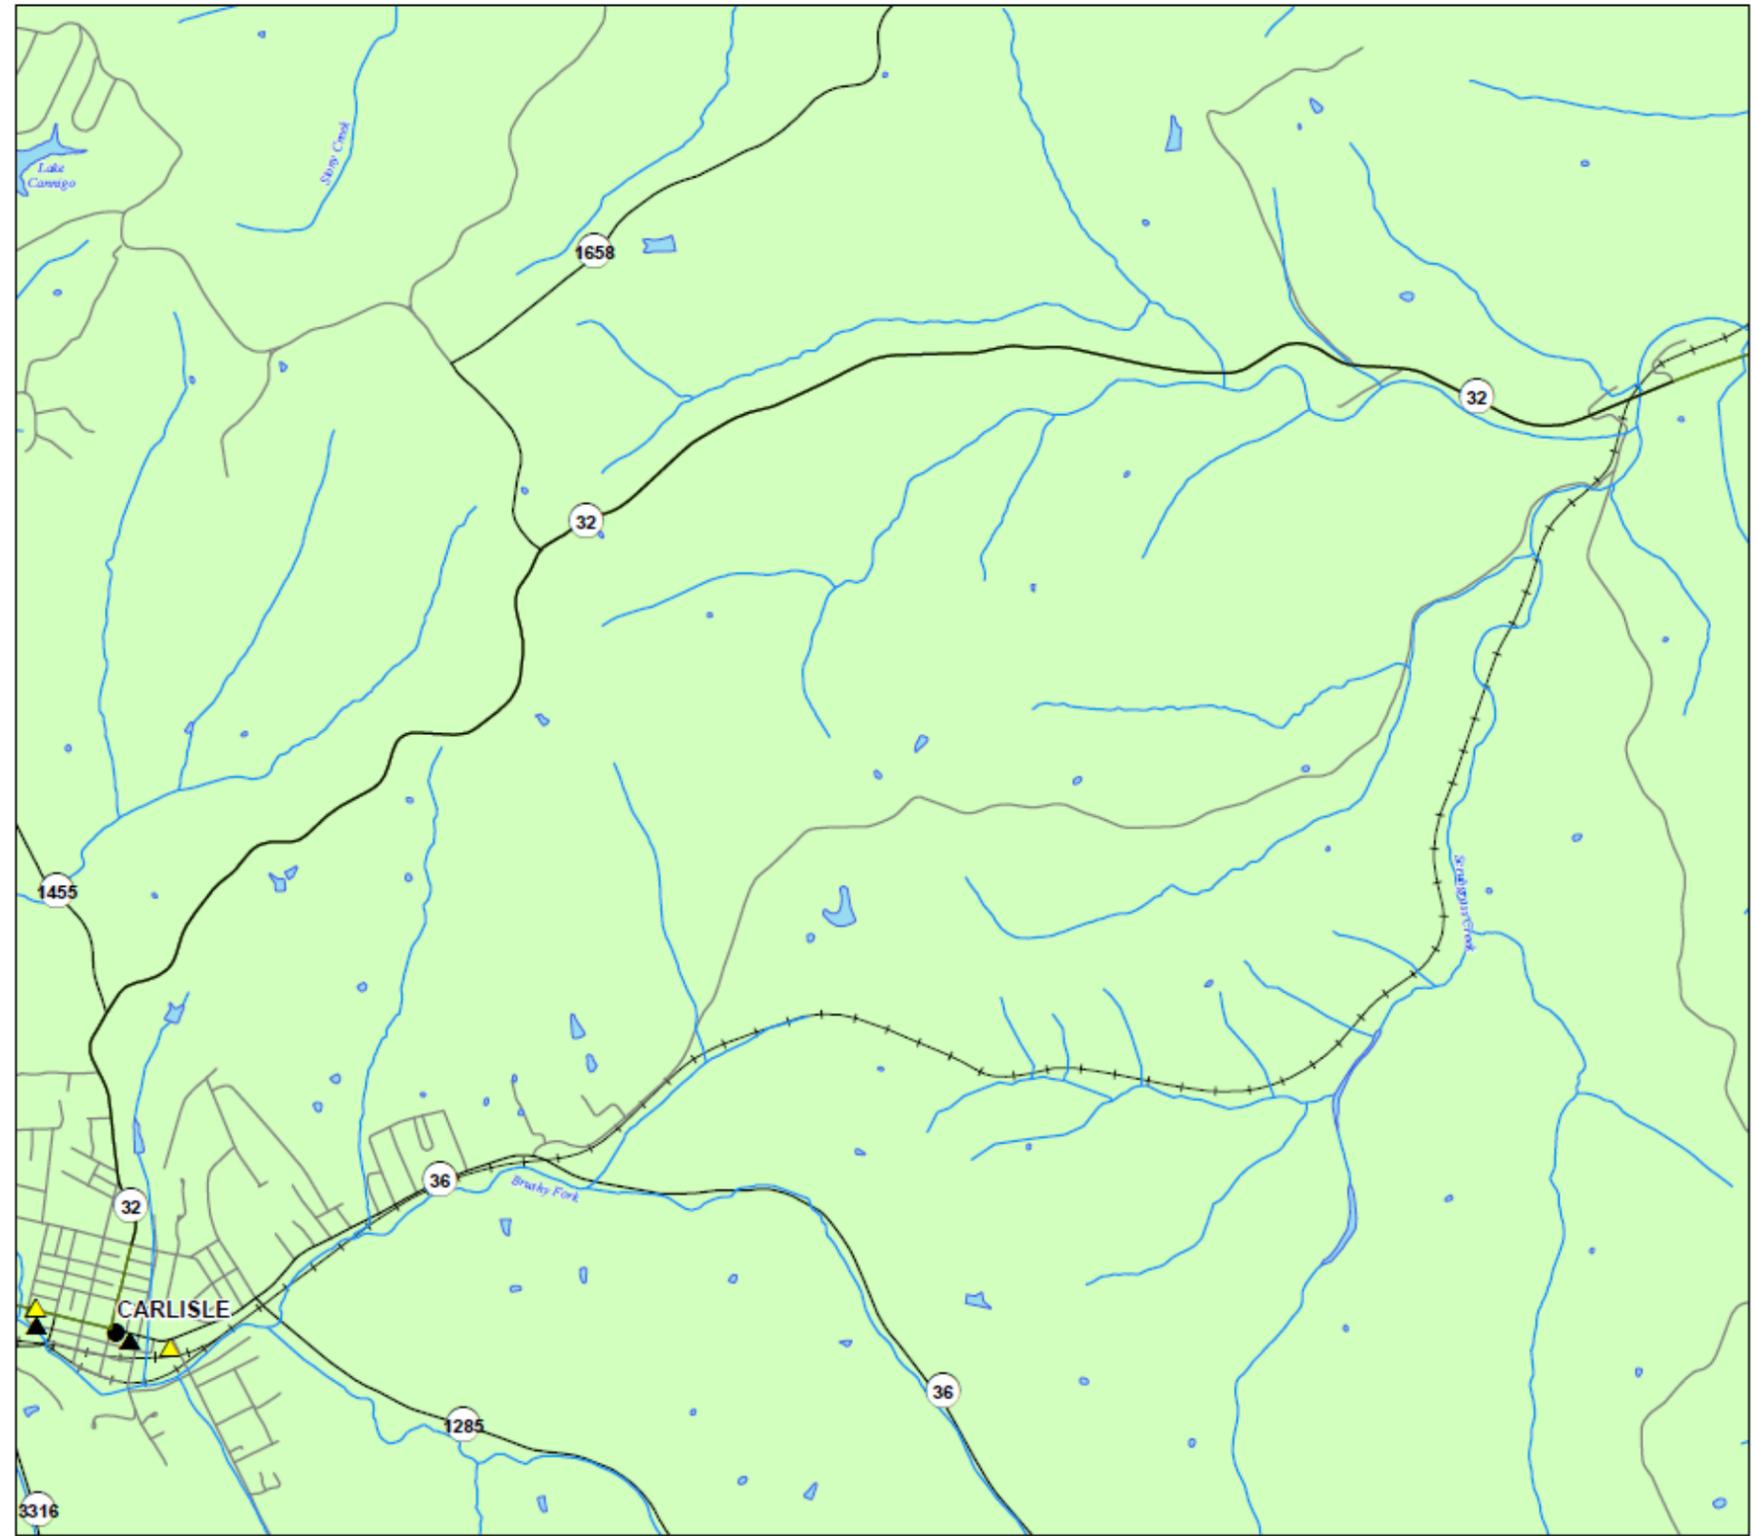
Nicholas Planning Study - Wells and Springs Map

- State Roads
 - Local Roads
 - Active Railroad
 - Rivers and Streams
 - Waterbodies
 - Project Area
- Groundwater Wells**
- Monitoring Wells
 - Plugged Wells

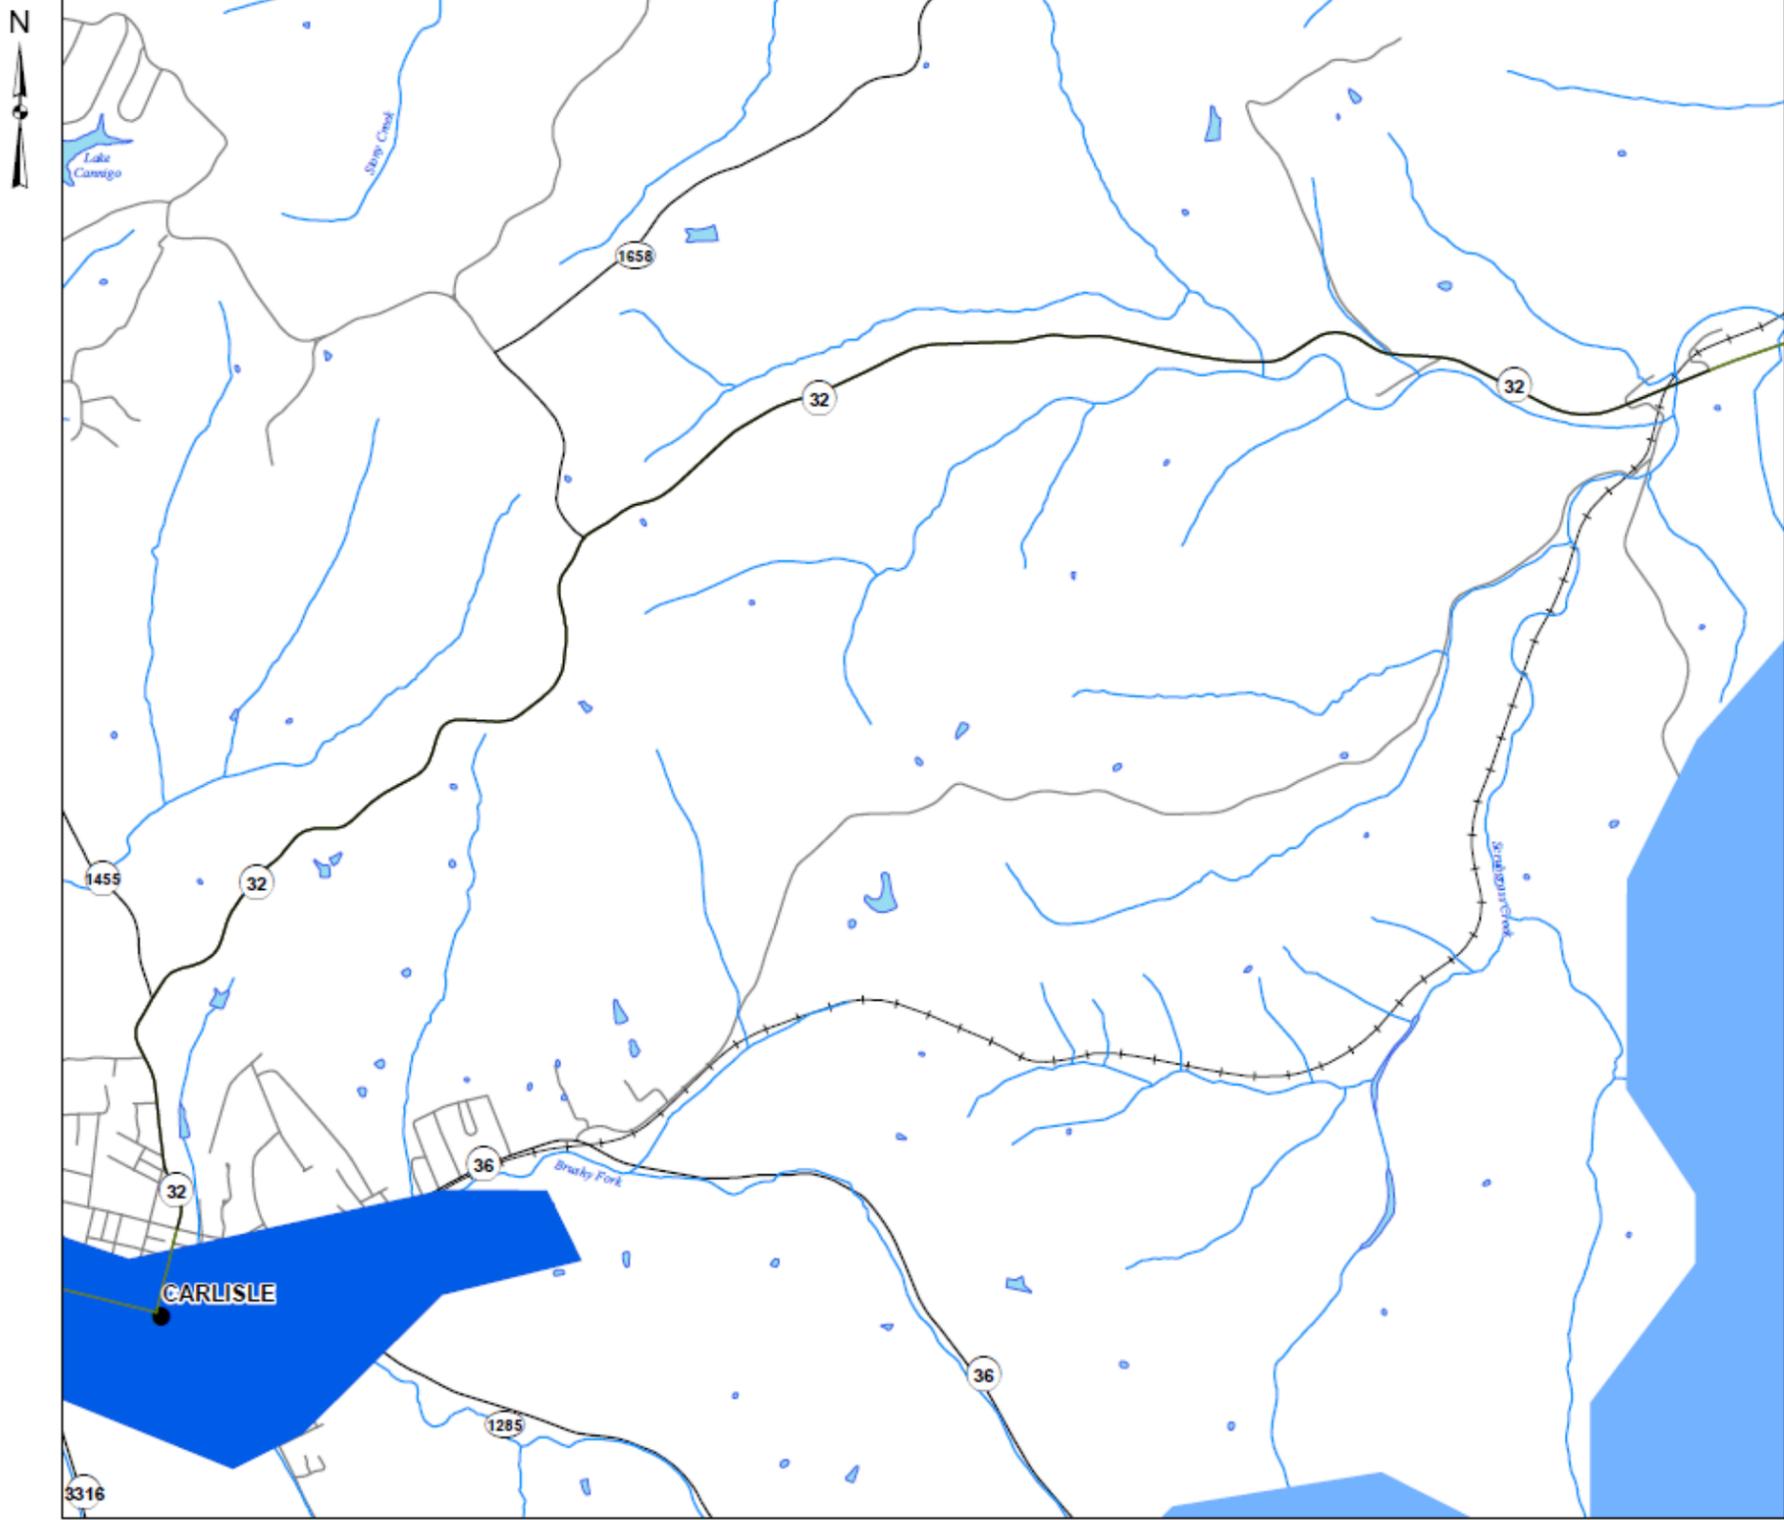
Nicholas Planning Study - Karst Potential Map

- State Roads
 - Local Roads
 - + + Active Railroad
 - Rivers and Streams
 - Waterbodies
 - Project Area
- | Karst Potential | |

Karst features are known to be in the Outer Bluegrass Physiographic Region, and karst development should be anticipated in this project area. The western portion of the project is in close proximity to a mapped high karst prone area (Appendix D). Springs are common between the limestone and shale beds and can be observed in the field during heavy rain falls. Any discoveries of sinkholes or springs should be noted and inventoried.

Geologic mapping and field observations does not indicate the presence of sinkholes (Appendix D). Any open sinkhole and/or solution cavities within the limits of construction, whether shown on the plans or not, that are not used for drainage purposes, shall be filled and/or capped in accordance with the current edition of Section 215 of the Standard Specifications for Road and Bridge Construction.
