G. GEOTECHNICAL OVERVIEW

MEMORANDUM

P-005-2018

SUBJECT: Nelson County
Western Bardstown Connectivity Study
Item No. 4-8809.00
EMARS 9278301D
Preliminary Geotechnical Assessment

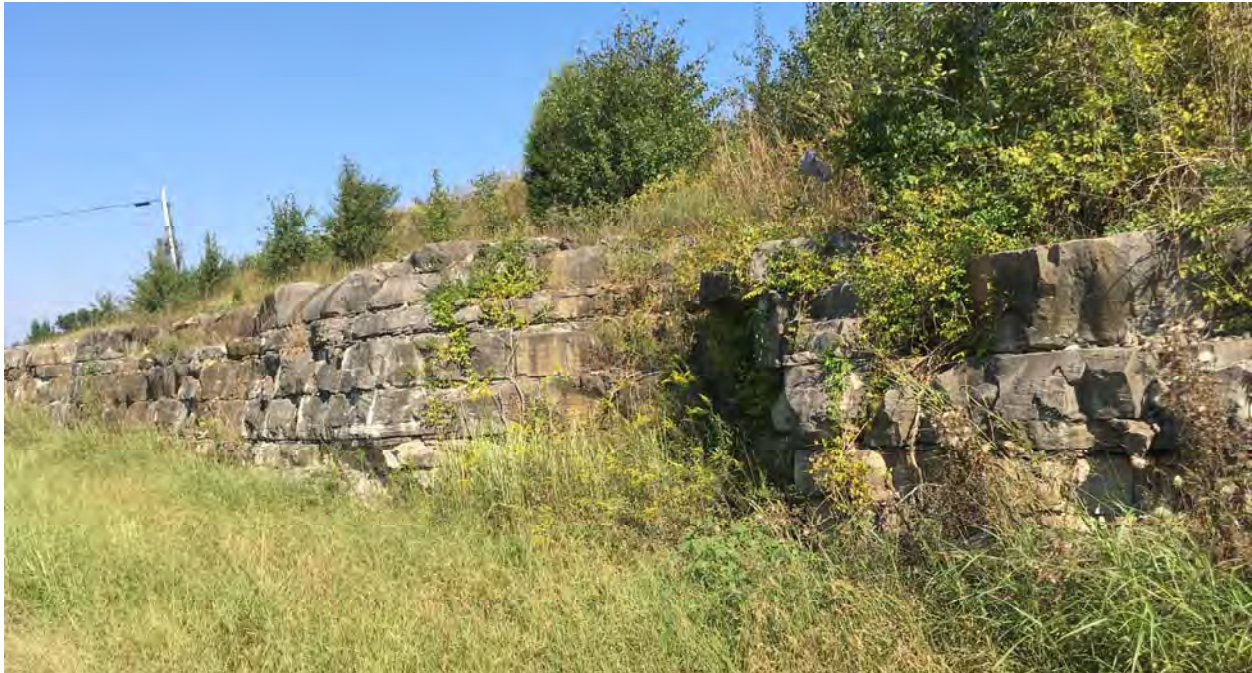
Typical cut slope for dolomite and limestone formations (KY 245 @ MP 6.1-6.2).

The dolomite and limestone formations (Beechwood Limestone Member of the Sellerburg Limestone, Louisville Limestone, Laurel Dolomite, Brassfield Dolomite and Saluda Dolomite Member of the Drakes Formation) are suitable for most construction requirements including embankment foundation construction and rock roadbed. Rock quarries in the vicinity of Bardstown excavate bedrock from the Louisville Limestone and Laurel Dolomite Formations for concrete aggregate. The dolomite and limestone formations have a potential to be karst. Karst features such as solutioned bedrock and sinkholes are expected to be encountered during construction and may increase planned excavation and require additional rock quantities for mitigation. Multiple sinkholes were identified during a field visit and mapped by the Kentucky Geological Survey (see attached geologic map). Any sinkholes encountered during construction will require an investigation and remediation as outlined under section 215, Treatment of Open Sinkholes, of the standard specifications for road and bridge construction.

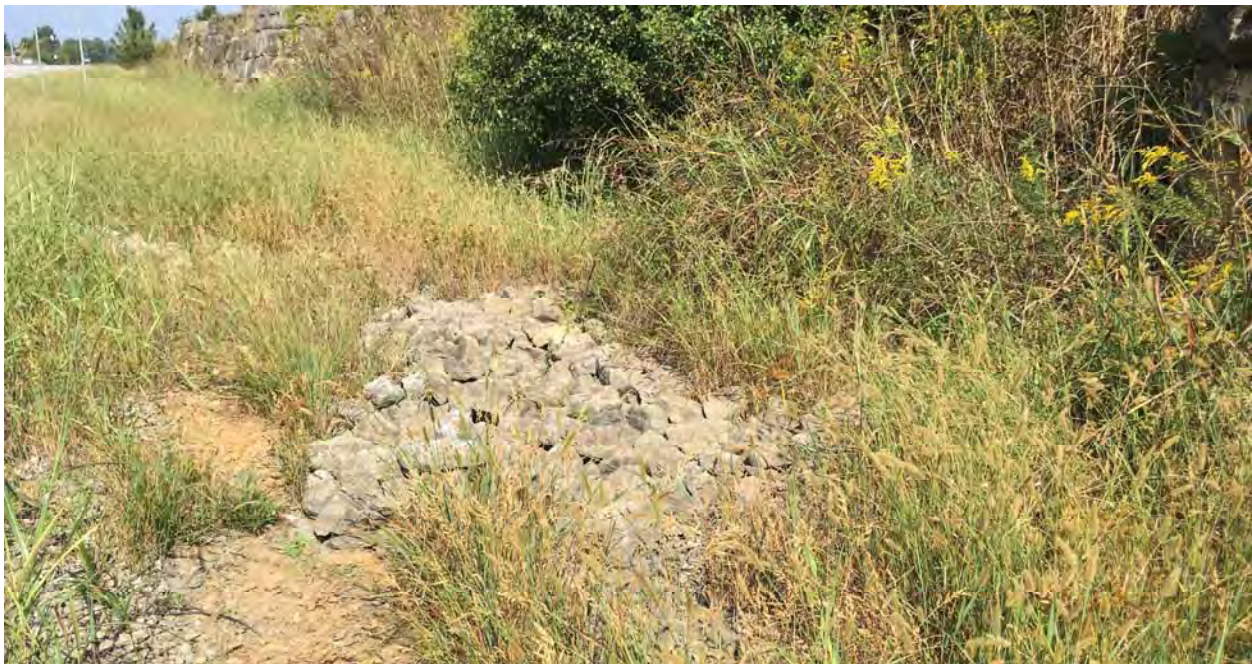
Sinkhole repair along KY 245@ MP 6.1-6.2.

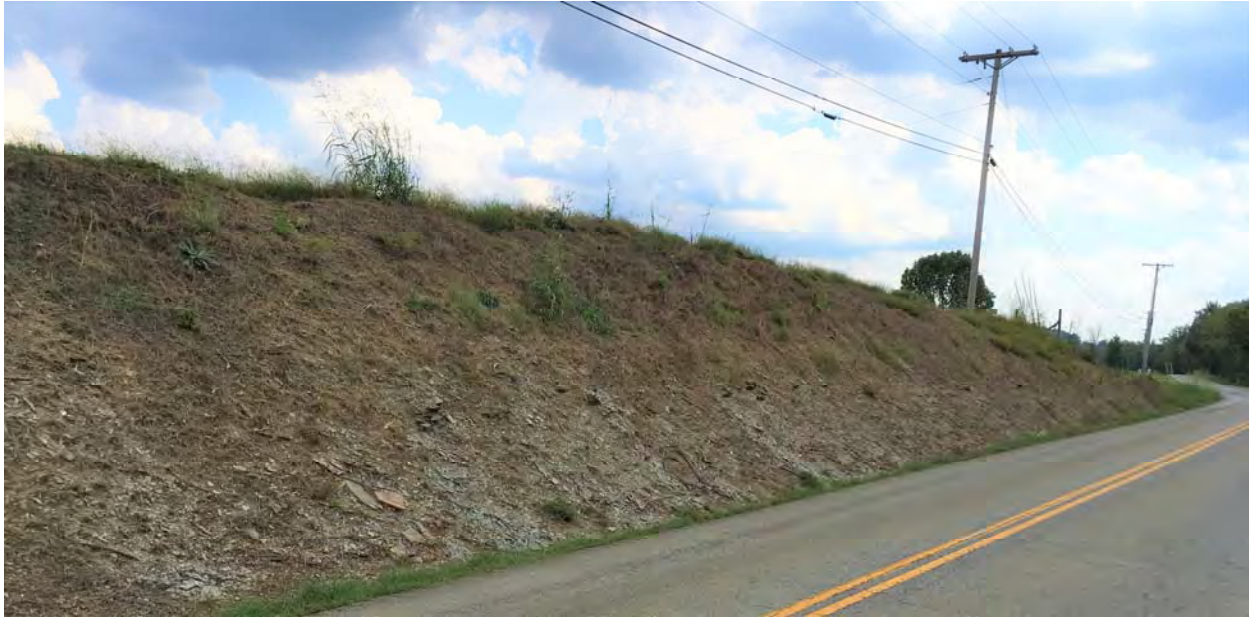
The New Albany Shale Formation exposed in cut slope along KY 733 @ MP 11.9.

The New Albany Shale will be encountered at the highest elevations along ridge tops and plateaus. The New Albany Shale is black to dark gray, carbonaceous, containing pyrite nodules. A metal-rich, acidic drainage commonly occurs when pyrite from the New Albany Shale Formation is exposed to air and water creating an environmental hazard. Additional efforts are required to

mitigate cut slopes and embankments consisting of this pyritic shale. The preferred mitigation is to encapsulate any material exposed from the New Albany Shale Formation with clay or clay shale, and top soil. Special concrete for structures, sign and guardrail posts are required in these locations. Alignments limiting disturbance through this formation is recommended.

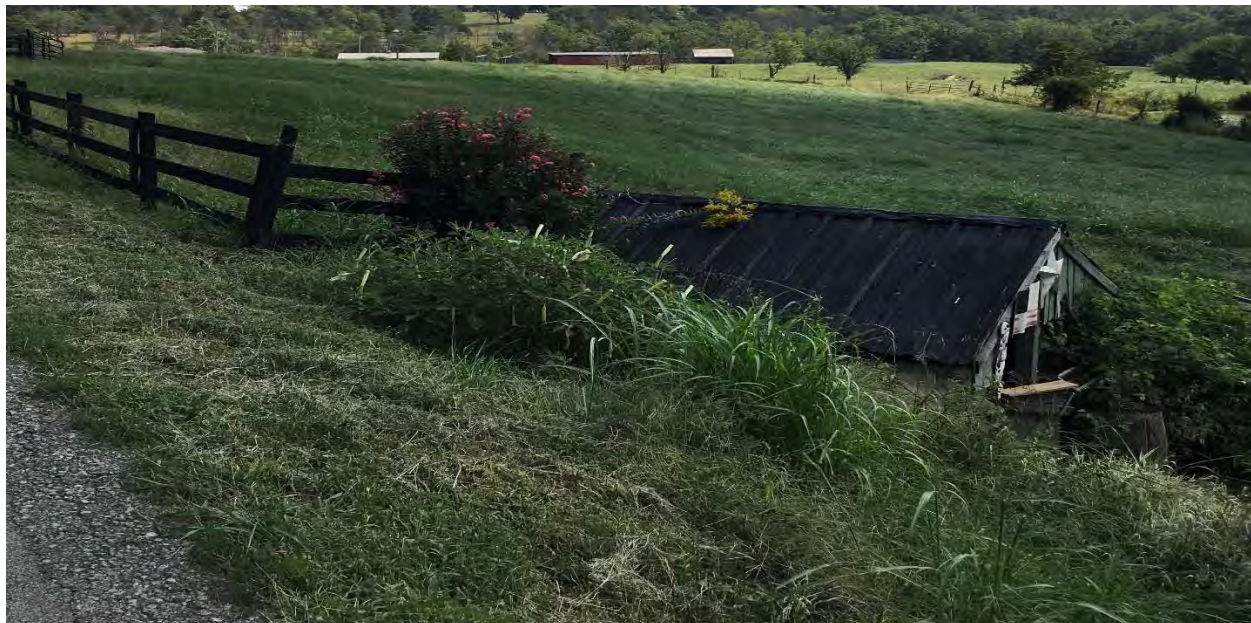
Spring box along KY 2737 @ MP 3.7.

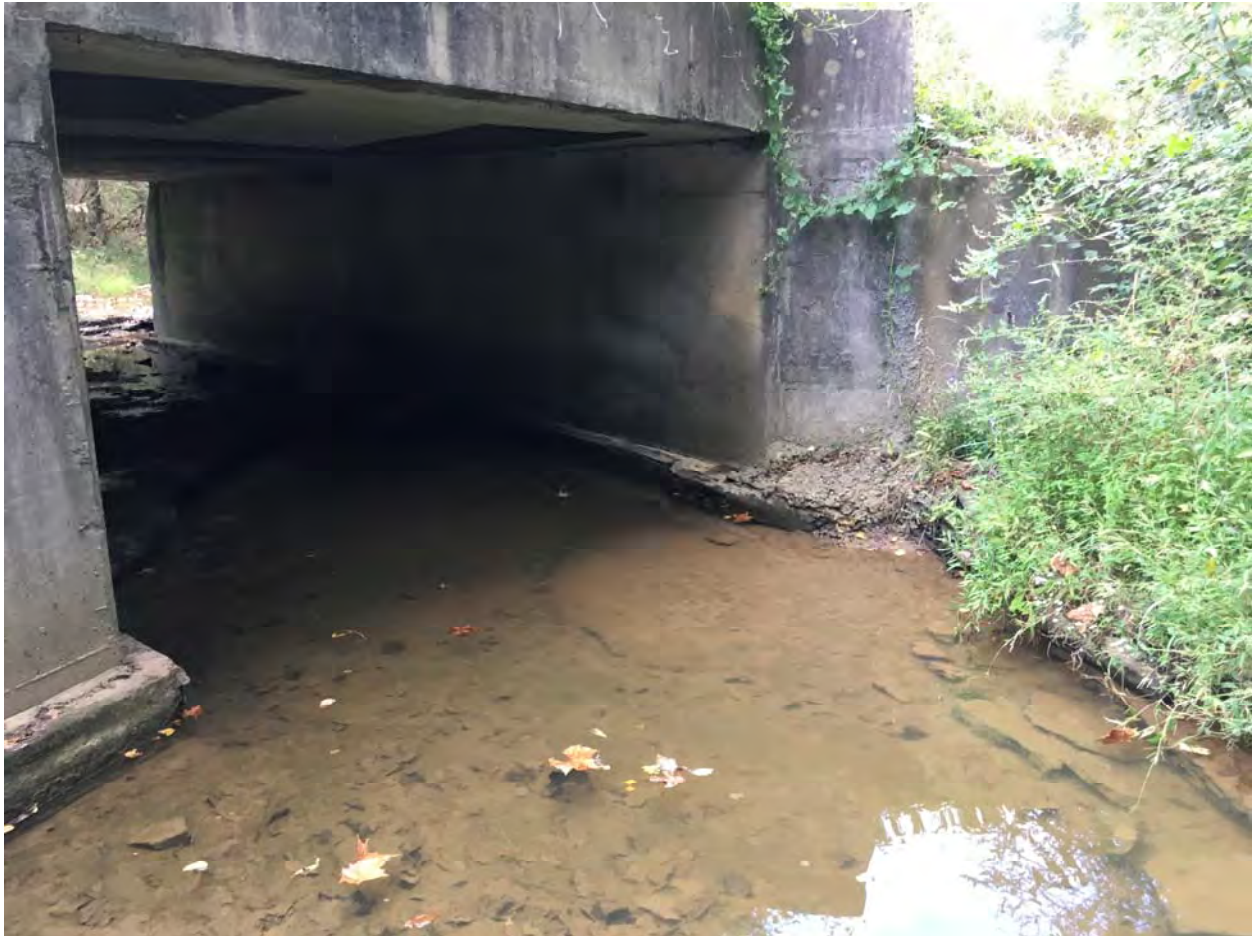
Structure founded on exposed bedrock on KY 2737 @ MP 1.1.

Foundations for bridges in the study area are generally rock bearing (end bearing piles, drilled shafts or spread foundations). Smaller structures such as retaining walls and box culverts may be founded on soil or bedrock. Some measures may be required for foundations constructed in the Waldron Shale and Osgood Formations, where the bedrock is considered erodible.

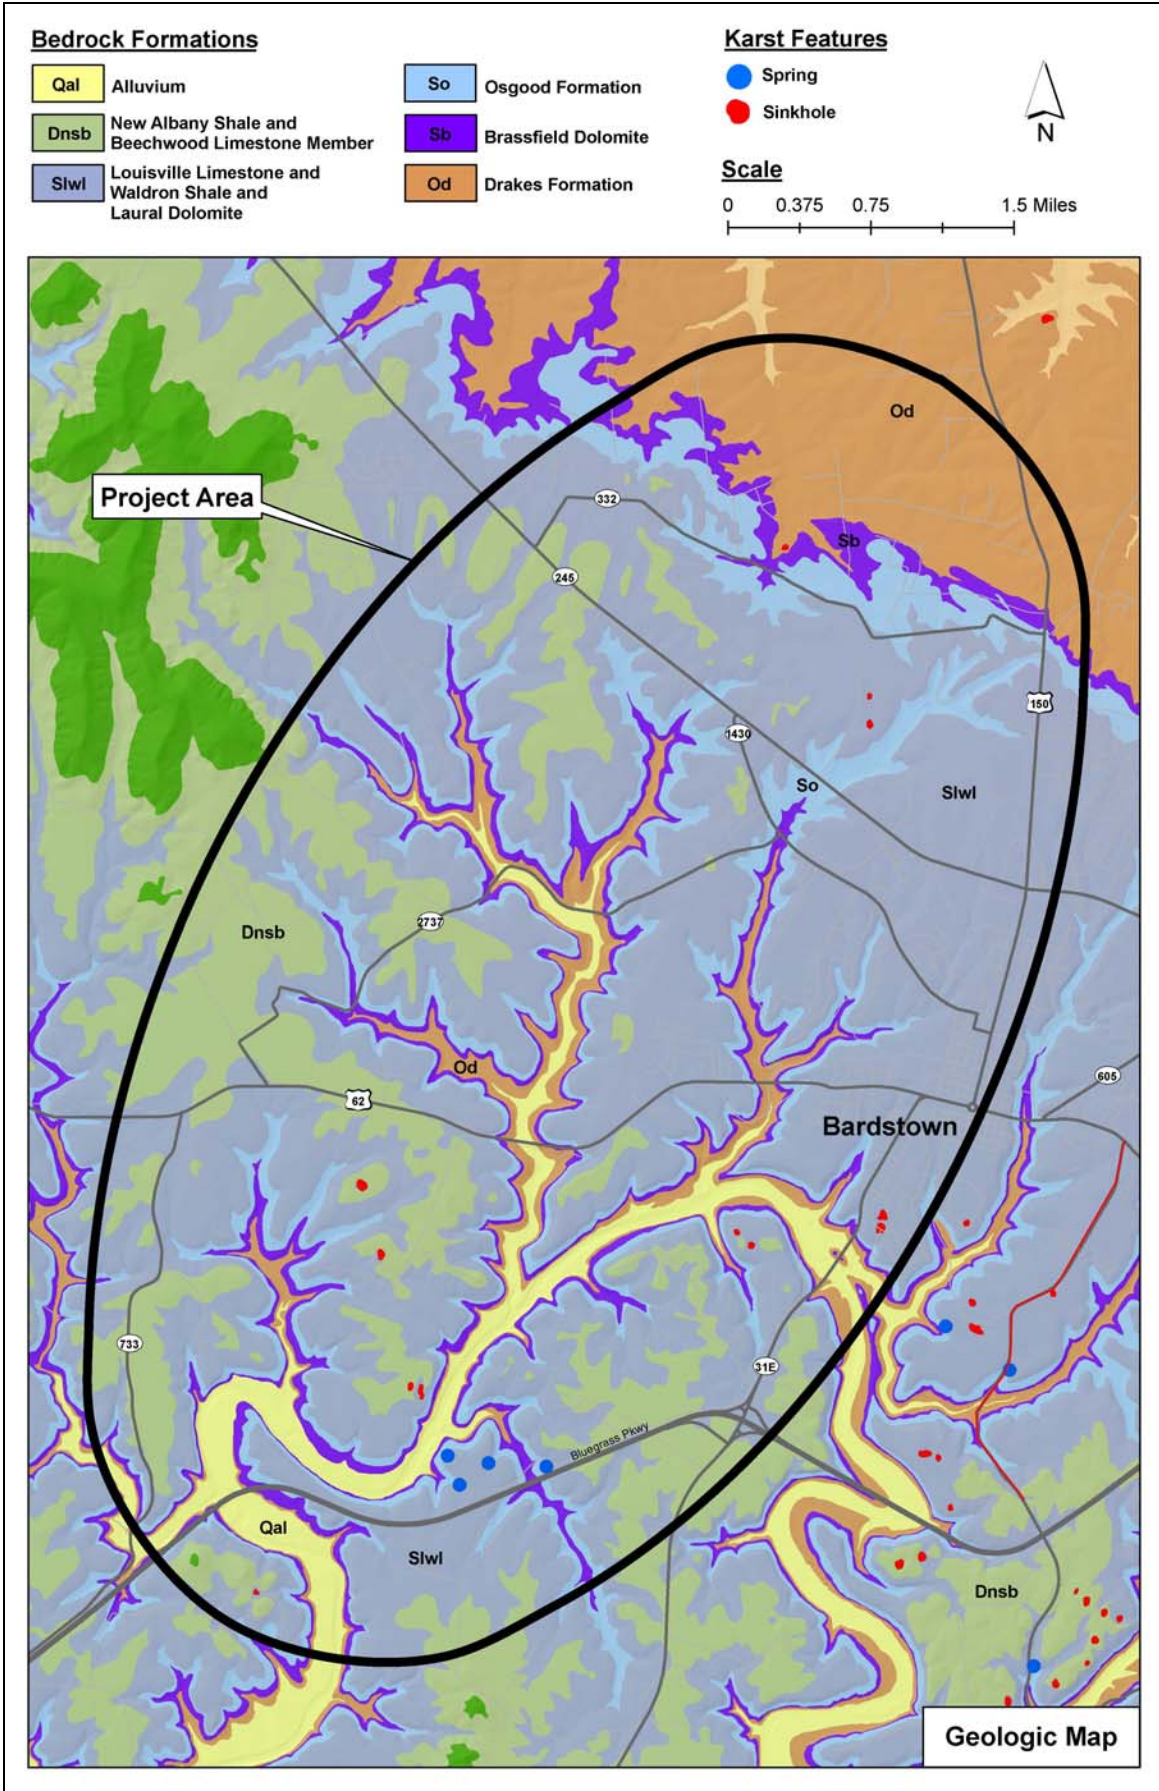
Geologic Map

The site is located in The Knobs Physiographic Region of Kentucky straddling the Cravens and Bardstown 7.5 Minute Quadrangles. Based on geologic mapping, bedrock within the study area consists of dolomite and limestone separated by three distinct formations (layers) of shale. Bedrock formations in the subject area are depicted on the attached geologic map.
