KENTUCKY TRANSPORTATION CABINET

Cumberland Expressway Upgrade Study

Final Report • March 2022

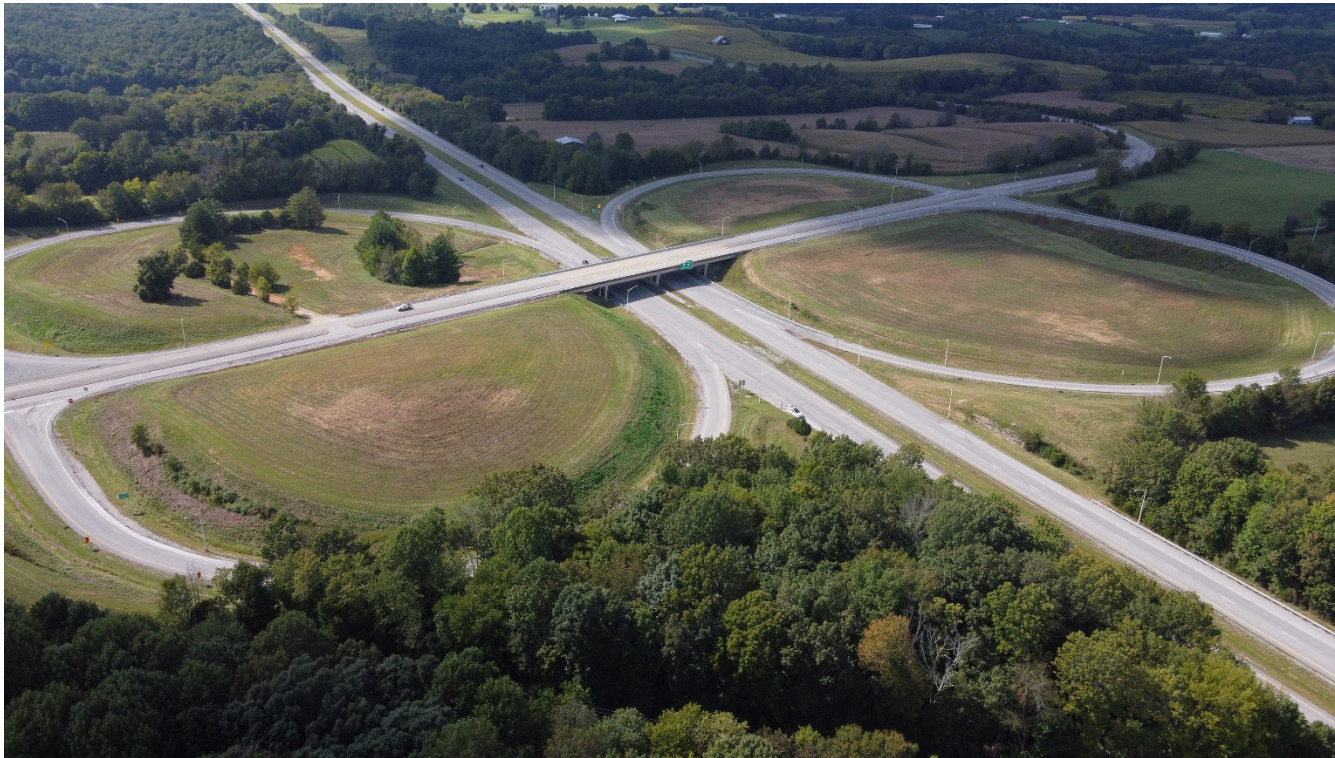
Figure 9: Exit 27 (US 68, Glasgow Road) Interchange

The interchange at Exit 27 (US 68, Glasgow Road) in Metcalfe County is the only interchange with weaving characteristics not meeting Interstate standards. This type of interchange is known colloquially as a “Tollbooth Interchange” per its function prior to the removal of tolls on the Kentucky Parkway system. **Figure 9** shows the cloverleaf design that does not meet standards.

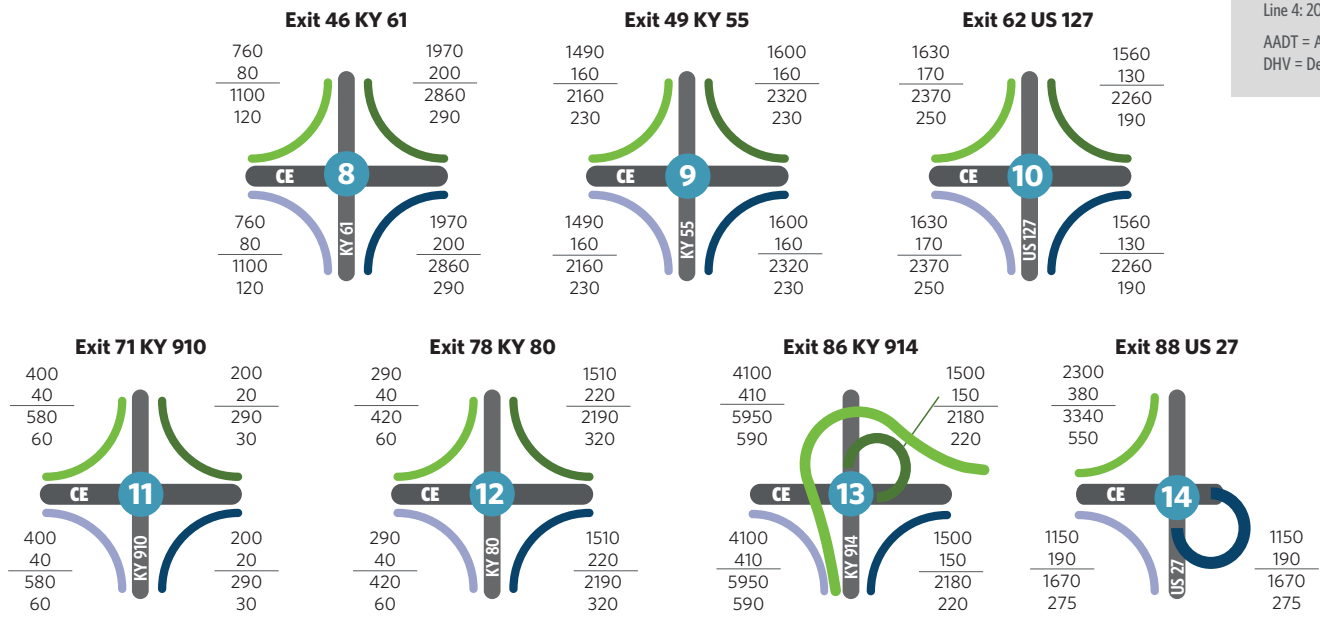
Figure 10: 2020 and 2045 AADT and DHV

- Line 1: 2020 AADT
- Line 2: 2020 DHV
- Line 3: 2045 AADT
- Line 4: 2045 DHV

AADT = Average Annual Daily Traffic
DHV = Design Hourly Volume

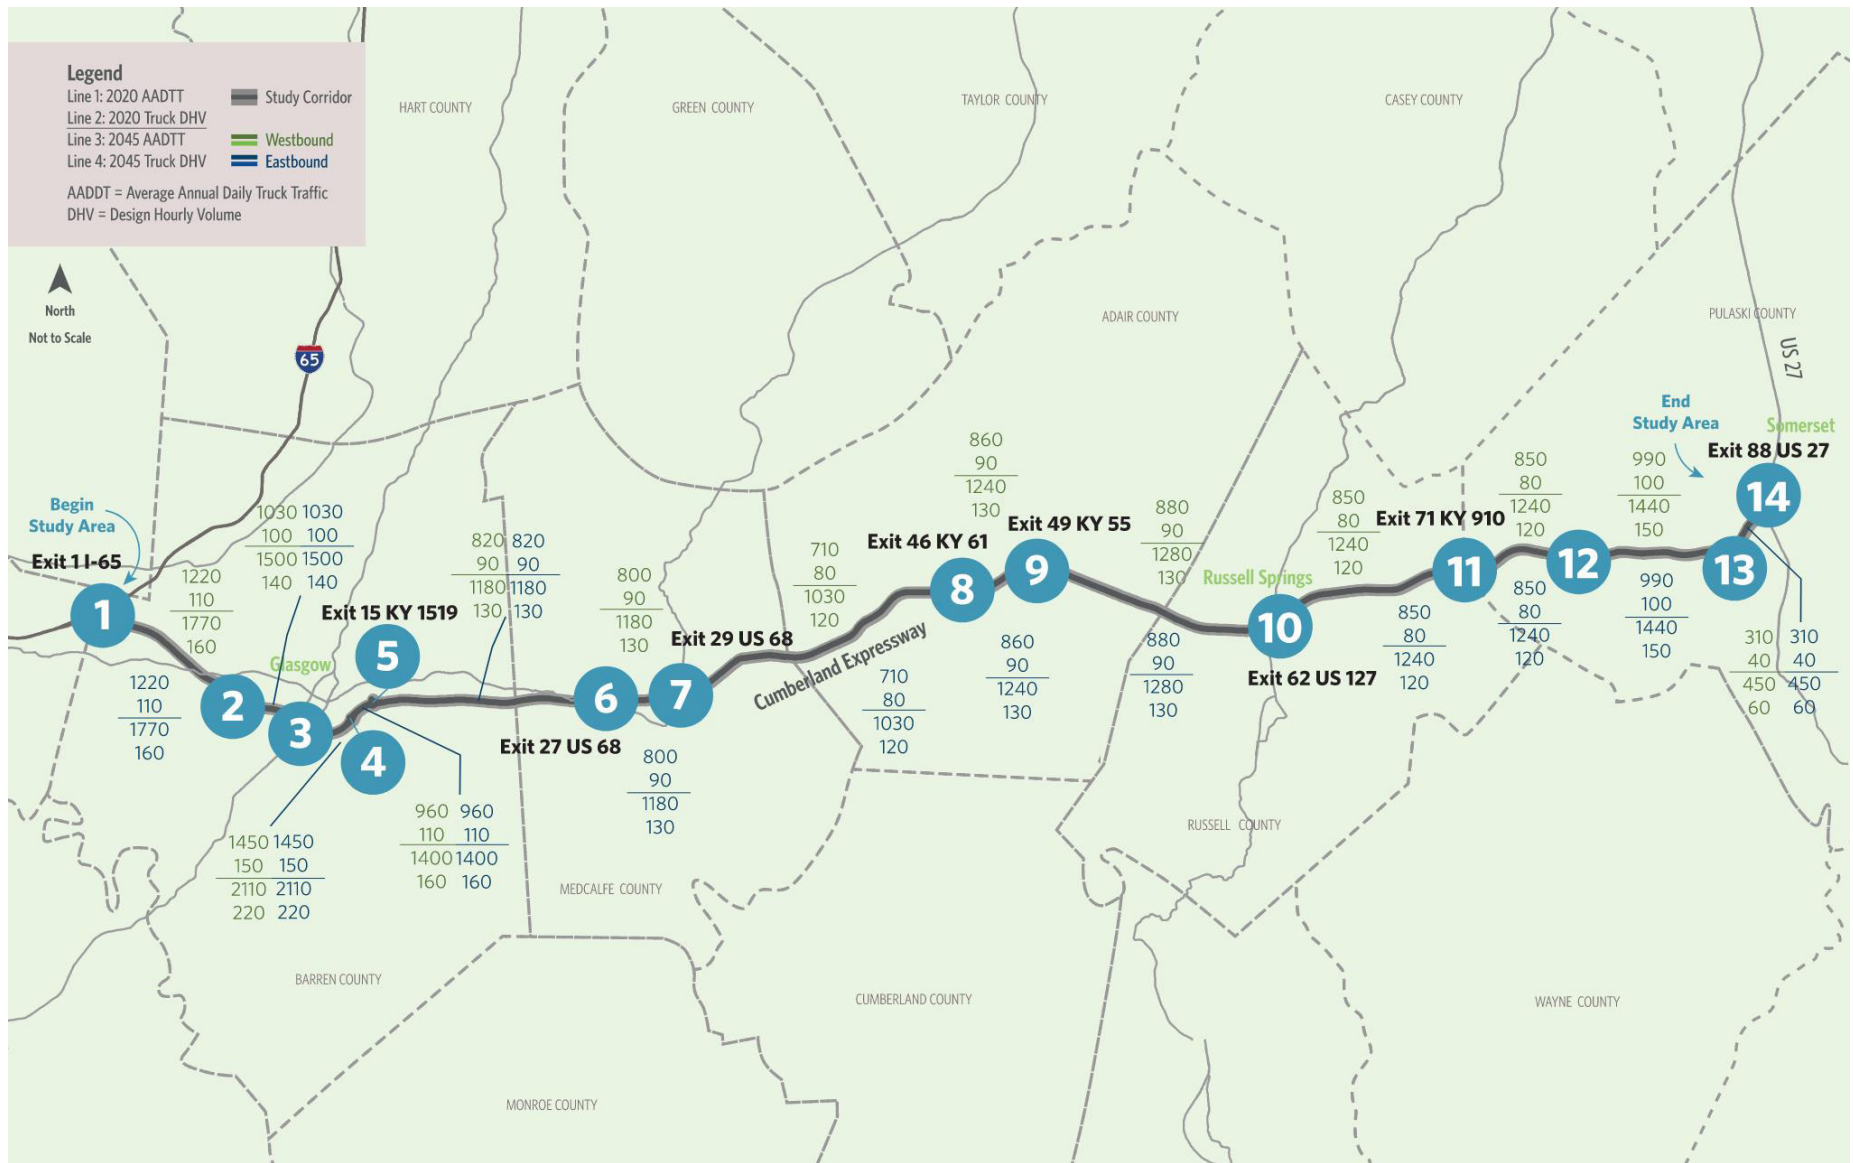
Figure 11: Truck AADT and DHV

Truck data was obtained from KYTC to estimate Average Annual Daily Truck Traffic (AADTT) and truck DHVs for each segment of the Cumberland Expressway. The final balanced directional AADTTs ranged from a low of 310 (620 in both directions) at the far east end of the Cumberland Expressway to a high of 1,450 (2,900 in both directions) near Glasgow. The final directional truck DHVs ranged from a low of 40 (80 in both directions) at the far east end of the Cumberland Expressway to a high of 150 (300 in both directions) near Glasgow (**Figure 11**). Mainline truck percentages on the Cumberland Expressway range from 17% to 27% for daily volumes and from 13% to 21% for DHVs.

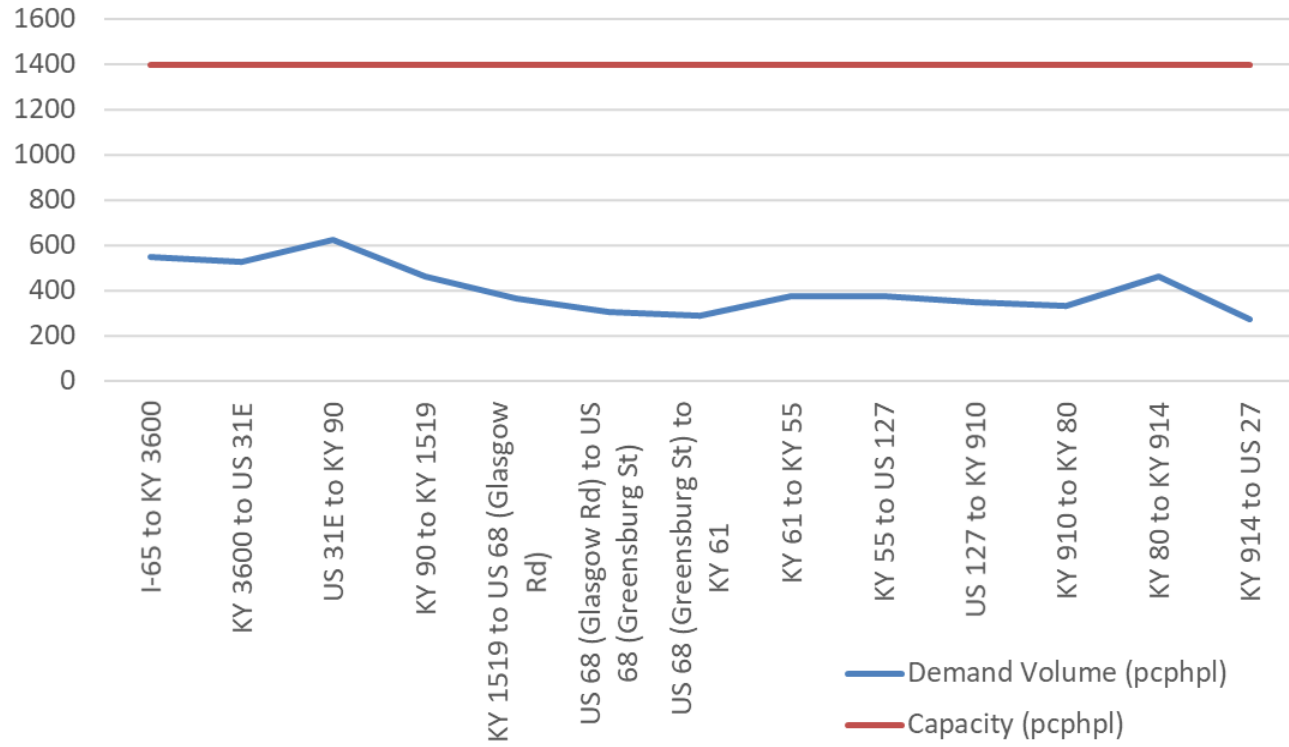
Figure 12: Eastbound 2045 Per Lane DHVs Compared to LOS D Service Volume Threshold

The traffic operational analysis was conducted using the capacity screening methodology from the *Planning and Preliminary Engineering Applications Guide to the Highway Capacity Manual*⁵ (NCHRP Report 825, 2016) to evaluate the potential for operational issues. Given that the volumes on the Cumberland Expressway appeared to be well below the capacity of the facility even in the highest volume areas, this screening approach was determined to be the most appropriate method for quickly and effectively determining if a detailed traffic operational analysis was needed for the study.

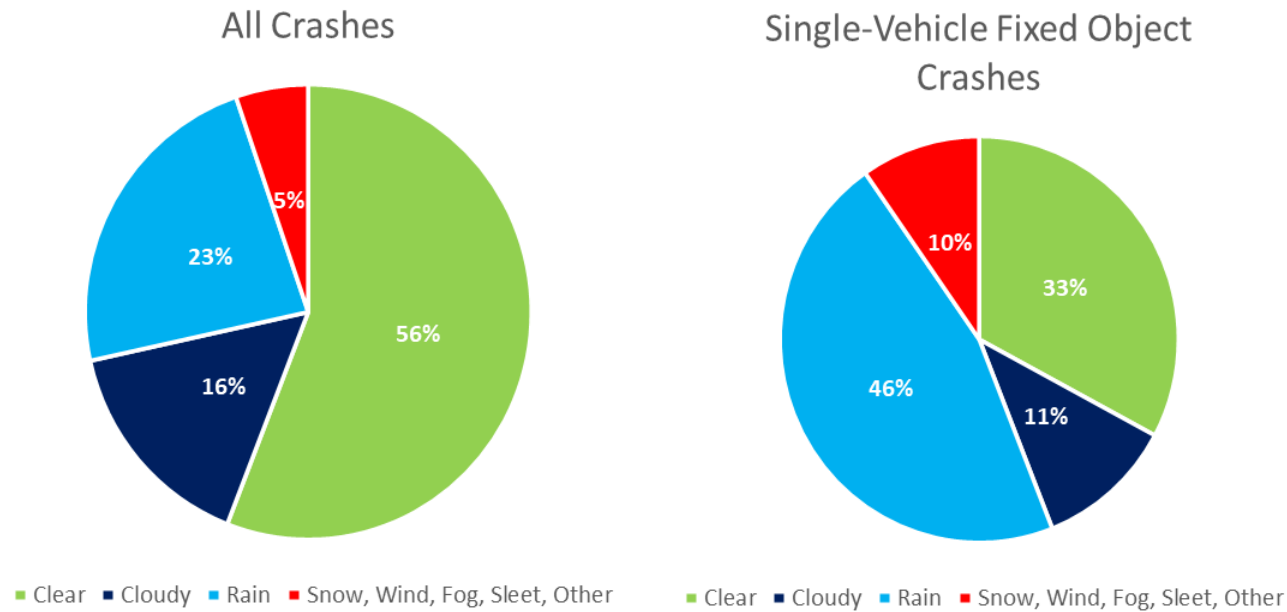
Figure 14: All Crashes and Single-Vehicle Fixed Object Crashes by Weather (2015-2019)

For single vehicle crashes that involved the driver striking a fixed object, weather played an important role. **Figure 14** provides crashes by weather conditions for all crashes and for single vehicle fixed-object crashes only.

The percent of these crashes occurring during inclement weather (rain, snow, sleet, fog, etc.) is 56% compared with 28% for all crashes.

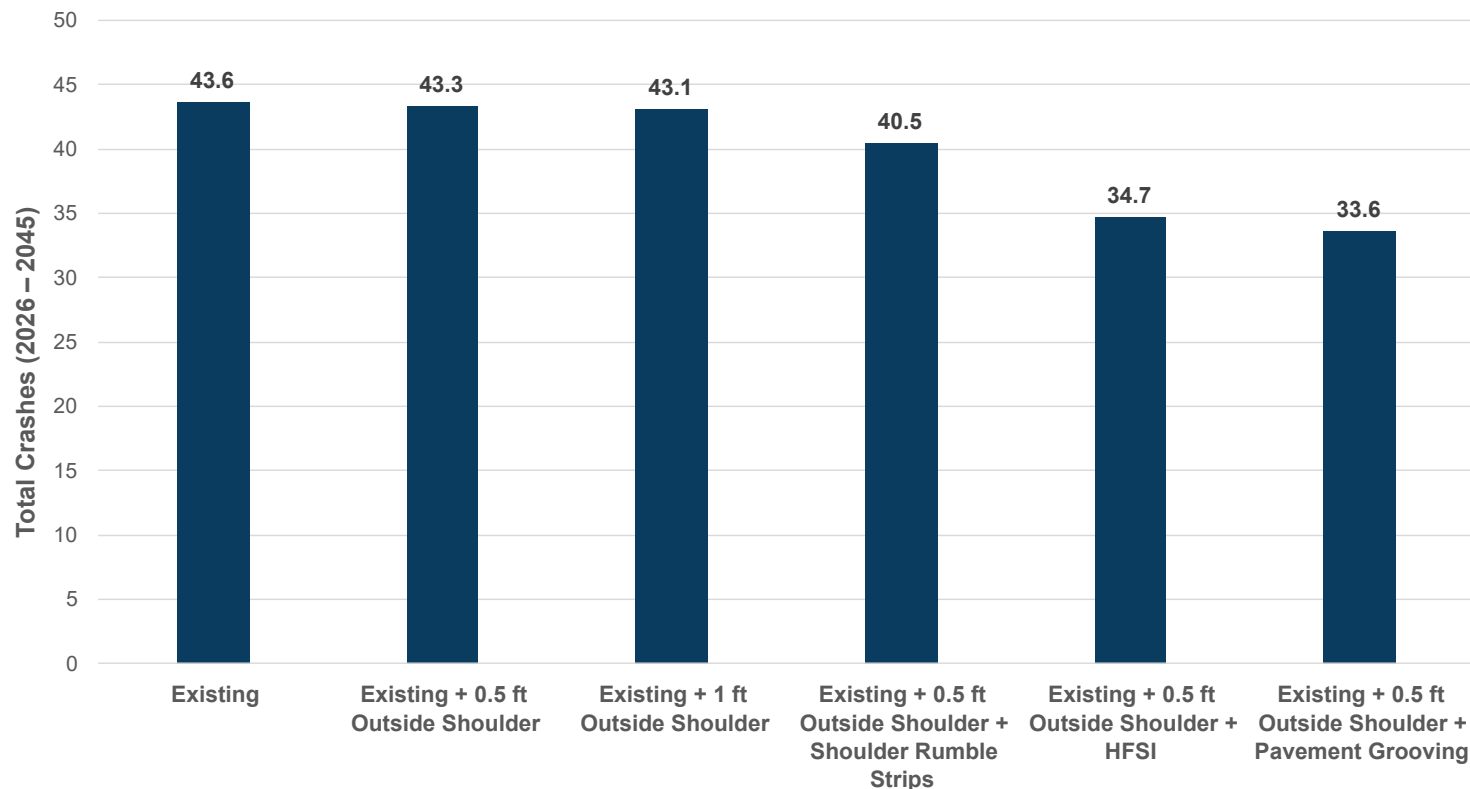
Figure 22: Predicted Crashes on Fishing Creek Bridges (2026 to 2045)

The results of the predictive safety analysis for a 20-year period (2026-2045) are illustrated in **Figure 22**. As shown, upgrading the bridge railings and adding 0.5 feet in clear width to each bridge will have a nominal impact on the predicted number of crashes (<1 crash prevented over 20 years), though upgrading the railings could prevent a more severe crash from occurring. Similarly, there was little marginal benefit from the full compliance option of widening the bridges by 1.0-foot.

The options that combined the upgraded railings with low-cost safety improvements all resulted in higher crash reductions (reductions of 3 to 10 crashes over the 20-year period). The currently recommended concept would be to replace the outside railing with a crashworthy concrete railing, which would increase the clear width by 0.5-foot on each bridge,

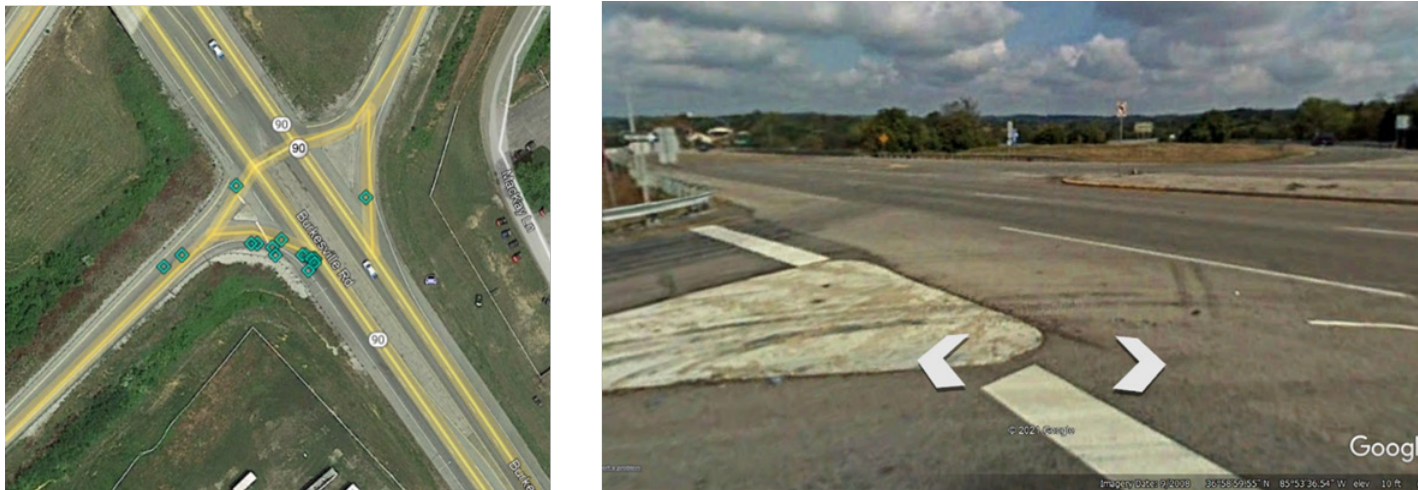
Figure 26: Exit 14 (KY 90) Eastbound Off-Ramp Crashes and Sight Distance Issues

A high number of crashes were identified at the end of the eastbound off-ramp to Exit 14 (KY 90). Many of these crashes appeared to be related to the channelized right turn. **Figure 26** shows the location of crashes next to a Google Earth Street View image looking north from the channelized right turn lane. One potential improvement that could be considered for this location is to convert the channelized right turn into a “Smart Right

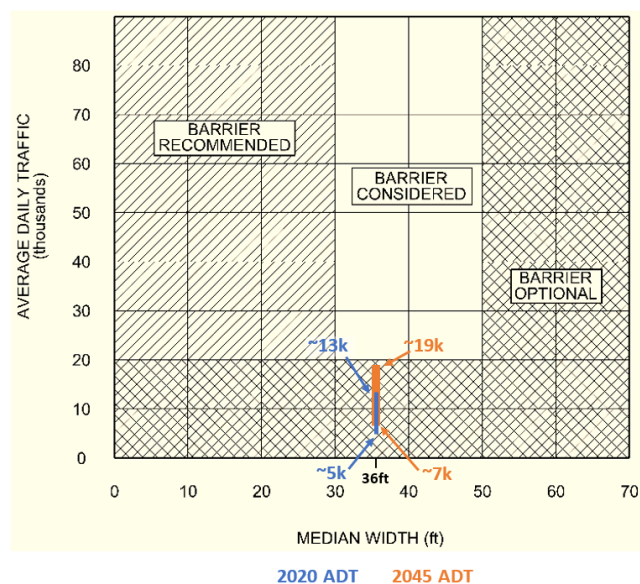
Figure 29: 2011 Roadside Design Guide Criteria for Median Barriers on Fully Access Controlled Highways

According to the crash data for the corridor, there were 62 median crossover crashes during the five-year analysis period. This determination is based on the median crossover “flag field” in the CDAT crash data. The 62 crashes had a higher typical severity when compared to all crashes in the corridor, with seven (11%) of the 62 being fatal crashes as shown in

Given the high severity of the crossover crashes relative to all crashes, the fact that there was some observed clustering of the crashes, and that the current guidance appears to suggest a barrier is optional, it was decided that a high-level benefit cost analysis would be useful to provide direction on installing cable median barrier.
