I-65 Bridges from I-264 to Kennedy Interchange

Planning Study

Jefferson County, KY

August 2019

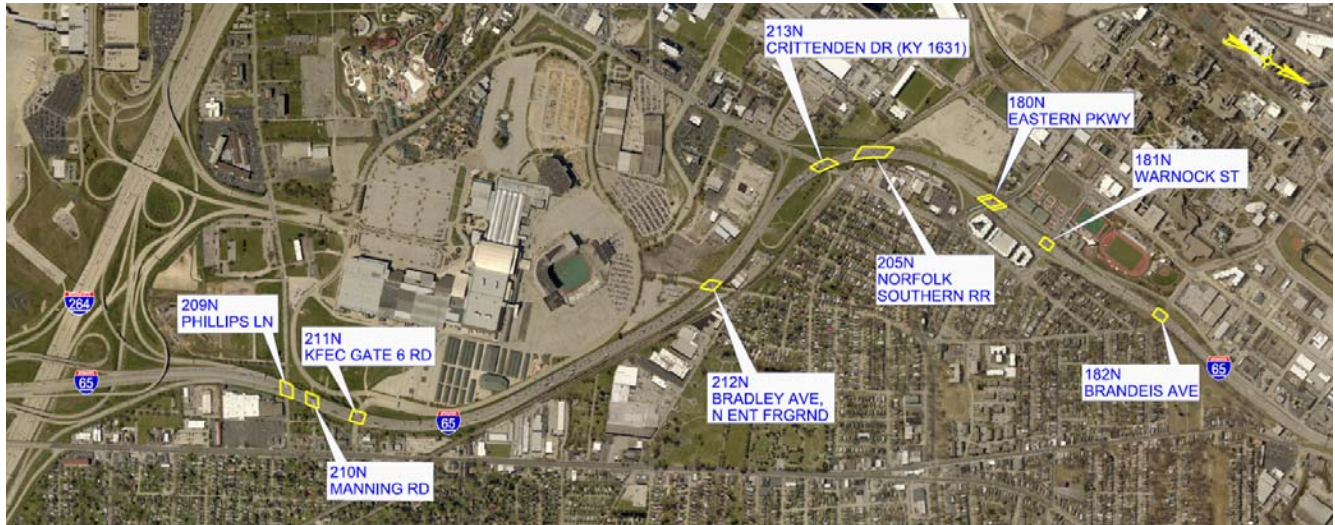
Figure ES1: Study Bridges – South

The Kentucky Transportation Cabinet (KYTC) initiated a study of the I-65 Bridges in Jefferson County in June 2018. This study's objective is to assess conditions and prioritize and develop conceptual strategies for repair or replacement of all bridges along Interstate 65 between the Watterson Expressway (I-264) and the rebuilt Kennedy Interchange in Louisville, KY, 28 bridges in all (**Figures ES1 and ES2**).

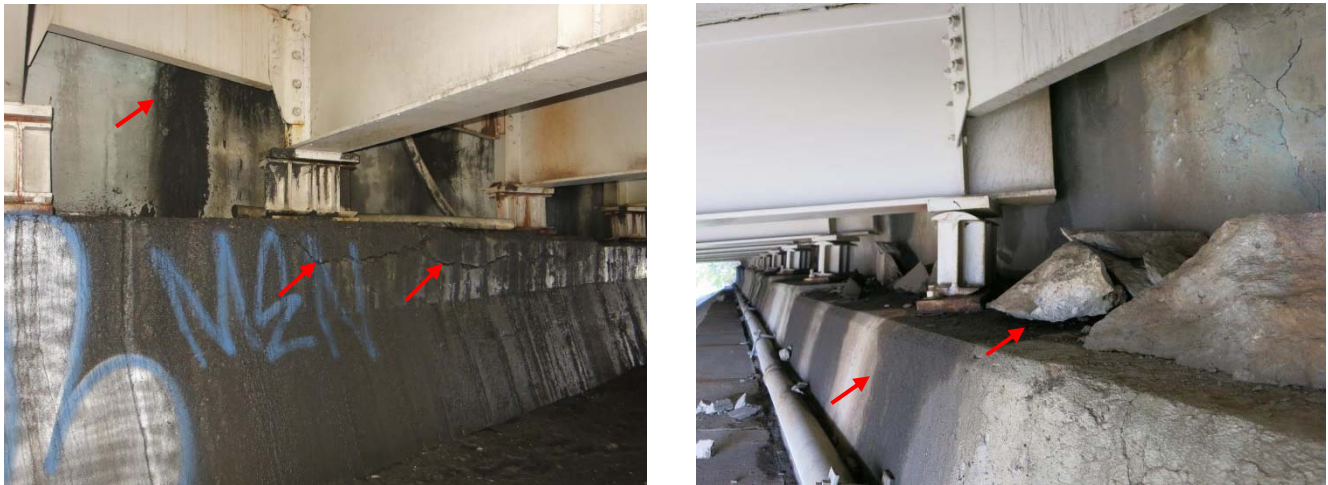
Figure ES3: Typical Abutment Joint Leakage and Concrete Damage

The vast majority of bridges in this study have active corrosion within the concrete at their abutments and concrete girder ends, if comprised of concrete girders. This is the location of expansion joints, and it is evident that many joints have failed and are leaking (**Figure ES3**). Abutment joint elimination via deck slab extension is recommended wherever possible (**Figure ES4**).

Traffic operational analyses show that the effect/impact of the single-lane closure with traffic shift is comparable to complete direction closures with weekend-only work. The continuous single-lane closure to traffic is the recommended maintenance of traffic scheme to allow time for abutment joint elimination of half a bridge width, by direction, at a time.

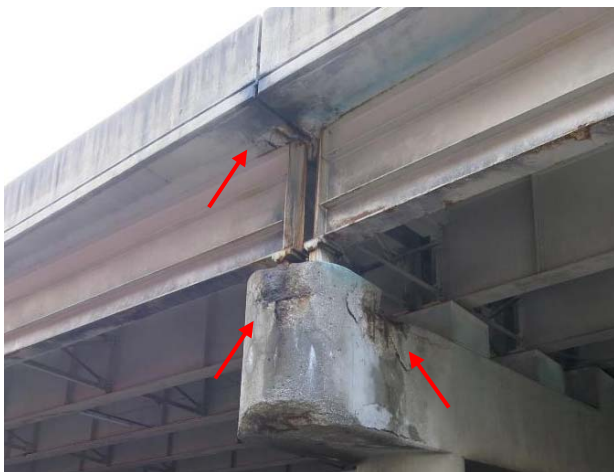
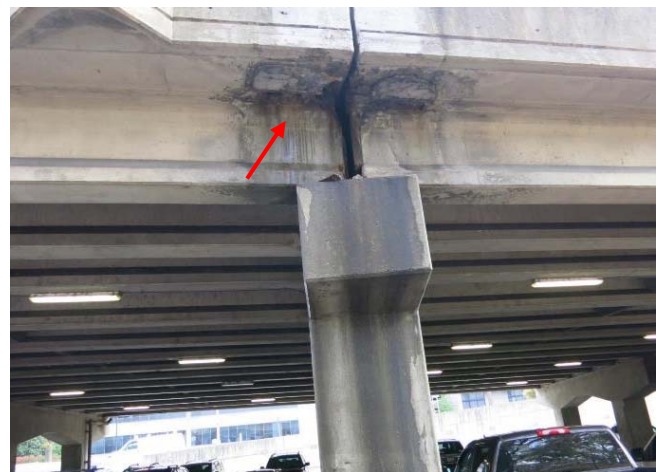
Figure ES5: Typical Pier Joint Leakage and Concrete Damage

Similarly, expansion joints at piers have identical leakage and corrosion problems and can be eliminated in some instances (**Figure ES5**). Pier joint elimination by implementing link-slabs and reconfiguring bearings for longitudinal movement and load resistance is recommended wherever possible (**Figure ES6a and ES6b**).

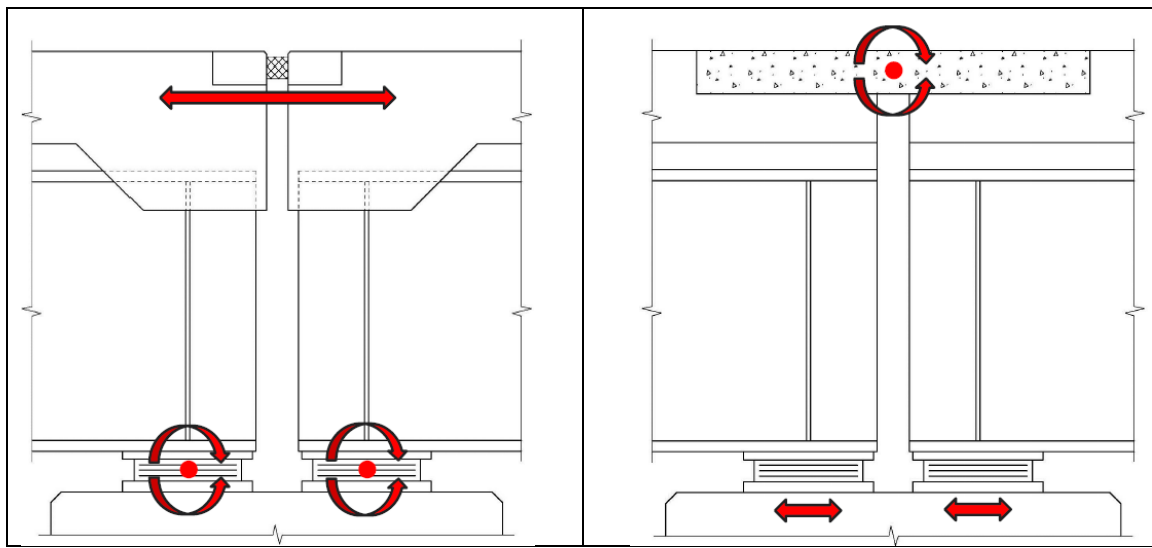
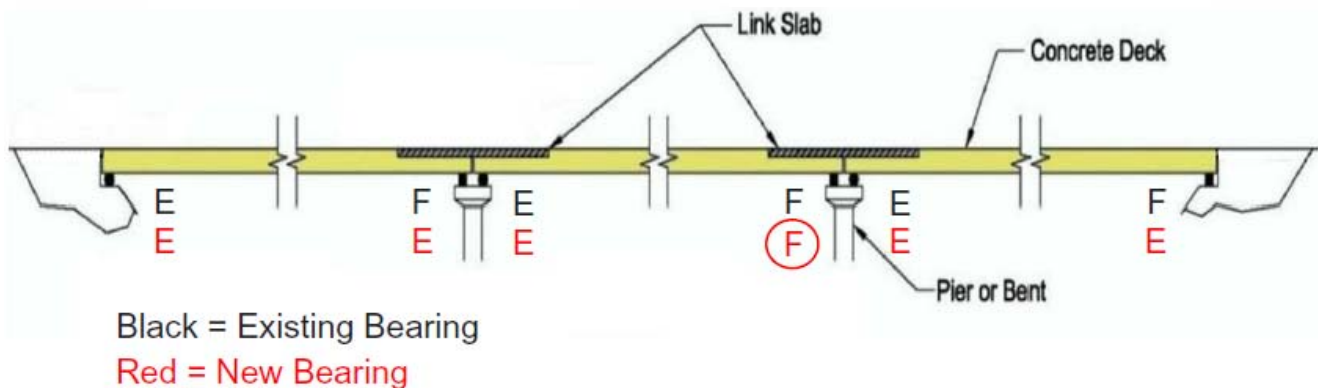
Figure ES6b: Changes to Bridge Using a Link Slab (New York Department of Transportation Presentation)

Pier Configuration with Joint

Pier Configuration with Link-Slab

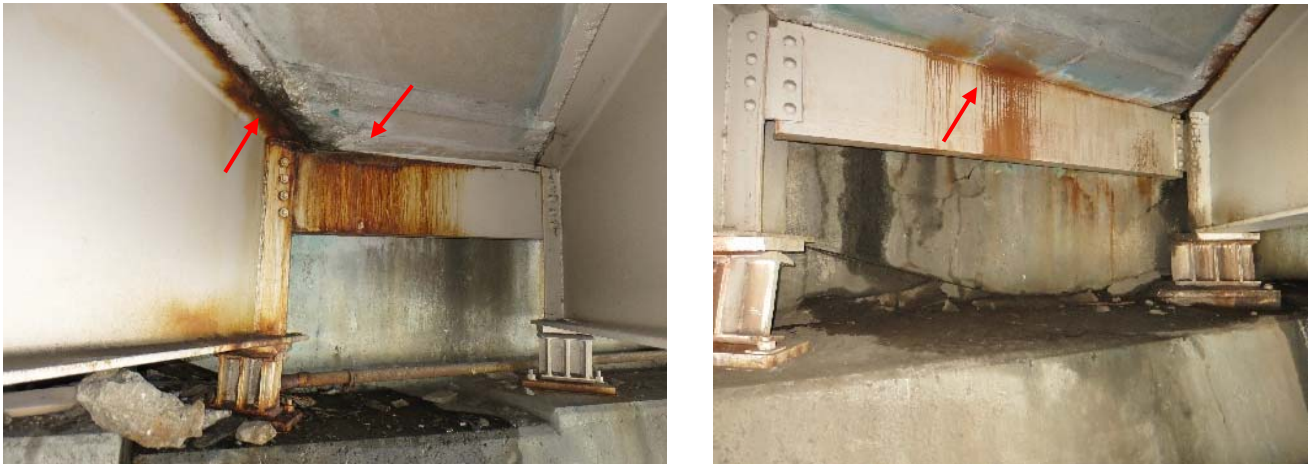
Figure ES7: Typical Slab Delamination at Bridge Ends

Several instances of slab debonding at bridge ends were observed. (**Figure ES7**) It is recommended to add shear studs to the top flange of the steel beams when abutment joints are eliminated. Likewise, corrosion was observed at several joints between bridge barriers at the median (**Figure ES8**). Elimination of this median joint is also recommended by replacing the two barriers with a single barrier, similar to the north end of the study area.

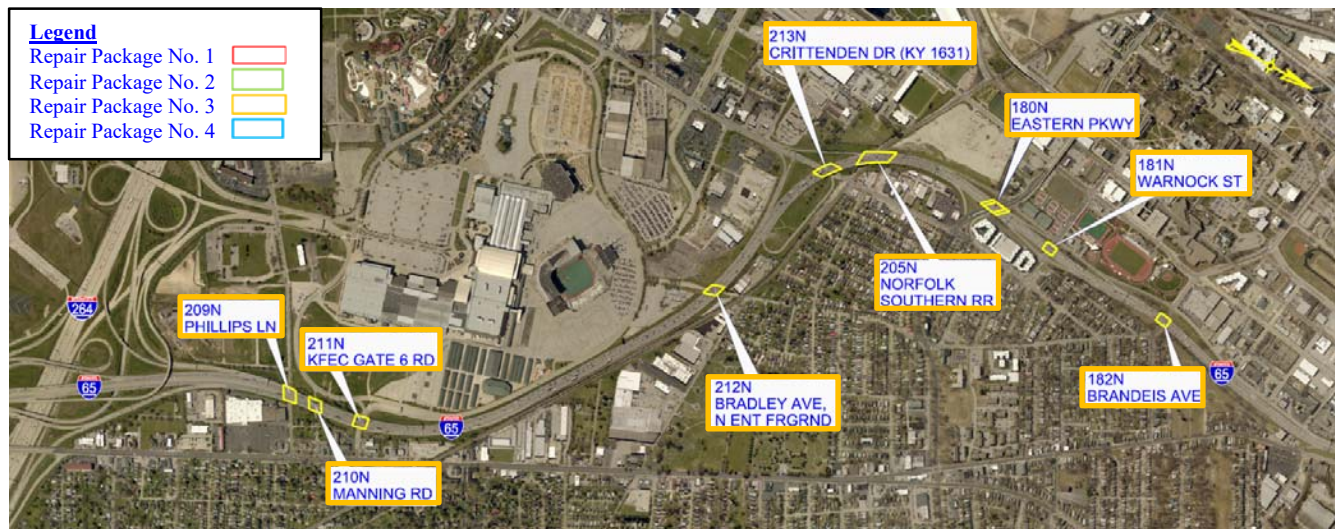
Figure ES9: Repair Package Grouping – South

Moderate Priority: Phillips Lane to Brandeis Avenue

Repair Package No. 3: 209N, 210N, 211N, 212N, 213N, 205N, 180N, 181N, 182N

Low Priority: Preston Street Ramps to Breckinridge Street

Repair Package No. 4: 208N, 207N, 206N, 187N, 186N, 185N, 184N, 190N, 189N
