# I-65 Bridges from I-264 to Kennedy Interchange

## Planning Study

### Jefferson County, KY

August 2019

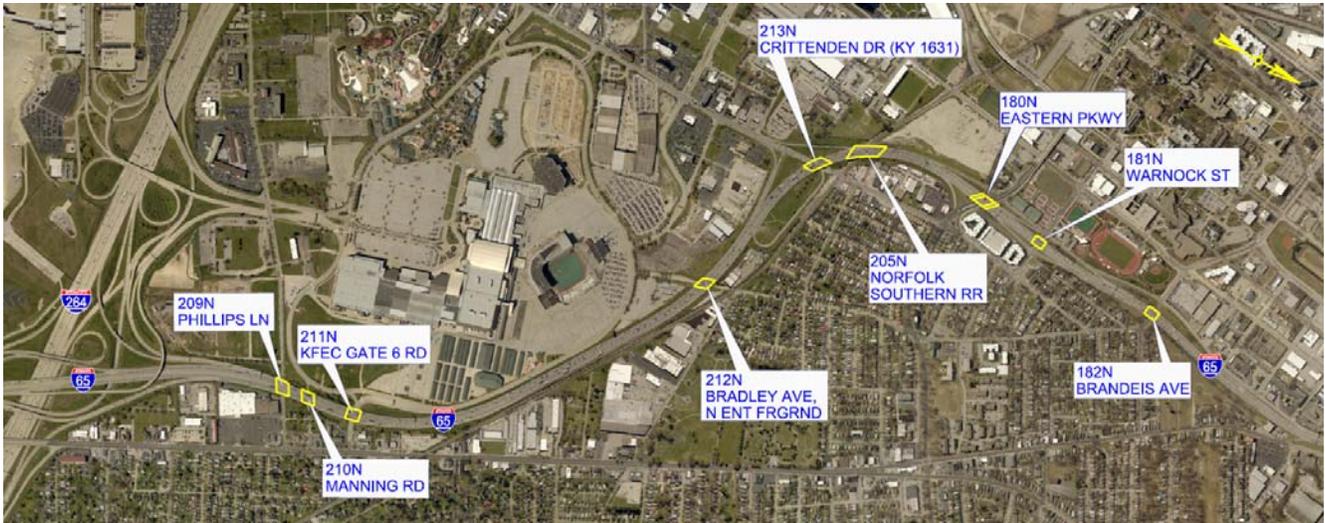
Figure ES1: Study Bridges – South

The Kentucky Transportation Cabinet (KYTC) initiated a study of the I-65 Bridges in Jefferson County in June 2018. This study's objective is to assess conditions and prioritize and develop conceptual strategies for repair or replacement of all bridges along Interstate 65 between the Watterson Expressway (I-264) and the rebuilt Kennedy Interchange in Louisville, KY, 28 bridges in all (**Figures ES1 and ES2**).

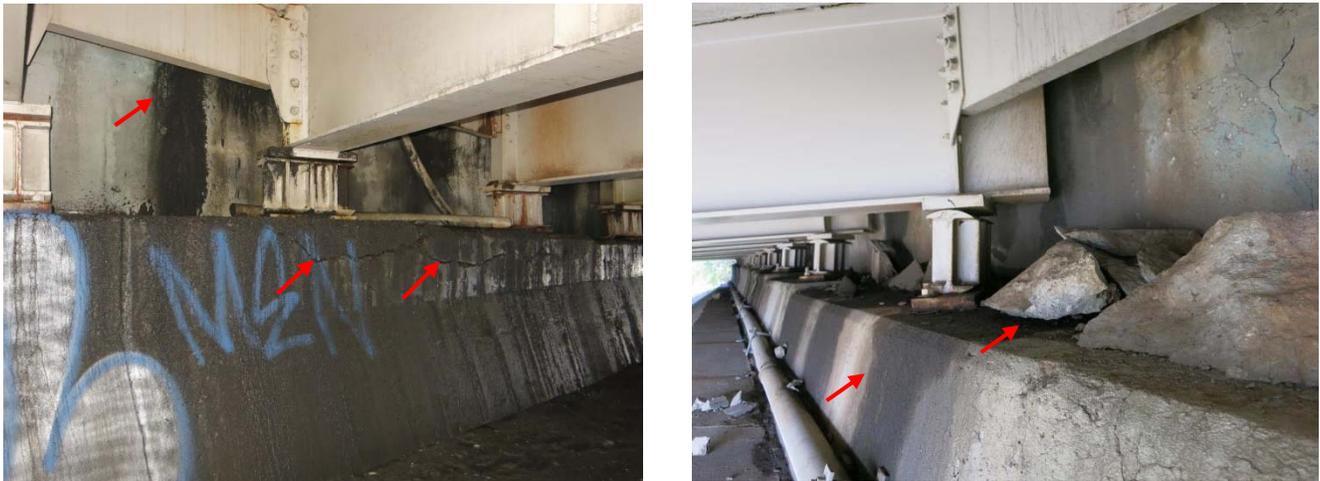
The vast majority of bridges in this study have active corrosion within the concrete at their abutments and concrete girder ends, if comprised of concrete girders. This is the location of expansion joints, and it is evident that many joints have failed and are leaking (**Figure ES3**). Abutment joint elimination via deck slab extension is recommended wherever possible (**Figure ES4**).

Figure ES3: Typical Abutment Joint Leakage and Concrete Damage

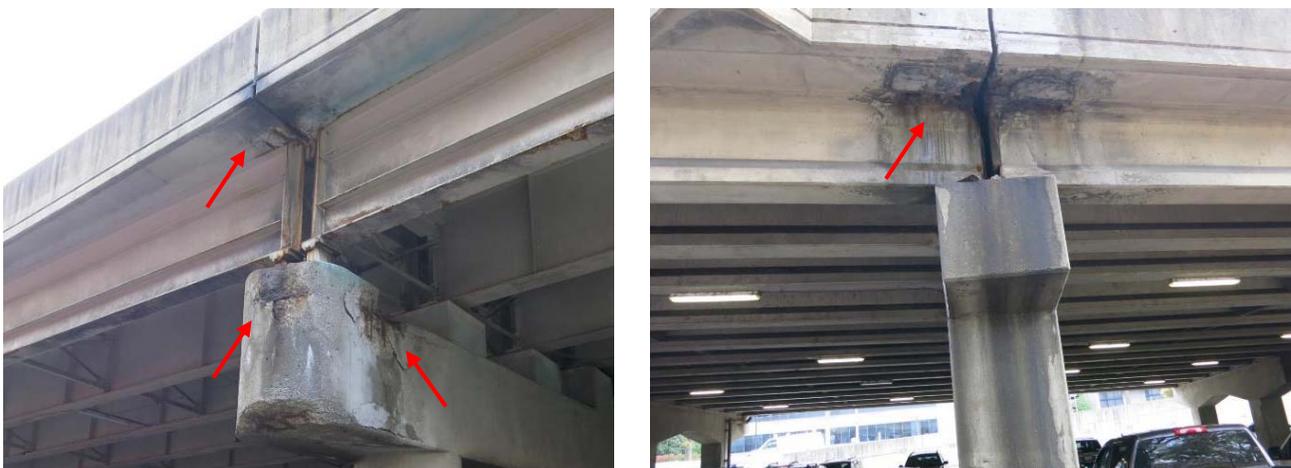
Similarly, expansion joints at piers have identical leakage and corrosion problems and can be eliminated in some instances (**Figure ES5**). Pier joint elimination by implementing link-slabs and reconfiguring bearings for longitudinal movement and load resistance is recommended wherever possible (**Figure ES6a and ES6b**).

Figure ES5: Typical Pier Joint Leakage and Concrete Damage

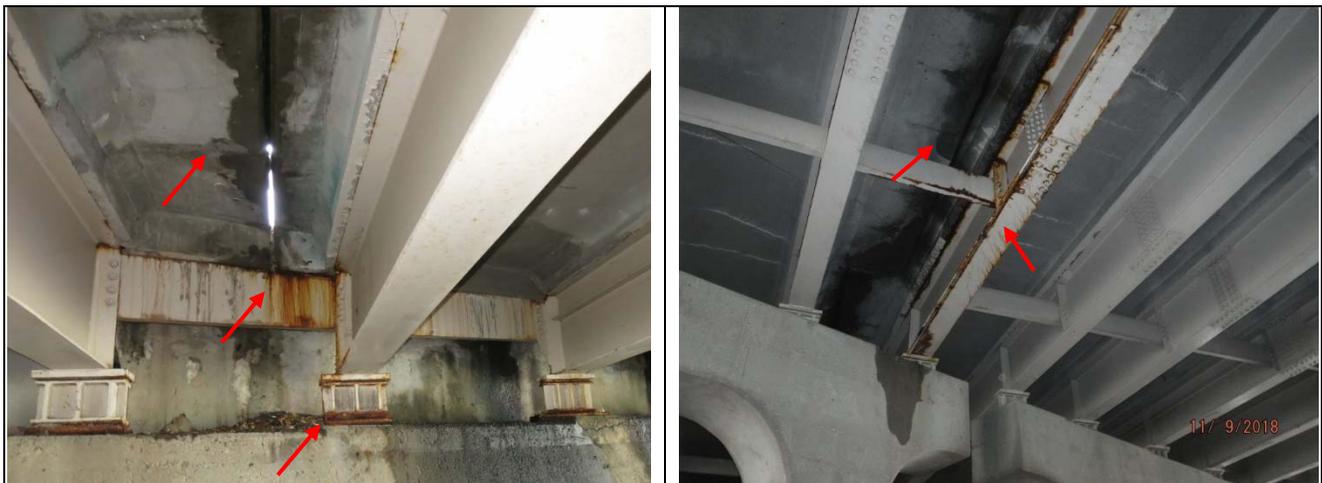
Figure ES8: Typical Median Joint Leakage and Corrosion

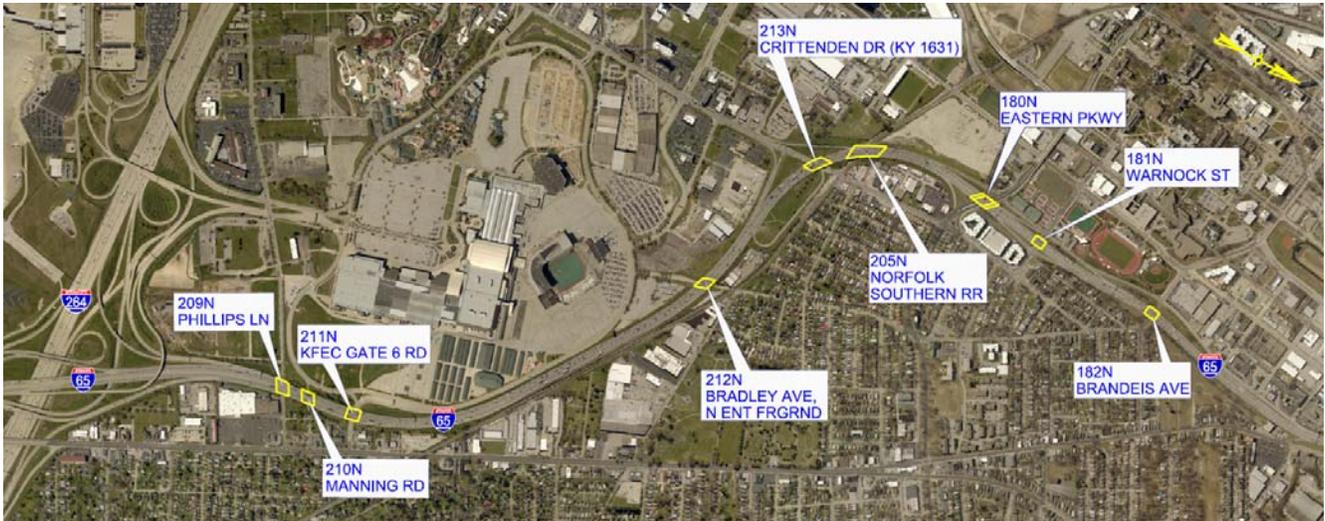
Figure 1: Study Bridges – I-264 to Brandeis Avenue

The Kentucky Transportation Cabinet (KYTC) initiated a study of the I-65 Bridges in Jefferson County in June 2018. This study examines the conditions, prioritizes, and develops conceptual strategies to address deficiencies of 28 Interstate 65 bridges between the Watterson Expressway (I-264) and the rebuilt Kennedy Interchange in Louisville, Kentucky (**Figures 1 and 2**). This corridor carries an annual average daily traffic (AADT) of nearly 120,000 vehicles. The area of bridge deck encompassed within these structures is over 717,000 square feet, or about 16.5 acres.

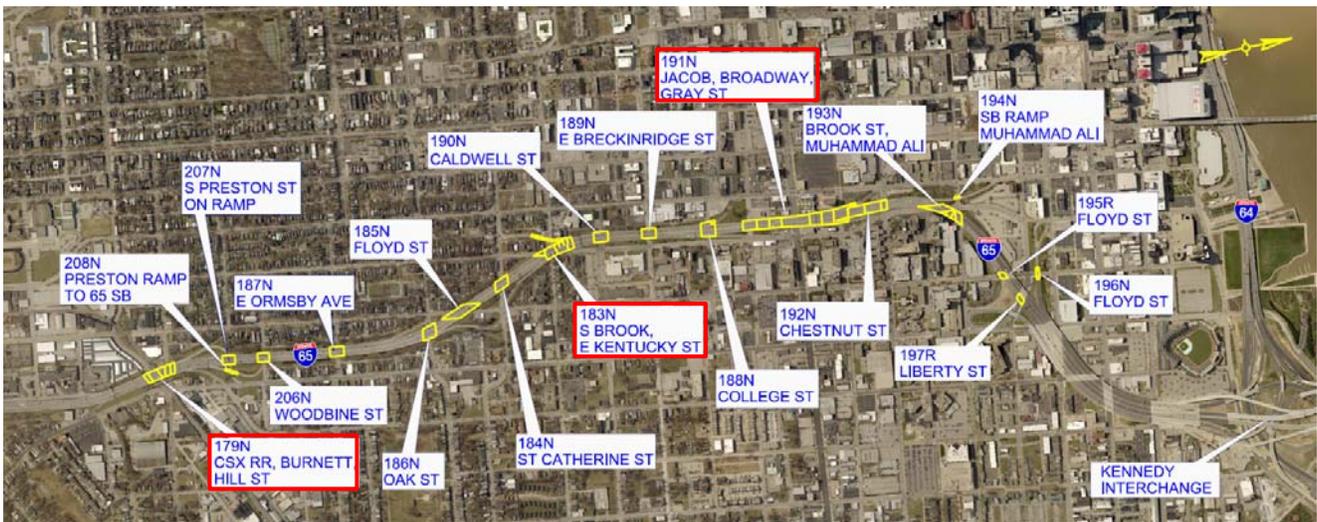
Figure 2: Study Bridges – Burnett/Hill Street to Kennedy Interchange

Three bridges were identified as priorities for KYTC: 179N over CSX RR, Burnett Avenue, and Hill Street; 183N over Brook Street and Kentucky Street; and 191N over Jacob Street, Broadway Street, and Gray Street. Replacement scenarios have also been developed for bridges 183N and 179N due to

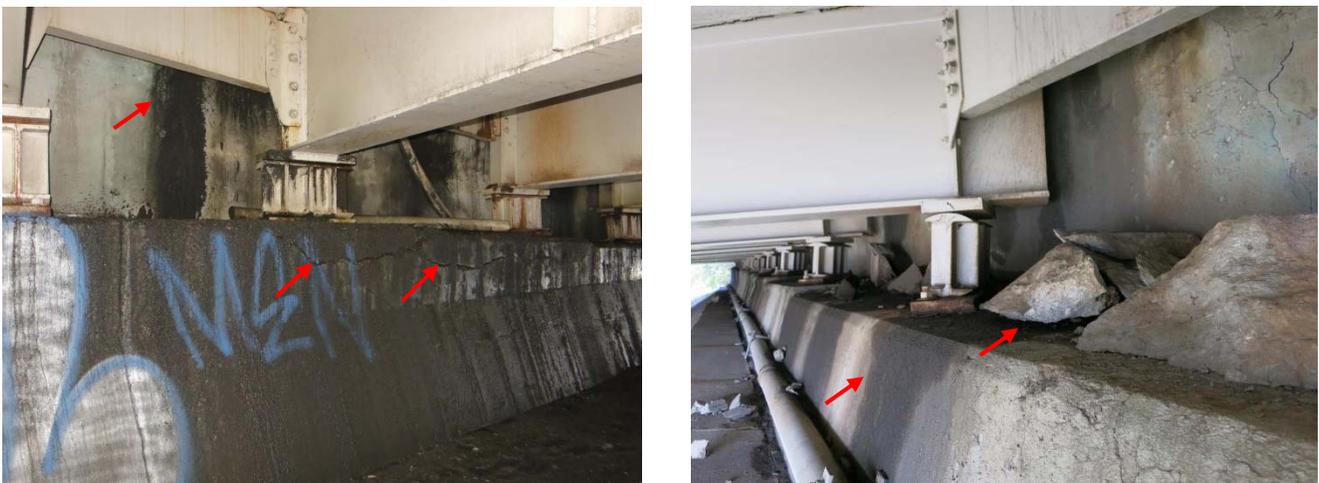
Most bridges within this study area were constructed as part of Louisville's North-South Expressway in the late 1950's. Since then, most have been widened and, on / off ramps have been added. Some superstructure replacements have occurred. A significant portion of the study bridges are original and, being 60 years old, have specific areas of distress. One of the most detrimental deficiencies to the longevity of the bridges is joint leakage, as mentioned in the previous section (Engineering Investigation). Several bridges have obvious joint leakage at abutments and resulting damage to the reinforced concrete abutments (**Figures 9a and 9b**).

Figure 9a: Typical Abutment Joint Leakage and Concrete Damage

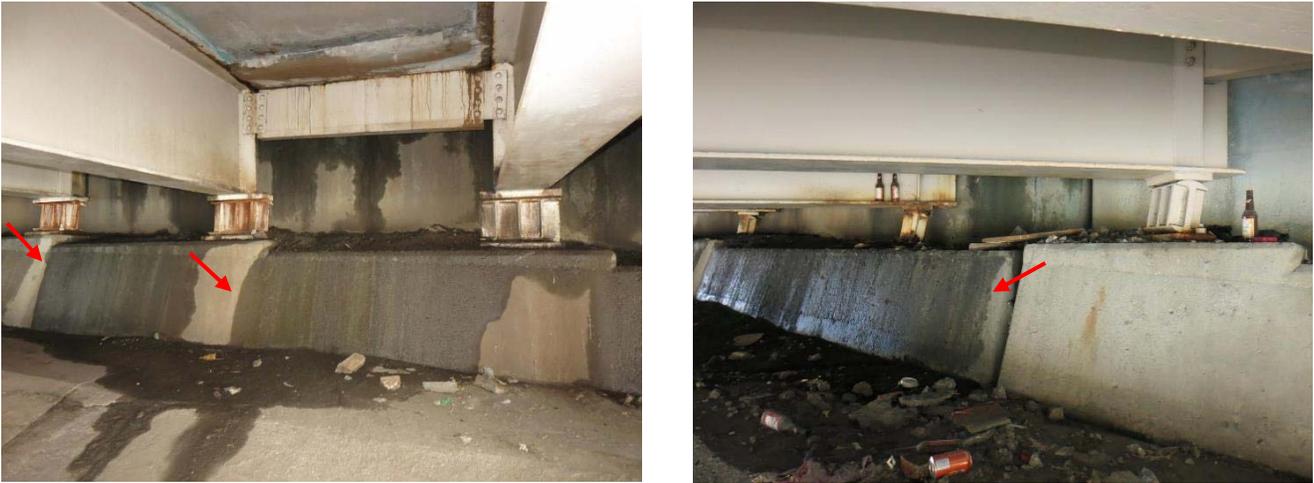
Figure 9b: Typical Abutment Joint Leakage and Concrete Damage

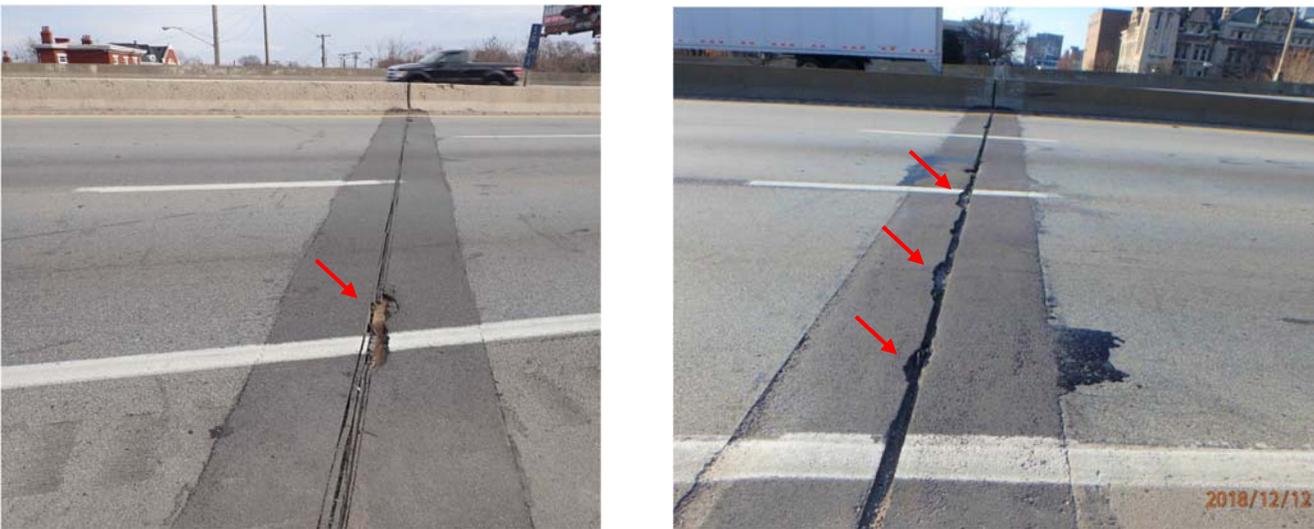
Bridge expansion joints show distress or failure at many locations. Even joints recently replaced in 2017 showed signs of premature failure and leakage onto the substructures below (**Figure 10**).

Figure 10: Expansion Joints Replaced in 2017 showing signs of distress in 2018 Inspections

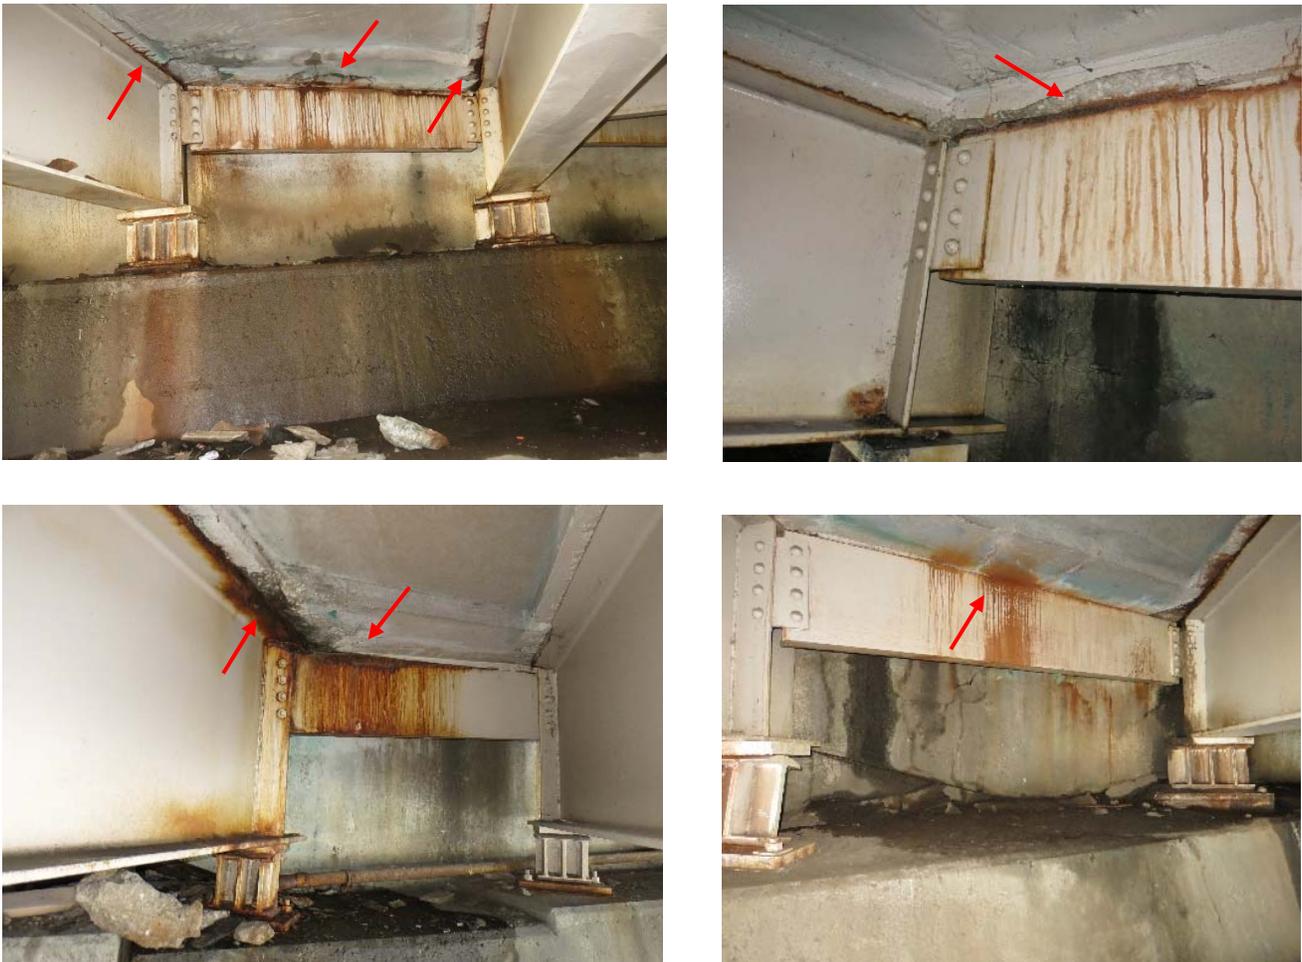
During our field reviews, the slab at several bridges had become debonded from the steel girders several feet out from the ends of bridge (**Figure 12**). It is recommended to add shear studs to the top flange of the steel girders to ensure the slab and girders remain in intimate contact.

Figure 12: Typical Slab Delamination at Bridge Ends

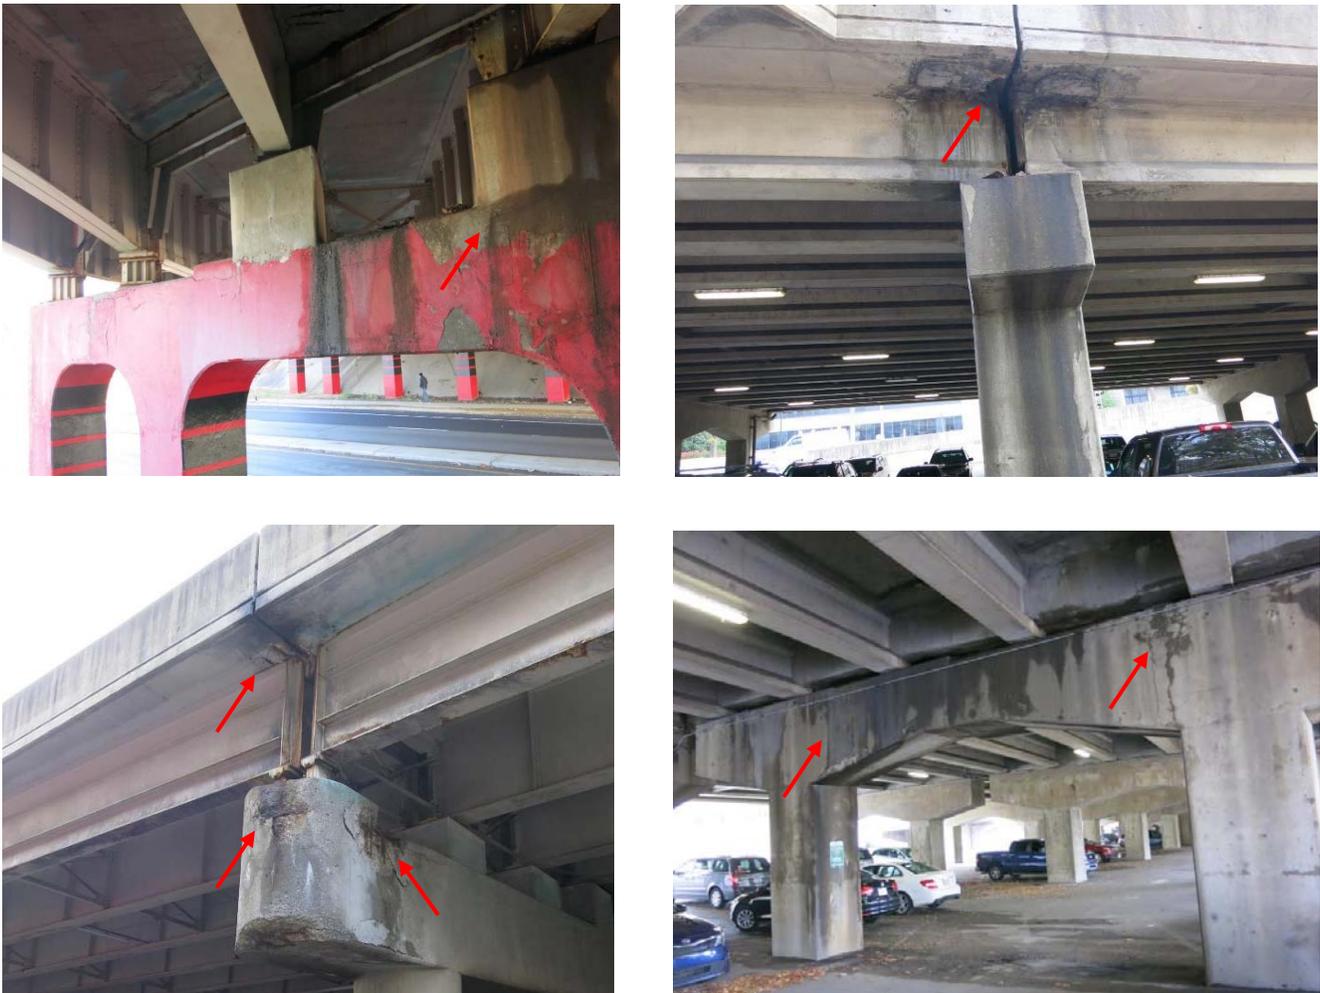
Similarly, expansion joints at piers have identical leakage and corrosion problems as those at abutments and can sometimes be eliminated. As discussed previously, a recent successful example of their removal can be found in Louisville on the I-265 bridges over Westport Road. Pier joints were eliminated by designing link-slabs across the joint area. This solution was accompanied by revised bearings to accommodate thermal movements at the piers and abutments.

Figure 13: Typical Pier Joint Leakage and Concrete Damage

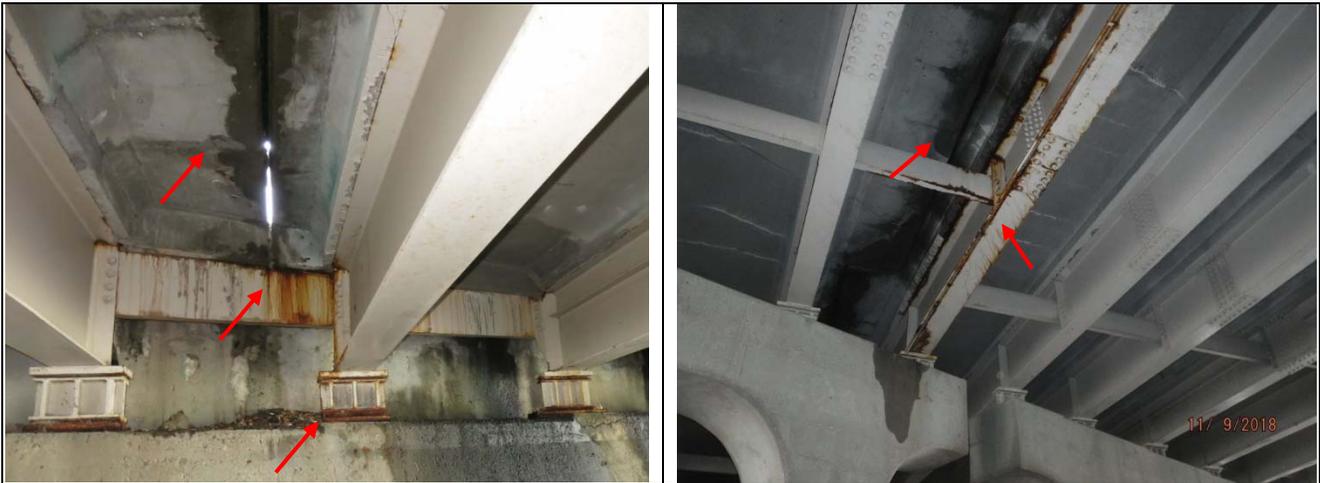
Although not an expansion joint, the gap between the median bridge barriers is small, allows saltwater spray down onto the adjacent girders, and is in an interior location that gets no sunshine and very little air circulation to dry. These conditions are present at many of the joints with corrosion of the slab overhangs and girder deterioration (**Figure 15**). Elimination of this median joint is recommended by replacing the two barriers with a single barrier, similar to the north end of the study area.

Figure 15: Typical Median Joint Leakage and Corrosion

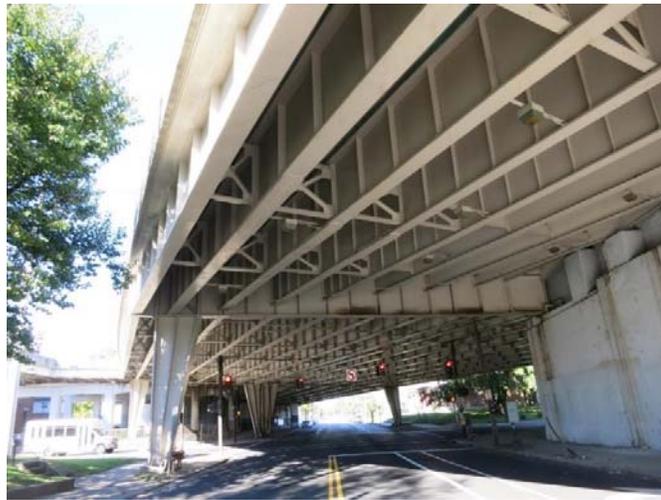
Figure 19: Bridge 183N, I-65 over Brook Street and Kentucky Street

This bridge crosses over an intersection (**Figure 19**) in the Old Louisville Historic District, the third largest district of its kind in the country. The bridge has fracture critical steel straddle bents, as shown in red on **Figure 20**, and numerous undesirable geometries and structural details. The crack locations can be found in red on **Figures 21a and 21b** along with the crack sizes and growth history in **Figure 22**. The cracks highlight in red, on **Figure 22**, have grown since the last inspection and the ones highlight in green are new. Because of its location, the city streets are unlikely to be realigned, so straddle pier supports are likely necessary for new construction.

Options to repair the cracking include coverplating and by encasement into a post-tensioned (PT), integral straddle pier (Figures 23 and 24). Replacement options are also postulated with PT straddle bents where needed. Abutments are large counterfort breastwall abutments on numerous piles. Replacement options leave most, or all of, the existing abutments in place, and to span over them to establish new integral end bents (Appendix M).

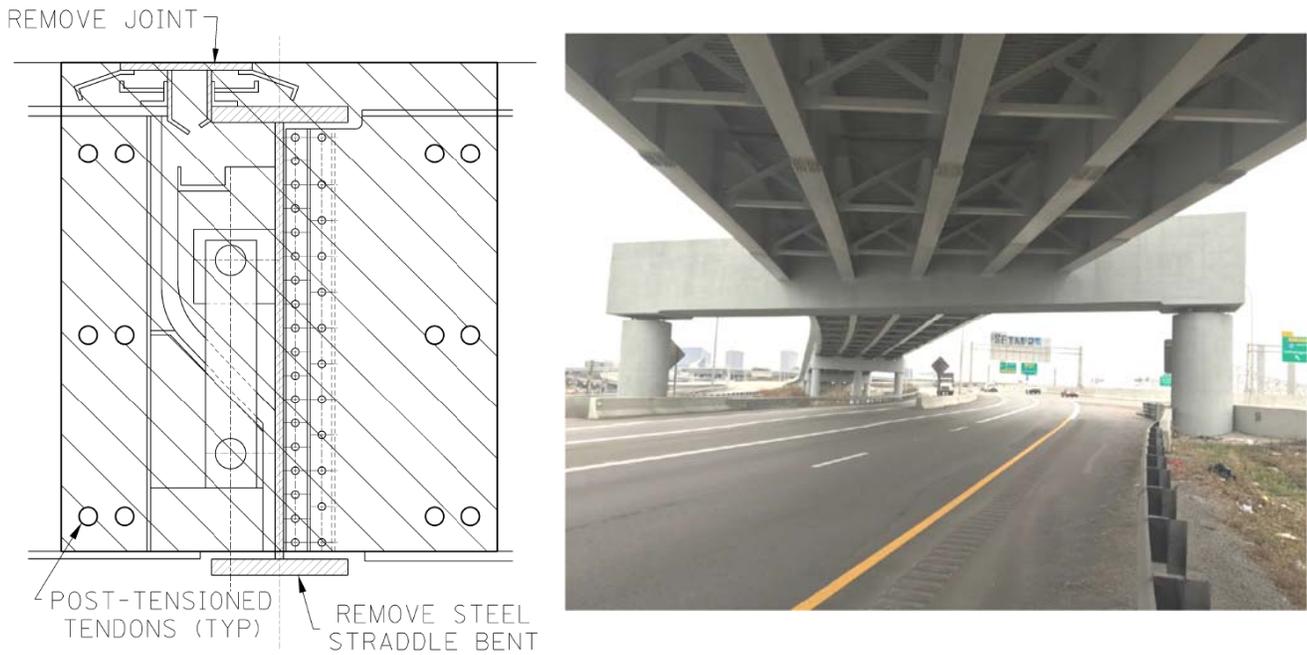
Figure 24: Post-Tensioned Integral Straddle Bent Option and Example from Kennedy Interchange

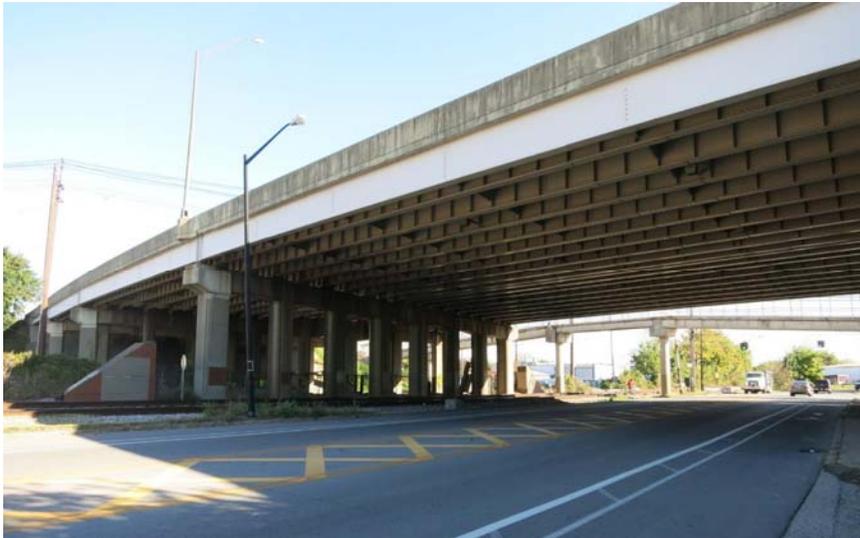
Figure 25: Bridge 179N over Burnett Avenue, Hill Street, and CSX Railroad

This bridge (**Figure 25**) recently had emergency shoring due to disintegration of some of the south abutment's concrete-bearing areas (**Figure 26**). Repair and replacement options are provided (**Appendices F and M**). Repair options include abutment and pier joint elimination. Replacement options include superstructure replacement with re-use of some of the existing substructures. The south abutments would not be used in this case, but would be spanned over to new integral end bents. A complete bridge replacement estimate is also included.

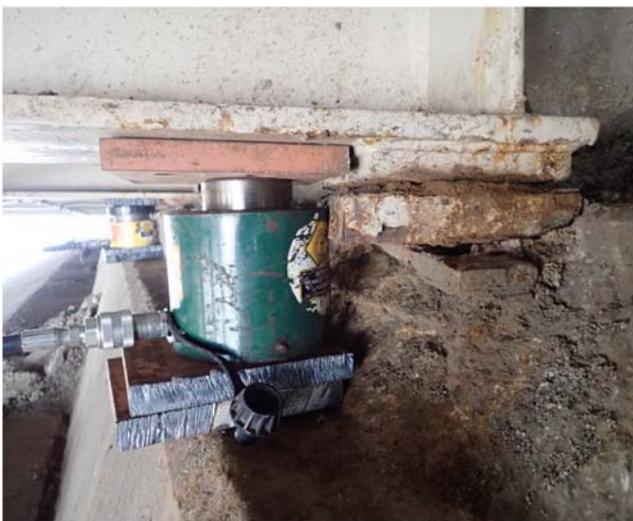
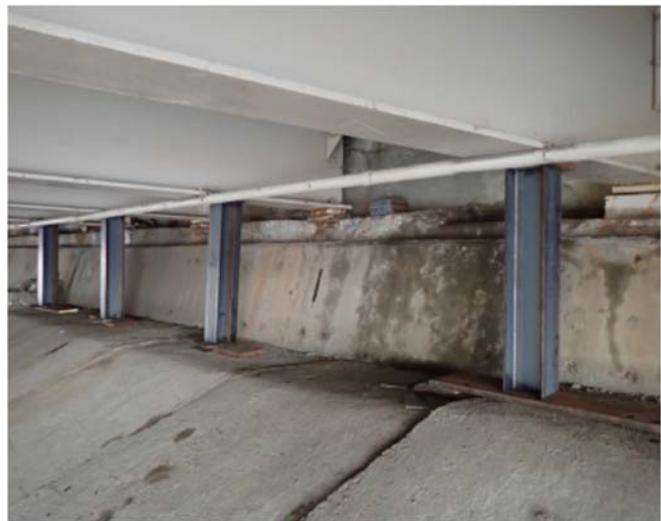
Abutment 1-Girder 9  
(End Bent B-Girder 20)

Girders 7 through 10 at Abutment 1

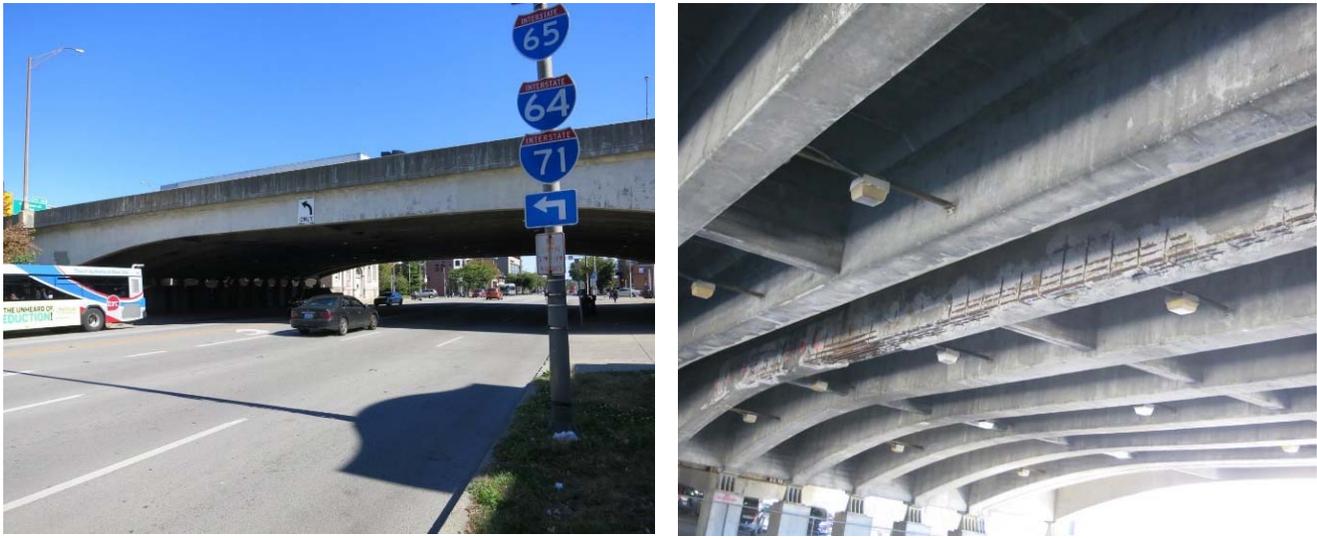
This bridge is 1,208 ft long with seven continuous structural units of steel, prestressed concrete girders, and one Reinforced Concrete Deck Girder (RCDG) unit. The greatest repair need is the northbound, median-side girder of the RCDG unit over Broadway Street (**Figure 27**). The severe deterioration can be fixed in place with Fiber Reinforced Polymer (FRP) fabric bonded to the repaired surface, or by removing the damaged girder line and replacing it with a new prestressed concrete girder and slab area. Both options are provided, with additional repairs and a few joint eliminations (**Appendix F**).

Figure 27: Bridge 191N over Broadway Street showing Corroded Concrete Girder

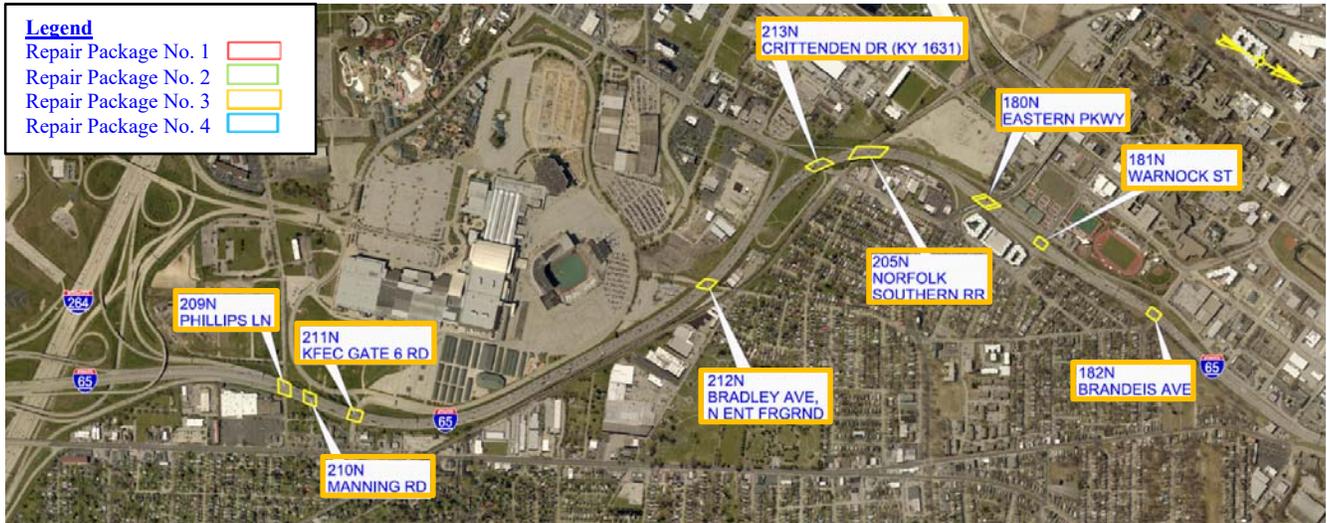
Figure 32: Repair Package Grouping – South

All 28 bridges were ranked as High, Moderate, or Low priority based on condition. The three priority bridges, identified in the above section, are the only ones ranked High, eight ranked as Moderate and 17 ranked Low priority. Ideally, repair/replacement of the high priority bridges (179N, 183N, and 191N) would be first. Then, all eight bridges rated in the moderate-priority group would be fixed next, followed by the 17 in the low-priority group. So construction crews are not hopscotching around the corridor for years on end, it is recommended to geographically group the eight moderate-priority bridges with lower priority bridges (**Figures 32 and 33**). The bridge prioritization ranking and grouping for construction can be found in **Table 8, Table 9, Table 10, and Table 11**.
