# KY 151 Safety Study

## Anderson and Franklin Counties

From US 127 to I-64  
Alton Road/Graefenburg Road

Prepared by  
**Kentucky Transportation Cabinet**  
Division of Planning  
November 2016

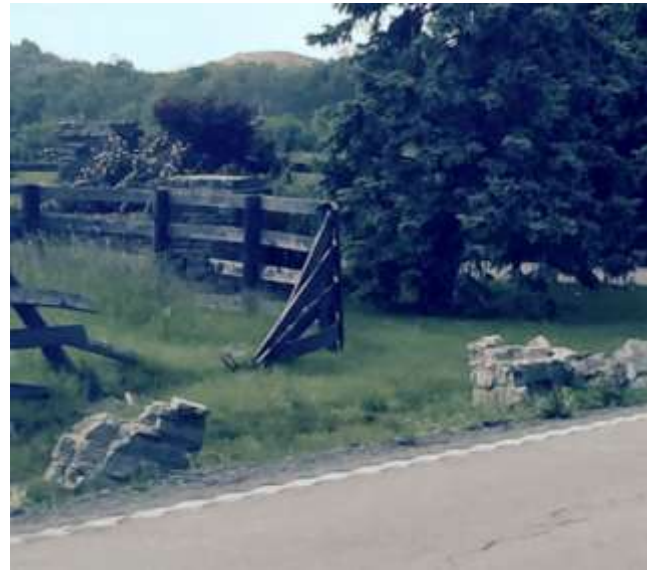
Fence and mailbox damaged by CMV crash in 2016

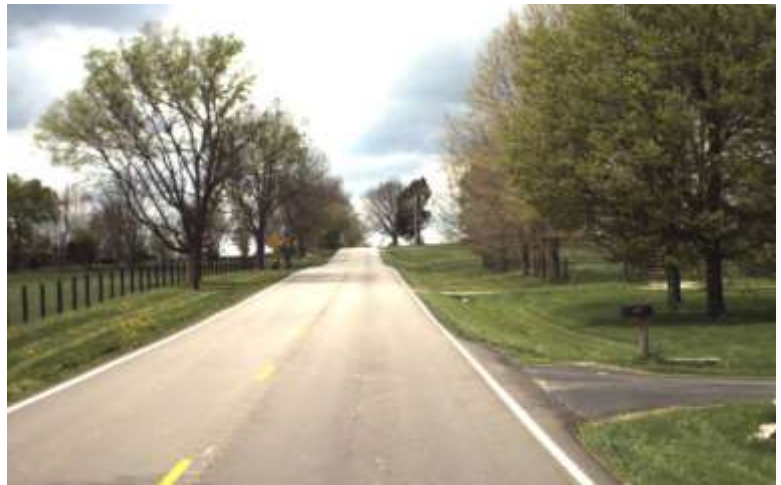
Figure 1 – KY 151 Safety Study Corridor

The KY 151 study corridor is a two-lane roadway which connects US 127 in Anderson County north of Lawrenceburg to I-64 in Franklin County west of Frankfort as shown in **Figure 1 (p.2)**. The study corridor is approximately 6.9 miles in length and runs approximately south to north. The southern section of the roadway is locally known as Alton Road, while the northern part is known as Graefenburg Road. KY 151 in Anderson County begins at milepoint (MP) 0.0 at the US 127 intersection, and ends at the Anderson/Franklin County line, MP 4.587. The KY 151 study area in Franklin County begins at MP 0.0 at the Anderson/Franklin County line, and continues to MP 2.3 at I-64. KY 151 continues north of the I-64 interchange and ends at US 60 (MP 3.22).

The KY 151 study corridor, highlighted in yellow in **Figure 1 (p.2)**, serves as a shorter route between locations south of the KY 151 and US 127 intersection, and locations west of the KY 151 and I-64 interchange. The alternative route, highlighted in orange in **Figure 1 (p.2)**, using US 127 to travel north to the US 127 and I-64 interchange, then traveling west on I-64 to the I-64 and KY 151 interchange, adds approximately 5 miles length, and 7½ minutes of travel time, versus using the KY 151 corridor. US 127 is a four-lane divided principal arterial roadway with a median and 4- to 10-foot paved shoulders.

The previous study, titled *Route Study, KY 151 Alton Bypass from North End of Lawrenceburg Bypass to the Anderson-Franklin County Line and US 127 Alton Bypass*, was completed in 1969 prior to the construction of US 127 in its current location. Old Frankfort Road, US 512, was the original alignment of US 127, see **Figure 1 (p.2)**. The study looked at alternative alignments for US 127 to bypass the community of Alton.

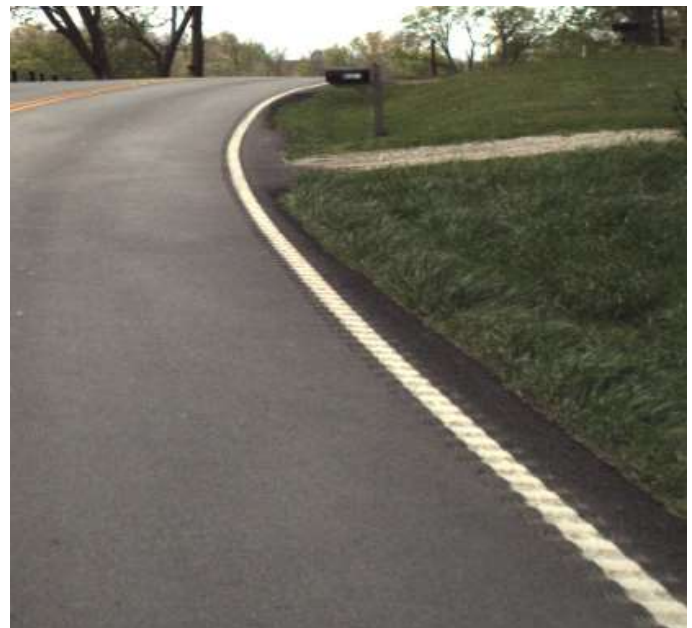
**Figure 4: Curve at MP 3.0, Anderson County**

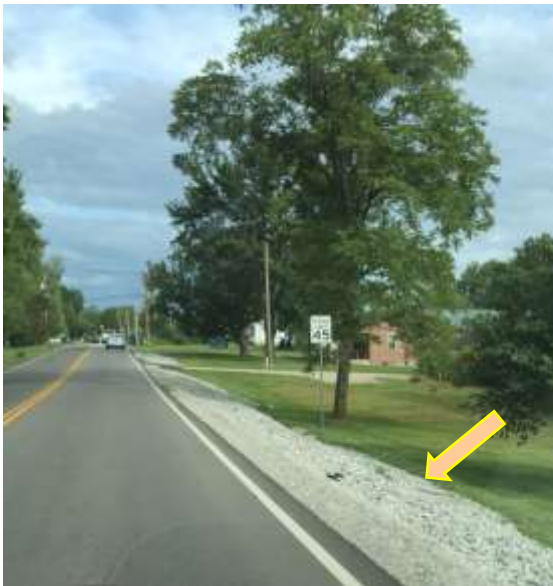
To mitigate the possibly low or narrow shoulders contributing to the CMV crashes at the three locations, the shoulders between Alton and MP 4.1 have been widened to address the initial findings of this study.

**Shoulder widening in Alton area**

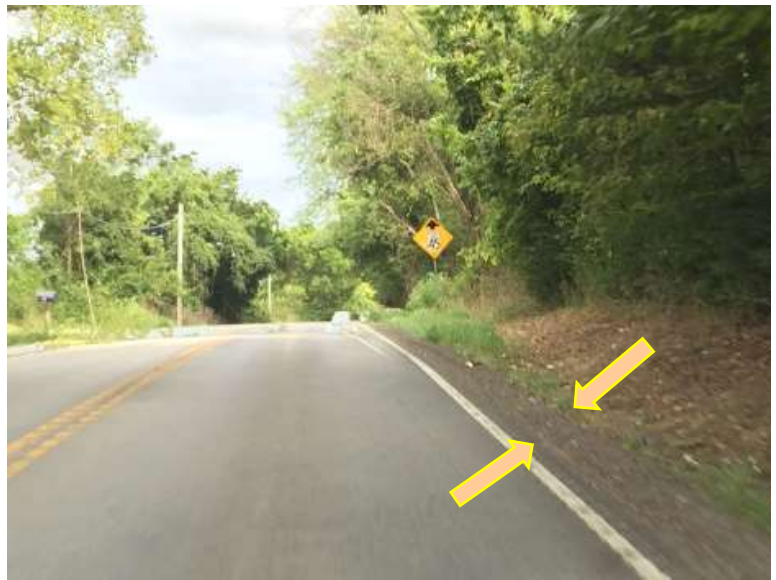
**Shoulder widening**

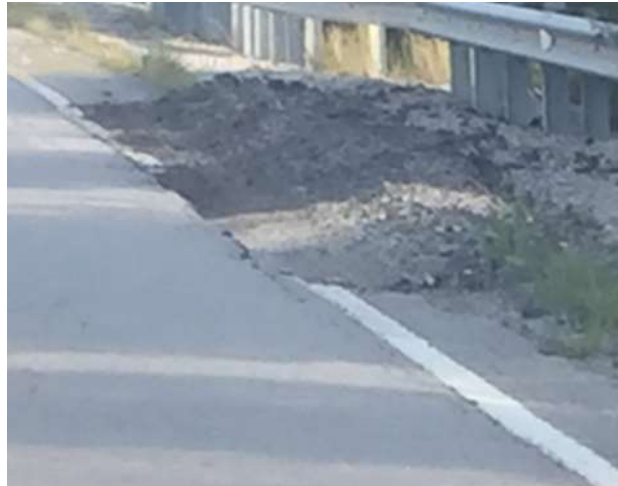
Since the 2014 inspection, minor localized spots of asphalt pavement mat tearing and shoulder failure caused by the turning movements of garbage trucks were noted in the southbound right turn lane in close proximity to the landfill in Franklin County. This type of distress is considered a materials application related failure.

Shoulder failure

- In Franklin County, repair the localized distressed pavement and shoulder areas, and fill in any low shoulders in the southbound right turn only lane in proximity to the landfill
