Data Needs Analysis

Mercer County
Bridge Replacement
US 68 over Shaker Creek
Item No. 7-1128

Prepared by
KYTC District 7 Planning

October 9, 2012

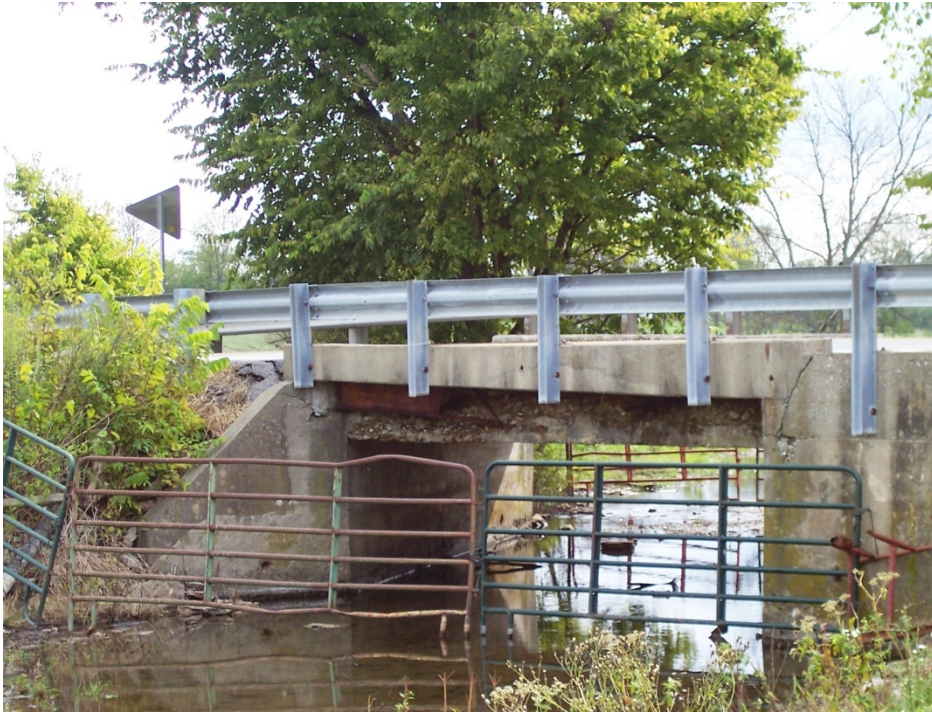
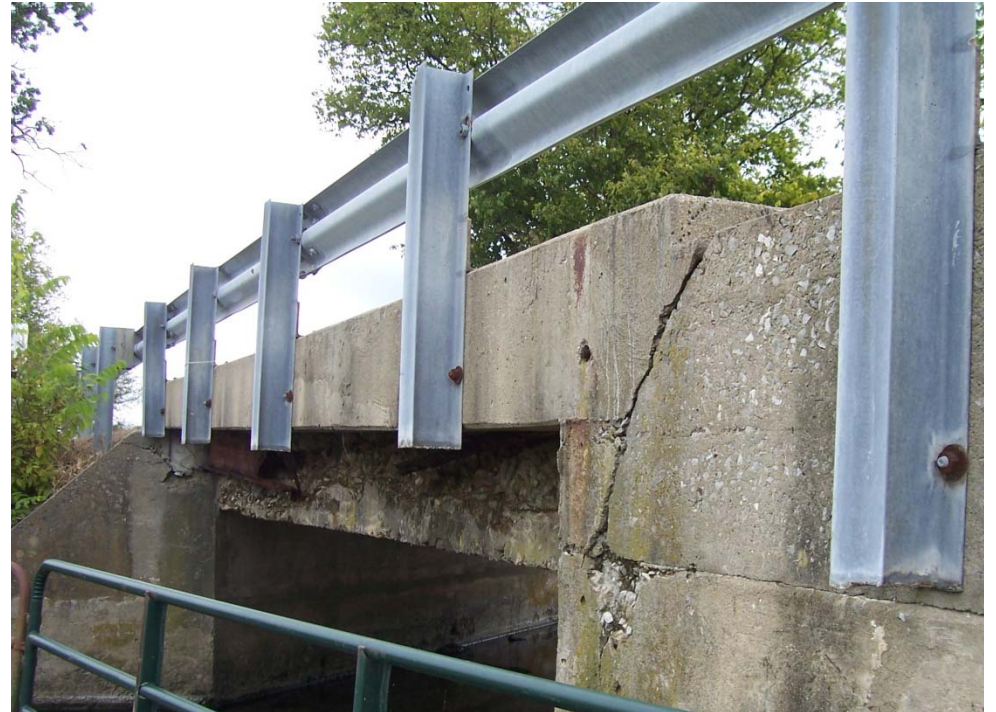
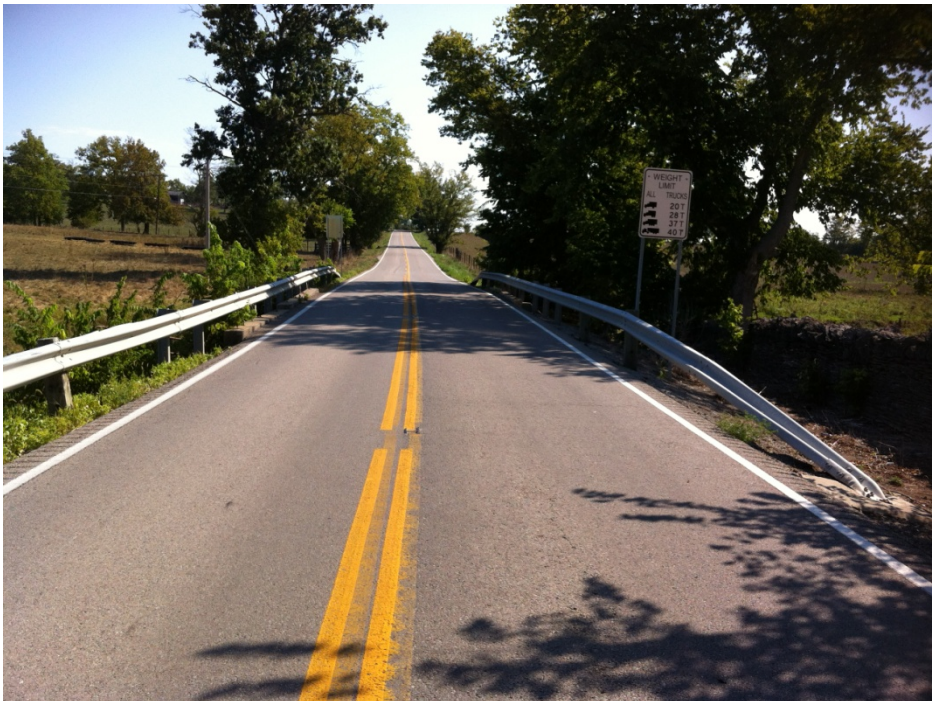
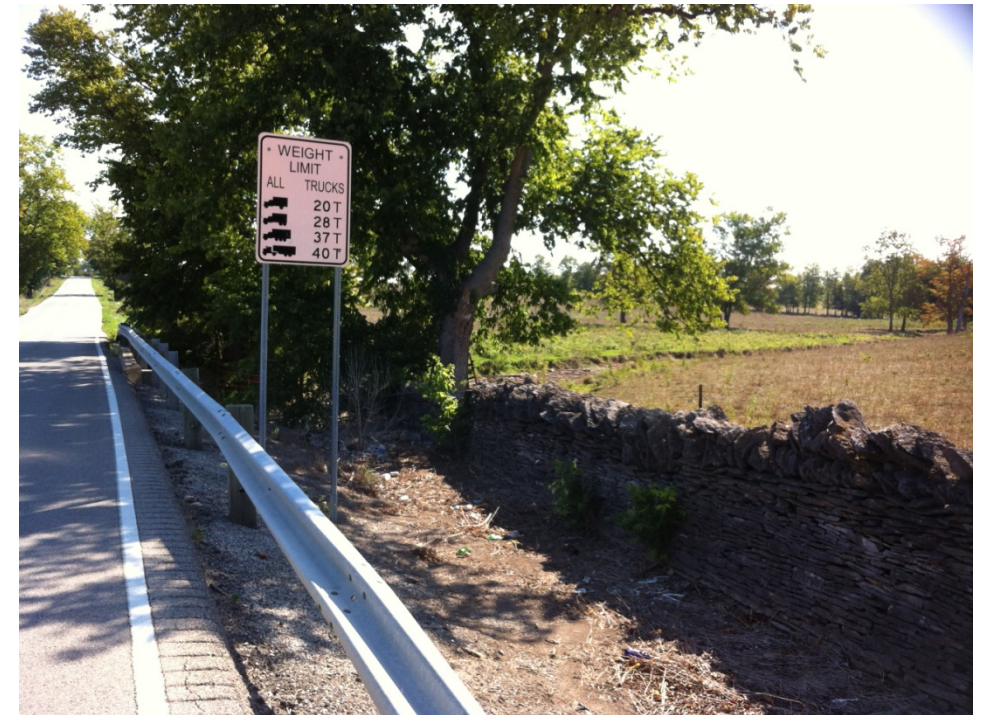
A bridge inspection was completed in August 2011 (Appendix B). Based on the report, this 22.97ft structure has a sufficiency rating of 36.20 and is functionally obsolete. From a reconnaissance survey in August 2012, there appeared to be moderate deterioration and vertical & horizontal cracking in abutments, as well as cracked pavement along the bridge (Appendix C).

Str	Unit	Elm/Env	Description	Description
1		215/1	R/Conc Abutment	MODERATE DETERIORATION AND VERTICAL AND HORIZONTAL CRACKING IN ABUTMENTS.
1		334/1	Metal Rail Coated	< none >
1		359/1	Soffit Smart Flag	EXTERIOR PORTION OF SLAB IS DETERIORATING. MODERATE CRACKING AND EFFLORESCENCE IN BOTTOM OF SLAB.
1		39/1	Unp Conc Slab/AC Ovl	< none >
1		503/1	RC Curb	MODERATE CRACKING IN CURBS.
