Subject: Kenton County
Turkeyfoot Road (KY 1303) Corridor Study
Barnwood Drive to Northern I-275 Ramp
MP 5.085 to 5.797
Preliminary Geotechnical Overview

GEOTECHNICAL OVERVIEW REPORT P-001-2018

Turkeyfoot Road (KY 1303) Corridor Study
From Barnwood Drive to North End of Bridge over I-275

Kenton County, KY

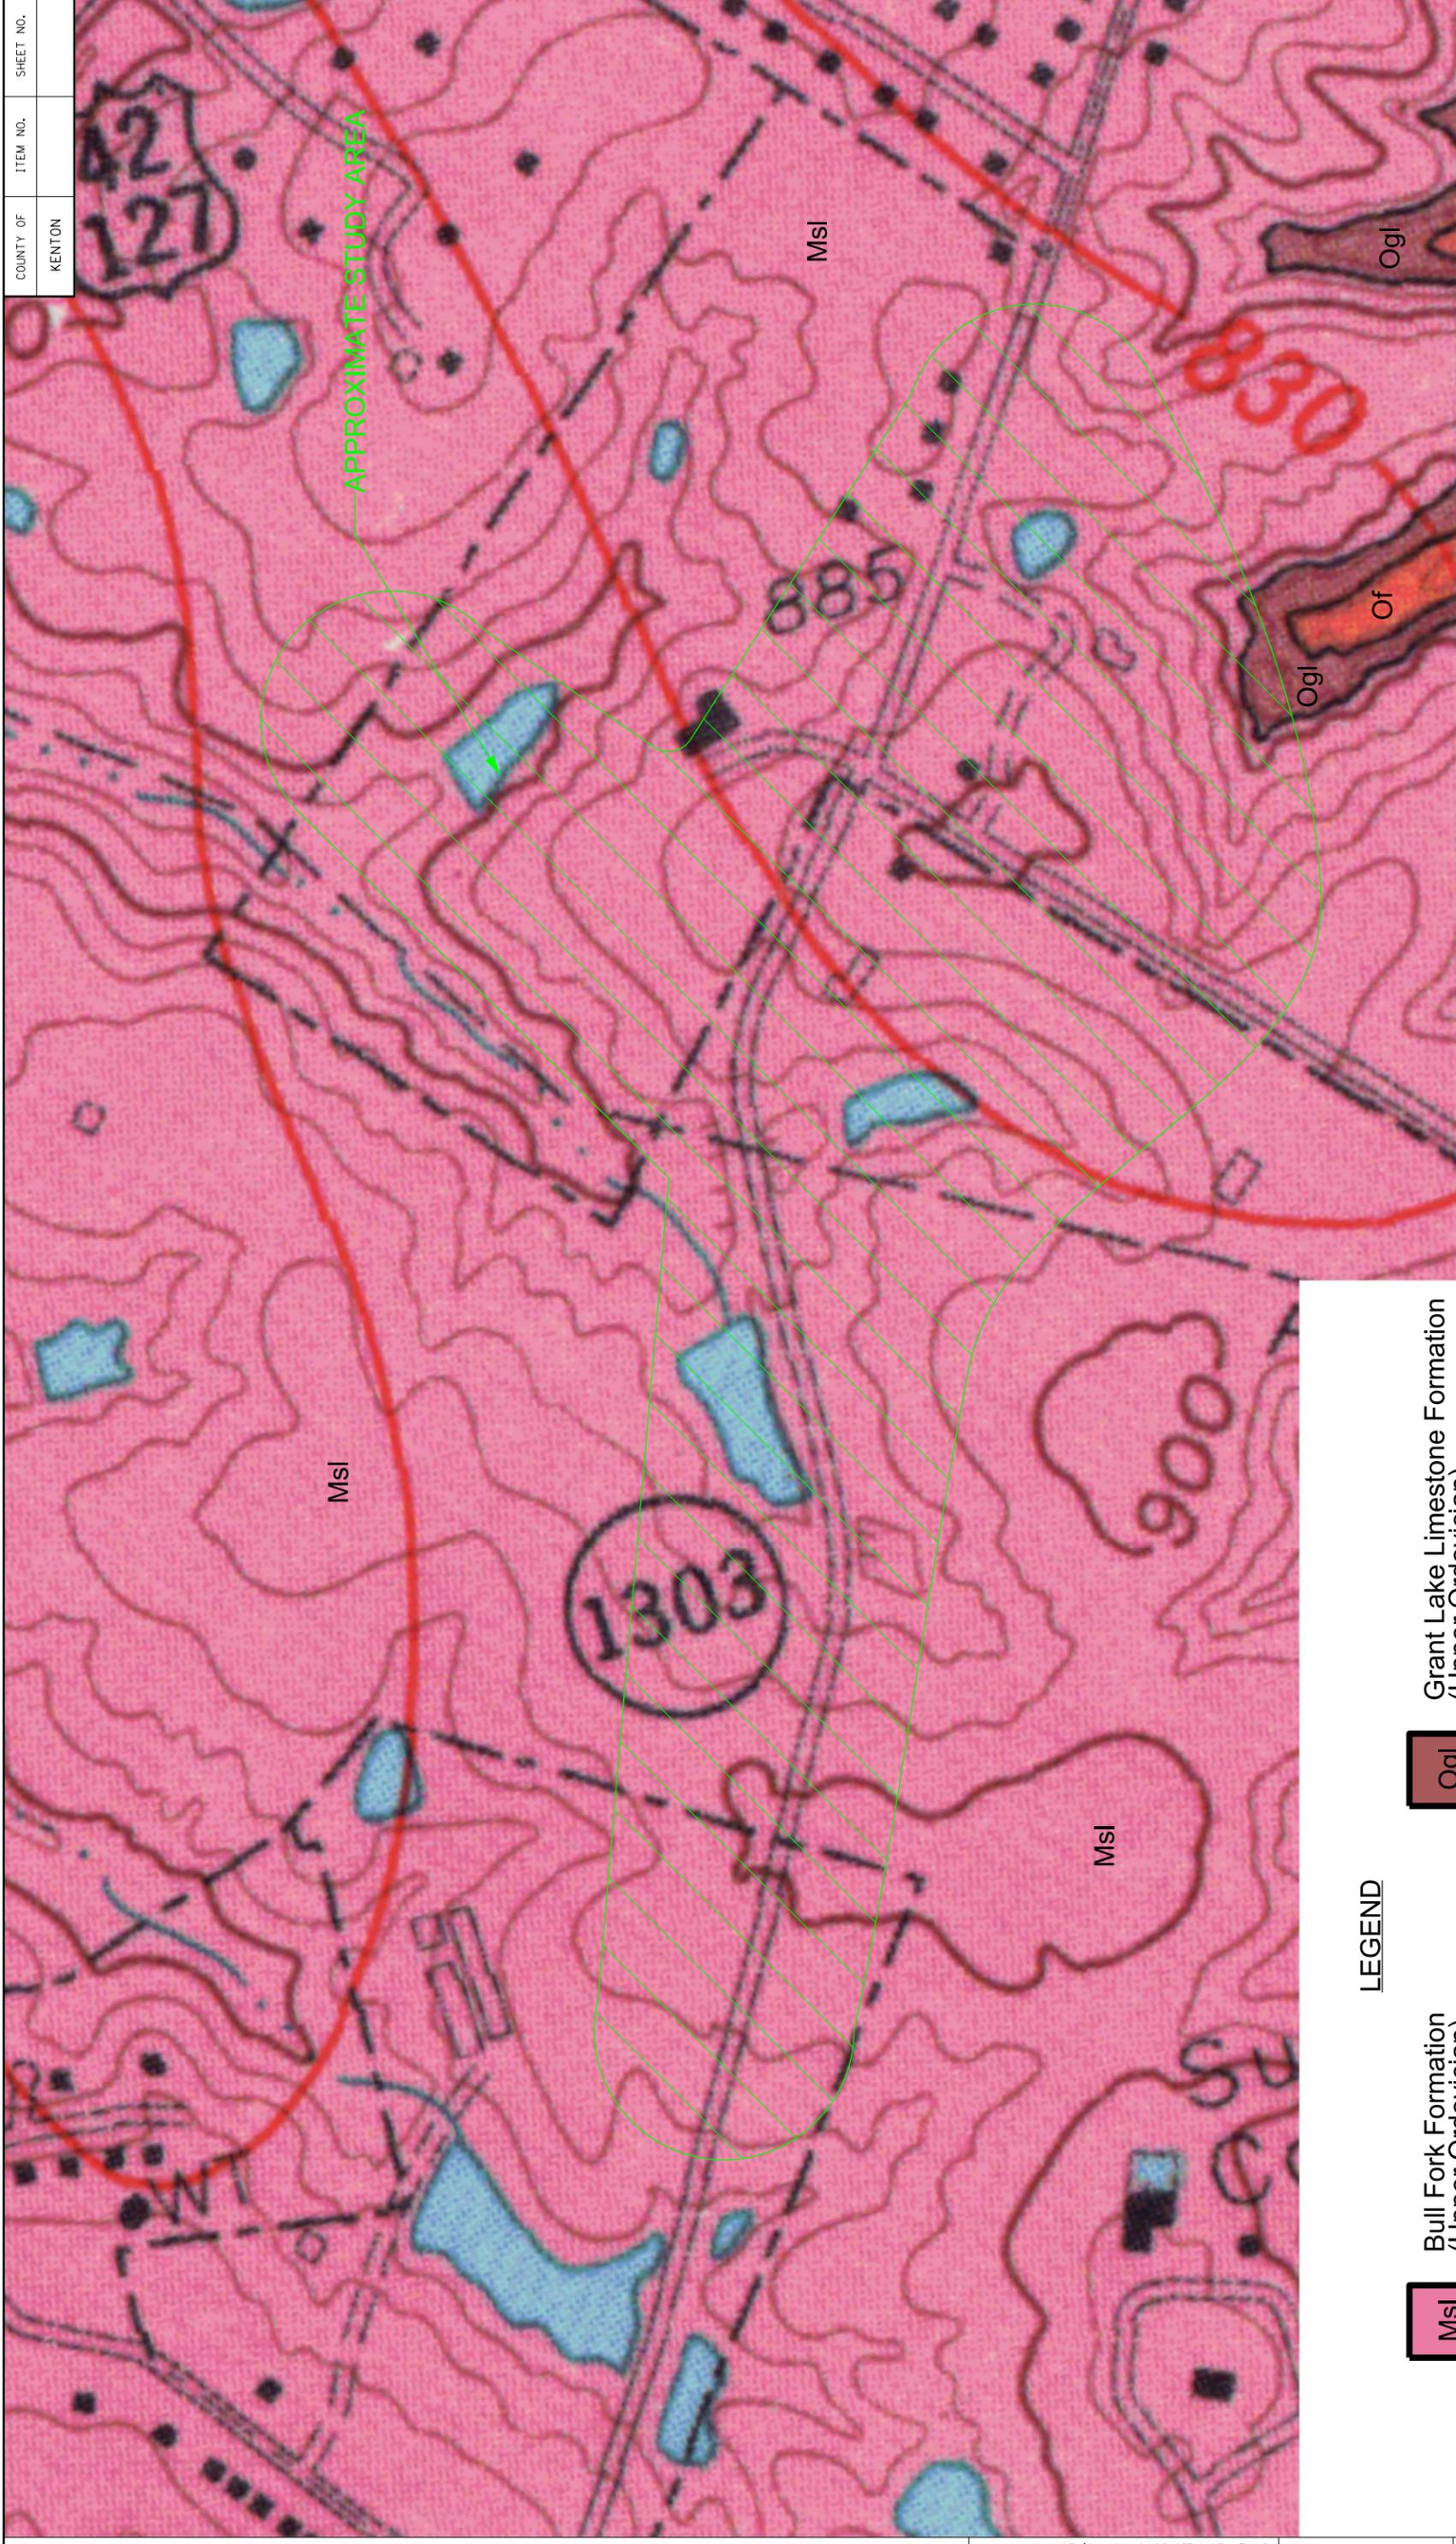
- Bull Fork Formation (Upper Ordovician)
- Grant Lake Limestone Formation (Upper Ordovician)
- Ogl
- Structural Contours
- Of
- Fairview Formation (Upper Ordovician)

Available geologic mapping (*Geologic map of the Covington quadrangle, northern Kentucky, USGS, 1971* and the Kentucky Geological Survey Geologic Map Information Service online) indicates bedrock which underlies the study area is comprised primarily of the Upper Ordovician-aged Bull Fork Formation. The Bull Fork Formation is predominantly comprised of interbedded limestone and shale. The limestone, which is typically fossiliferous, occurs as more than 50 percent of the formation and is described as being medium to light-gray in color where freshly exposed. The shale is medium-gray to dark-greenish-gray in color when freshly exposed and is typically non-durable and requires slaking prior to being placed as an engineered fill. Regional dip in the study area was reviewed based on subsurface structure contours drawn at the base of the

Bellevue Tongue of the Grant Lake Limestone and indicates a dip of about 13 feet per mile, or about ¼ percent from west to east.

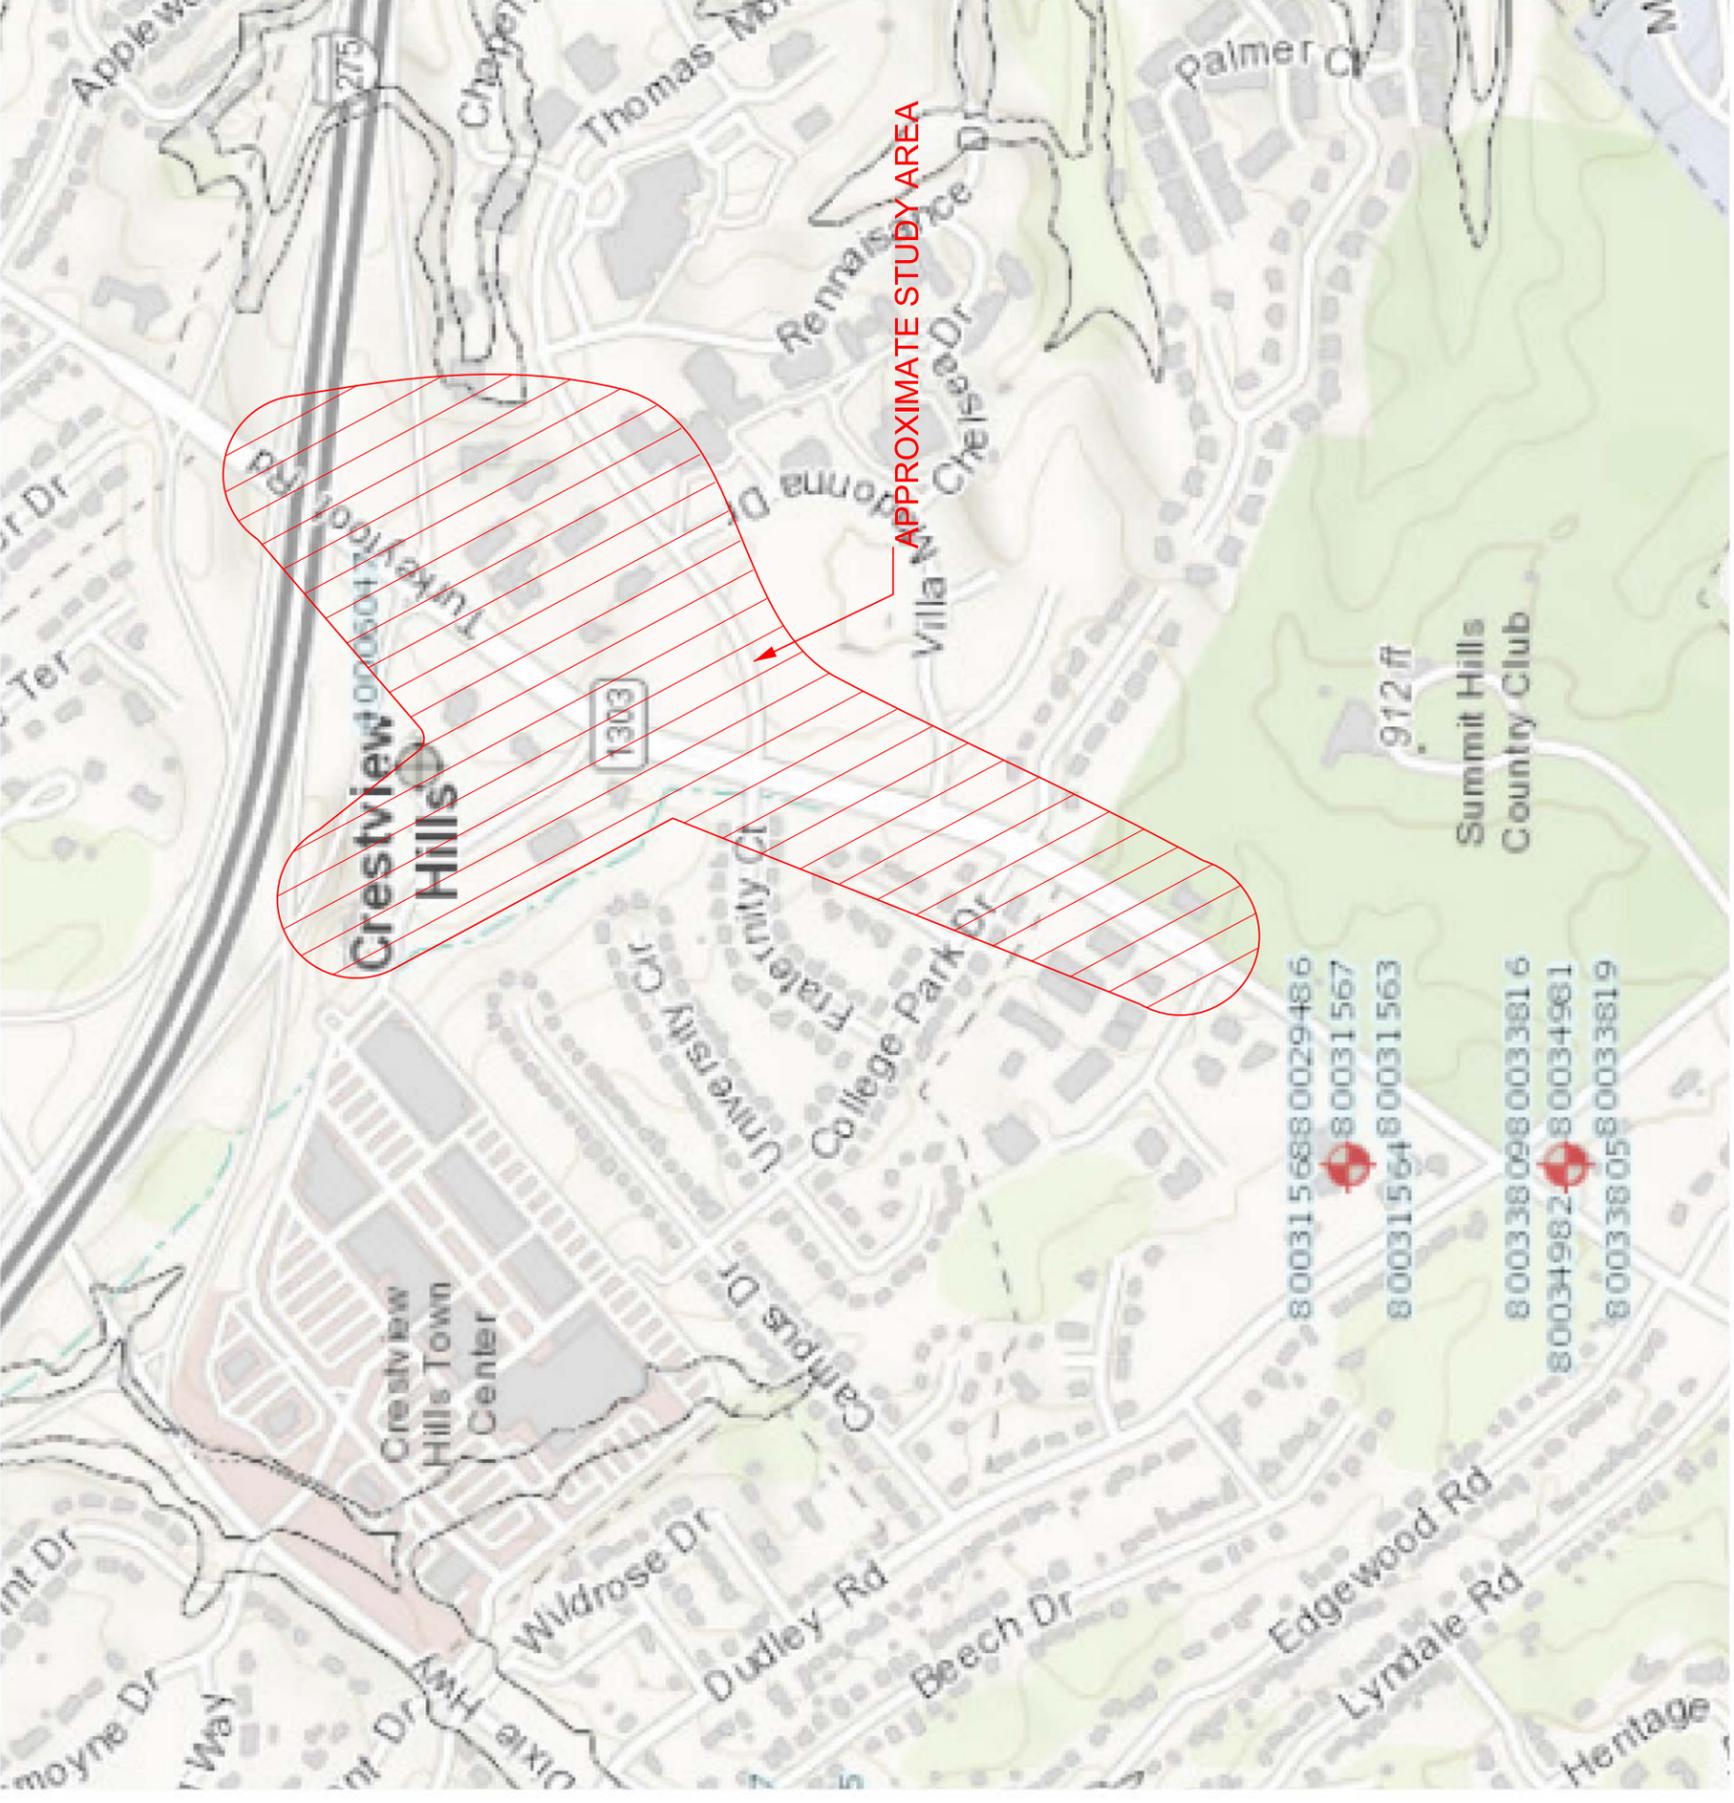
TURKEYFOOT ROAD
WATER WELLS AND SPRINGS

- Other
- Domestic
- Industrial
- Agriculture
- Monitoring Well
- Public
- Mining
- Geothermal
- Spring

Mapping did not indicate any potential for karst development and no known coal zones or oil or gas fields exist in the project area. Two monitoring wells were noted from the KY Geologic Map Information Service north and south of the intersection of Dudley Road and Turkeyfoot Road.

- **Several monitoring wells or other water wells were indicated to lie within the study area upon review of online mapping near the intersection with Dudley Road.** Any water wells, cisterns, manholes or catch basins not incorporated into any new design and identified prior to or during construction should be closed in accordance with Section 708 of the current edition of the Standard Specifications for Road and Bridge Construction.
