Appendix D

Drainage and Sidewalk Field Assessment

Chenoweth Lane Corridor Study
Jefferson County, KY
Item No. 5-531.00
Existing Drainage Conditions

Chenoweth Lane
Field Assessment Points
25 September 2015

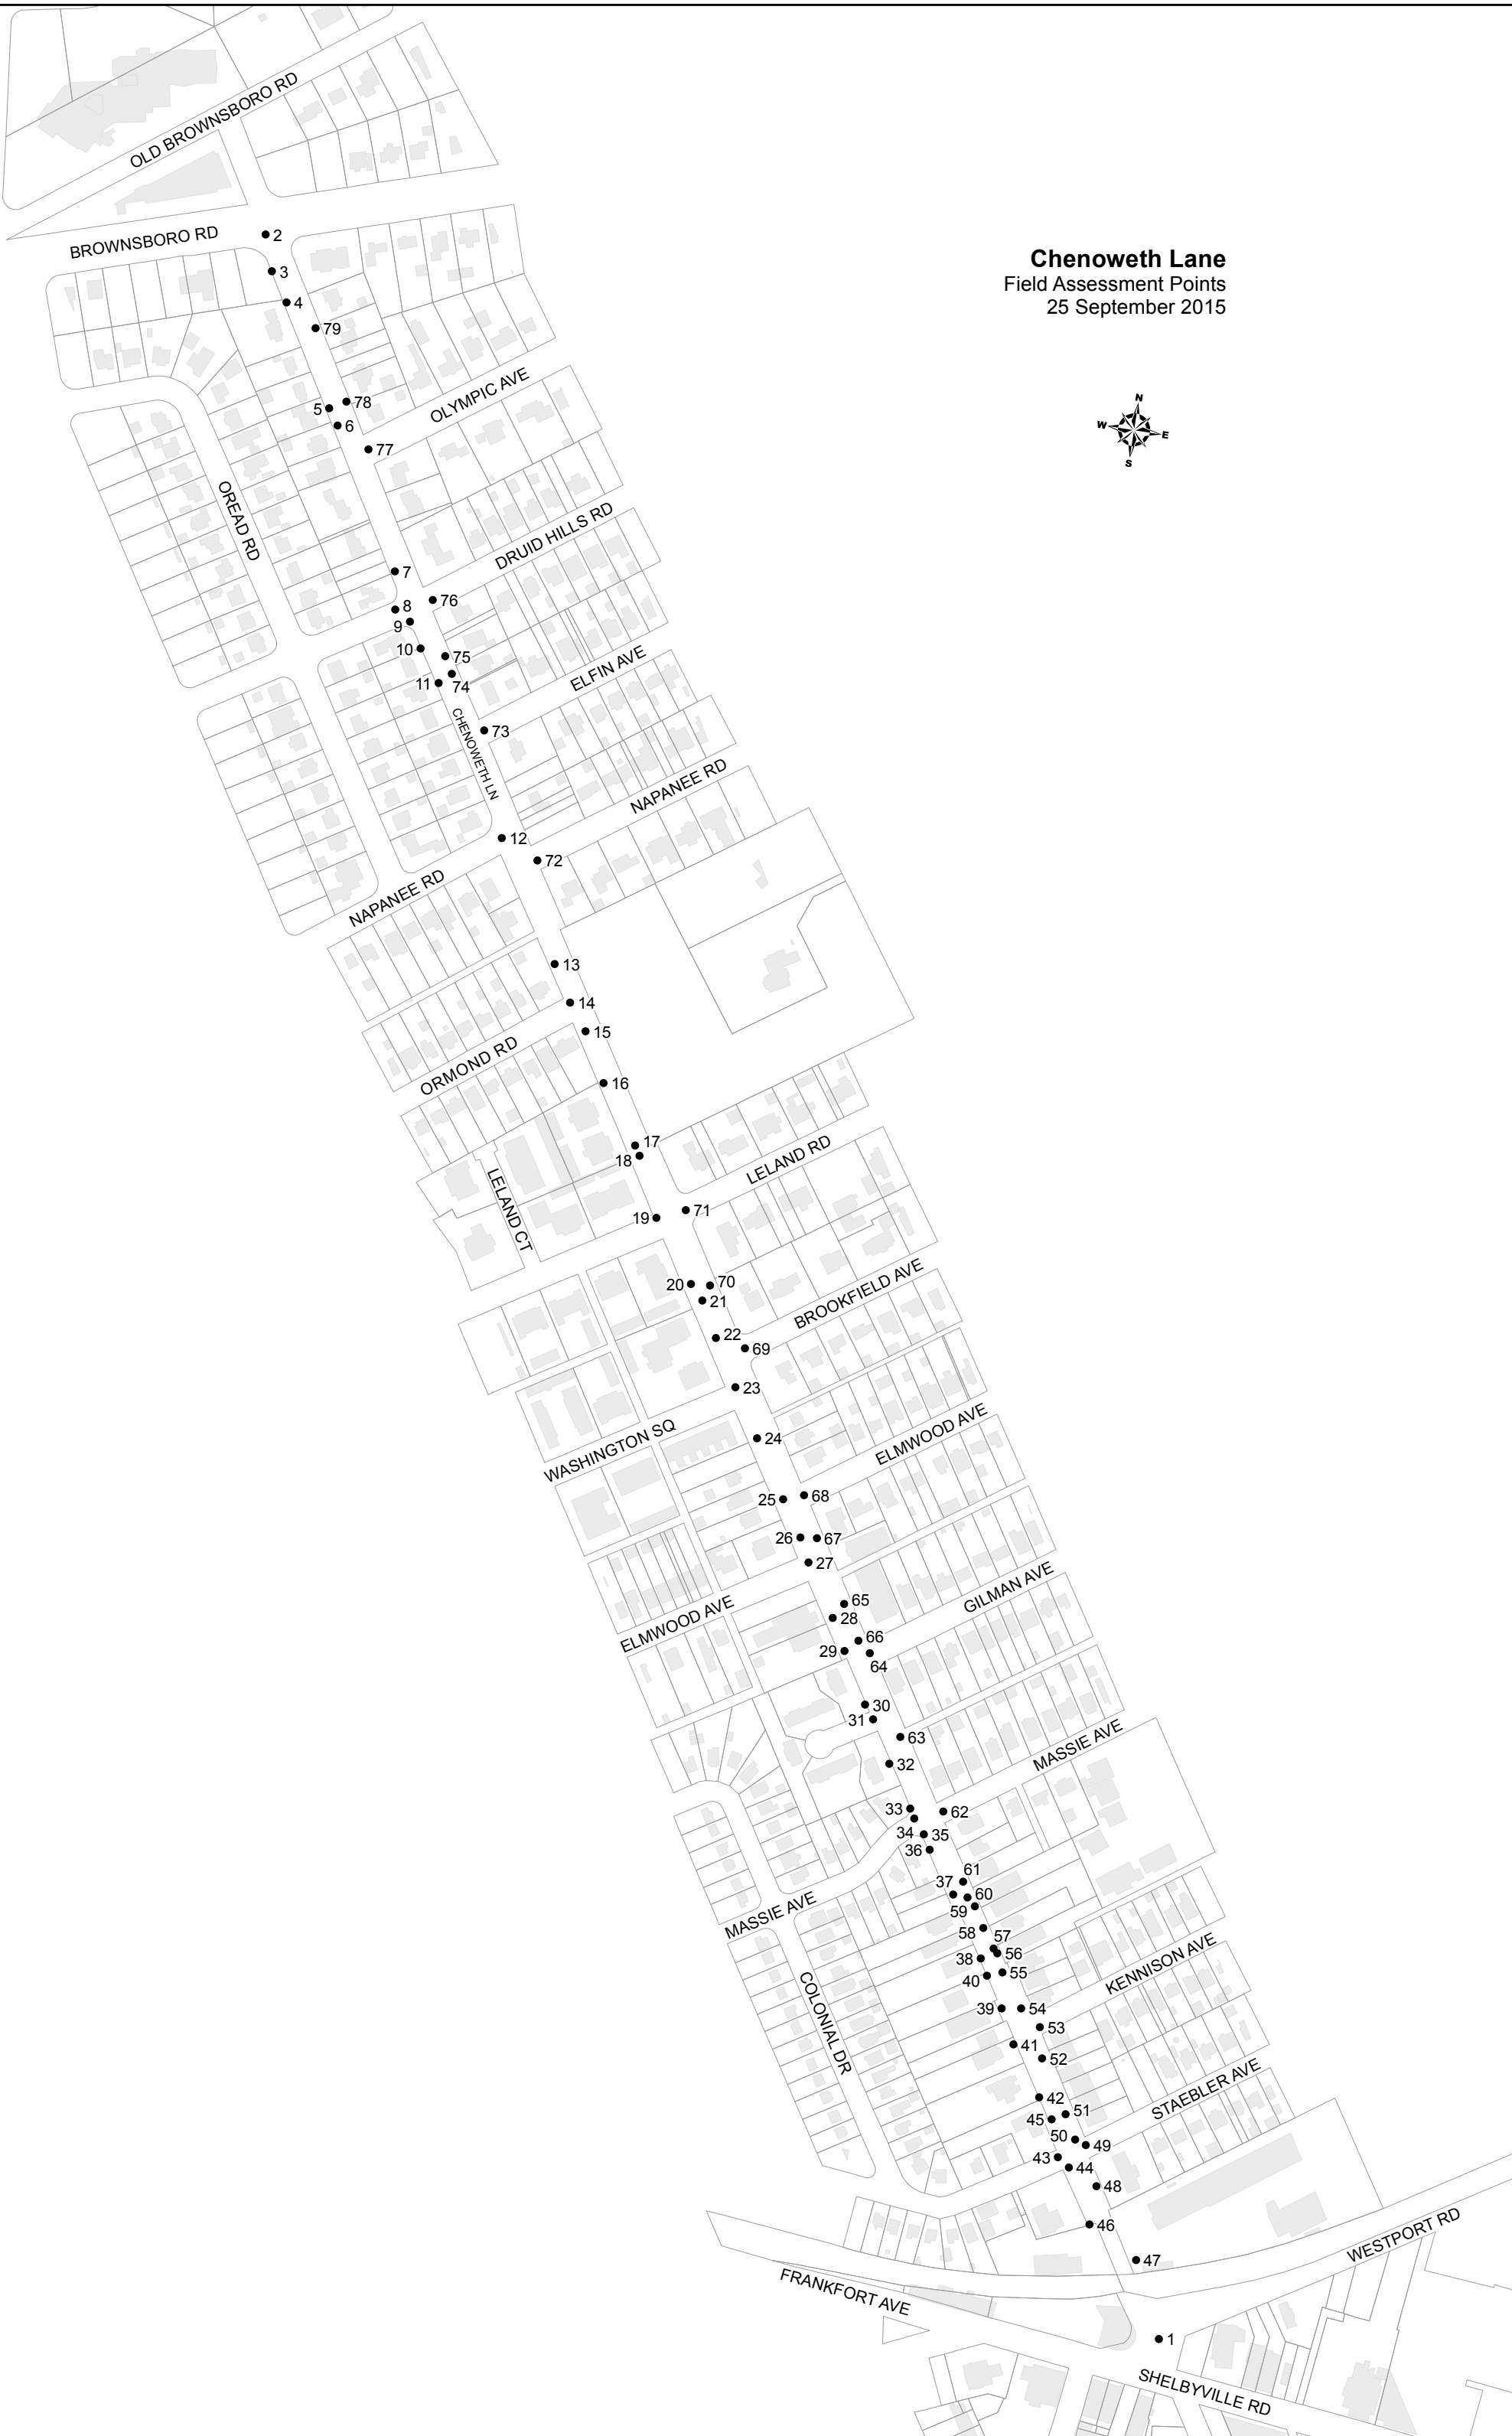
Name	Descript
POI 1	Chenoweth and Westport intersection
POI 2	Chenoweth and Brownsboro intersection; Crosswalks exist on all legs, thermo stripe with decorative patterned/colored crosswalks, with color fading. Compliant accessible ramps in all directions, with ped signals and actuated button controllers. Bad utilit
POI 3	Water meters and steep shoulder conditions with large trees near R/w.
POI 4	End of curb and gutter, no roadside ditch to south.
POI 5	Loop driveway in R/w
POI 6	Sanitary manhole in shoulder.
POI 7	Large tree in shoulder, hackberry.
POI 8	Druid Hills Road, no sidewalk improvements.
POI 9	24" square drainage inlet, with 12" PVC outlet toward south.
POI 10	24" square yard drainage inlet, 12" pipe continues south.
POI 11	18" dia. Yard inlet, outlet condition undetermined. Still no defined roadside ditch.
POI 12	Napanee Road, 4' sidewalk on south side, terminates in dirt path at CL.
POI 13	Shallow roadside ditch begins north of Ormund Road.

POI 14	Ormund Road, no sidewalks. Corner drainage basins in mixed condition, north side covered/obscured; south 15" pipe heavily silted; west yard inlet shallow make-shift 12" pipe inlet.
POI 15	Roadside ditch continues south. Hydrant along R/w fence.
POI 16	12-15" rcp driveway pipe heavily silted with creek stone headwalls.
POI 17	18" rcp driveway pipe half silted with creek stone headwalls.
POI 18	18" cmp driveway pipe half silted with concrete headwalls.
POI 19	Leland Road, no sidewalks. 12" clay/12x15 trench box crossing with metal covers.
POI 20	18" rcp driveway pipe with creek stone headwalls.
POI 21	18" rcp driveway pipe with concrete headwalls.
POI 22	Abandon driveway entrance, 15" cmp heavily silted
POI 23	Washington Square, no sidewalks. 18" rcp cross drain with combo Dropbox/headwall inlet on north side. Pipe continues south beyond intersection.
POI 24	Dbl grate yard inlet, 18x36" grate over 48" manhole, with 30" pipe continuing south.

POI 25	Single grate yard inlet, 12x15" grate over small box, with 15" rcp outlet to east.
POI 26	Single grate yard inlet, 12x15" grate over small box, with 15" rcp outlet to east.
POI 27	Elmwood Avenue, no sidewalks. Custom drainage inlet on south side
POI 28	Single grate yard inlet, 12x15" grate over small box, with 15" rcp outlet to east.
POI 29	Single grate yard inlet, 12x15" grate over small box, with 15" rcp outlet to east.
POI 30	Single grate yard inlet, 12x15" grate over small box, with 15" rcp outlet to east.
POI 31	Chenoweth Court, no street sidewalks, only interior connects from street. Standard curb inlets on either side at back of radius. 12" rcp to east.
POI 32	Single grate yard inlet, 12x15" grate over small box, with 15" rcp outlet to east.
POI 33	36" dia grate over manhole, pipes undetermined.
POI 34	Massie Avenue, no sidewalks.
POI 35	4' Sidewalk along Chenoweth begins and continues south.

POI 36	36" dia grate over manhole, pipes undetermined.
POI 37	36" dia grate over manhole, pipes undetermined.
POI 38	36" dia grate over manhole, pipes undetermined.
POI 39	36" dia grate over manhole, in paved shoulder, pipes undetermined.
POI 40	4' sidewalk continues in generally good condition, but with areas of broken joints, settling, and non compliant slopes resulting.
POI 41	36" dia grate over manhole, in paved shoulder, pipes undetermined.
POI 42	36" dia grate over manhole, in paved shoulder, pipes undetermined.
POI 43	Staebler Avenue, no sidewalks, accessible ramps for walk along Chenoweth recently installed.
POI 44	36" square grate over manhole, at edge of third lane, pipes undetermined.
POI 45	Three lane section begins.
POI 46	36" square grate over manhole, at edge of third lane, in paved shoulder, next to curb inlet structure, pipes undetermined.
POI 47	Accessible ramps at Chenoweth Square entrance. 5' sidewalk continues north.

POI 48	6' total sidewalk with curb and decorative paver strip along Heine Brothers frontage.
POI 49	Staebler Avenue, 4' sidewalk along north side, 4' sidewalk continues north from from north accessible ramp. 24" square grate over manhole, within westbound lane, pipes undetermined.
POI 50	Curb inlet.
POI 51	4' sidewalk flush with paved shoulder.
POI 52	4' sidewalk flush with shallow concrete gutter.
POI 53	Kennison Avenue, sidewalks on both north and south sides; 4' south side intersects Chenoweth sidewalk with two steps (inaccessible) whereas north side is new 5' sidewalk intersecting in accessible transition to Chenoweth walk.
POI 54	Area of low broken sidewalk, asphalt overlay and broken settled areas.
POI 55	Silted abandon driveway pipe
POI 56	Silted 12" driveway pipe.
POI 57	12" square inlet.
POI 58	12" rcp driveway pipe.
POI 59	12" square inlet over manhole.
POI 60	12" silted driveway pipe. 4' Sidewalk in mixed quality but overall average condition, some areas of asphalt drive overlay and older sections of exposed aggregate.

Name	Descript
POI 61	Begin drainage ditch continuing north.
POI 62	Massie Avenue, 4' sidewalk on north side only, new accessible ramps along Chenoweth. 18" cross drain with broken concrete head walls.
POI 63	12" driveway entrance pipe no headwall.
POI 64	Gilman Avenue, 4' sidewalks on both sides between stone column signature pilasters. 15-18" cmp roadway cross drain.
POI 65	No walk across open parking lot for St Matthews Feed and Seed.
POI 66	12" yard inlet with 12" PVC to north. 12" cmp across parking lot frontage.
POI 67	12" cmp driveway pipe, silted.
POI 68	Elmwood Avenue, 4' sidewalks both sides, new accessible ramps along Chenoweth sidewalk. Undetermined roadway cross pipe.
POI 69	Brookfield Avenue, no sidewalks. New accessible ramps along Chenoweth sidewalk. No visible cross pipe.
POI 70	Undetermined driveway pipes, cmp silted.
POI 71	Leland Road, no sidewalks, new accessible ramps along Chenoweth. 12" rcp roadway cross pipe, with no head walls.

POI 72	Napanee Road, no sidewalks, new accessible ramps along Chenoweth.
POI 73	Elfin Avenue, no sidewalks, new accessible ramps along Chenoweth. 12" cmp roadway cross pipe. Sidewalks in much better condition from Napanee north.
POI 74	36" square drainage inlet, 8" and 24" pipes from north, 24" from west.
POI 75	8" clay driveway pipe with concrete headwall.
POI 76	Druid Hills Road, no sidewalks, new accessible ramps along Chenoweth.
POI 77	Olympic Avenue, no sidewalks, new accessible ramps along Chenoweth.
POI 78	8" correlated/PVC driveway pipe.
POI 79	8" cast iron driveway pipe across two driveways.
