## **GEOTECHNICAL OVERVIEW**

## P-008-2014

**SUBJECT:** Madison, Clark, Powell and Estill Counties

**Preliminary Geotechnical Assessment**

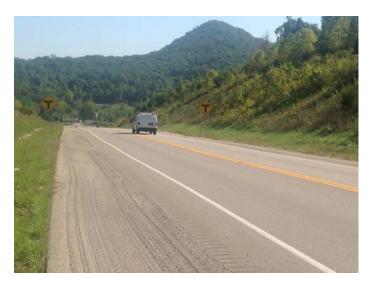
Typical Knob seen from KY 499

"The Knobs" is the physiographic region that borders the Outer Bluegrass. It consists of hundreds of isolated, steep sloping, often cone-shaped hills. Many of the knobs are still capped by erosionally-resistant limestones or sandstones. The sharp slopes of the Knobs are mostly composed of shales of the Mississippian-age Borden Formation, which are less resistant to erosion than the overlying limestones and sandstones. The base of the Knobs commonly contain Devonian black shales.

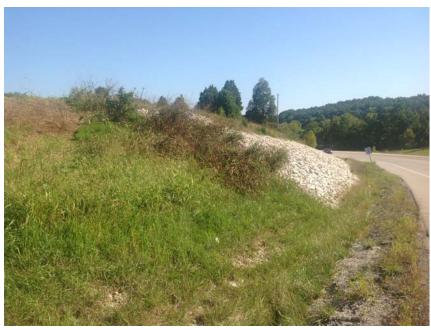
Landslide repair on relatively flat slope underlain by poor shales on KY 89 near Clay City.

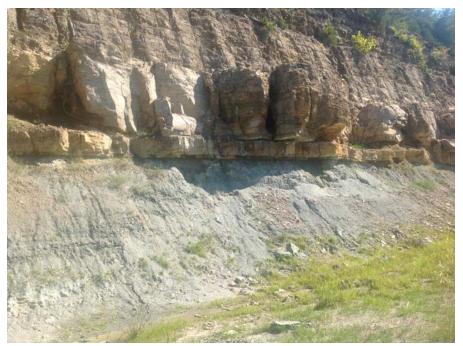
Shale weathering under weather resistant dolomite.

There are a number of existing rock cuts on the project which should be evaluated for remediation due to excessive weathering of shales underlying a more resistant cap bedrock. Some remediation has already taken place on numerous slopes in the project area.

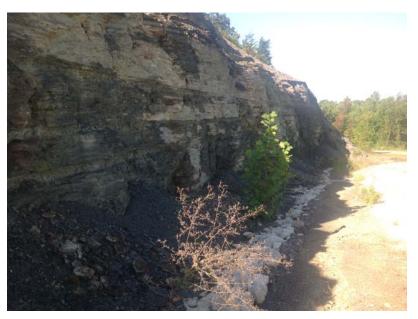
New Albany Shale in Cut near Clay City

New Albany (Black or Pyritic) Shale: Although this material tends to be more durable that some of the other shales in this area, it is known to produce acidic runoff. Mitigation is often required in cuts and this mitigation can be a major design concern. The potential to encounter New Albany Shale will be prevalent through a large part of the project, especially in the east.

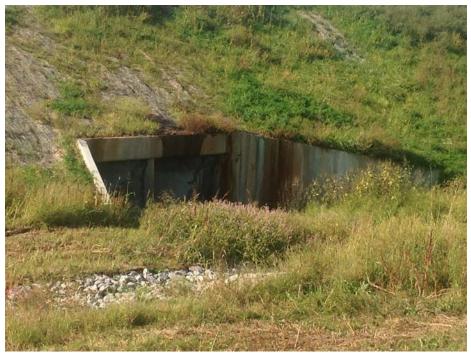
Box Culvert under Mountain Parkway Ramp near Kiddville showing staining due to Acidic runoff from New Albany Shale Backfill.

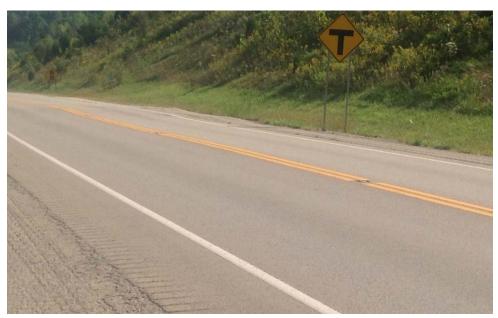
Irregular (wavy) Pavement due to swelling shales on KY 499

Crab Orchard Shales: At KY 499 near Irvine the Crab Orchard Formation was encountered during construction. Special Shale Compaction was utilized for construction of the fills. The fills appear to be stable. Shortly after construction it was noted that the roadbed was heaving in the cut sections. Through investigation it was found that the Crab Orchard Shale at this location, due to its material characteristics, was prone to swelling. It would appear that this swelling continues to this day as the roadbed appeared wavy upon inspection. Any cuts in this vicinity that encounter the Crab Orchard Formation should warrant particular attention. Fills should utilize Special Shale Compaction.
