First Look Study  
Replace Bridge and Approaches  
Over Turtle Creek

Long Stretch Road  
Item No. 6-1068.00  
Bracken County, CR-1023

Prepared By:  
Kentucky Transportation Cabinet (KYTC)  
Denise Ford, EIT & KYTC District 6

March 1, 2011

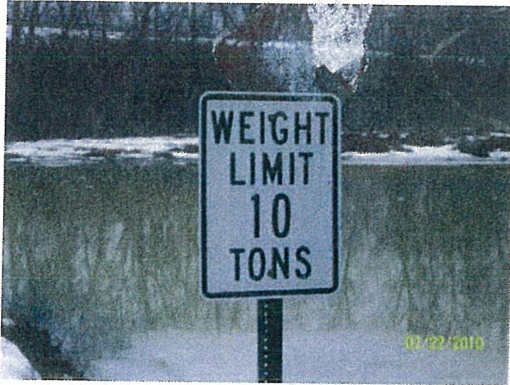
Weight Limit Sign at the forward approach (10 tons)

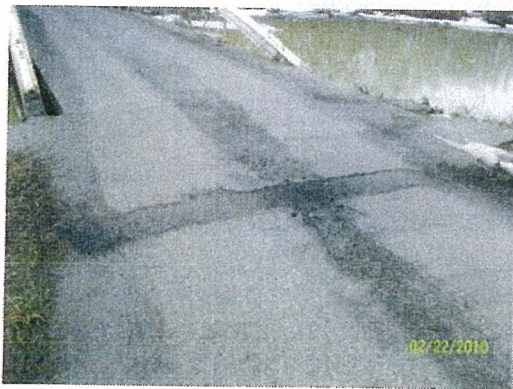
Approach transition at the forward location

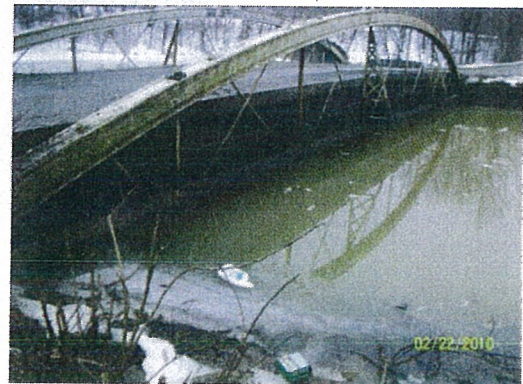
Right side view of structure, note clearance between lower chord and surface of stream

The existing bridge is structurally deficient, and is within the flood plain. Currently the pool channel is only 8" from the bottom chord element of the bridge. See KYTC Bridge Inspection Report Appendix E.

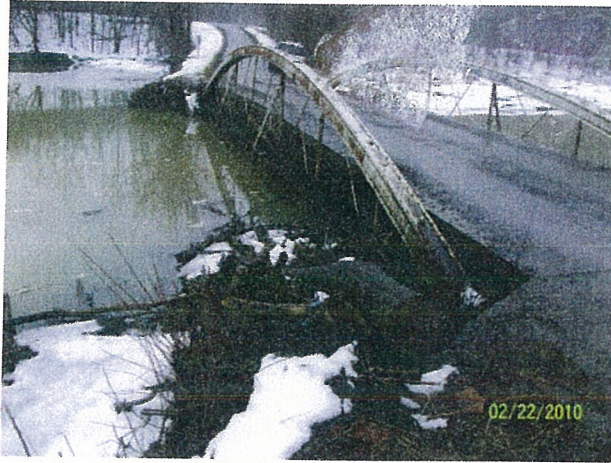
Left side view of structure, note  
channel drift debris

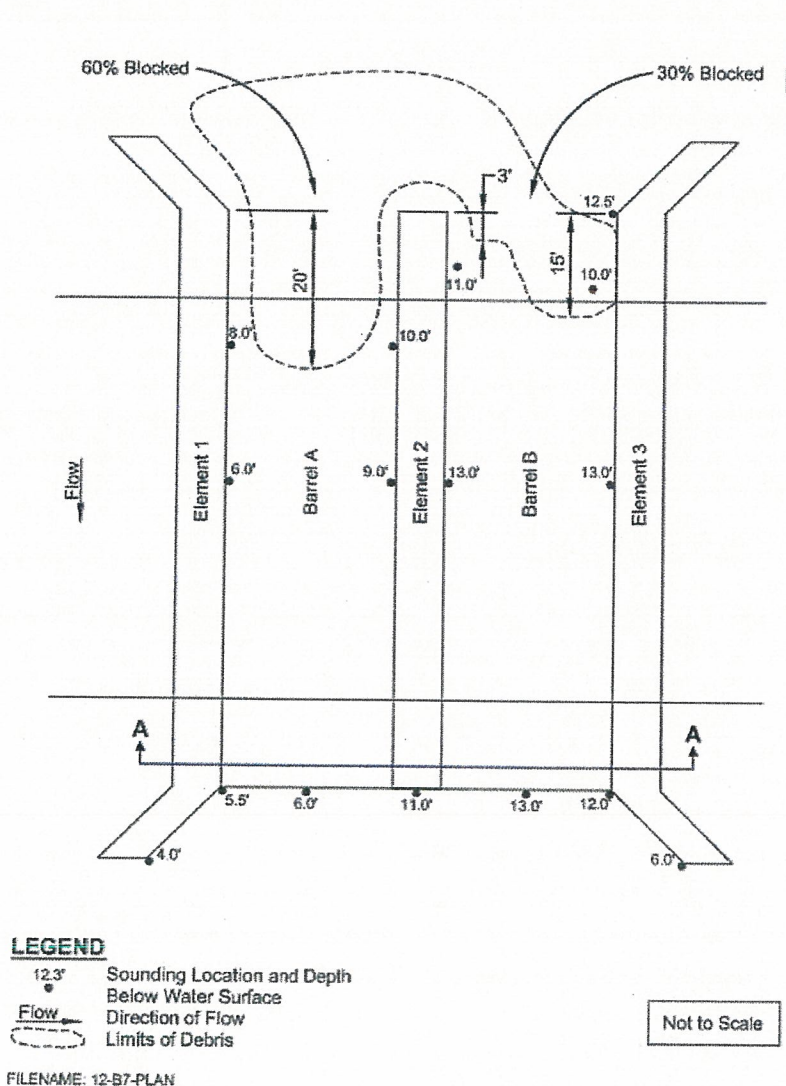
FILENAME: 12-B7-PLAN

Description Plan View Crew AAC, JCG, RBC, TCB

**NOTE:** All depths refer to depth below water surface at time of inspection

1. There is 2 inches of separation between the northeast wingwall and headwall.
2. There is a crack located 70.0 feet south of the north face, the crack extends in the transverse direction on Element 1, 2 and 4. The crack varies across the elements from hairline to 1 inch on the east side of Element 2, the maximum penetration is 2 1/2 inches.
3. The diver could not pass all the way through the barrel. The upstream end is blocked approximately 60 percent by debris with a penetration into the culvert of 20 feet.

1. There is a 3 inch gap between southwest wingwall and headwall.
2. The floor is exposed with very little sediment on approximately 90 percent of the culvert.
3. The bottom of the culvert is 13.0 feet below the water surface.
4. There is a crack located 70 feet south of the north face, extending from Element 2 across Element 5 and down Element 3. The crack varies from hairline across the roof to 6 inches wide at the floor on Element 3 with 6 inches of penetration.
5. At 3 feet off the bottom of the culvert on the east wall of the culvert is a spall 6 inches tall and 1 foot wide with 3 inches of penetration.
6. The diver could not pass all the way through the barrel. The upstream end is blocked approximately 30 percent by debris with a penetration into the culvert of 35 feet.
7. The roof cracks show some efflorescence and branching.

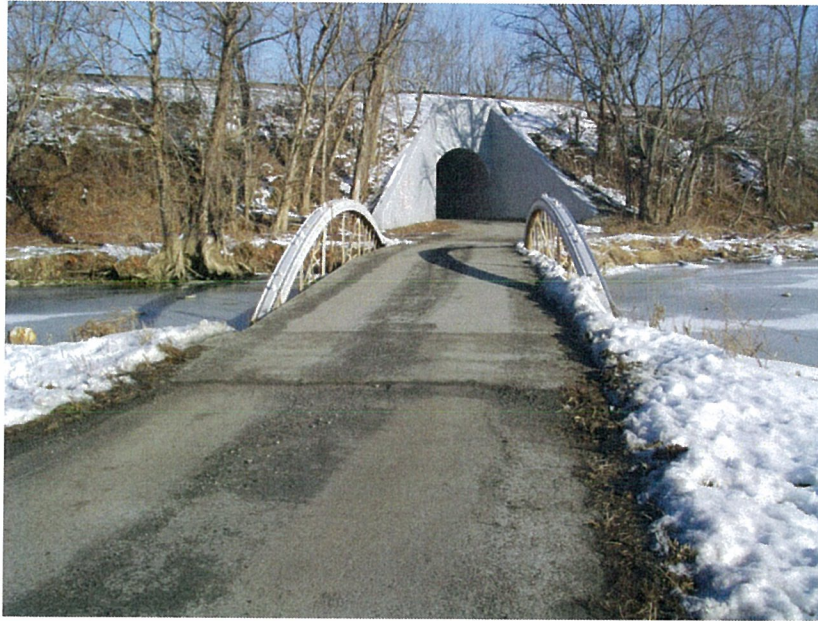
Bridge over Turtle Creek looking north

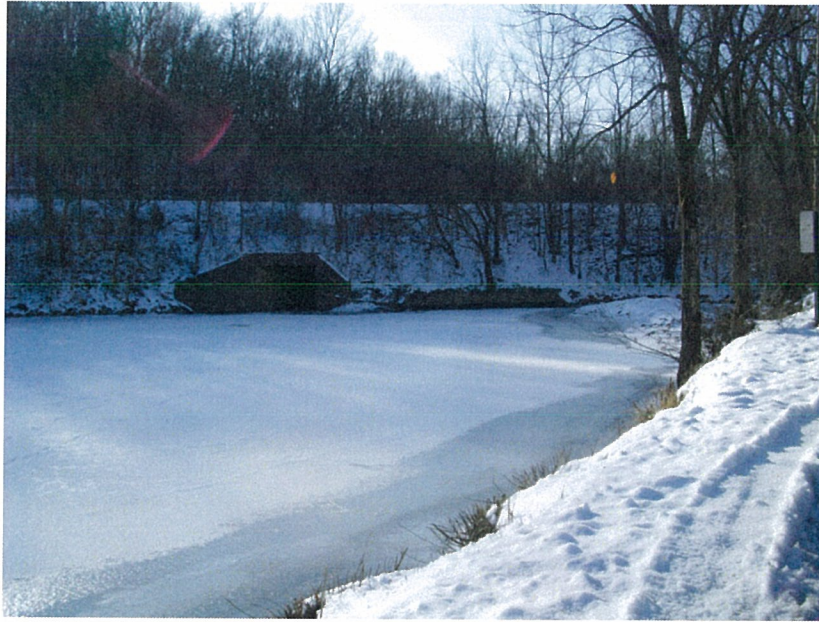
Estimated Single 12 ft X 12 ft Reinforced Concrete Culvert and Double 14 ft X 14 ft Reinforced Concrete Culvert at KY 8

There are two culverts upstream from the bridge. One is a 14 ft X 14 ft double reinforced concrete culvert on the bridges inventory list.

See Culvert Inspection Report in Appendix E. The culvert is submerged, and both barrels are blocked with debris. There are cracks in the vertical members, and in both roof sections near the mid-point. The second culvert is newer, and it is estimated to be a single 12 ft X 12 ft culvert.
