# KY 151 Safety Study

## Anderson and Franklin Counties

From US 127 to I-64  
Alton Road/Graefenburg Road

Prepared by  
**Kentucky Transportation Cabinet**  
Division of Planning  
November 2016

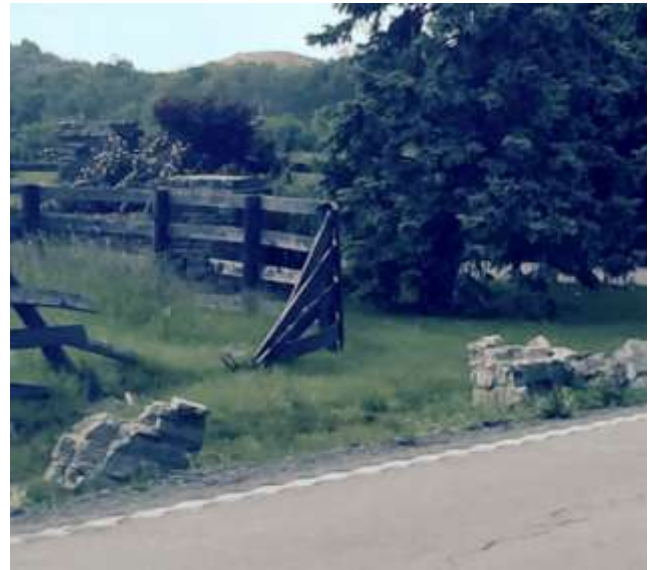
Fence and mailbox damaged by CMV crash in 2016

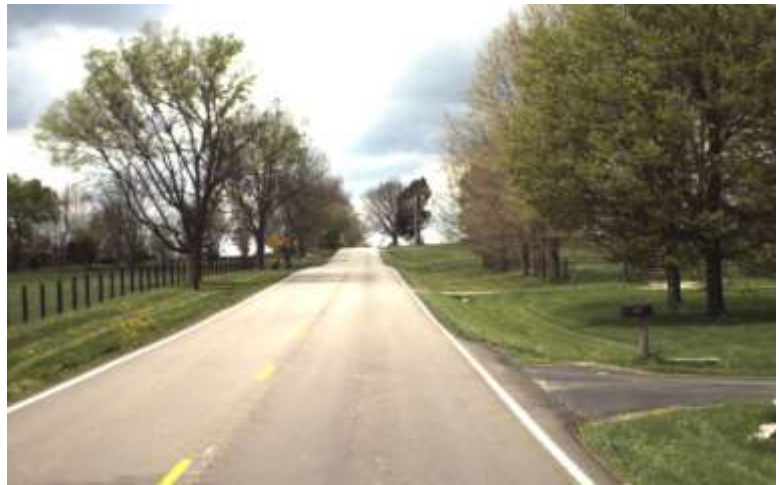
Figure 1 – KY 151 Safety Study Corridor

The KY 151 study corridor is a two-lane roadway which connects US 127 in Anderson County north of Lawrenceburg to I-64 in Franklin County west of Frankfort as shown in **Figure 1 (p.2)**. The study corridor is approximately 6.9 miles in length and runs approximately south to north. The southern section of the roadway is locally known as Alton Road, while the northern part is known as Graefenburg Road. KY 151 in Anderson County begins at milepoint (MP) 0.0 at the US 127 intersection, and ends at the Anderson/Franklin County line, MP 4.587. The KY 151 study area in Franklin County begins at MP 0.0 at the Anderson/Franklin County line, and continues to MP 2.3 at I-64. KY 151 continues north of the I-64 interchange and ends at US 60 (MP 3.22).

The KY 151 study corridor, highlighted in yellow in **Figure 1 (p.2)**, serves as a shorter route between locations south of the KY 151 and US 127 intersection, and locations west of the KY 151 and I-64 interchange. The alternative route, highlighted in orange in **Figure 1 (p.2)**, using US 127 to travel north to the US 127 and I-64 interchange, then traveling west on I-64 to the I-64 and KY 151 interchange, adds approximately 5 miles length, and 7½ minutes of travel time, versus using the KY 151 corridor. US 127 is a four-lane divided principal arterial roadway with a median and 4- to 10-foot paved shoulders.

The previous study, titled *Route Study, KY 151 Alton Bypass from North End of Lawrenceburg Bypass to the Anderson-Franklin County Line and US 127 Alton Bypass*, was completed in 1969 prior to the construction of US 127 in its current location. Old Frankfort Road, US 512, was the original alignment of US 127, see **Figure 1 (p.2)**. The study looked at alternative alignments for US 127 to bypass the community of Alton.

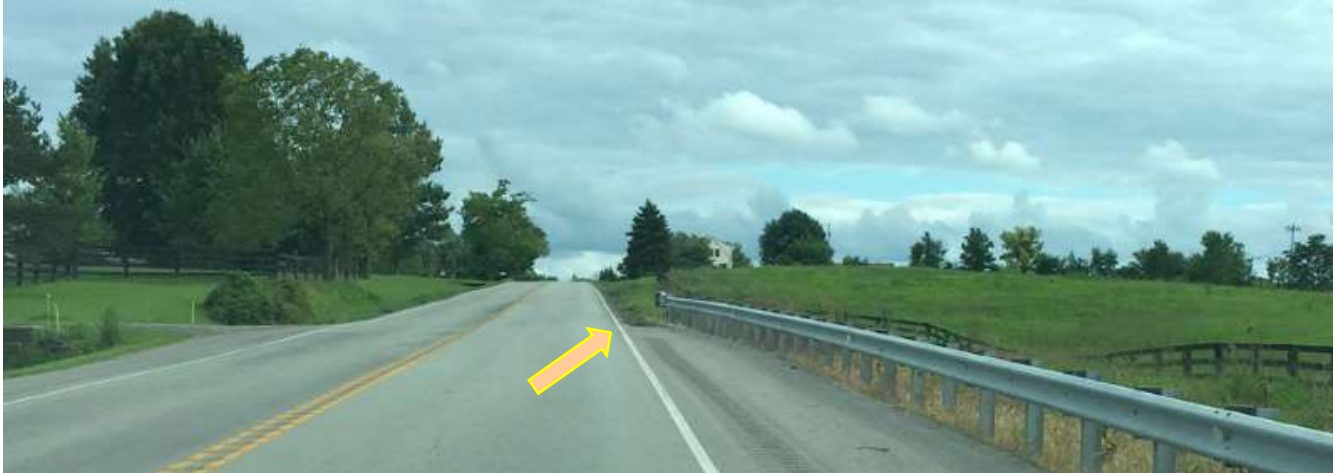
**Change in paved width at MP 4.1, Anderson County, looking southbound**

To mitigate the possibly low or narrow shoulders contributing to the CMV crashes at the three locations, the shoulders between Alton and MP 4.1 have been widened to address the initial findings of this study.

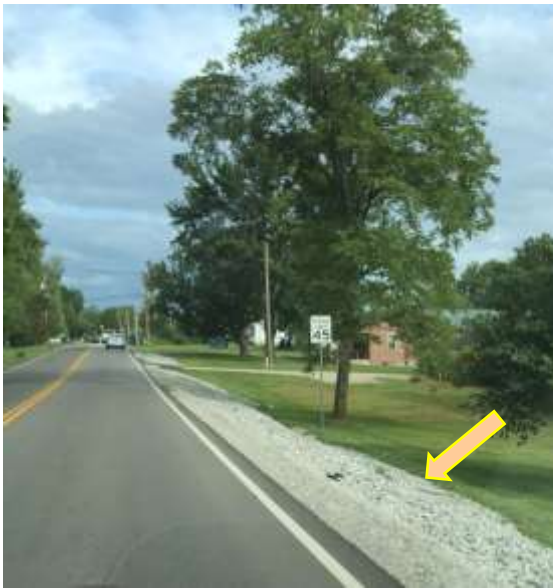
**Shoulder widening in Alton area**

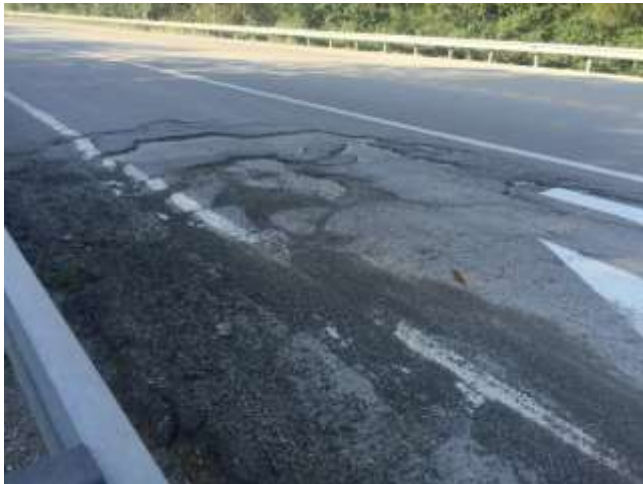
Since the 2014 inspection, minor localized spots of asphalt pavement mat tearing and shoulder failure caused by the turning movements of garbage trucks were noted in the southbound right turn lane in close proximity to the landfill in Franklin County. This type of distress is considered a materials application related failure.

Asphalt mat tearing

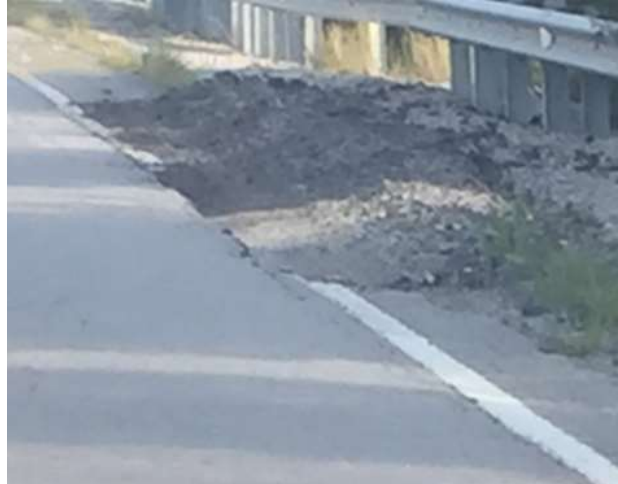
Shoulder failure
