PHOTOGRAPHS

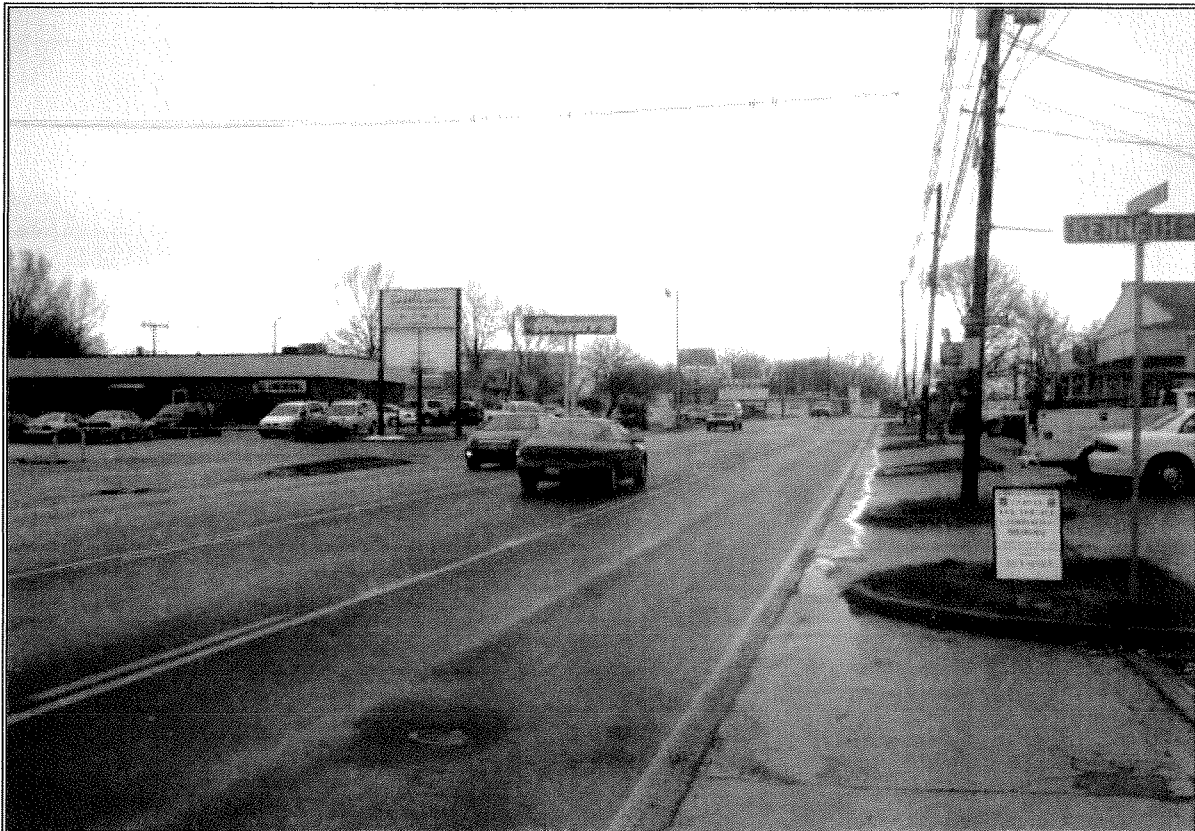
Photograph 1: Typical view of northern portion of proposed corridor, looking southwest from near the northern terminus at Strawberry Lane. Many businesses on the north (right) side of the road are very close to the existing roadway. Southside Drive Widening. December 6, 2004.

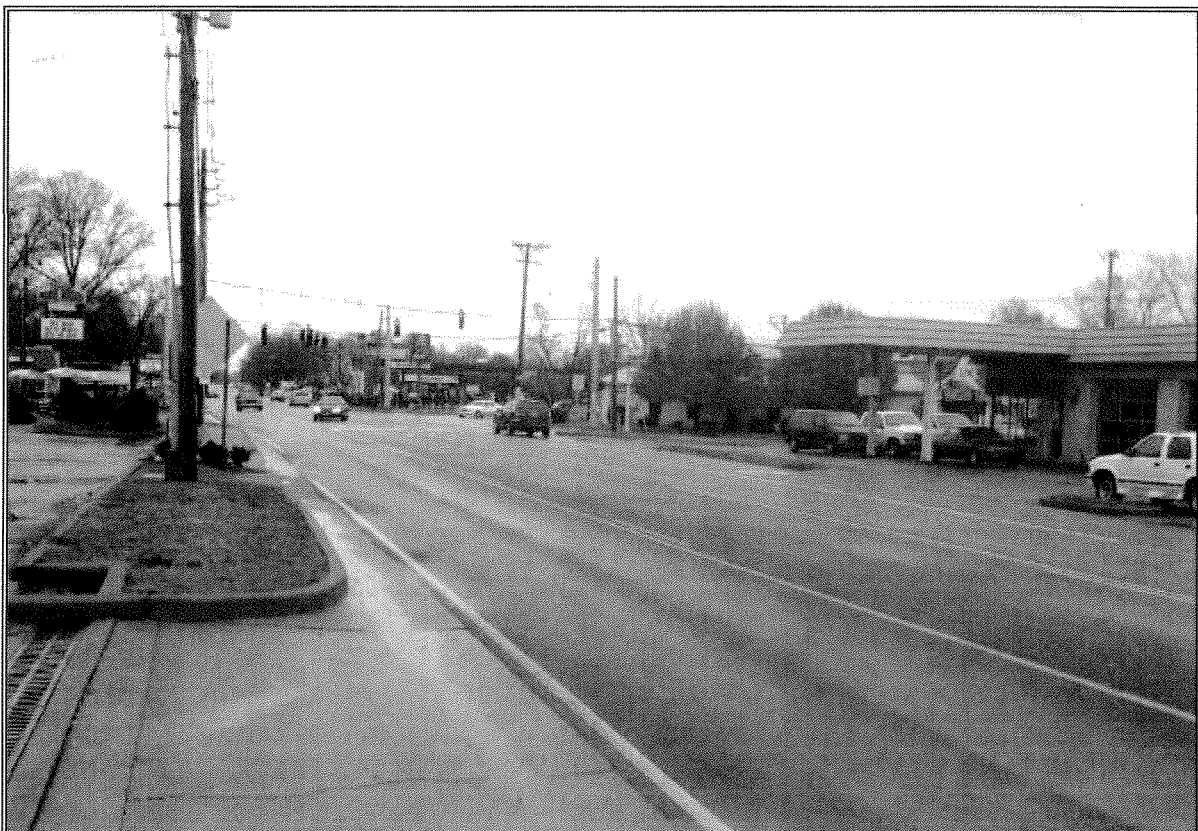
Photograph 2: View of northern terminus of the corridor at the intersection of Southside Drive and Strawberry Lane. Currently, the intersection is five pointed as it includes the dead-end Roberts Avenue, which runs behind the vacant service station (right side of photograph). Southside Drive Widening. December 6, 2004.

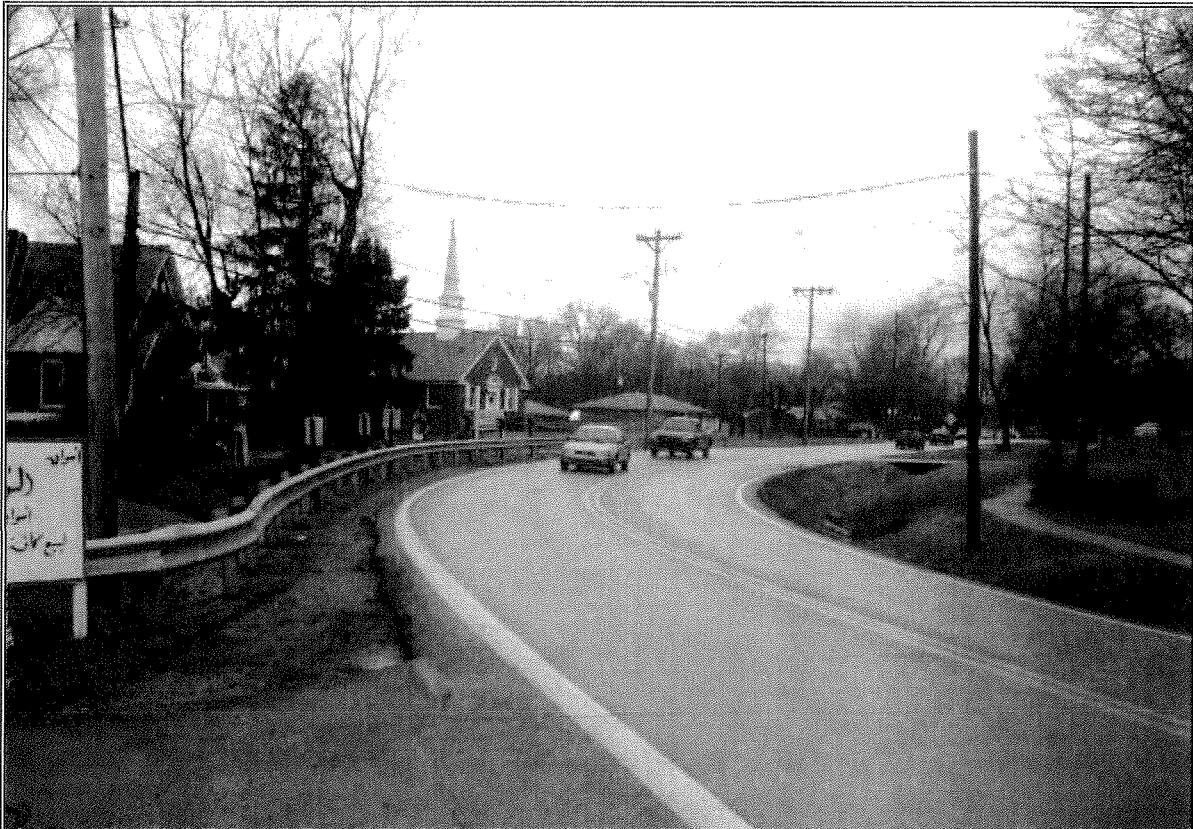
Photograph 3: Typical view of the southern portion of the project corridor, looking west from east of Saint Mark's Church. This section is dominated by single-family residential development. Southside Drive Widening. December 6, 2004.

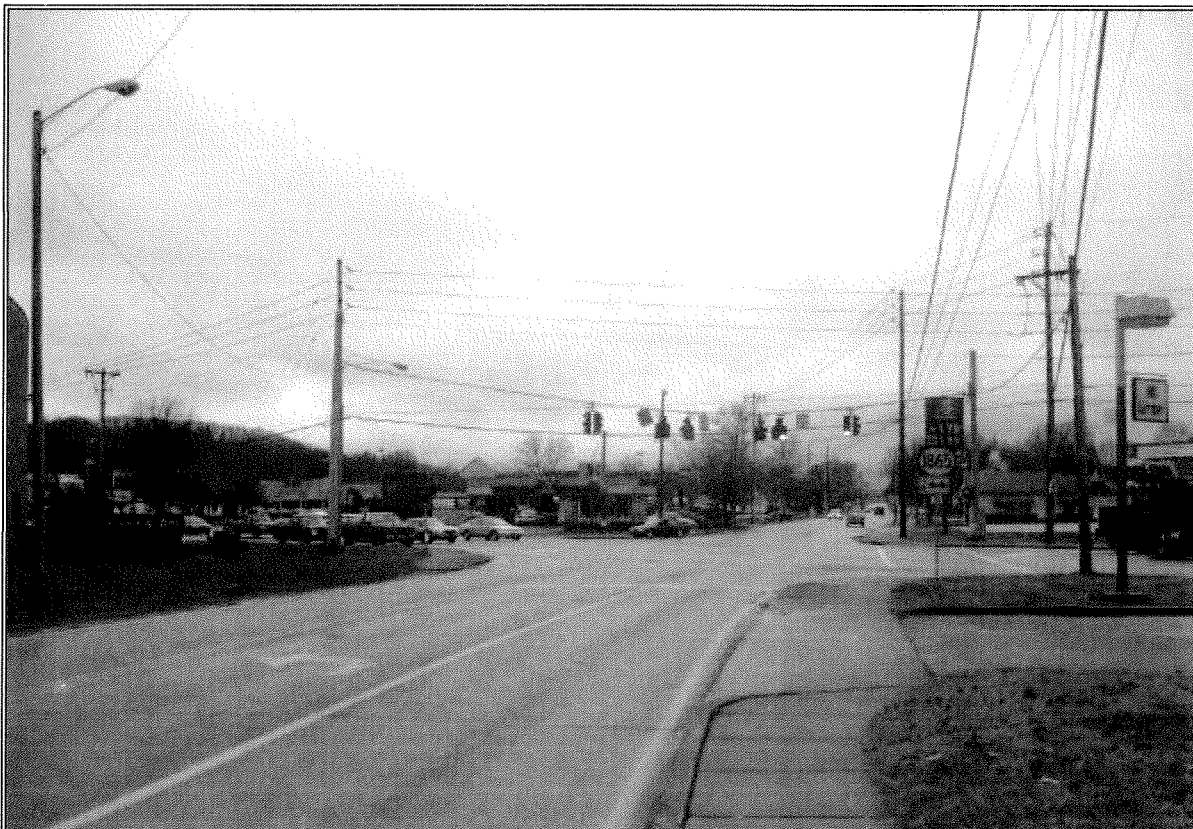
Photograph 4: View of southern terminus of the corridor, looking southwest along Southside Drive at New Cut Road. Properties around the intersection include Our Lady of Mount Carmel Church and School, and one active and one vacant gas station. Southside Drive Widening. December 6, 2004.

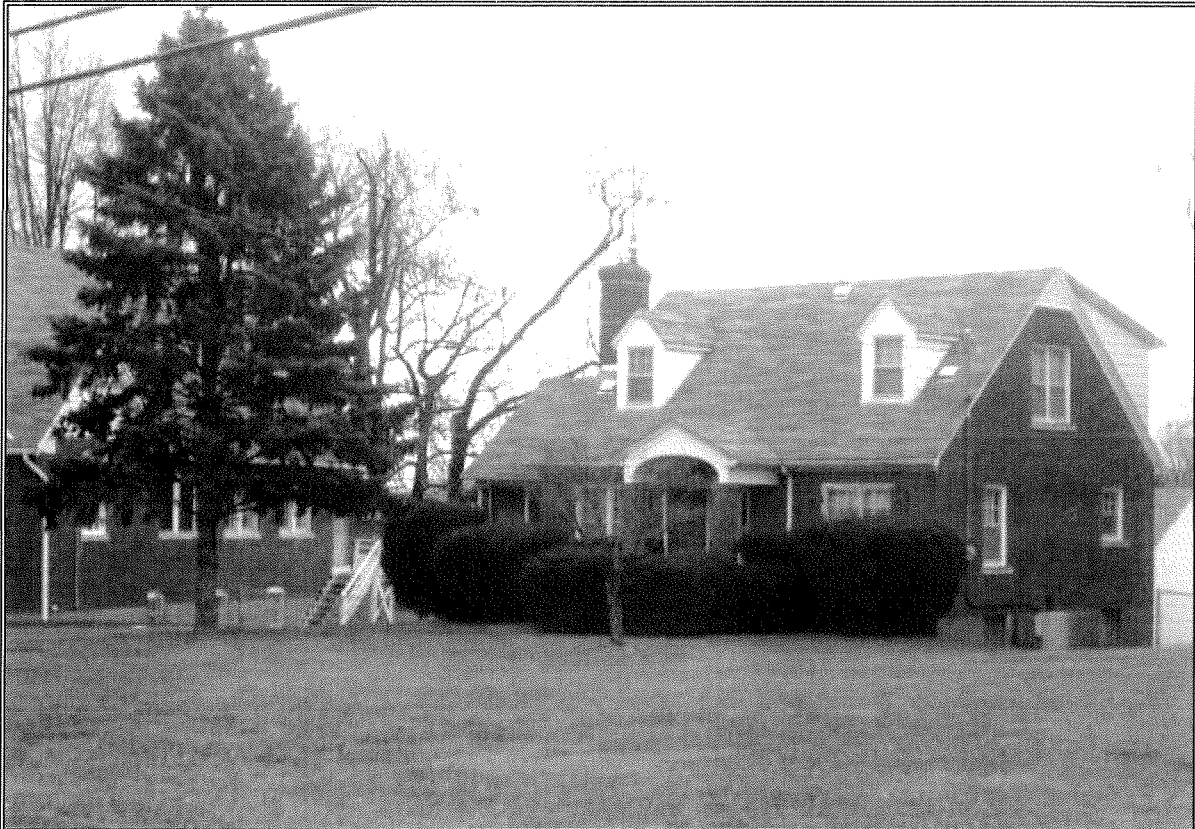
Photograph 5: Two buildings on the Saint Mark's Lutheran Church property meet National Historic Register criteria and present potential Section 4(f) issues. Southside Drive Widening. December 6, 2004.

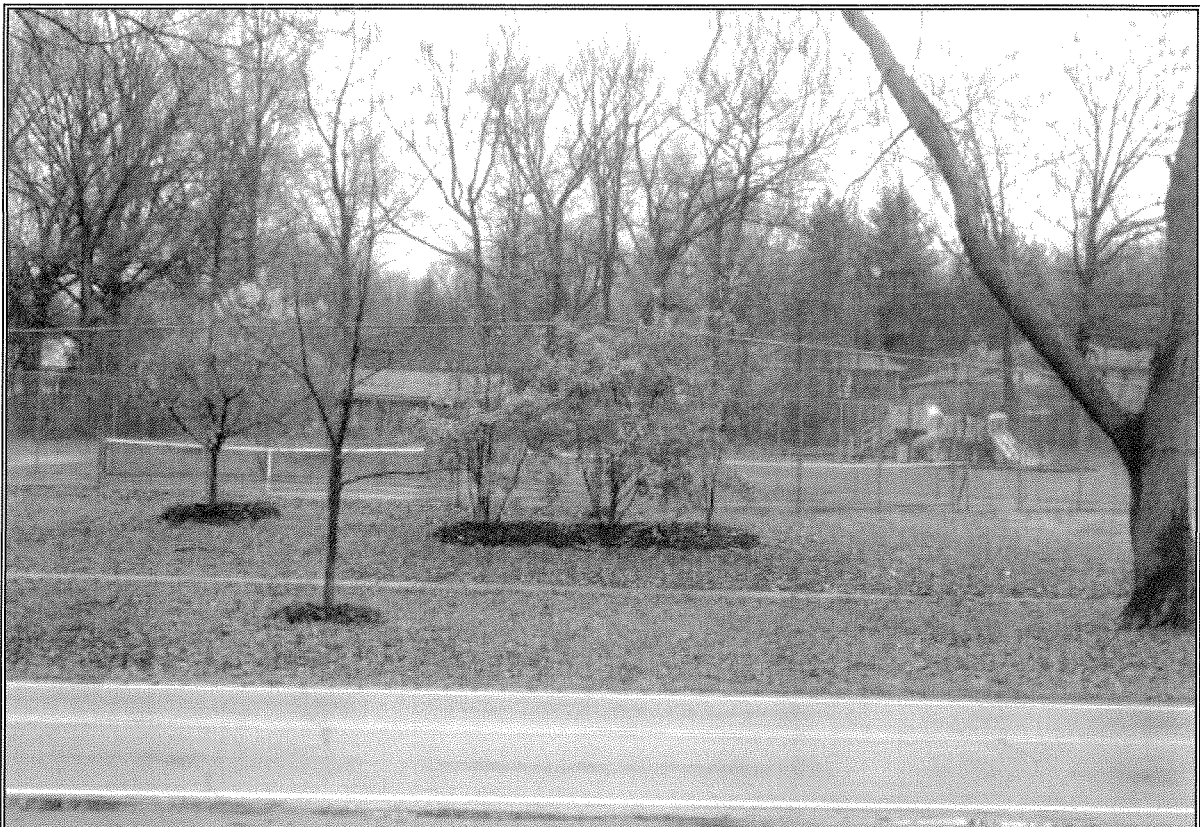
Photograph 6: The approximately four-acre Auburndale Park is located in the southern portion of the project corridor. Any impacts to the park will require Section 4(f) coordination. Southside Drive Widening. December 6, 2004.

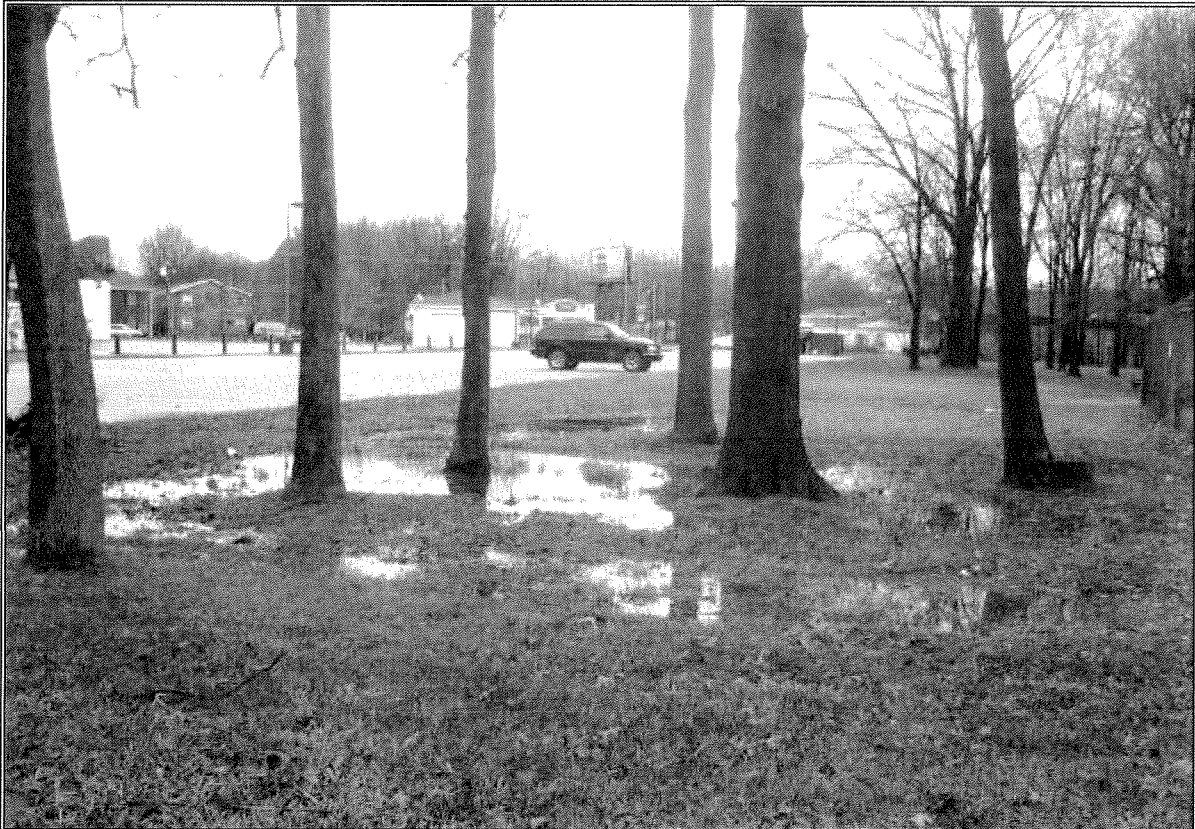
Photograph 7: View of one wetland in the project corridor, located west of 7328 Southside Drive. Southside Drive Widening. December 6, 2004.

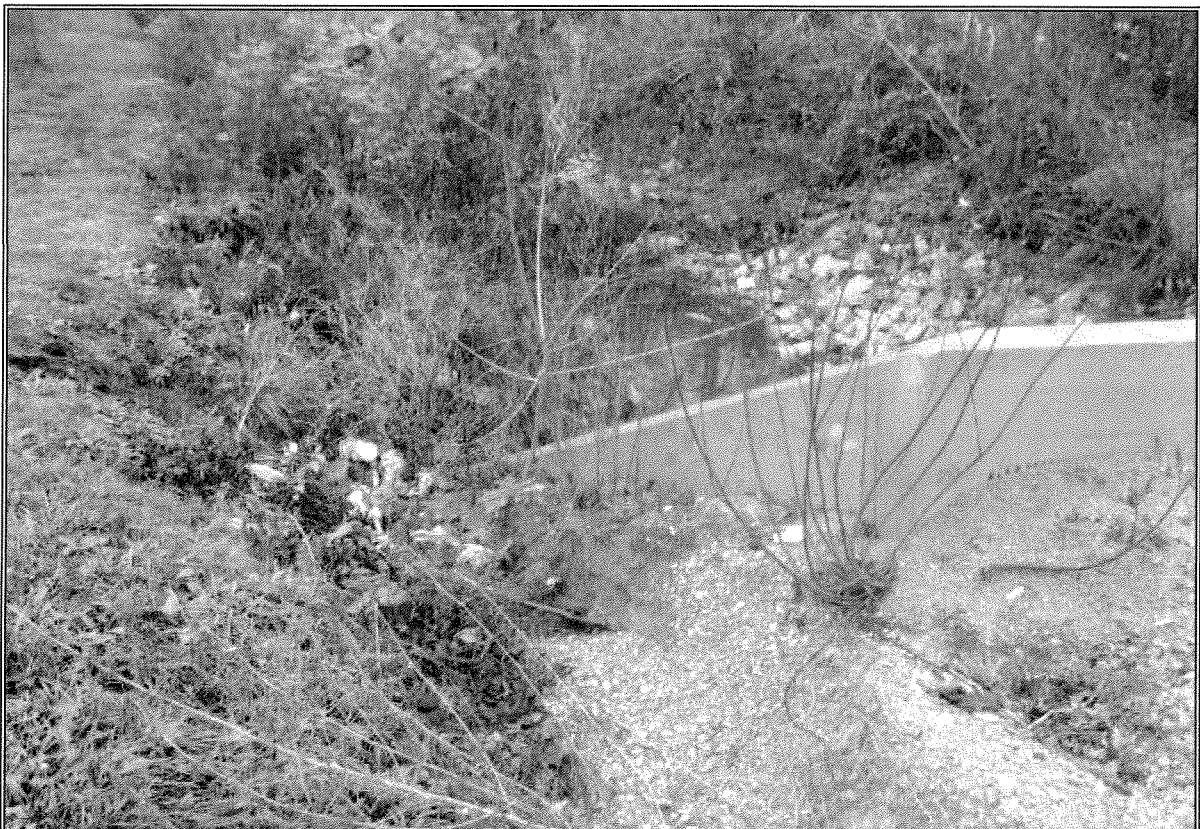
Photograph 8: View of an unnamed ephemeral stream crossing, west of 7031 Southside Drive. The stream emerges from a culvert on the south side of the road but lacks an aboveground channel on the north side of the road. Southside Drive Widening. December 6, 2004.
